HAZARDOUS MATERIALS SURVEY AND 2023 REASSESSMENT 104 HENDERSON AVENUE, OTTAWA, ON

Project No.: Z2021102HZ/ CCC-230252-00

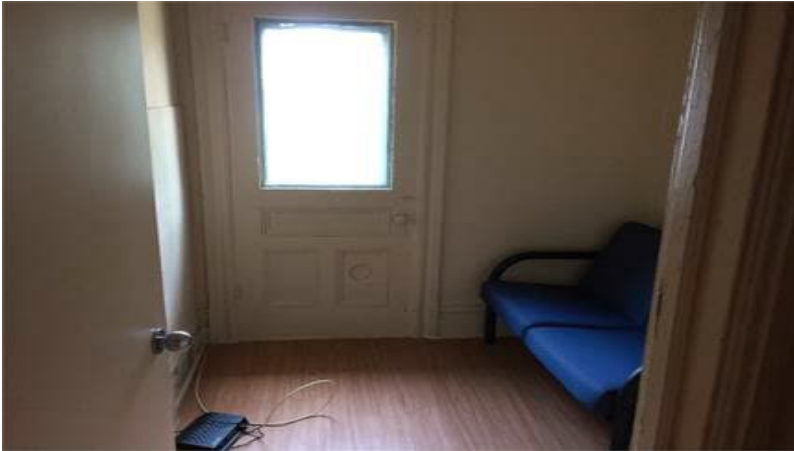
Photo 1: View of typical finishes observed at the building located at 104 Henderson Avenue.

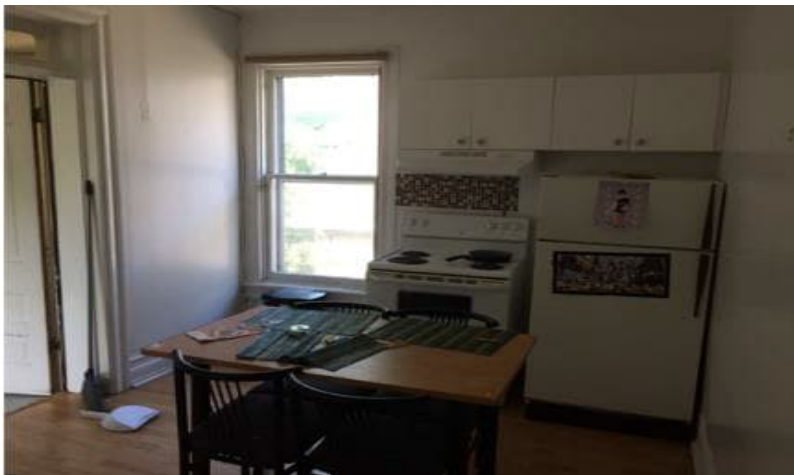
Photo 2: View of typical finishes observed at the building located at 104 Henderson Avenue.

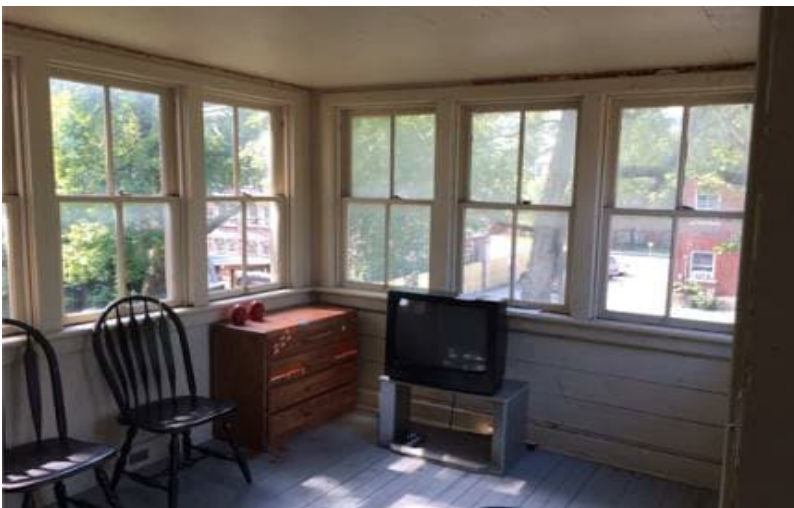
Photo 3: View of typical finishes observed at the building located at 104 Henderson Avenue.

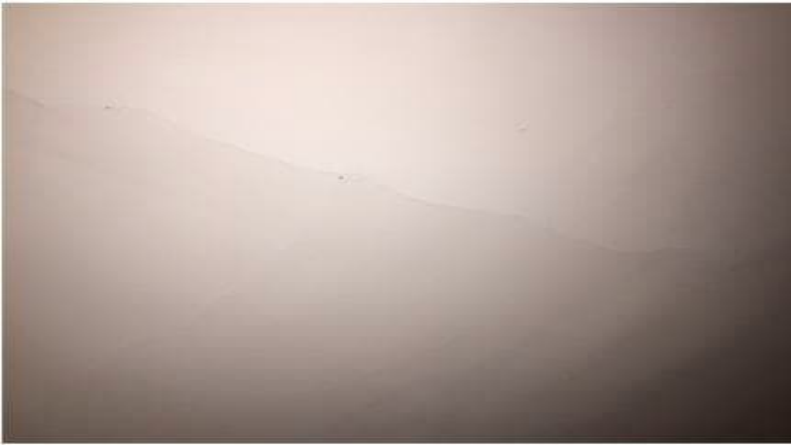
Photo 4: View of asbestos-containing ceiling plaster observed to be in fair condition in Room B on the 1st floor of the subject building.

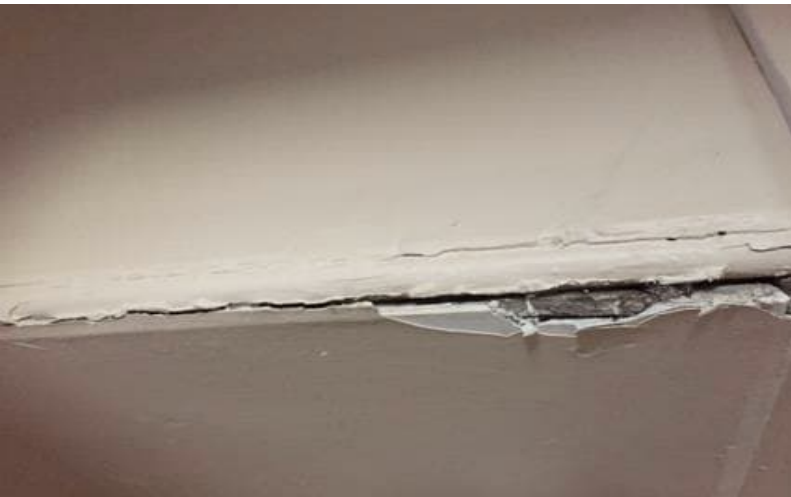
Photo 5: View of asbestos-containing ceiling plaster observed in poor condition in the hallway on the 2nd floor of the subject building

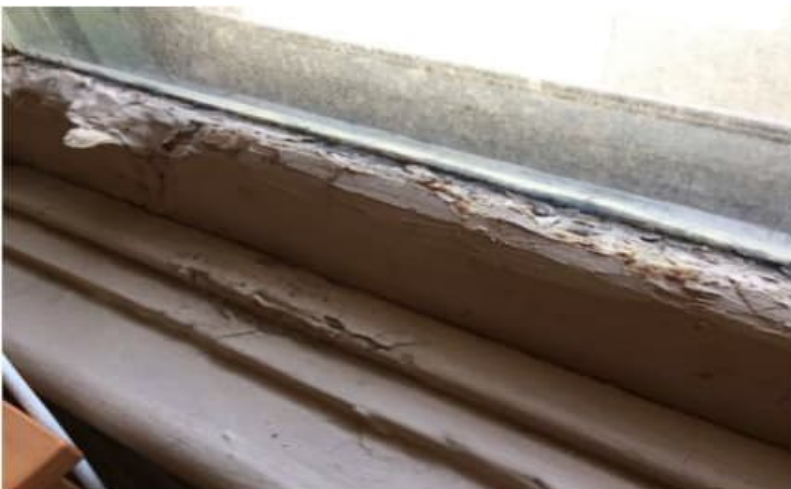
Photo 6: View of lead-containing beige paint observed to be in fair condition in Room A on the 2nd floor of the subject building.

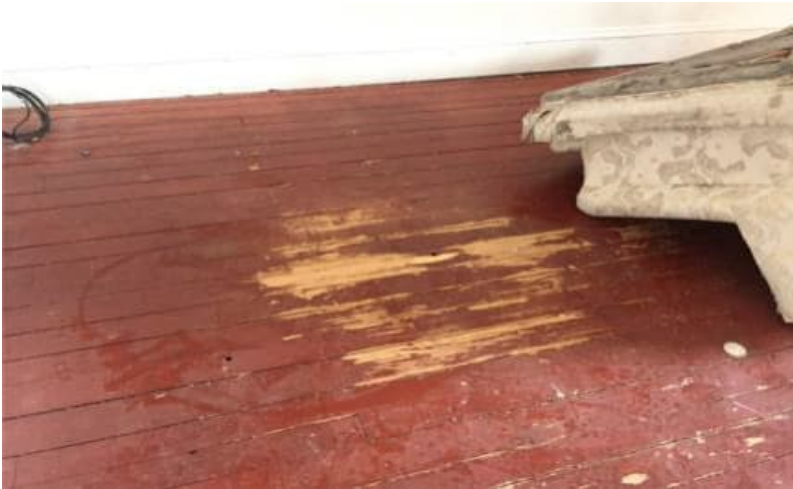
Photo 7: View of lead-containing maroon paint observed to be in poor condition in Room B on the 3rd floor of the subject building.

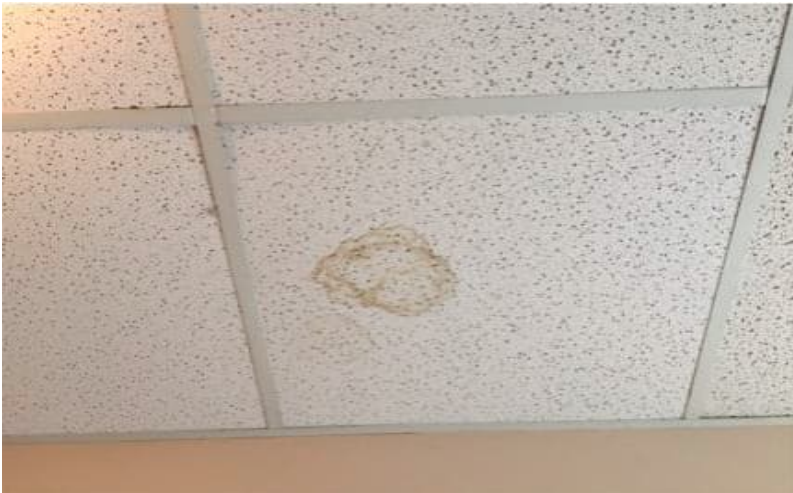
Photo 8: View of water-damaged ceiling tile observed in the living room on the 1st floor of the subject building,

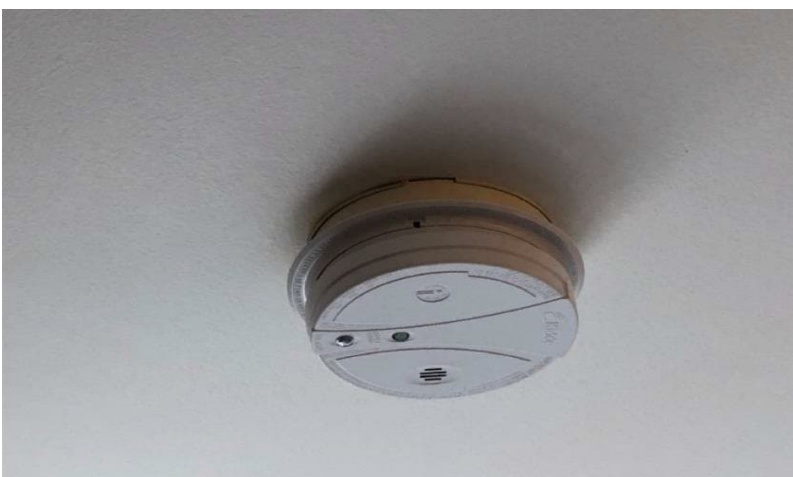
Photo 9: Typical view of smoke detectors containing radioactive materials.
