# HAZARDOUS MATERIALS SURVEY AND 2023 REASSESSMENT 112 HENDERSON AVENUE, OTTAWA, ON

Project No.: Z2021102HZ/ CCC-230252-00

University of Ottawa

McIntosh Perry Limited (MPL)

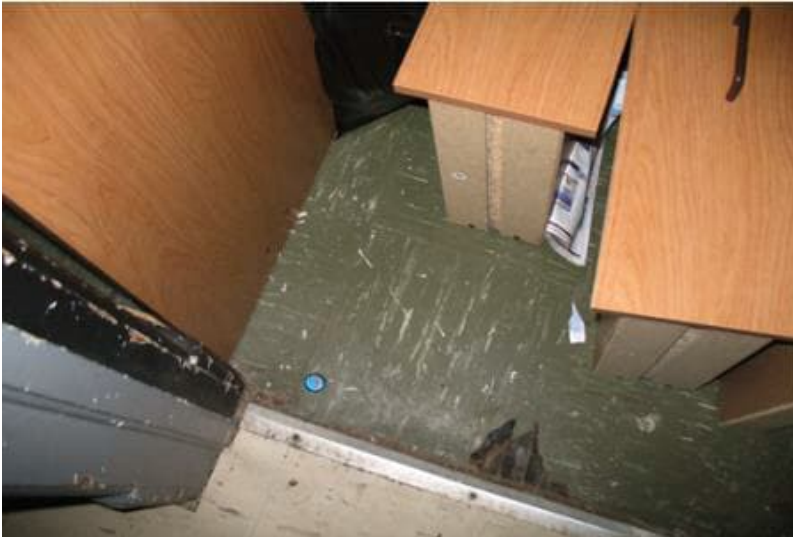
- Previously identified vinyl floor tiles (12"x12" – Green with White Dots) were observed in Room 102. The laboratory analytical results of the vinyl floor tile samples collected indicate that this material **contains 10.6% Chrysotile asbestos**. This material is considered non-friable, and it should be noted that this flooring was not observed but is suspected to be underneath newer flooring.
- Vinyl floor tiles (12"x12" – Grey) were observed on the top of the basement stairs (Room 110) of the subject building. The laboratory analytical results of the vinyl floor tile samples collected indicate that this material does not contain asbestos. The associated mastic (Black) does not contain asbestos.

**Photo 4:** View of previously sampled asbestos-containing vinyl floor tile in the southside bedroom, now presumed to be under new flooring. (Ref. 0459870 (27))

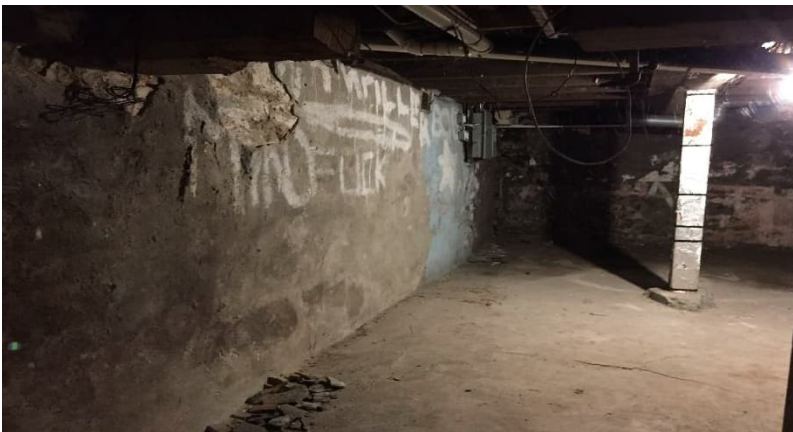
A texture coat was observed throughout the basement of the subject building. The laboratory analytical results of the texture coat samples collected indicate that this material **contains 3% Chrysotile asbestos**. This material is considered friable and was observed to be in good condition.

**Photo 5:** View of asbestos-containing texture coat observed to be in poor condition in the basement.

- ACMs identified to be in poor condition must be repaired/removed immediately, following Type 1/2/3 asbestos abatement work procedures as detailed in O. Reg. 278/05 and disposed of as asbestos waste under O. Reg. 347;

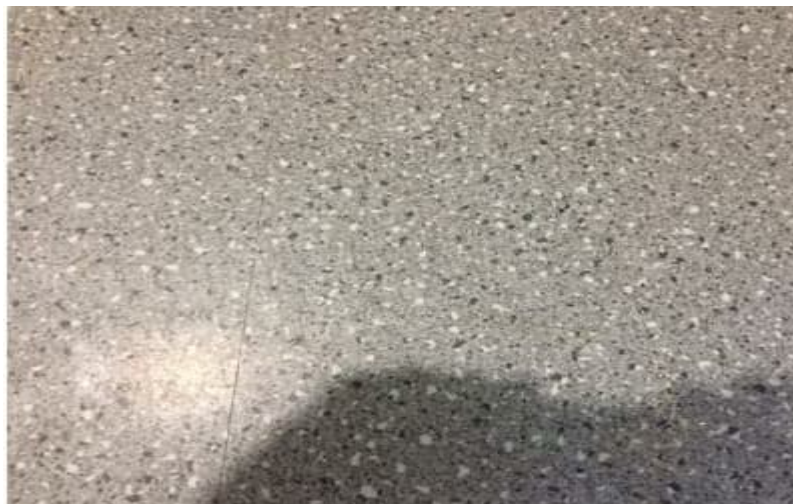
- Vinyl Sheet Flooring (Grey, Black, Blue) was observed throughout the kitchen (Room 104) on the 1<sup>st</sup> floor of the subject building. The laboratory analytical results of the samples collected indicate that this material does not contain asbestos. The associated mastic (Clear) was also determined not to contain asbestos.

**Photo 6:** View of non-asbestos-containing vinyl sheet flooring observed in the kitchen on the 1<sup>st</sup> floor of the subject building.

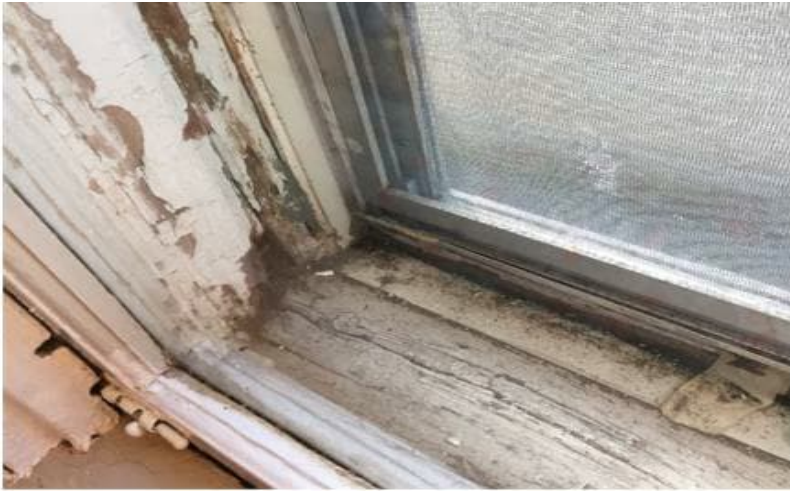
The paint finishes highlighted in pink in the above table are considered lead-containing paints or surface coatings with concentrations greater than 0.1% lead by weight. These paint finishes were observed to be in good condition except for select areas, which were observed in poor condition.

**Photo 7:** View of lead-containing white paint observed to be in poor condition in Room C on the 2<sup>nd</sup> floor of the subject building.

Paints identified to contain lead that is in poor condition must be immediately repaired and/or stabilized following a minimum Type 1/2 lead abatement procedures as per OMOL “Lead on Construction Project” dated April 2011.

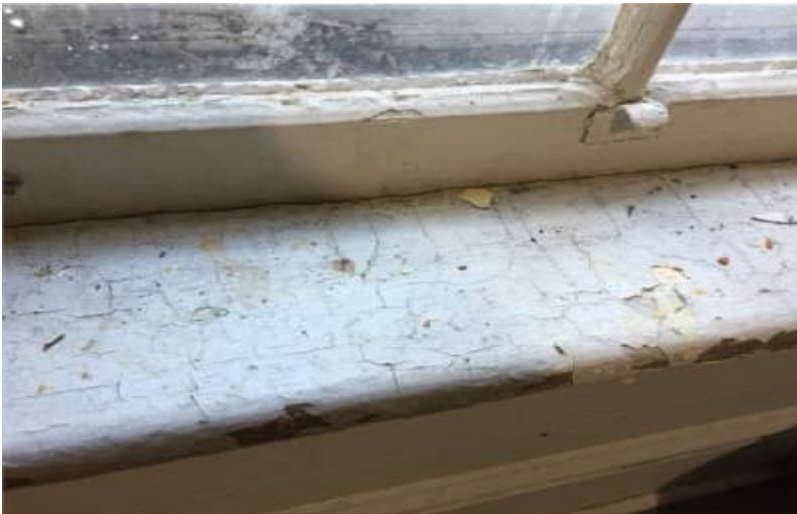
**Photo 8:** View of lead-containing white paint observed to be in poor condition in the kitchen on the 1<sup>st</sup> floor of the subject building.

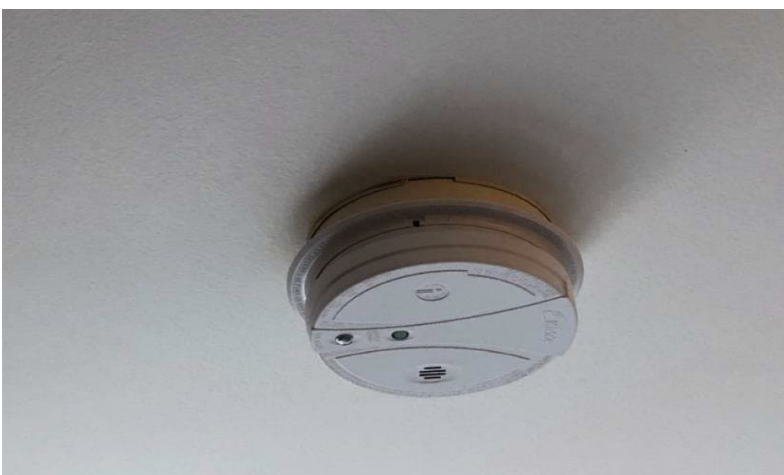
A visual assessment of the subject building was conducted to determine if any electrical components containing radioactive materials were present. Smoke detectors were observed throughout the subject building, which contained small quantities of radioactive material.

**Photo 9:** Typical view of smoke detectors containing radioactive materials.

The radioactive sources in smoke alarms are sealed and contained within a metal case inside the smoke detector and must not be damaged or tampered with. These materials do not pose a hazard as long as they remain contained and properly disposed of at the time of removal or replacement.

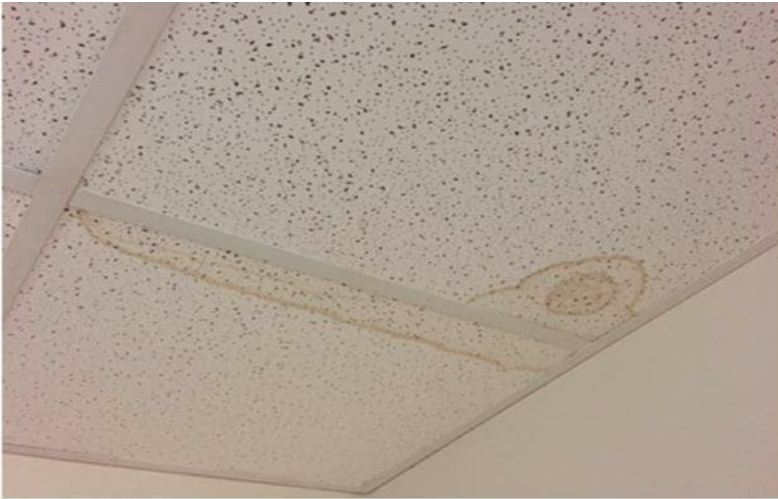
A visual survey of the subject building was conducted to determine if water damage was present. MPL identified select areas throughout the subject building where materials were affected by water damage.

**Photo 10:** View of water damaged ceiling tiles observed in Room C on the 1<sup>st</sup> floor of the subject building.

Water-stained/damaged ceiling tiles observed throughout the subject building should be replaced as part of regular maintenance, and the underlying cause of the water leakage should be identified and repaired;

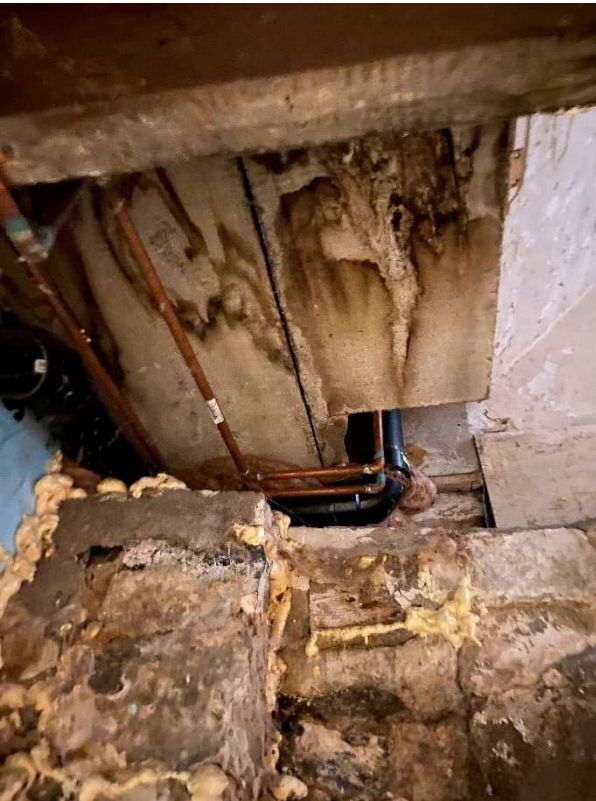
**Photo 11:** View of water damaged ceiling panels observed in the basement at the bottom of the stairwell.
