# HAZARDOUS MATERIALS SURVEY AND 2023 REASSESSMENT 118 HENDERSON AVENUE, OTTAWA, ON

Project No.: Z2021102HZ / CCC-230252-00

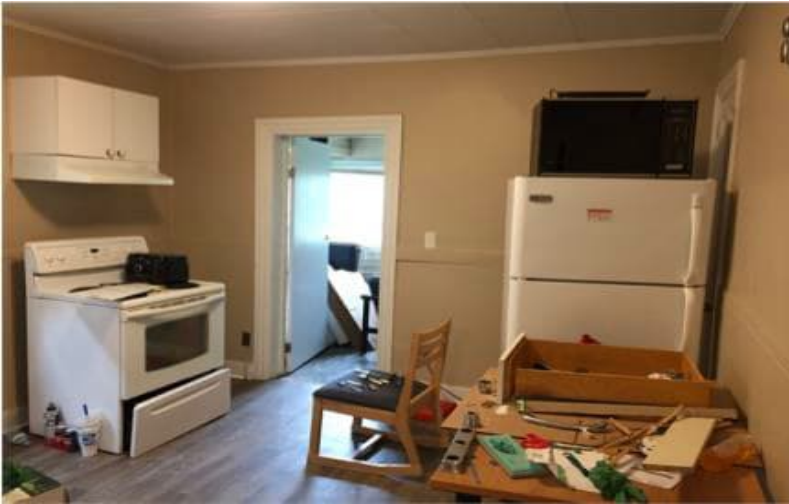
**Photo 1:** View of typical finishes observed at the building located at 118 Henderson Avenue.

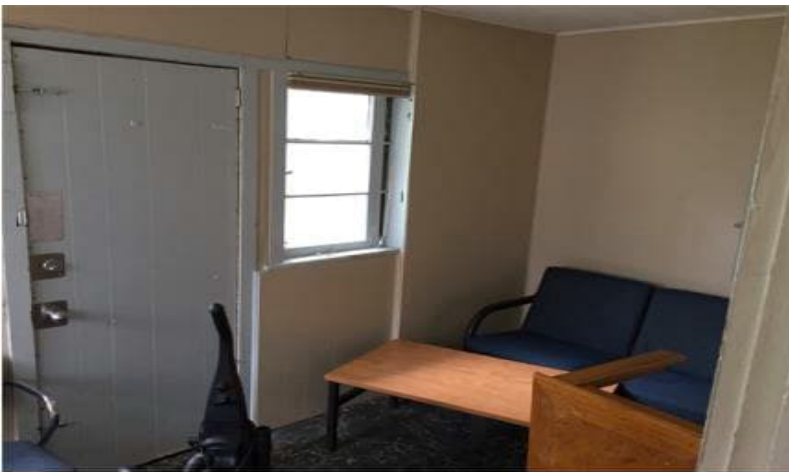
**Photo 2:** View of typical finishes observed at the building located at 118 Henderson Avenue.

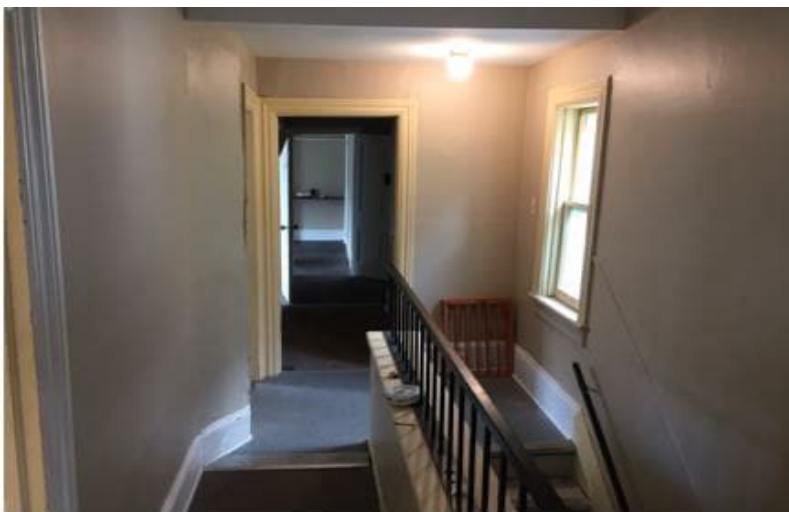
**Photo 3:** View of typical finishes observed at the building located at 118 Henderson Avenue.

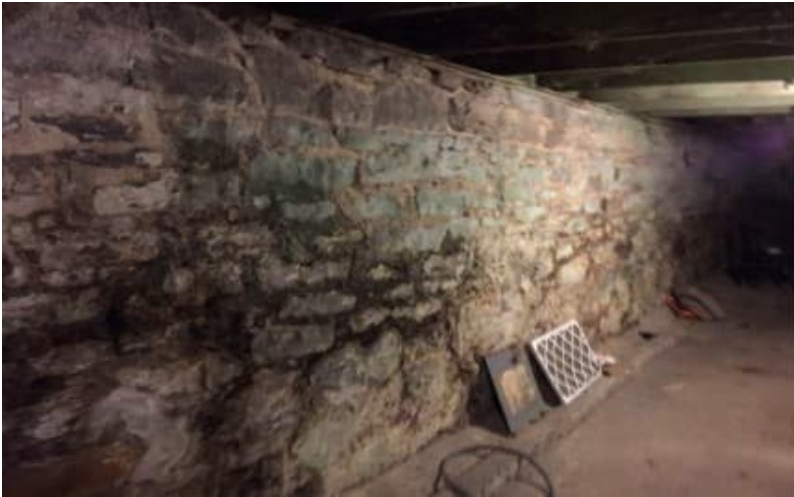
**Photo 4:** View of typical finishes observed at the building located at 118 Henderson Avenue.

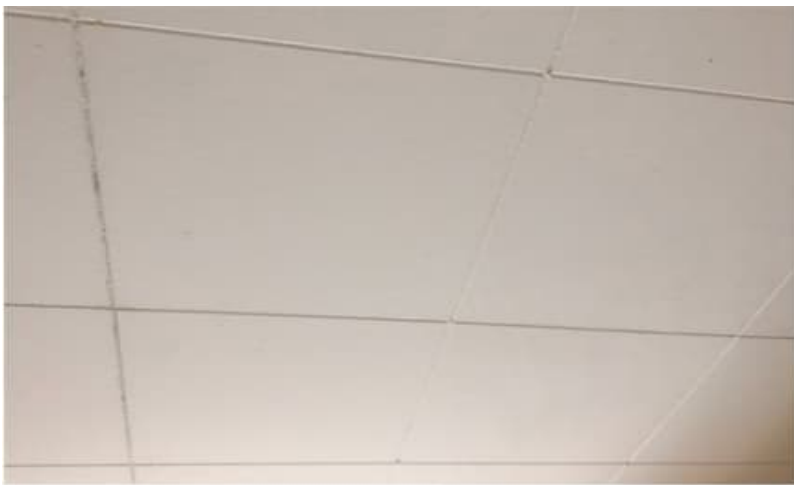
**Photo 5:** View of non-asbestos-containing acoustic ceiling tiles observed in the bathroom on the second floor.

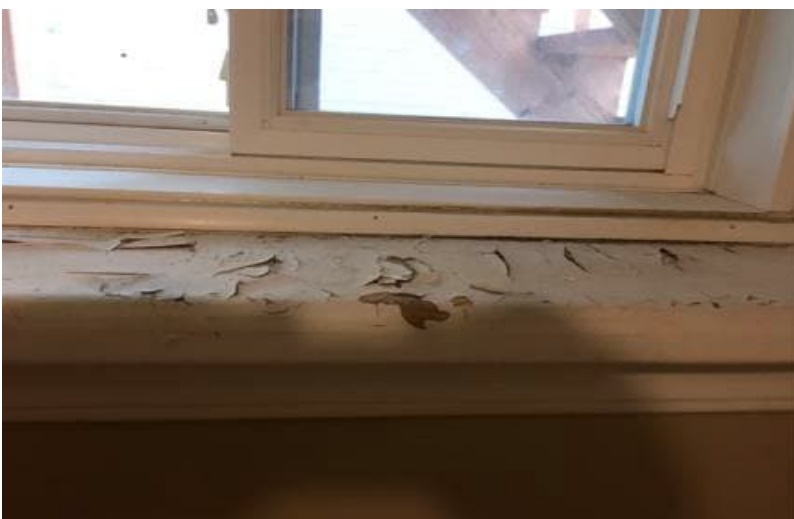
**Photo 6:** View of lead-containing white paint observed to be in poor condition in bathroom of the first floor.

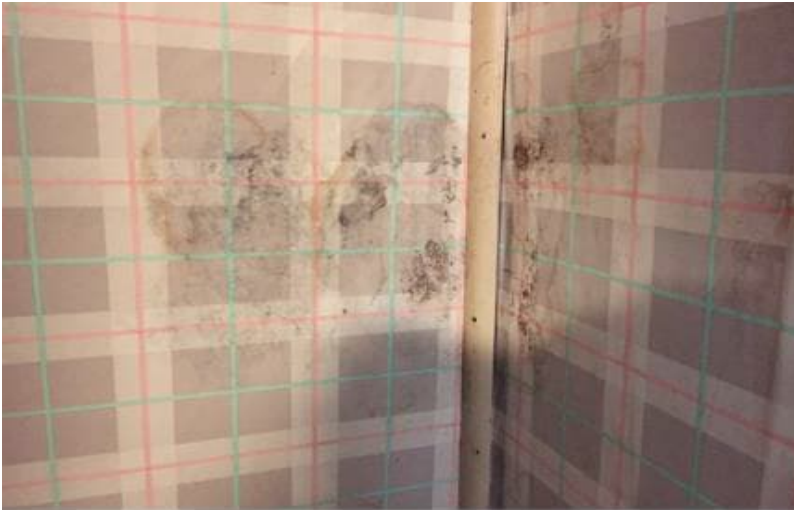
**Photo 7:** View of suspected mould growth observed at the top of the basement stairs.

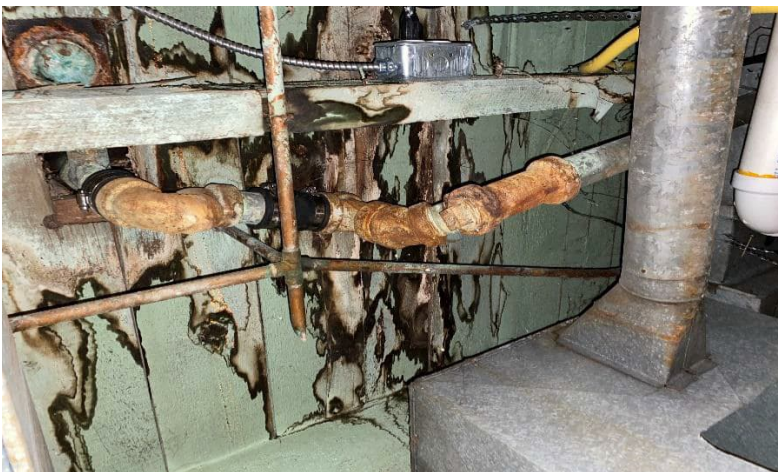
**Photo 8:** View of water damage and growth observed on the ceiling in the basement.

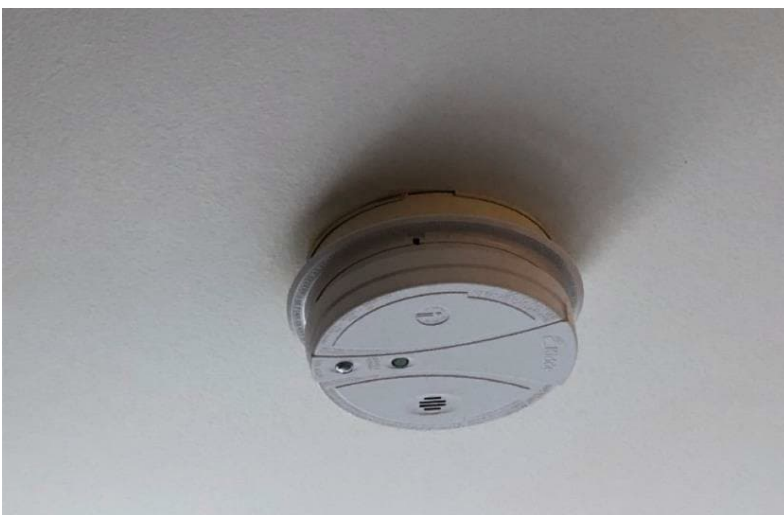
**Photo 9:** Typical view of smoke detectors containing radioactive materials.
