HAZARDOUS MATERIALS SURVEY AND 2023 REASSESSMENT 129 - 141 LOUIS-PASTEUR PRIVATE, OTTAWA, ON

Project No.: Z2021101HZ / CCC-230252-00

University of Ottawa

March 6, 2024

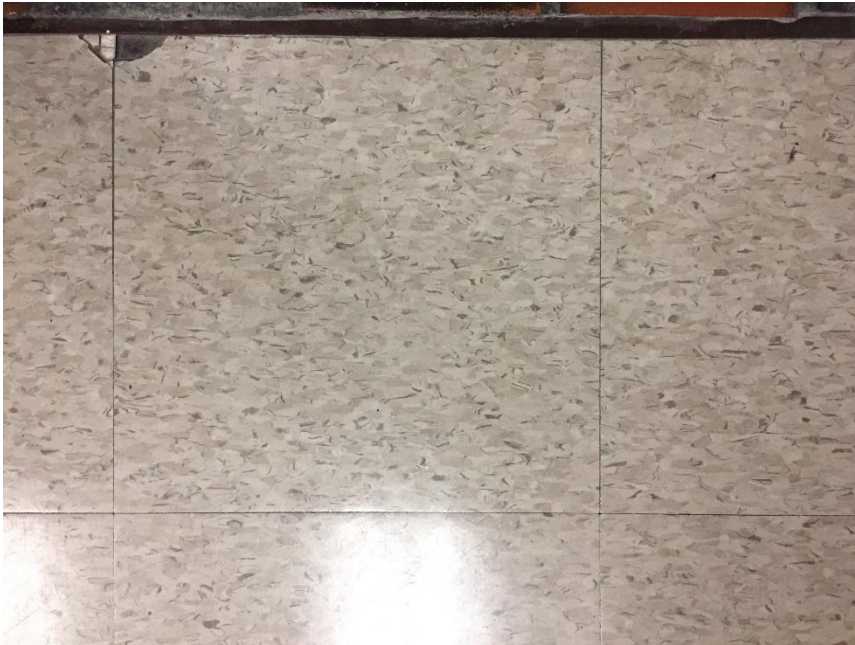
- Vinyl floor tiles (12" x 12" - Light and Dark Grey Smudge) were observed and previously sampled in Room 117. The laboratory analytical results indicate that this material contain **5% Chrysotile asbestos**. The material was observed to be in good condition. The associated mastic (Black) was also found not to contain asbestos.
- Vinyl floor tiles (12" x 12" - White with Grey Streaks) were observed and previously sampled in Room 176. The laboratory analytical results indicate that this material contain **5% Chrysotile asbestos**. The material was observed to be in good condition
- Vinyl floor tiles (12" x 12" - White w/Grey Mix) were observed and previously sampled in Room 281. The laboratory analytical results indicate that this material does not contain asbestos. The associated mastic (Beige) was also found not to contain asbestos.

Photo 1: View of asbestos containing VFT – 12"X12" Light and Dark Grey in Room 177

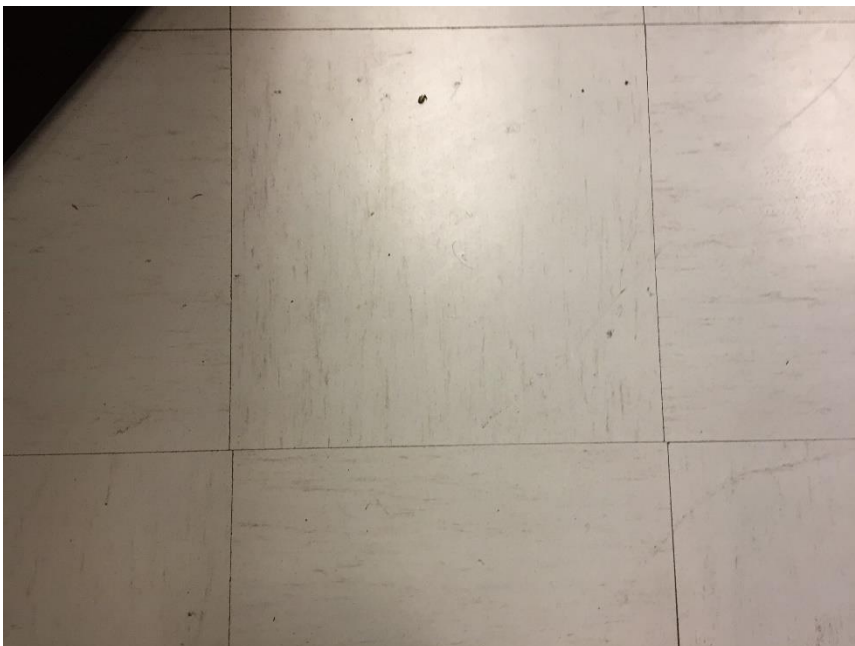
Photo 2: View of asbestos containing VFT – 12"X12" Beige in Room 176

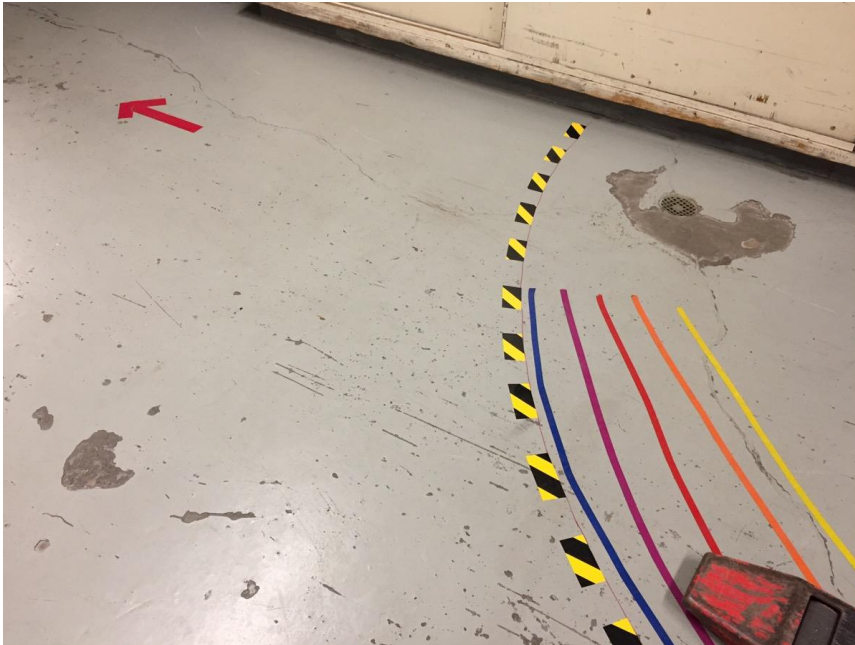
The paint finishes highlighted in blue in the above table were determined to contain low concentrations of lead which are less than or equal to 0.1%. These paint finishes were observed to be in fair and good condition.

Photo 5: View fair condition grey floor paint with low lead concentration in Room 100C

Paints identified to contain lead that are in fair condition should be either repaired (where possible) and/or closely monitored for signs of further deterioration.

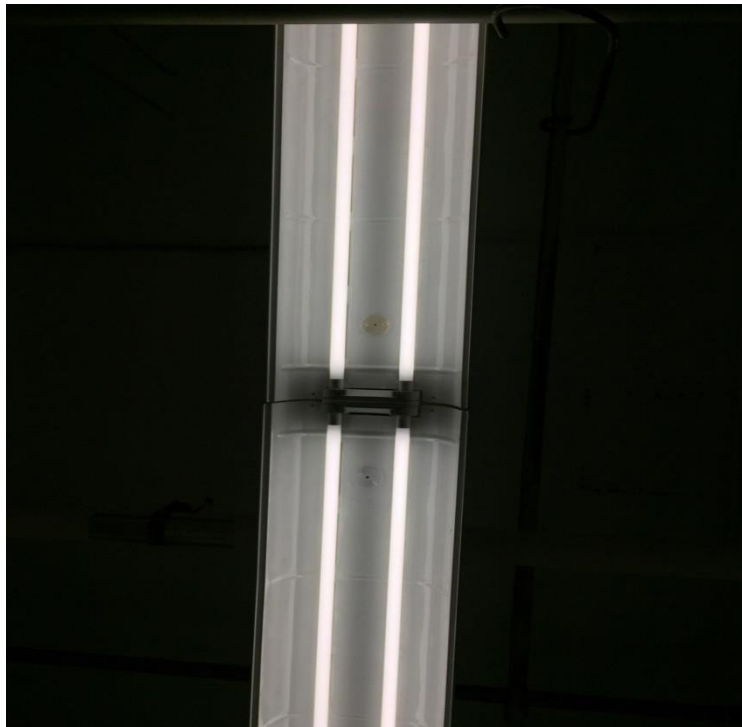
The subject building is illuminated by LED and fluorescent lights. MPL assessed representative ballasts in the building, and these ballasts were suspected to contain PCBs. These light ballasts were observed to be manufactured by Sylvania.

Photo 7 View of of flourscent bulb suspected to contain PCB

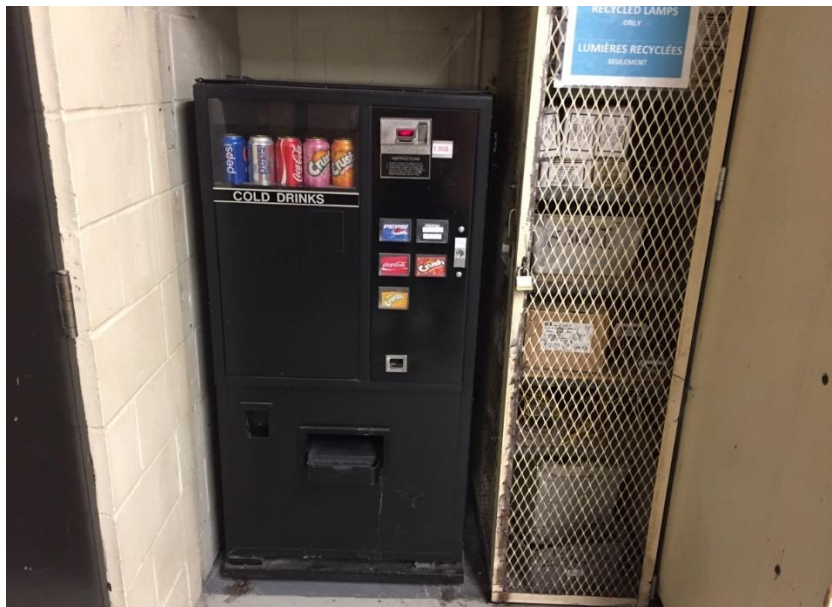
Photo 8 View of vending machine suspected to contain ODS in Room 100C
