HAZARDOUS MATERIALS SURVEY AND 2023 REASSESSMENT 143 SERAPHIN-MARION PRIVATE, OTTAWA, ON

Project No.: Z2021101HZ / CCC-230252-00

University of Ottawa

January 8, 2024

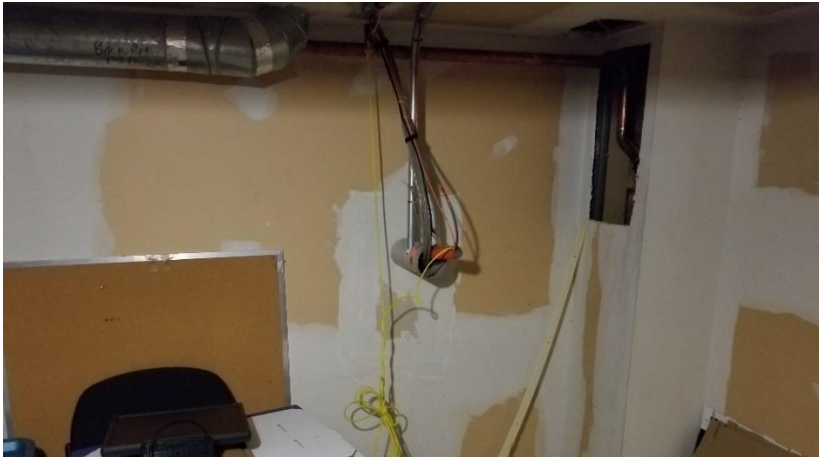
Drywall joint compounds were observed throughout the subject building. The analytical results of the samples previously collected in the laboratory indicate that this material **contains 1% chrysotile asbestos**. Since the drywall joint compound is homogeneous, all areas must be treated as asbestos-containing unless additional bulk sampling and analysis are confirmed otherwise. This material was observed to be in good condition.

Photo 1: A typical view of an asbestos-containing drywall joint compound was observed throughout the subject building.

- Materials identified to contain asbestos are in good condition, do not pose a risk to workers or occupants, and can be managed in place. Prior to any renovation or demolition activities that may disturb the ACMs, these materials must be removed following appropriate Type 1/2/3 asbestos abatement work procedures as detailed in O. Reg. 278/05 and disposed of as asbestos waste under O. Reg. 347;
- Please refer to Appendix E – Asbestos-Containing Materials Checklist for material conditions, quantities (where applicable), and recommended actions;

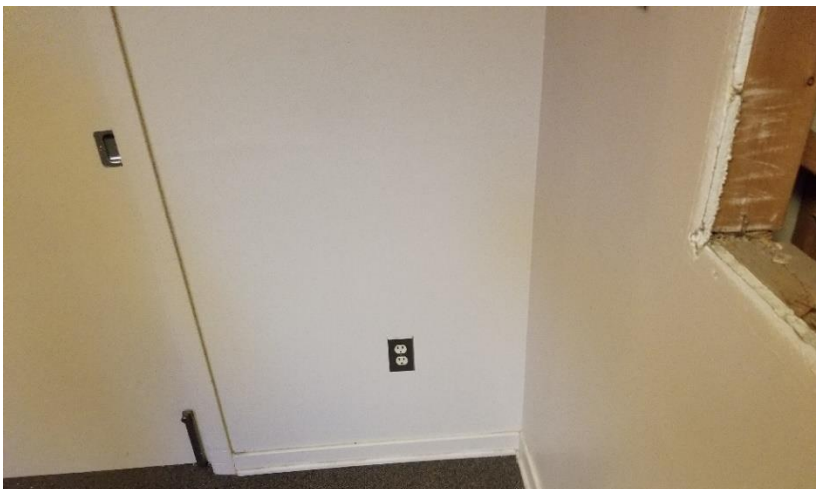
Photo 2: A typical view of an asbestos-containing drywall joint compound was observed throughout the subject building.

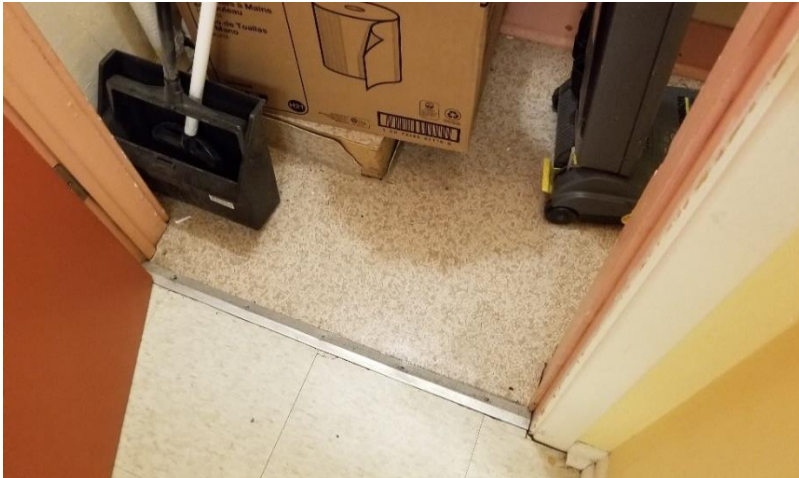
Vinyl floor tiles (12"x12"-White w/ Grey Flakes) were observed throughout the subject building. The laboratory analytical results of the vinyl floor tile samples previously collected from Room 104 indicate that this material does not contain asbestos. The associated mastic/backing material (Yellow and Beige) did not contain asbestos.

- Vinyl sheet flooring (Grey and White) was observed throughout the subject building. The laboratory analytical results of the vinyl sheet flooring samples previously collected from Room 200/200A indicate that this material does not contain asbestos. The associated mastic/backing material (Beige) did not contain asbestos.
- Vinyl sheet flooring (Rubber Stair Cover) was observed and sampled in Rooms 106/203. The laboratory analytical results of the vinyl sheet flooring samples previously collected indicate that this material does not contain asbestos. The associated mastic/backing material (Brown) did not contain asbestos.

Photo 4: View of non-asbestos Vinyl Sheet Flooring (Grey and White) and non-asbestos 12"x12" vinyl floor tiles (White w/ Grey Flakes).

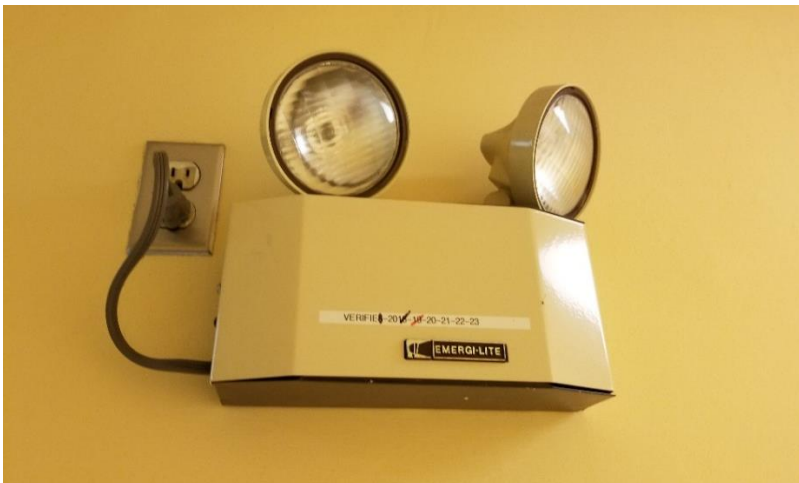
Lead-containing acid battery packs were observed throughout the subject building. These battery packs were observed on the walls and above the exits throughout the subject building.

Photo 5: A typical view of lead-battery packs was observed throughout the subject building.

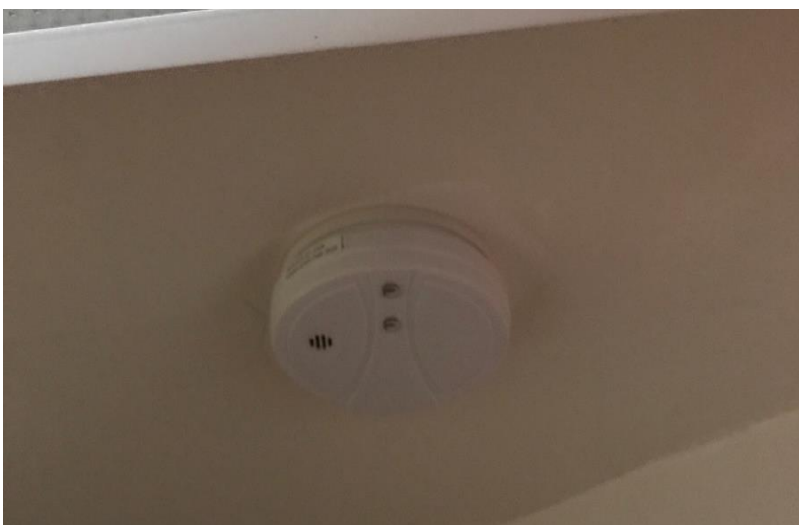
A visual assessment of the subject building was conducted to determine if any electrical components containing radioactive materials were present. Smoke detectors, which contained small quantities of radioactive material, were observed throughout the subject building.

Photo 6: A view of the radioactive-containing smoke detector was observed throughout Room 300.

The radioactive sources in smoke alarms are sealed and contained within a metal case inside the smoke detector and must not be damaged or tampered with. These materials do not pose a hazard as long as they remain contained and properly disposed of at the time of removal or replacement.

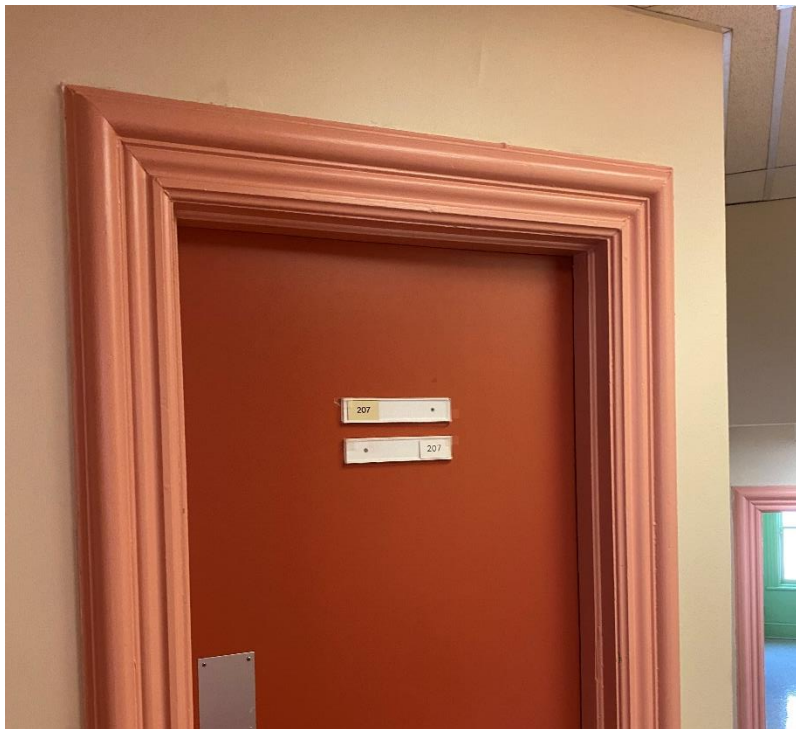
The paint finish highlighted in blue in the above table was determined to contain low lead concentrations, less than or equal to 0.1%. This paint finish was observed to be in good condition.

The paint finish highlighted in pink in the above table is considered a lead-containing paint or surface coating with concentrations greater than 0.1% lead by weight. This paint finish was observed to be in good condition.

Photo 7: Typical view of paint finishes during the 2023 reassessment near Room 207.

Paints identified to contain lead that are in good condition and do not pose a risk to workers or occupants can be managed in place.
