HAZARDOUS MATERIALS SURVEY AND 2023 REASSESSMENT 200 LEES AVENUE, OTTAWA, ONTARIO

Project No.: Z1920014HZ / CCC-230252-00

University of Ottawa

McIntosh Perry Limited (MPL)

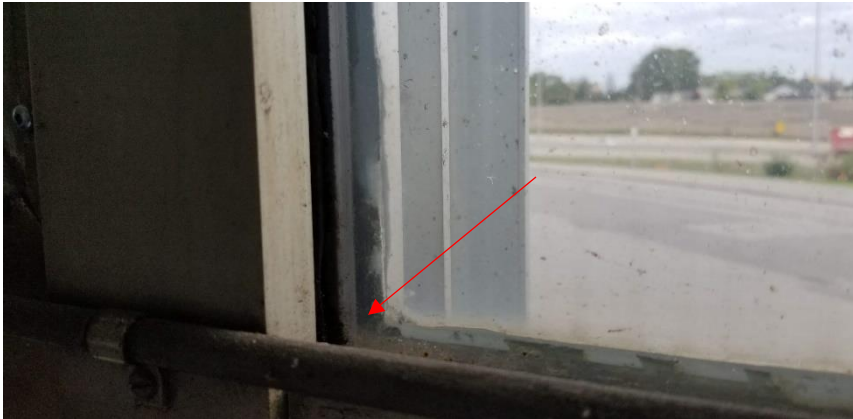
Interior window caulking (Black) was previously sampled from Room A139. The laboratory analytical results indicate that this material **contains 2% Chrysotile asbestos**. This material is considered non-friable and was observed to be in good condition.

Photo 1: View of asbestos-containing interior window caulking (black) observed to be in good condition in Room 139.

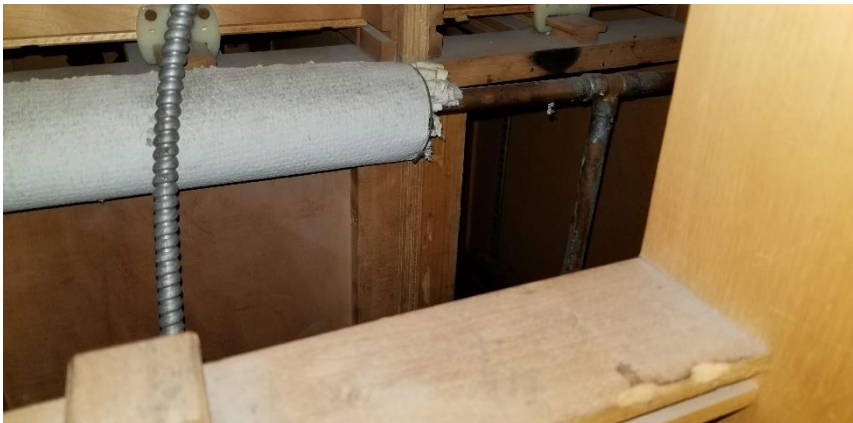
Mechanical pipe straight insulation was observed in between the workbenches in Room A105. The laboratory analytical results collected indicate that this material contains **10% Chrysotile asbestos**. This material is considered friable and was observed to be in poor condition.

Photo 2: View of asbestos-containing mechanical pipe straight insulation observed to be in poor condition in cabinet 510 in Room A 105.

- Asbestos-containing materials identified to be in poor condition must be repaired/removed immediately, following Type 1/2/3 asbestos abatement work procedures as detailed in O. Reg. 278/05 and disposed of as asbestos waste under O. Reg. 347;

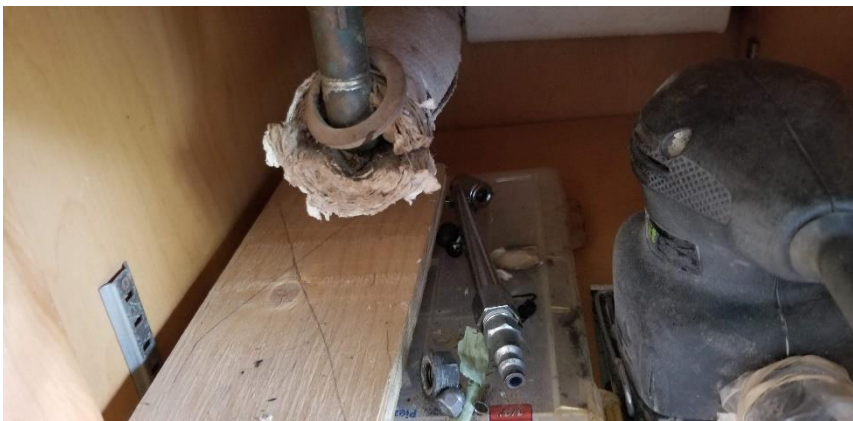
Photo 3: View of asbestos-containing mechanical pipe straight insulation observed to be in poor condition on the 2nd work bench outside the bike shop office in Room A 105.

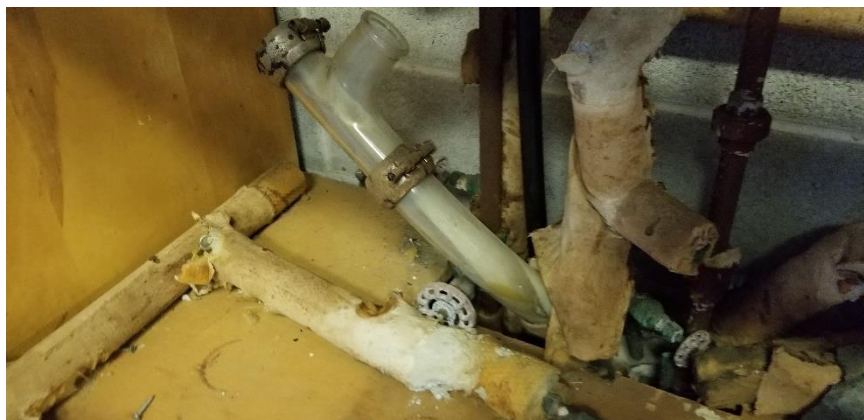
Mechanical piping elbows/fitting insulation was observed on mechanical pipe fittings in Room A104C and E029. The laboratory analytical results of samples previously collected indicate that this material **contains 60% Chrysotile asbestos**. This material is considered friable and was observed to be in good condition, with the exception of select areas which were observed in poor condition.

Photo 4: View of asbestos-containing mechanical pipe fittings observed to be in poor condition in Room A104.

This damage has been repaired.

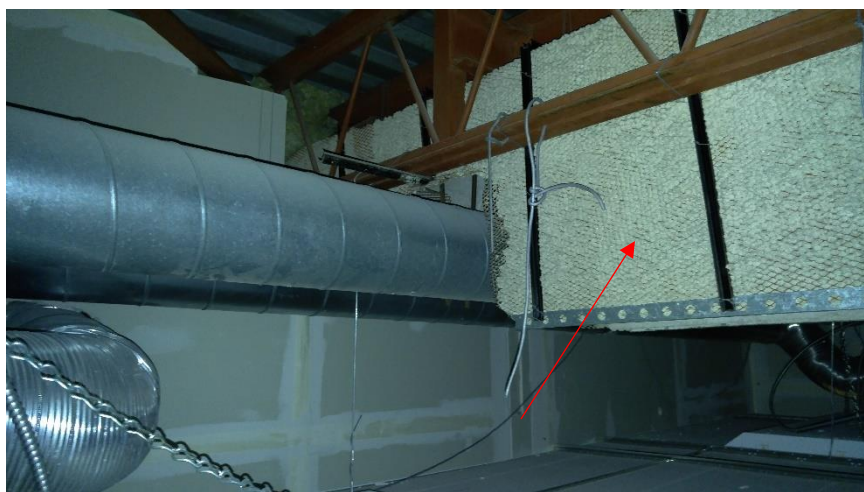
Wall plaster (Grey) on diamond mesh lath was observed in Room B215N. The laboratory analytical results of samples previously collected indicate that this material contains **1% Tremolite asbestos**. This material is considered friable and was observed to be in fair condition. MPL identified visually similar ceiling plaster on diamond mesh lath in Rooms C100D and A142 and noted to be in poor condition.

Photo 5: View of asbestos-containing plaster on steel mesh observed in Room B 215N.

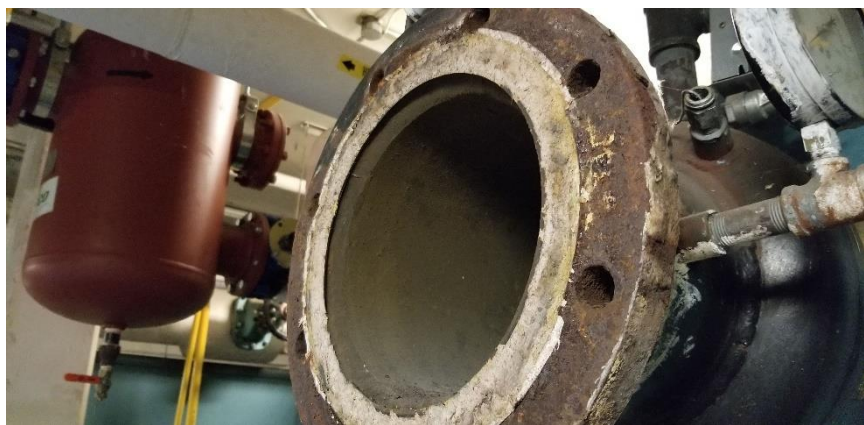
Mechanical pipe gasket (Beige) was observed in Room A02. The laboratory analysis indicated that this material **contains 65% Chrysotile asbestos**. This material is considered to be friable and was observed to be in poor condition.

Photo 6: View of asbestos-containing pipe gasket observed on the Unilux Boiler in Mechanical Room A02.

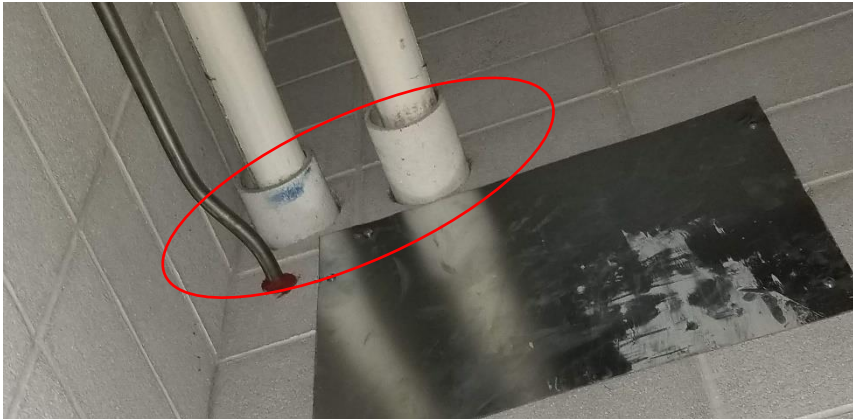
Transite materials was observed as segments of conduit pipe in Room A138C. To avoid possible damage, no bulk samples of the transite piping were collected. However, this material is **known to contain asbestos**. This material is considered to be non-friable and was observed in good condition.

Photo 7: View of asbestos-containing transite pipe (highlighted in red) observed to be in good condition Mechanical Room A138C.

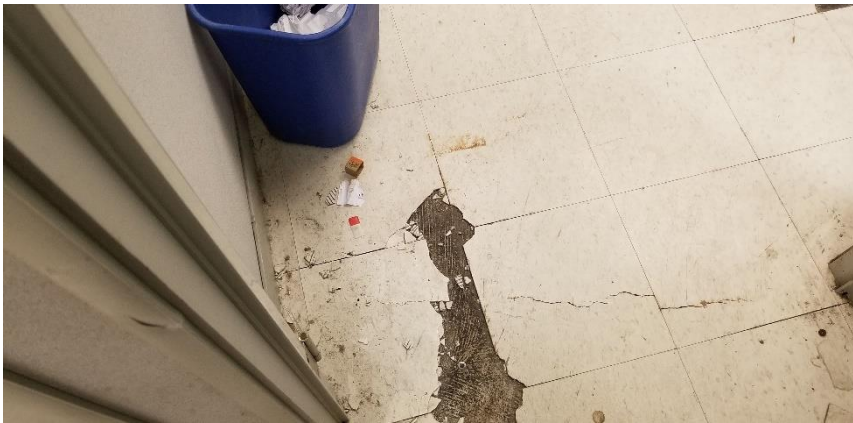
- Vinyl floor tiles (12"x12"-White w/ Beige Spots) was previously identified to **contain 6.5% Chrysotile asbestos** was observed in Room C144 and C110. This material is considered non-friable and was observed to be in poor condition.

Photo 8: View of asbestos-containing vinyl floor tile (12"x12"-White with beige spots) observed to be in poor condition in Room C144.

This damage has been repaired.

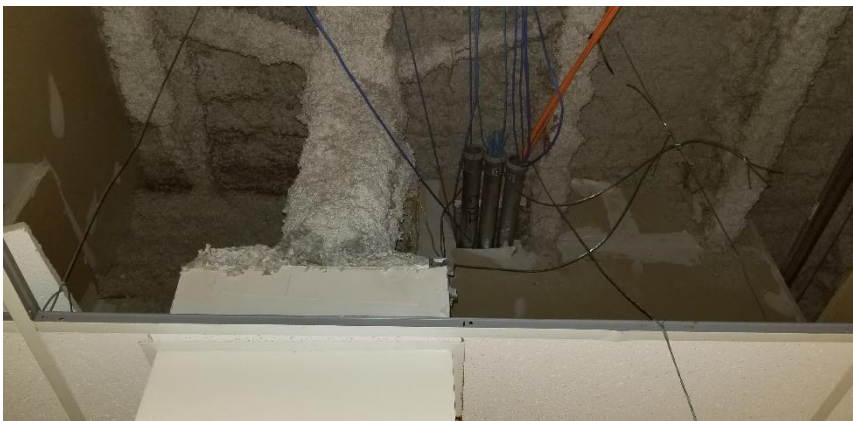
Sprayed fireproofing material (Grey) was observed on structural beams and walls within Rooms B100, C141C, and C201. The laboratory analytical results for the samples collected indicate that this material does not contain asbestos.

Photo 9: View of non-asbestos containing fireproofing observed above the suspended ceiling tiles in Room C141C.

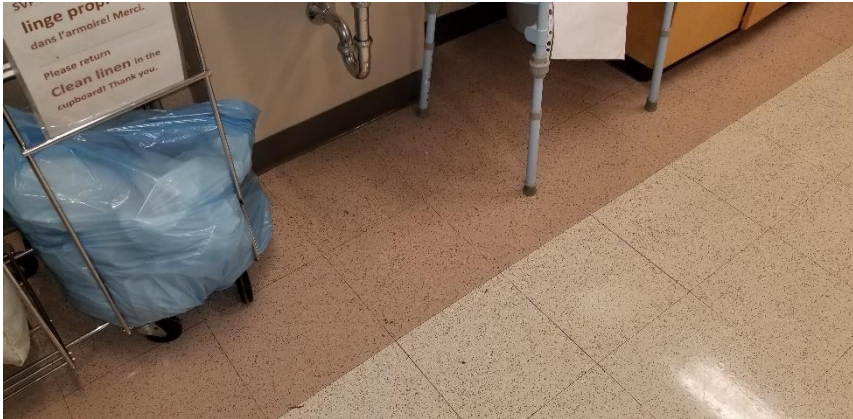
- Vinyl floor tiles (12"x12" – Pink with dots) were observed in Room C115. The laboratory analytical results of the vinyl floor tile samples previously collected indicate that this material and its associated mastic (black) does not contain asbestos.

- Vinyl floor tiles (12"x12" – Off-white with dots) were observed in Room C115. The laboratory analytical results of the vinyl floor tile samples previously collected indicate that this material and its associated mastic (black) does not contain asbestos.

Photo 10: View of non-asbestos containing vinyl floor tiles (12"x12"-Pink with dots) and vinyl floor tiles (12"x12"-Offwhite with dots) observed in Room C115.

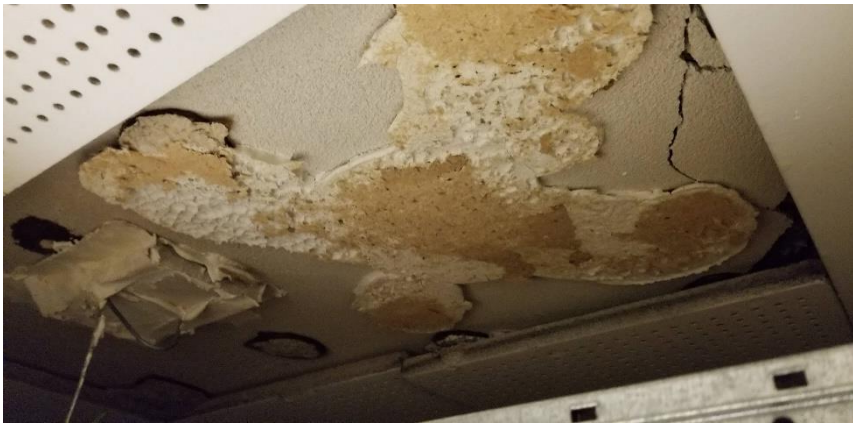
Photo 11: View of non-asbestos containing glued on acoustic tile (12"x12"-Uniform Holes) and adhesive mastic (brown) observed in the Men's Change Room in D108.

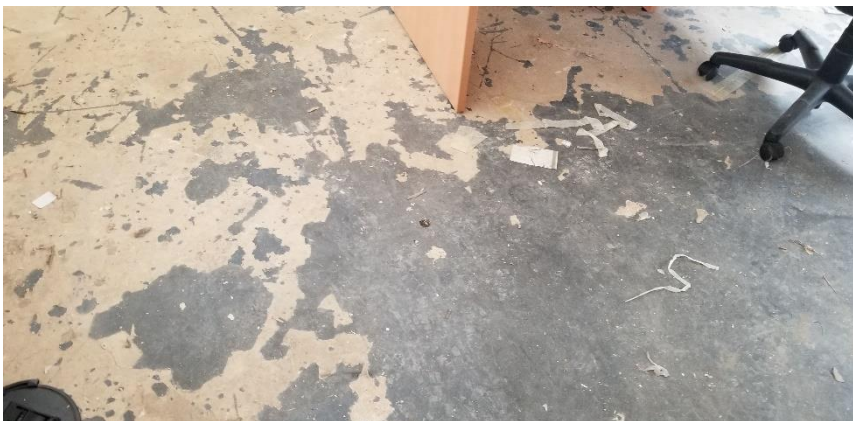
The paint finishes highlighted in blue in the above table were determined to contain low concentrations of lead which are less than 0.1%. These paint finishes were observed to be in good to poor condition.

Photo 12: View of low-level lead paint observed to be in poor condition in Room A144.

Paints identified to contain lead that are in poor condition must be immediately repaired and/or stabilized following a minimum Type 1/2 lead abatement procedures as per the OMOL Guideline "Lead on Construction Project" dated April 2011.

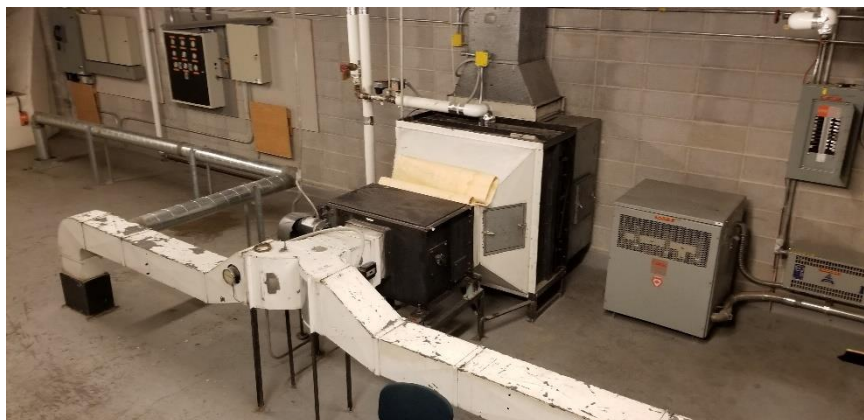
The paint finishes highlighted in pink in the above table are considered lead-containing paints or surface coatings with concentrations which are greater than 0.1%. These paint finishes were observed to be in good to poor condition.

Photo 13: View lead containing white paint observed to be in poor condition in Mechanical Room D201.

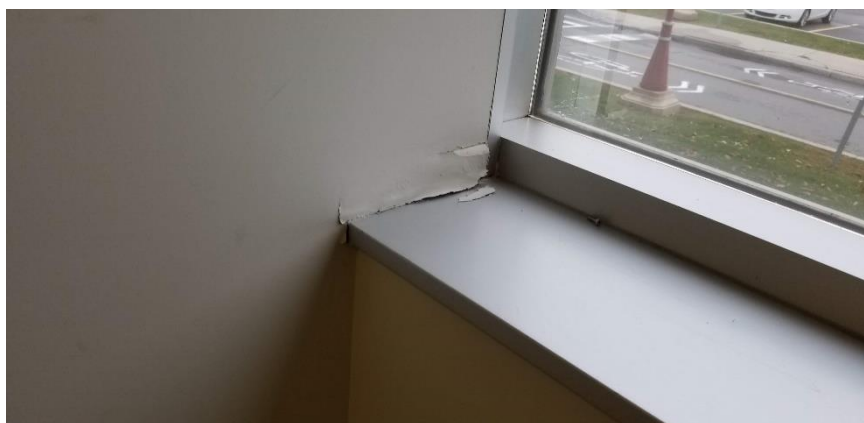
Photo 14: View of water damage on drywall observed in Room E117.

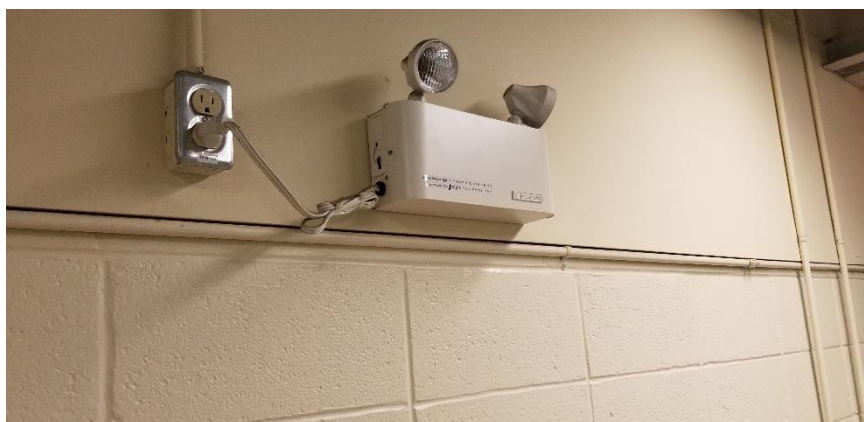
MPL identified lead-containing acid battery packs throughout the subject building. These battery packs were observed on walls and above exits throughout the surveyed building.

Photo 15: View of lead acid battery pack observed outside of D201.

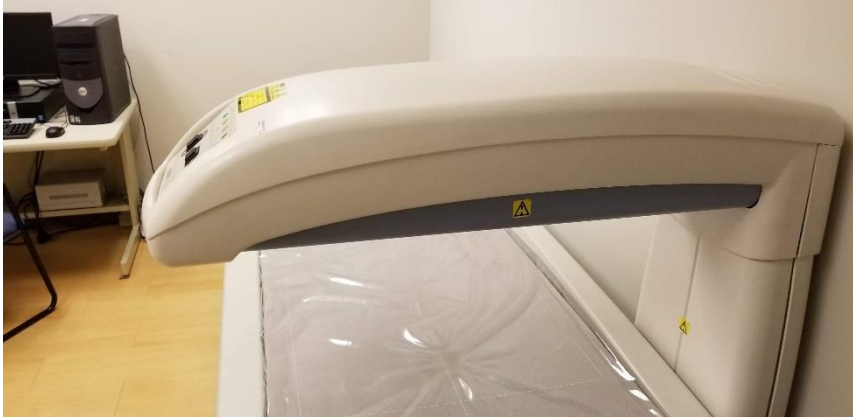
MPL observed diagnostic equipment suspected to contain radioactive materials within Room E029. Lead shielding material is suspected to be present within the walls of E029.

Photo 16: View of diagnostic machine suspected to contain radioactive materials observed in Room E029.

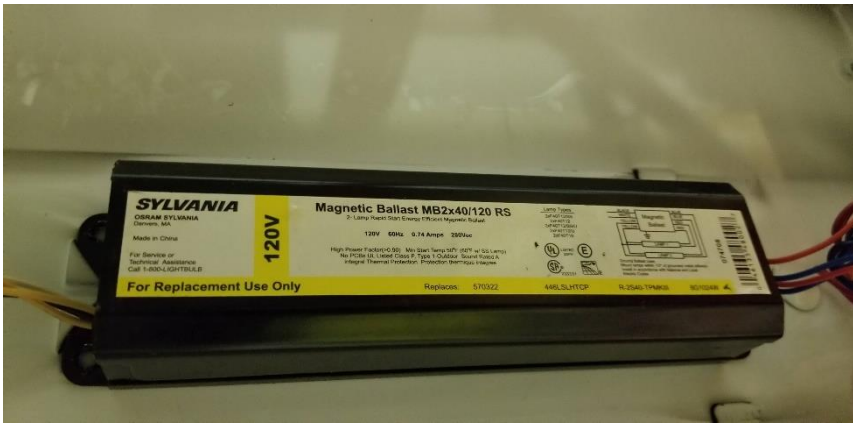
The subject building is illuminated by LED and fluorescent lights. MPL assessed representative ballasts in the building, and these ballasts were identified as non-PCBs content. These light ballasts were observed to be manufactured by Sylvannia.

Photo 17: Typical view of non-PCB containing light ballast observed throughout the surveyed building.

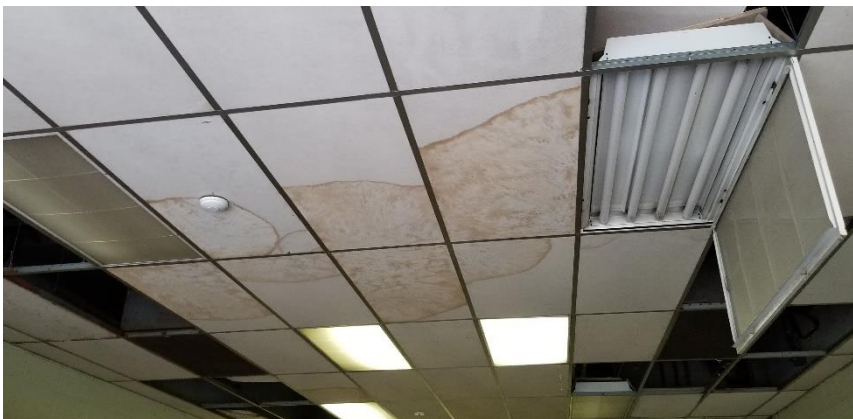
Photo 18: View of water-stained suspended ceiling tiles in Room A104C.

This damage has been repaired.
