HAZARDOUS MATERIALS SURVEY AND 2023 REASSESSMENT 200 WILBROD STREET, OTTAWA, ON

Project No.: Z1920014HZ / CCC-230252-00

University of Ottawa

March 12, 2024

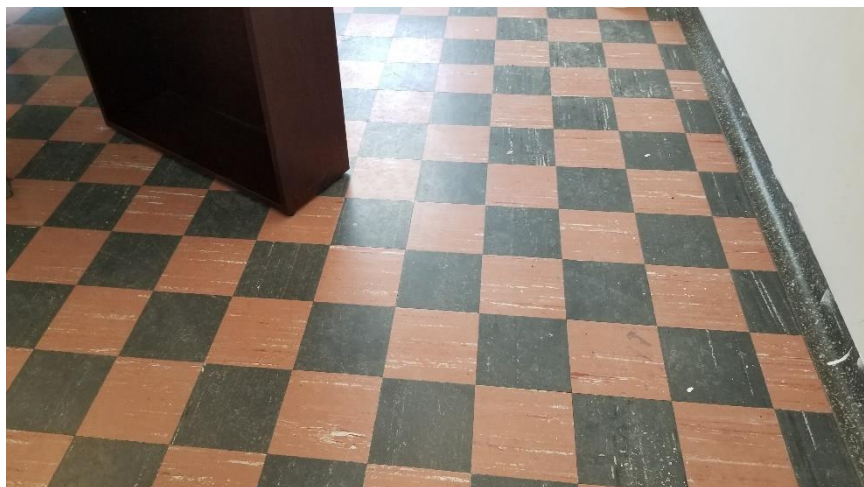
Photo 4: View of the asbestos-containing VFT 9"x9" - Pink & Dark Grey observed in good condition in Room 114B.

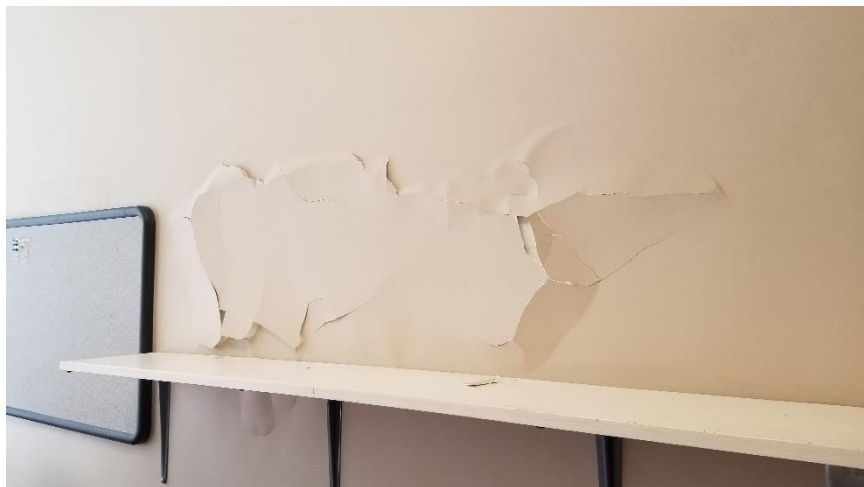
Photo 5: View of the Beige low-level lead wall paint observed in poor condition in Room 111.

Paints identified to contain lead that are in poor condition must be immediately repaired and/or stabilized following a minimum Type 1/2 lead abatement procedures as per OMOL Guideline “Lead on Construction Project” dated April 2011.

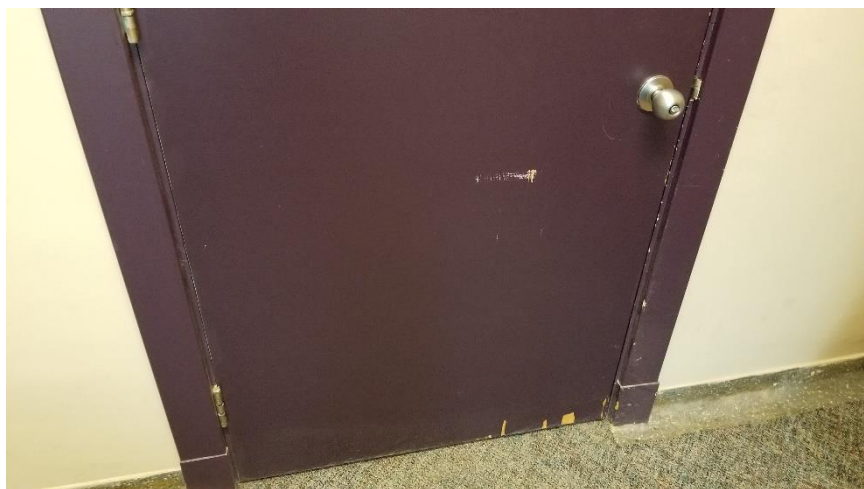
Photo 6: View of the Maroon low-level lead door paint observed in poor condition in Room 111.

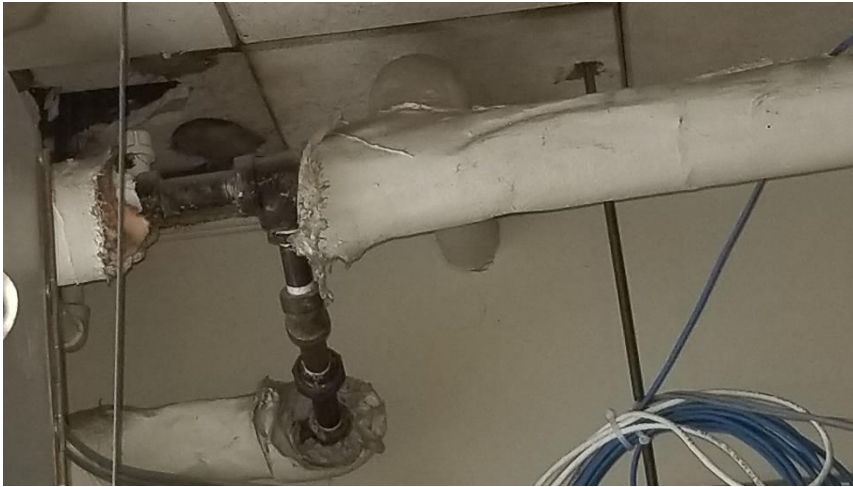
Previously identified parging cement elbows were observed in Room 02A, 03, 05, 07, 08 (A&C), 010 (A-C), 011, 013, 014 and 015B. This material **contains 65% Chrysotile asbestos** and is considered to be friable. This material was observed to be in good condition with the exception of select areas that were observed in poor condition.

Photo 13: Poor condition asbestos-containing parging cement elbows were observed in Room 010, above suspended ceiling tiles.

- Asbestos-containing materials identified to be in poor condition must be repaired/removed immediately, following Type 1/2/3 asbestos abatement work procedures as detailed in O. Reg. 278/05 and disposed of as asbestos waste under O. Reg. 347;

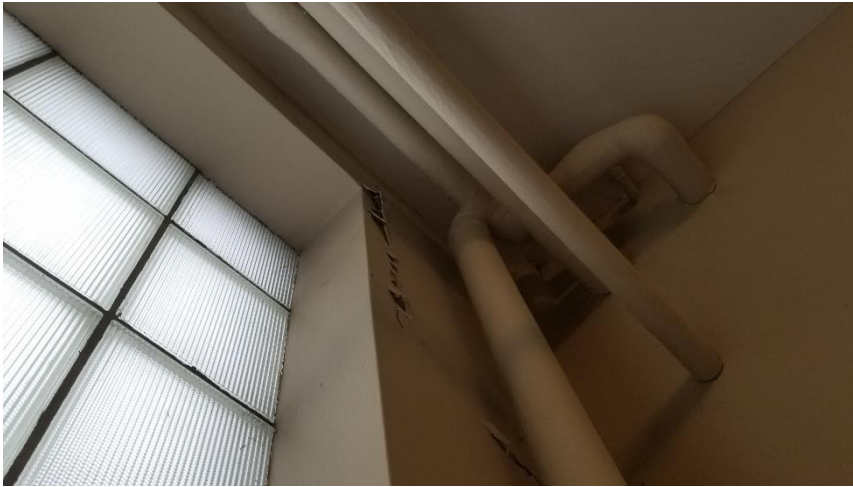
Photo 16: Representative view of the asbestos-containing parging cement elbows observed in good condition in the Women's Washroom Room 013.

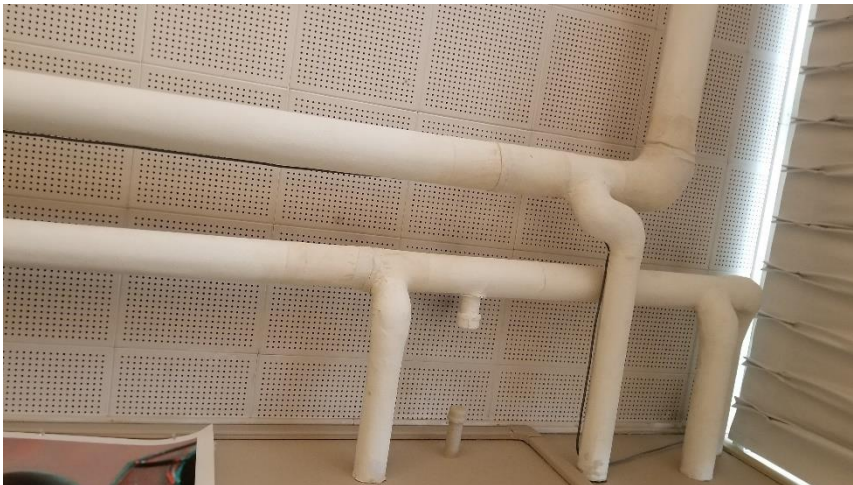
Photo 17: Representative view of the asbestos-containing parging cement elbows observed in good condition in Room 03.

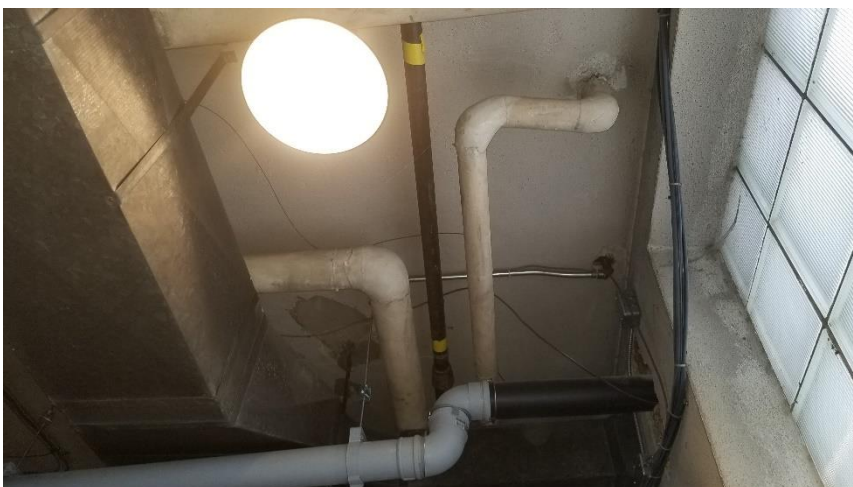
Photo 18: Representative view of the asbestos-containing parging cement elbows observed in good condition in the Furnace Room 011.

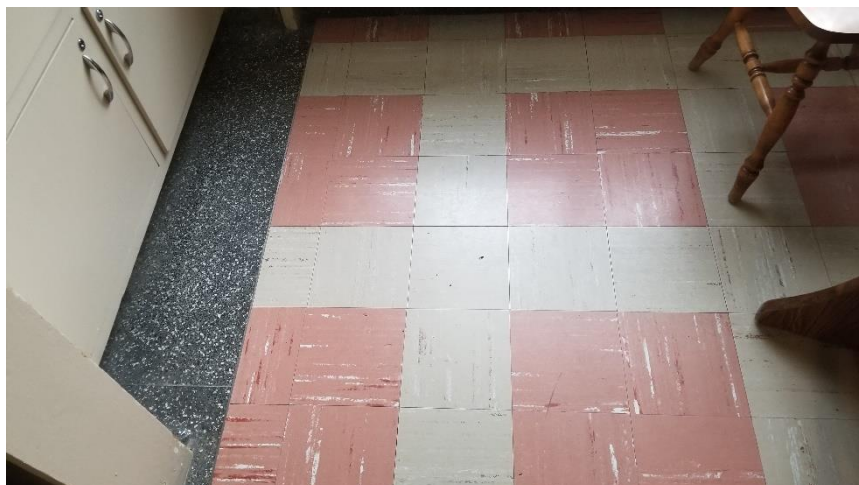
Photo 19: View of the asbestos-containing VFT 9"x9" - Pink & Beige observed in good condition in Room 015A.

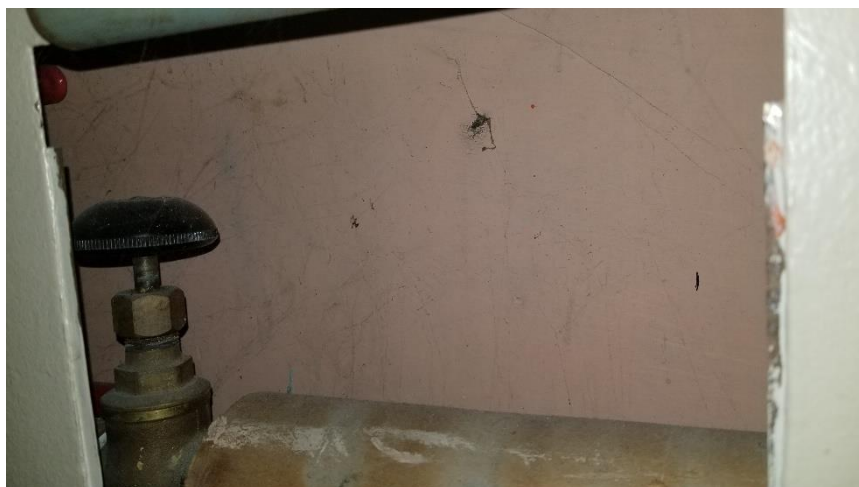
Photo 21: View of the Light Pink paint observed in Room 012, which was determined to contain low levels of lead, and enclosed behind radiator units.

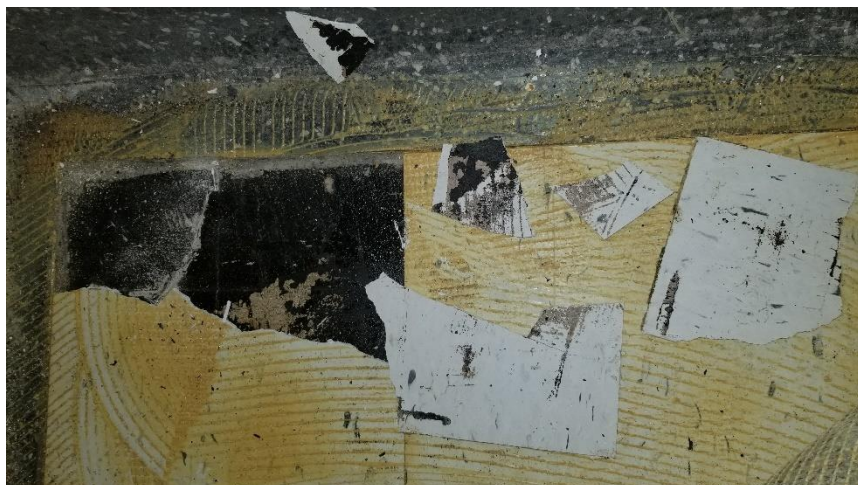
Photo 22: View of asbestos-containing vinyl floor tile mastic (Black) observed to be in good condition on the underside of the carpet in Room 07.

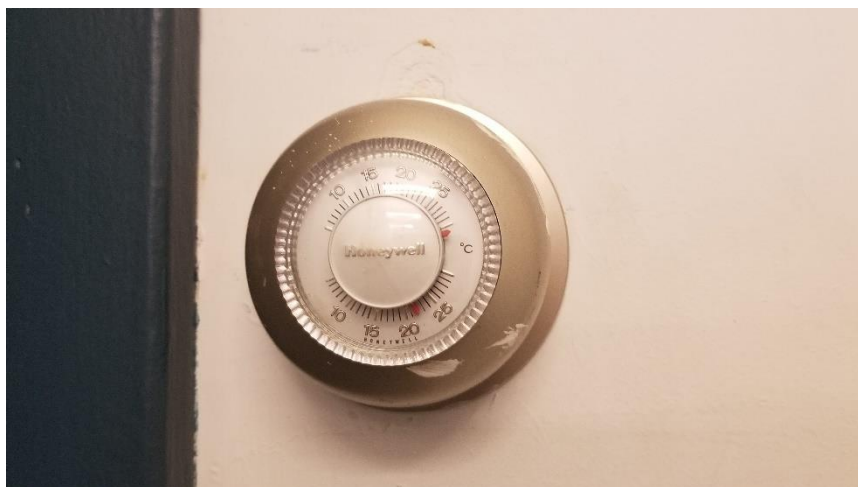
Photo 23: View of Honeywell thermostat containing one ampoule of liquid mercury observed to be in good condition on Room 07.

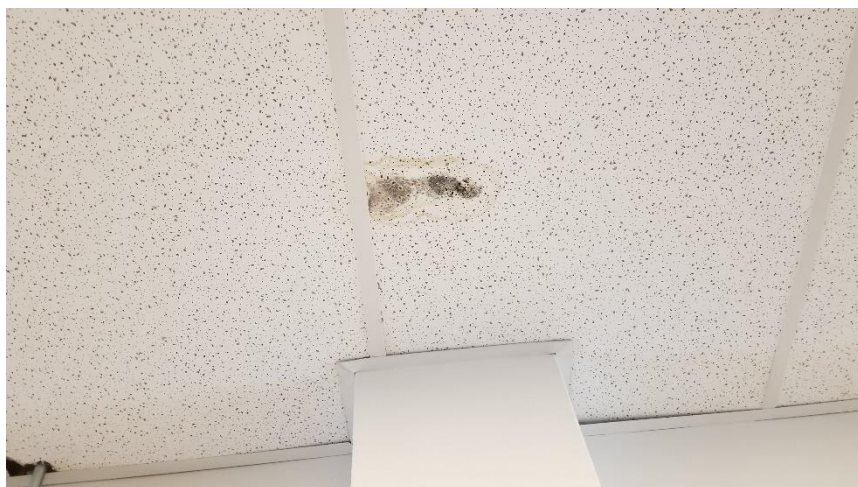
Photo 24: View of the mould impacted ceiling tile observed in Room 100.
