# HAZARDOUS MATERIALS SURVEY AND 2023 REASSESSMENT 542 KING EDWARD AVENUE, OTTAWA, ON

Project No.:0Z2021101HZ / CCC-230252-00

University of Ottawa

McIntosh Perry Limited (MPL)

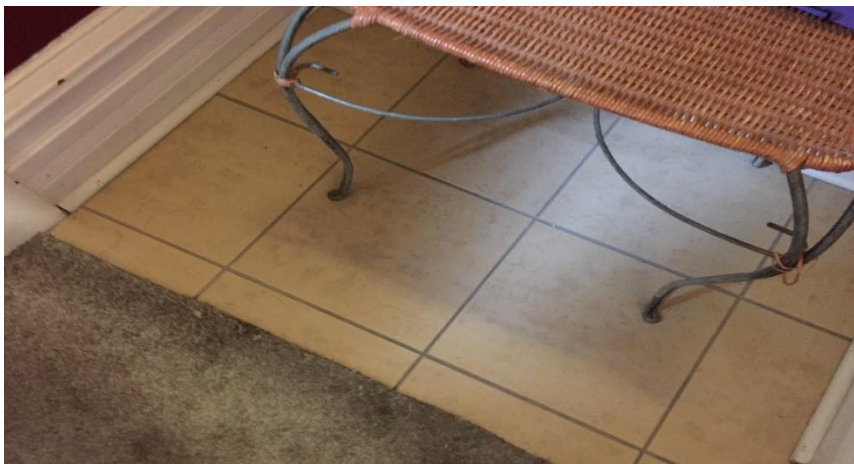
To avoid damage and compromising the integrity of the material, no bulk samples of the ceramic tiles grout were collected. Prior to renovation/demolition, ceramic tile grout should be examined and tested for asbestos content. Ceramic tile grout should therefore be considered to contain asbestos until bulk samples and analysis proves otherwise.

**Photo 2:** View of ceramic floor tile with suspect asbestos-containing grout on ground floor Room 100.

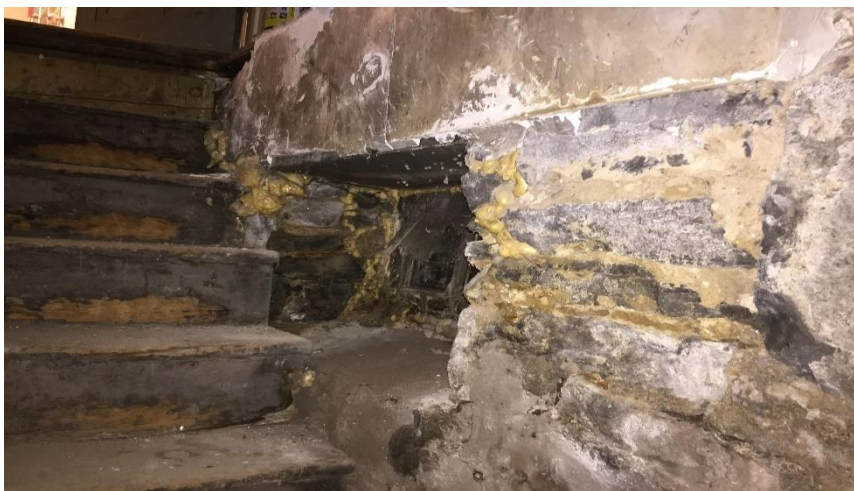
The paint finishes highlighted in pink in the above table are considered lead-containing paints or surface coatings with concentrations greater than 0.1% lead by weight. These paint finishes were observed to be in good condition with exception of selected areas in poor condition.

**Photo 3:** View of lead-containing paint (Grey) on plaster in poor condition in the Basement Room 003.

Paints identified to contain lead that are in poor condition must be immediately repaired and/or stabilized following a minimum Type 1/2 lead abatement procedures as per OMOL “Lead on Construction Project” dated April 2011.

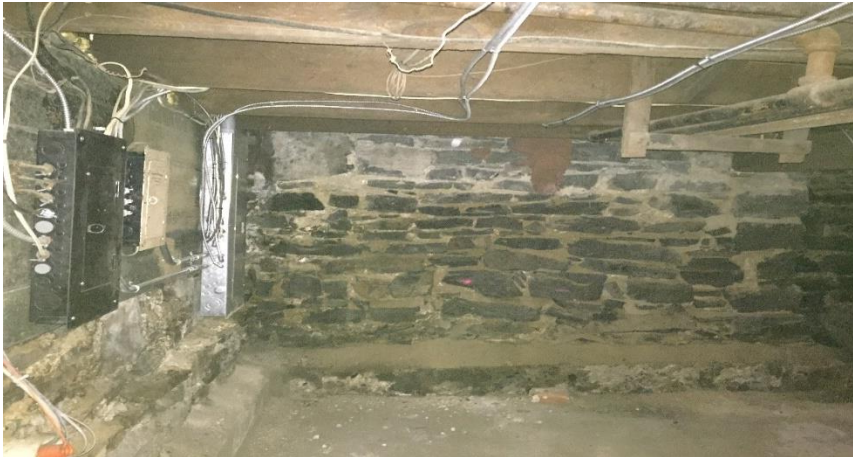
A visual survey of the subject building was conducted to determine if any water damaged was present. MPL observed signs of dampness throughout the basement stone foundation walls and perimeter concrete floor which appears to be caused by water infiltration.

**Photo 4:** View damp staining on stone foundation wall in the Basement level.

Further investigation should be conducted into the cause of water infiltration and necessary repairs completed.

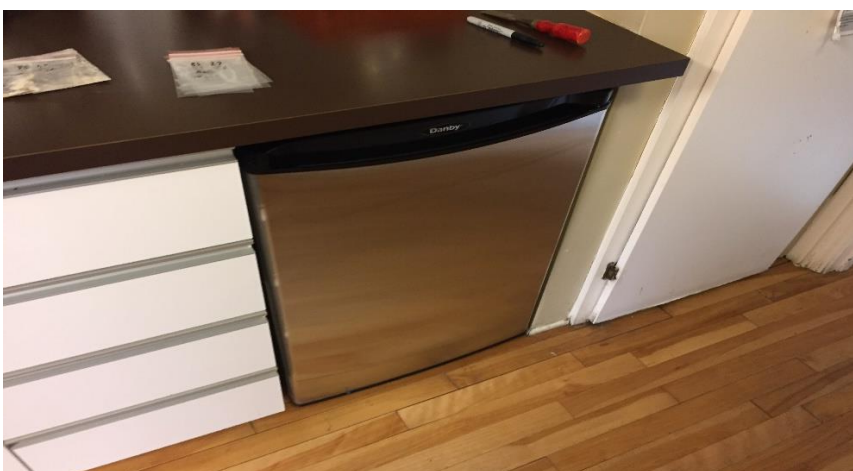
A visual assessment for equipment potentially containing ODSs and other halocarbons was conducted. Equipment containing ODSs or other halocarbons was observed in the subject building.

**Photo 9:** View of equipment observed to contain ODSs in Room 201.
