# HAZARDOUS MATERIALS SURVEY AND 2023 REASSESSMENT

## 545 KING EDWARD AVENUE, OTTAWA, ON

Project No.:0Z2021101HZ / CCC-230252-00

February 27, 2024

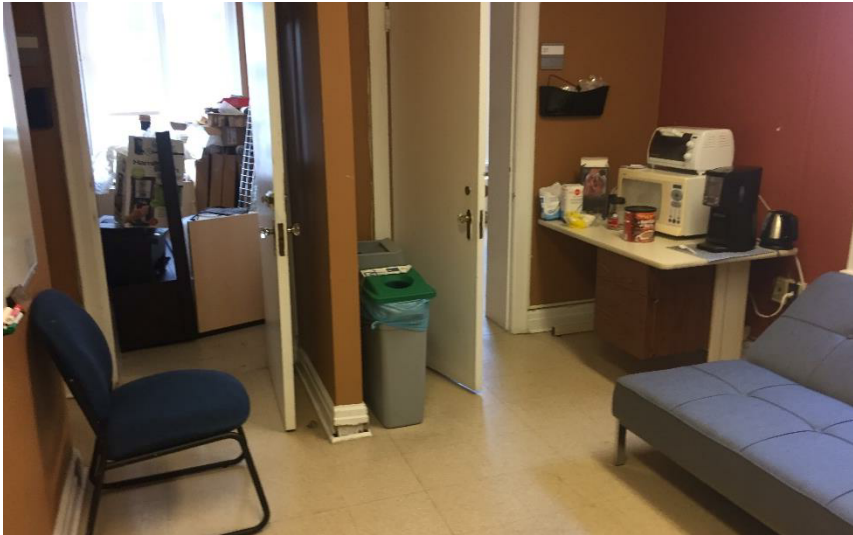
Photo 1: Representative view of the interior finishes observed throughout the subject building.

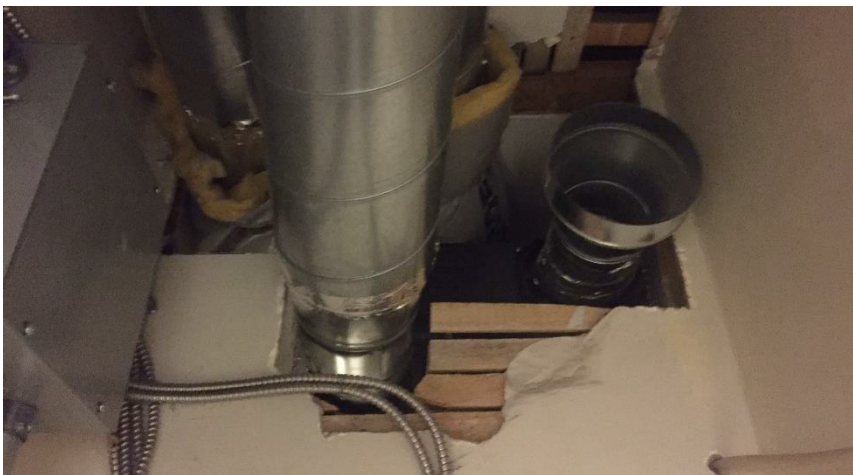
Wall and ceiling plaster was observed and previously sampled throughout the subject building. The laboratory analytical results of the samples collected from Rooms B8, B10, 13, 21C, 21A, and 27A indicate that this material does not contain asbestos.

Photo 2: View of the non-asbestos containing wall and ceiling plaster observed throughout the subject building.

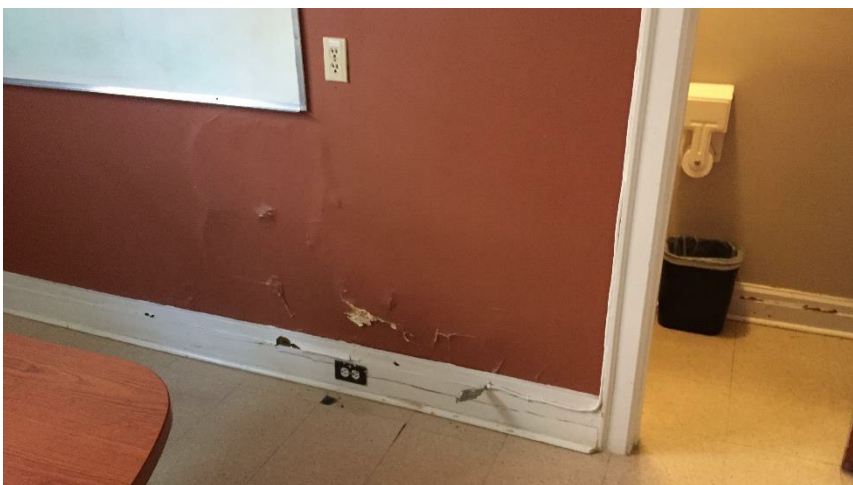
The paint finishes highlighted in pink in the above table are considered lead-containing paints or surface coatings with concentrations greater than 0.1% lead by weight. These paint finishes were observed to be in good condition, with the exception of select areas which were observed in poor condition.

Photo 3: View of the lead-containing paint (Mahogany) observed in poor condition in Room B5.

Paints identified to contain lead that are in poor condition must be immediately repaired and/or stabilized following a minimum Type 1/2 lead abatement procedures as per OMOL “Lead on Construction Project” dated April 2011.

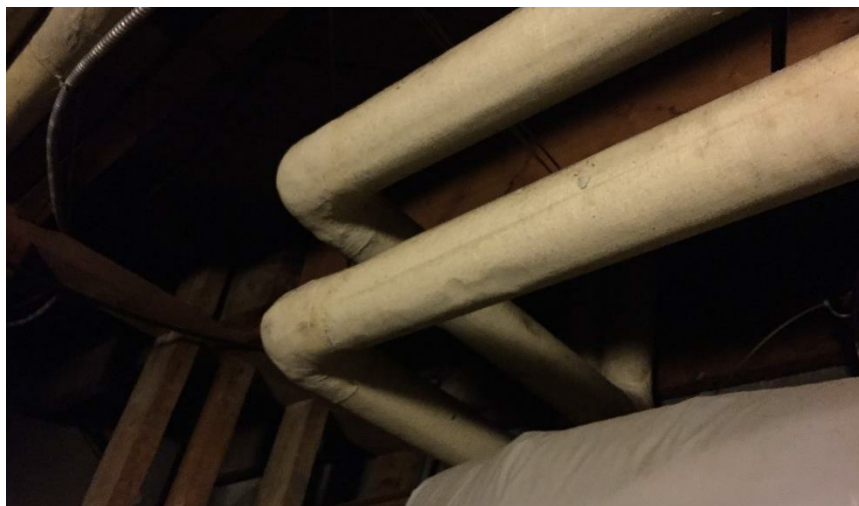
Previously identified asbestos-containing pipe straight insulation was observed in Room B8, B10, and B13. This material **contains 50% Chrysotile asbestos. This material is considered friable and was observed in good condition, with the exception of select areas which were observed in fair condition during 2023 Reassessment.**

Previously identified asbestos-containing pipe elbows/fittings insulation was observed in Room B8 and B10. This material **contains 65% Chrysotile asbestos**. This material is considered friable and was observed in good condition during the 2023 Reassessment.

Photo 4: Representative view of the asbestos-containing parging cement elbows and pipe straight insulation observed in Room B8.

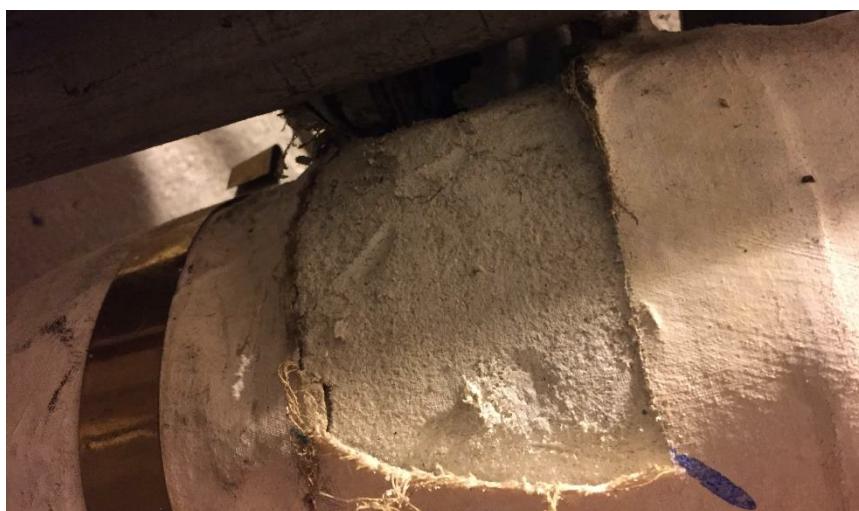
Photo 5: Representative view of the asbestos-containing pipe straight insulation observed in poor condition in Room B8.

- Asbestos-containing materials identified to be in poor condition must be repaired/removed immediately, following Type 1/2/3 asbestos abatement work procedures as detailed in O. Reg. 278/05 and disposed of as asbestos waste under O. Reg. 347;

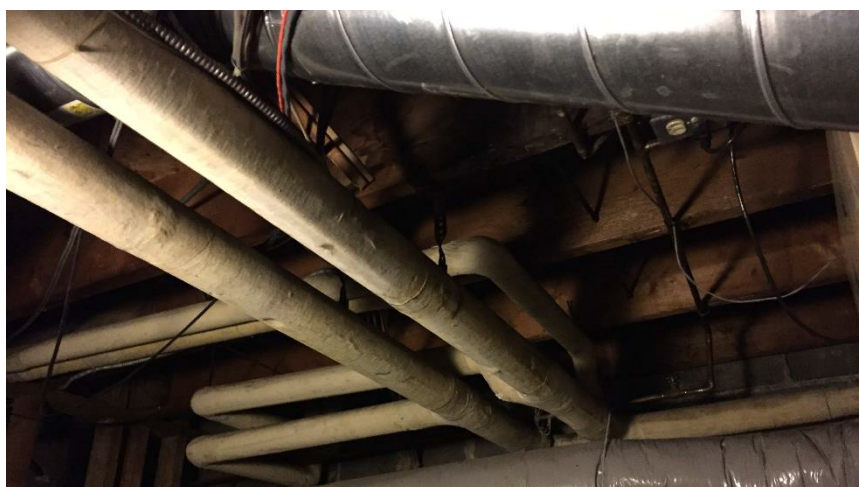
Photo 6: Representative view of the asbestos-containing parging cement elbows and pipe straight insulation observed in Room B10.

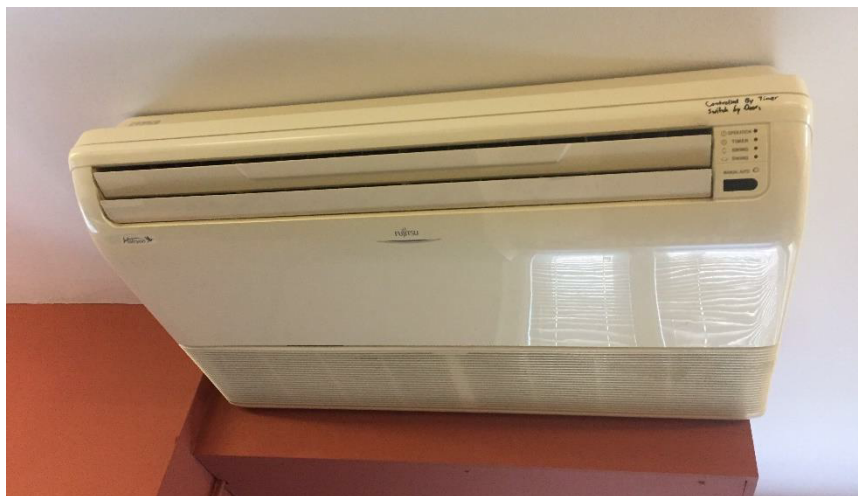
A visual assessment for equipment potentially containing ODSs and other halocarbons was conducted. Equipment containing ODSs or other halocarbons was observed in the subject building.

Photo 7: Representative view of equipment observed to contain ODSs throughout the subject building.

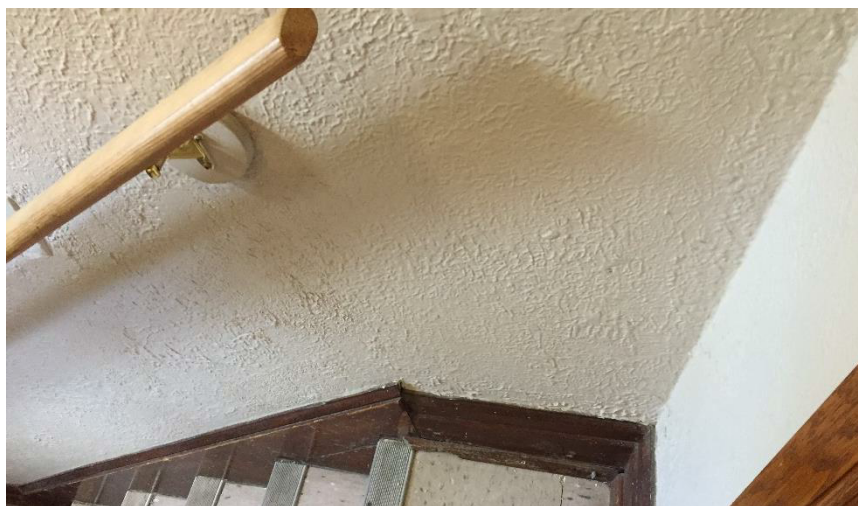
Photo 8: View of the non-asbestos containing wall texture coat observed in Room 10.
