# HAZARDOUS MATERIALS SURVEY AND 2023 REASSESSMENT 555 KING EDWARD AVENUE, OTTAWA, ON

Project No.: 0Z2021101HZ / CCC-230252-00

University of Ottawa

McIntosh Perry Limited (MPL)

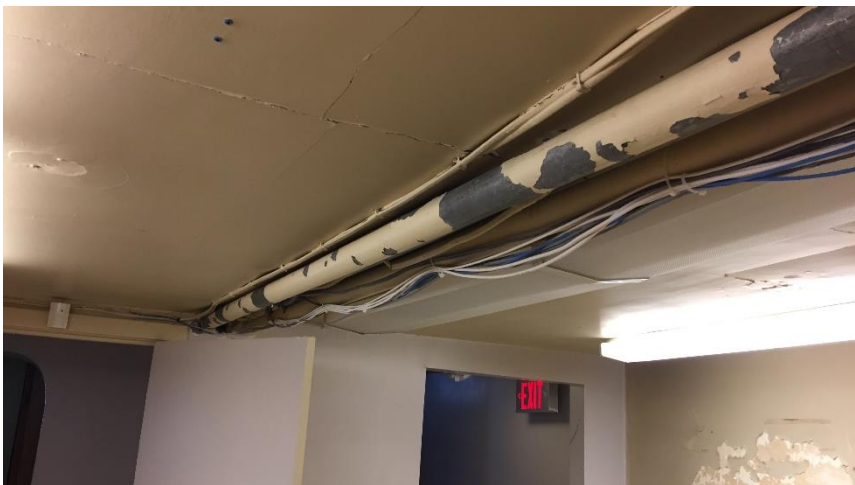
The paint finishes highlighted in pink in the above table are considered lead-containing paints or surface coatings with concentrations greater than 0.1% lead by weight. These paint finishes were observed to be in good condition, with the exception of select areas which were observed in poor condition.

**Photo 2:** View of the poor condition lead paint (Beige) identified on pipe straights in Room B5.

Paints identified to contain lead that are in poor condition must be immediately repaired and/or stabilized following a minimum Type 1/2 lead abatement procedures as per OMOL “Lead on Construction Project” dated April 2011.

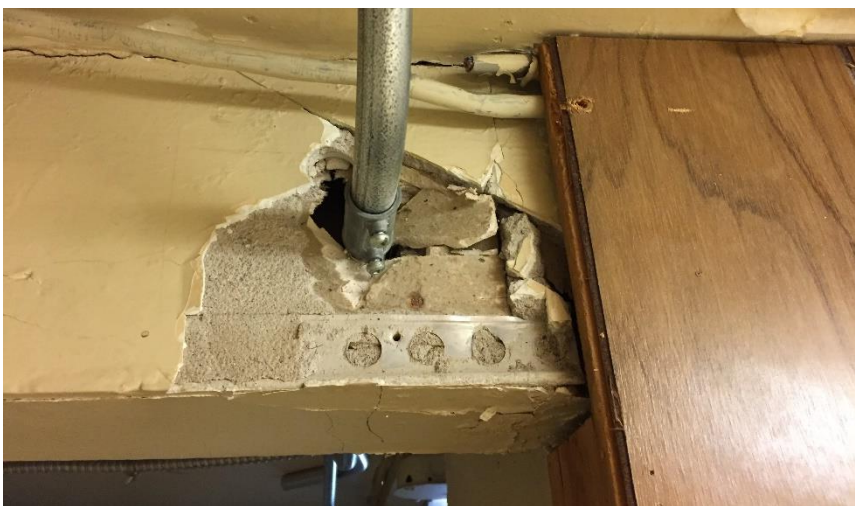
Plaster was observed and previously sampled in Rooms B1, B1A, B5, B6, B7, 202, and 207. The laboratory analytical results indicate that this material does not contain asbestos.

**Photo 3:** View of the non-asbestos containing wall plaster observed throughout the subject building.

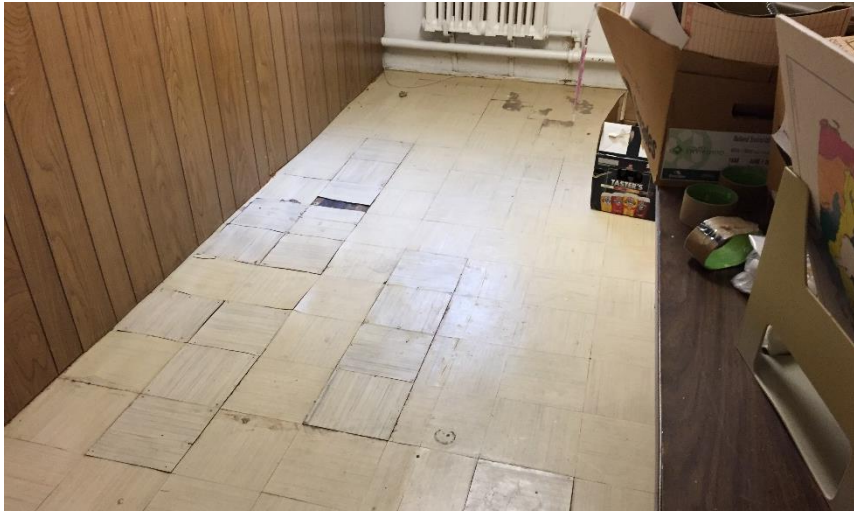
- ACM Vinyl Floor Tile (VFT) was observed to be in Good Condition in the basement of the subject building.
- ACM Vinyl Sheet Flooring (VSF) was observed to be in Good Condition in the basement of the subject building.
- No water damaged or mould affected materials were observed during the site survey.

- Previously identified asbestos-containing vinyl floor tiles (12" x 12"- Beige with Brown Lines) were observed throughout the subject building. This material **contains 16.5% Chrysotile asbestos**. This material is considered to be non-friable and was observed in good condition. **Previously identified locations with poor condition asbestos-containing vinyl floor tiles were observed to be removed during the 2022 Reassessment.**

**Photo 4:** View of the asbestos-containing vinyl floor tiles (12"x12" – Beige w/ Brown Lines) observed throughout the basement level.

- Materials identified to contain asbestos that are in good condition and do not pose a risk to workers or occupants can be managed in place. Prior to renovation/demolition activities that may disturb the ACMs, these materials must be removed following appropriate Type 1/2/3 asbestos abatement work procedures as detailed in O. Reg. 278/05 and disposed of as asbestos waste under O. Reg. 347;

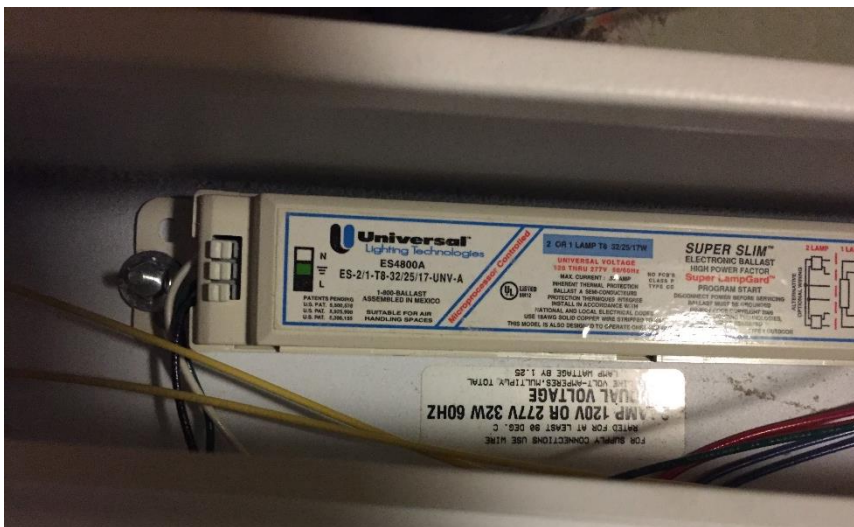
The subject building is illuminated by LED and fluorescent lights. MPL assessed representative ballasts in the building, and these ballasts were identified as non-PCBs content. These light ballasts were observed to be manufactured by Universal Lighting Technologies.

**Photo 5:** View of the non-PCB light ballasts observed throughout the subject building.

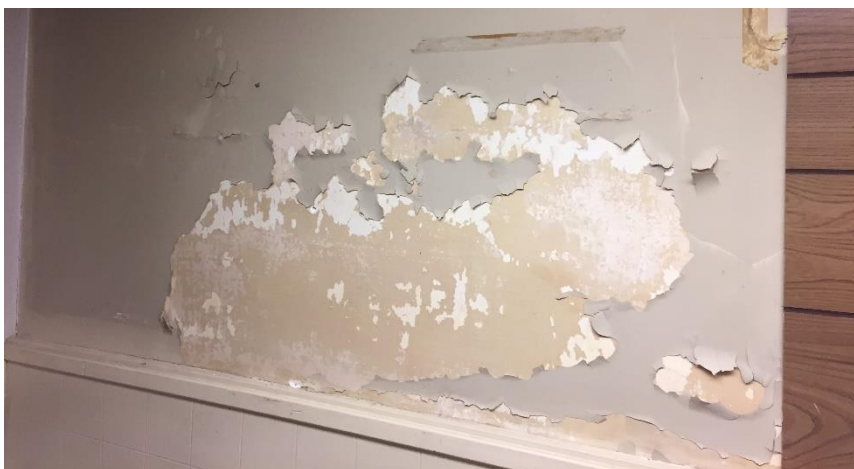
**Photo 6:** View of the poor condition lead-containing wall paint (Beige) observed in Room B5.

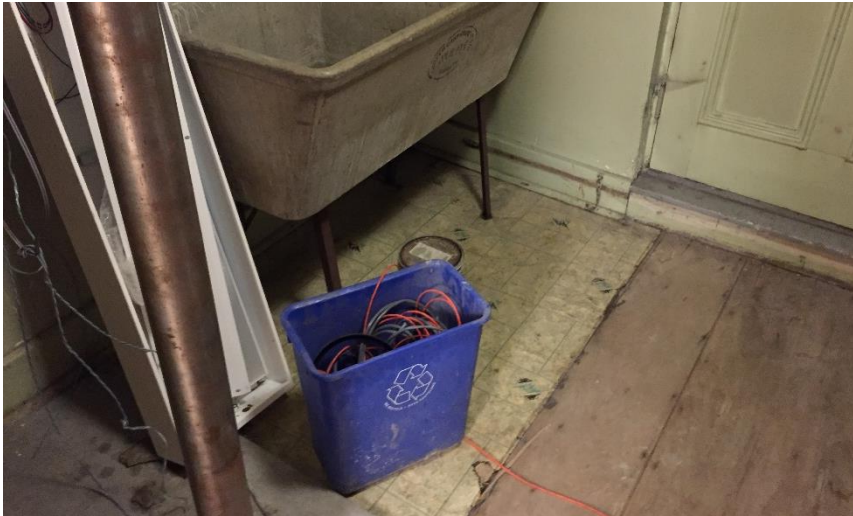
**Photo 7:** View of the asbestos-containing vinyl sheet flooring (Yellow Rectangular Pattern) observed in Room B9.

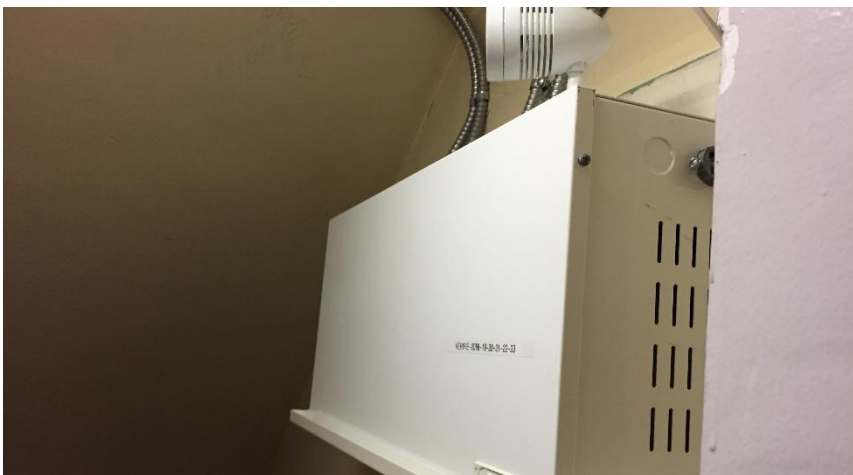
MPL identified lead-containing acid battery packs in Room B2. These battery packs were observed on walls within the subject building.

**Photo 8:** View of the lead-containing batteries observed in Room B2.

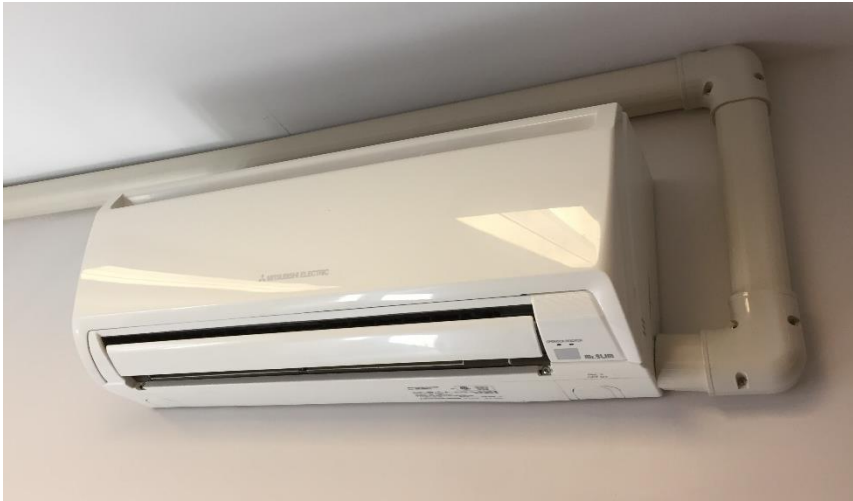
A visual assessment for equipment potentially containing ODSs and other halocarbons was conducted. Equipment containing ODSs or other halocarbons was observed in the subject building.

**Photo 10:** View of the equipment containing ODSs observed throughout the subject building.

Please refer to Appendix F – Hazardous Materials Checklist for equipment conditions, approximate quantities (where applicable), and recommended actions.

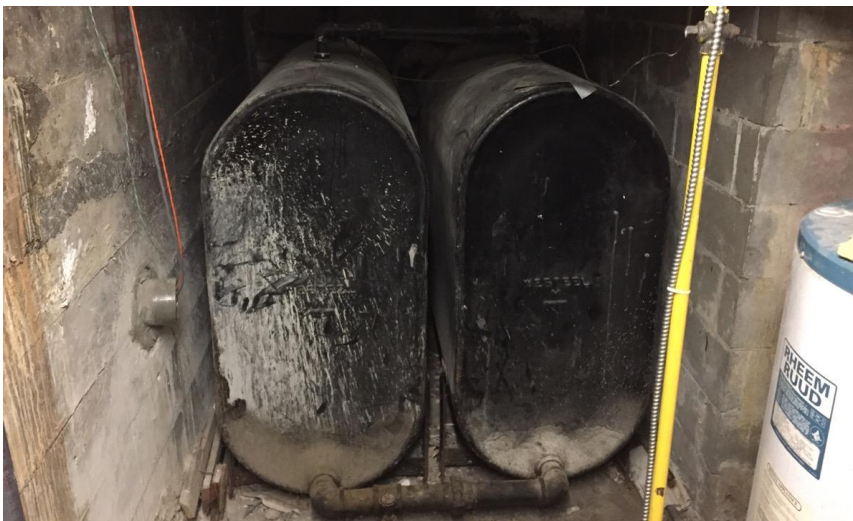
A visual survey of the subject building was conducted to determine if any USTs and ASTs were present. MPL observed two (2) above ground diesel storage tanks in Room B8.

**Photo 11:** View of the above ground diesel storage tanks identified in Room B8.

Please refer to Appendix F – Hazardous Materials Checklist for equipment conditions, quantities (where applicable), and recommended actions.
