HAZARDOUS MATERIALS SURVEY AND 2023 REASSESSMENT 559 KING EDWARD AVENUE, OTTAWA, ON

Project No.: 0Z2021101HZ / CCC-230252-00

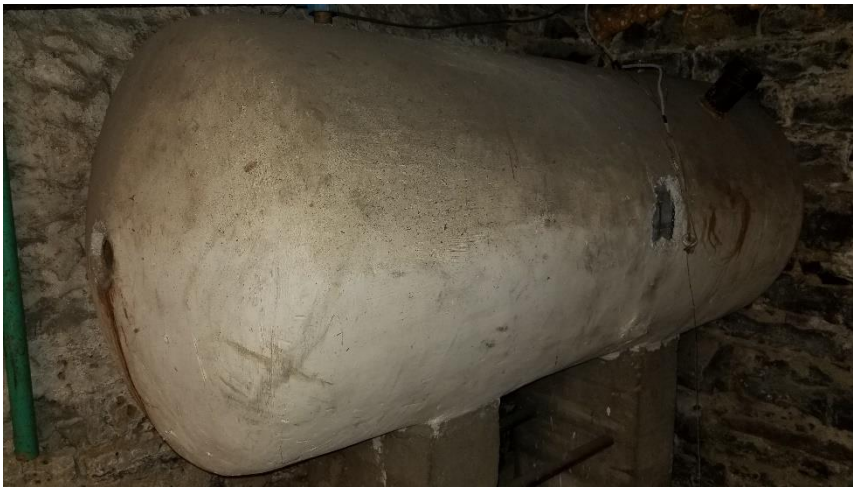
Photo 2: View of the asbestos-containing boiler tank insulation (paring cement) observed in poor condition in Room B5.

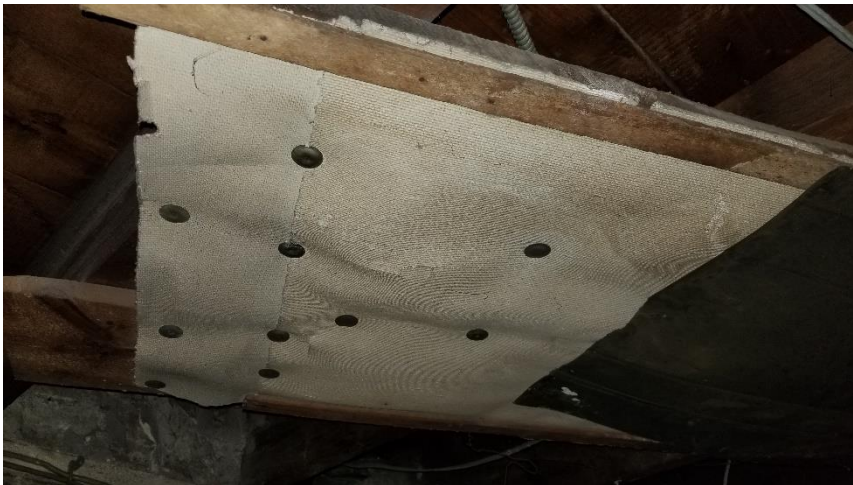
Photo 4: View of the asbestos-containing paper insulation (Grey) observed in poor condition in Room B5.

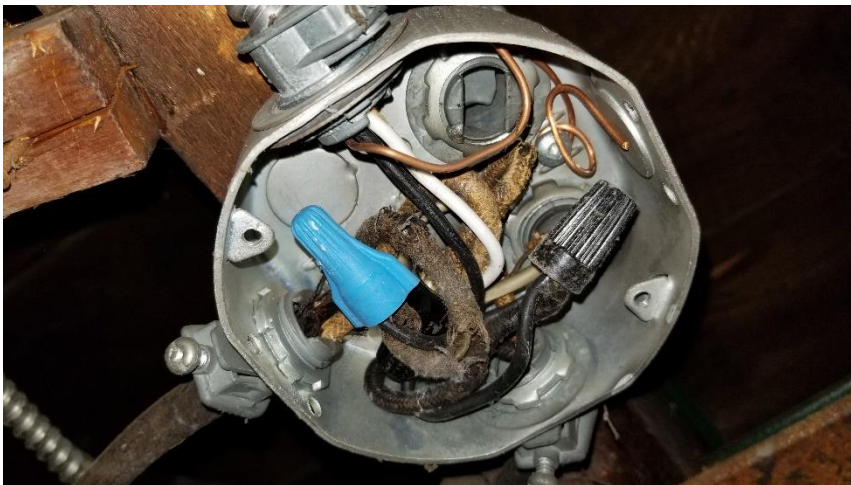
Photo 6: View of the electrical wire fabric cover (Brown) suspected of containing asbestos and PCBs in Room B5.

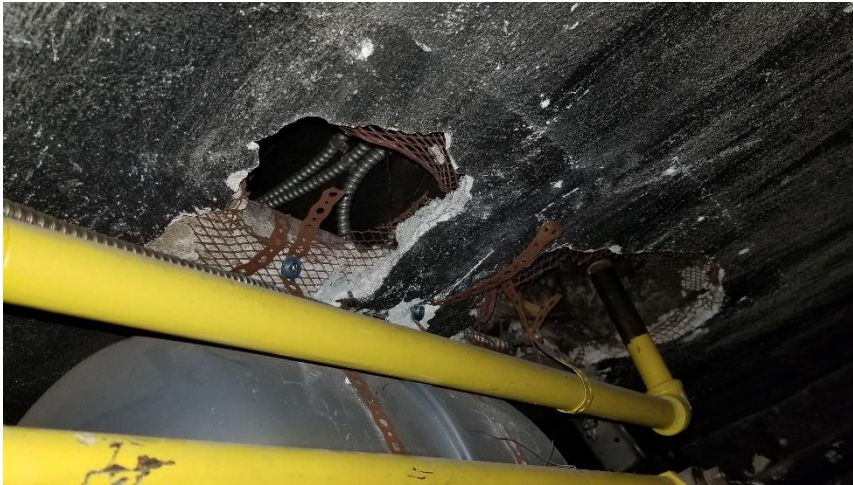
Photo 7: View of the non-asbestos ceiling plaster (Grey) observed in Room B6.

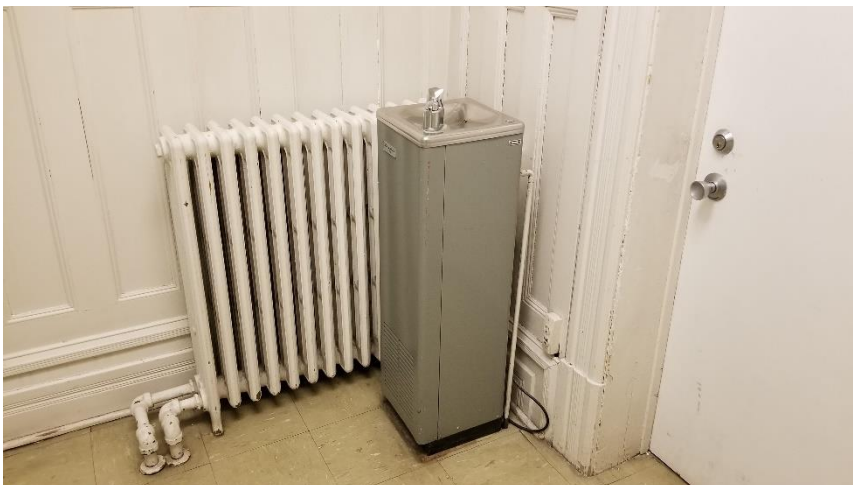
Photo 9: Representative view of equipment observed to contain ODSs in Room 101.

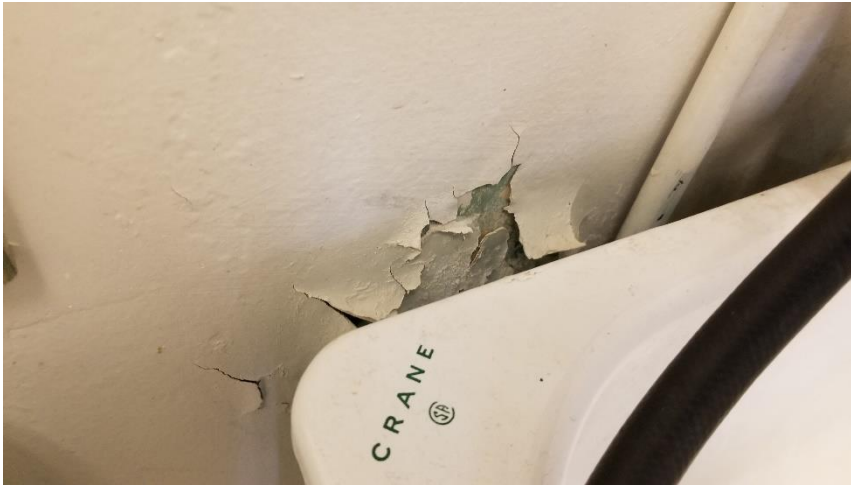
Photo 13: View of the lead-containing wall paint (White) observed in poor condition in Room 103 during the 2022 Reassessment.

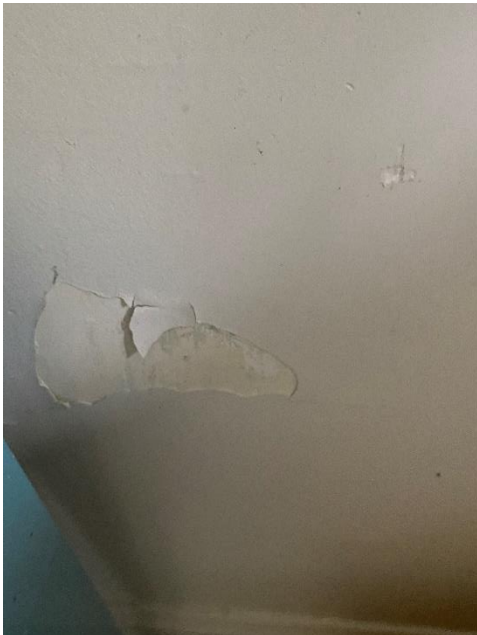
Photo 14: View of the lead-containing ceiling paint (White) observed in poor condition in Room 110 during the 2022 Reassessment.

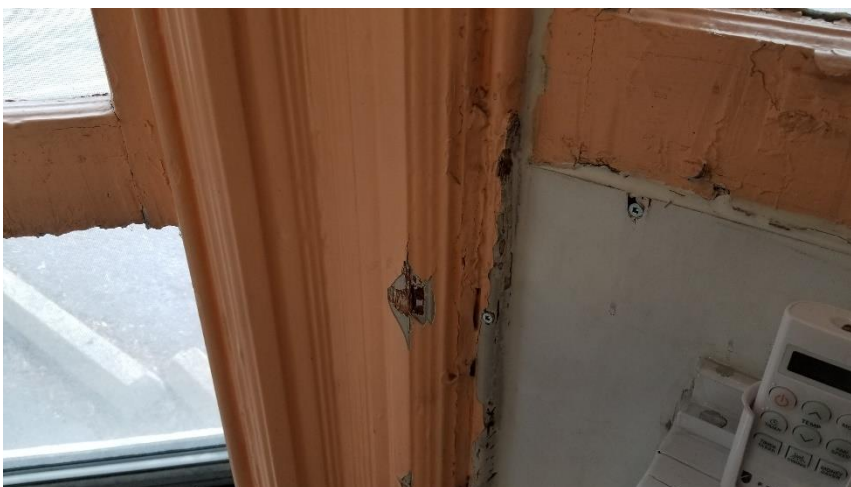
Photo 17: View of the lead-containing frame paint (Peach) observed in poor condition in Room 108.

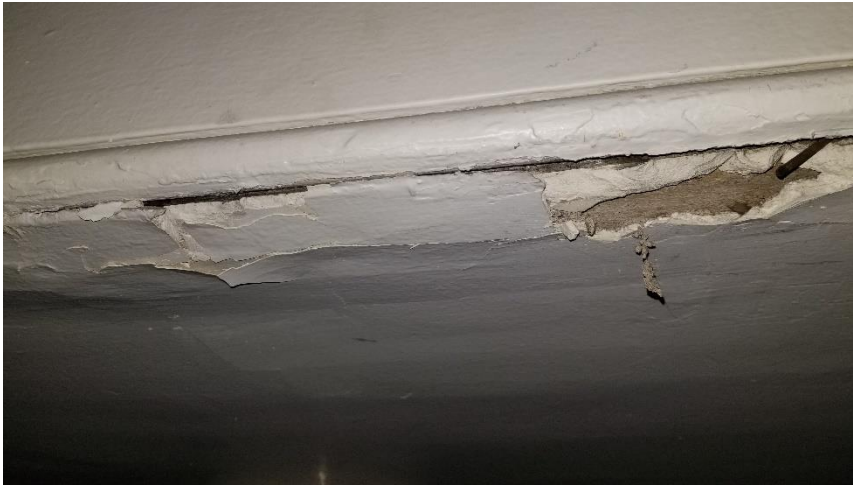
Photo 18: View of the asbestos-containing plaster observed in poor condition in Room 100.

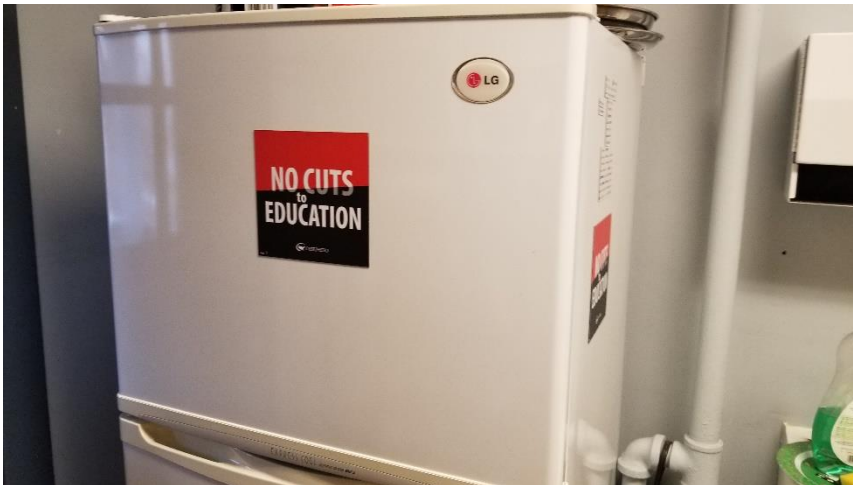
Photo 19: Representative view of equipment observed to contain ODSs in Room 211.

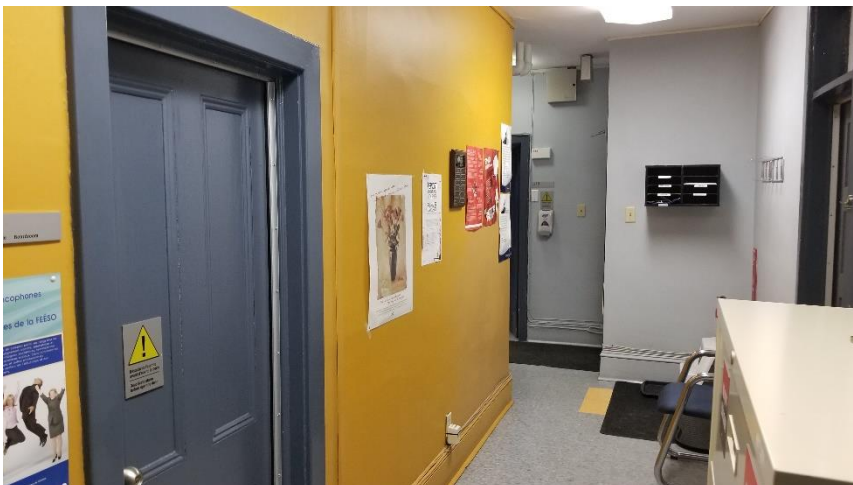
Photo 20: Representative view of the lead-containing paint (Dark Yellow) observed in good condition throughout the second floor.
