HAZARDOUS MATERIALS SURVEY AND 2023 REASSESSMENT 585 KING EDWARD AVENUE, OTTAWA, ON

Project No.: Z2021101HZ / CCC-230252-00

University of Ottawa

McIntosh Perry Limited (MPL)

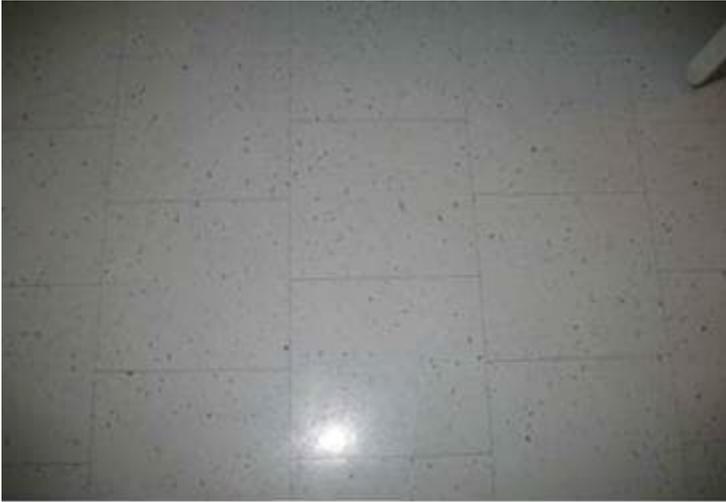
Photo 1: View of typical vinyl floor tile finishes observed at the building located at 585 King Edward Avenue.

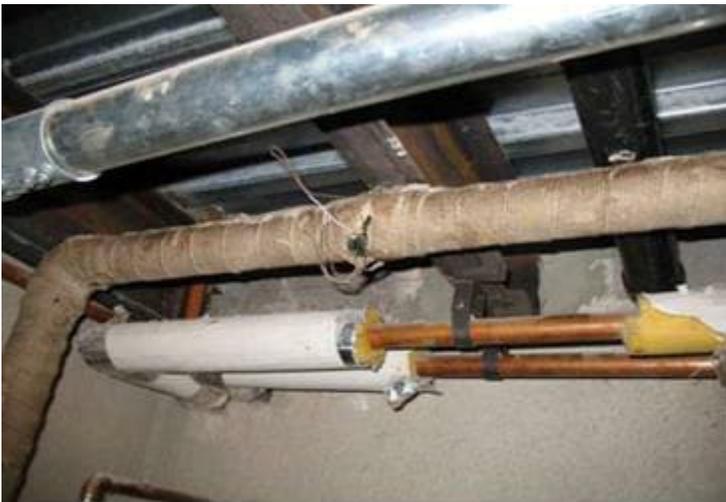
Mechanical pipe straight insulation was previously observed and sampled in the subject building. This material was found to **contain 5% Chrysotile asbestos**. This material is considered to be friable and was observed to be in good condition.

Photo 2: View of asbestos-containing thermal wrap observed in Room B6B.

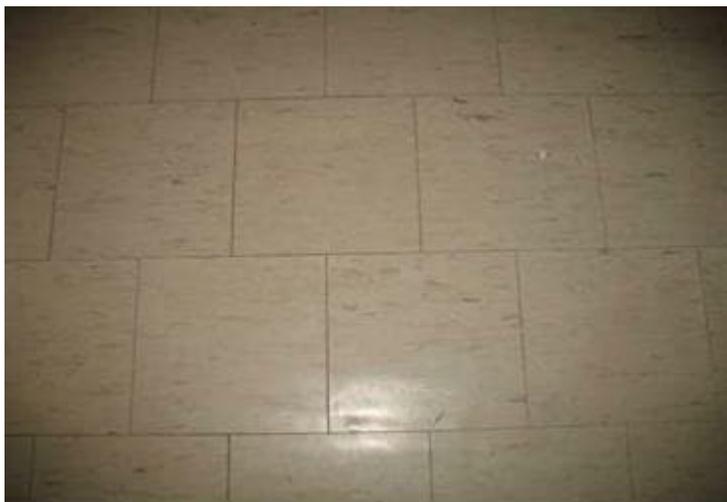
- Vinyl floor tiles (12"x12" – Brown) were previously observed and sampled in Room B-15. The laboratory analytical results of vinyl floor tile samples collected indicate that this material **contains 20.7% Chrysotile asbestos. This material is considered non-friable and was observed in good condition, except for select locations observed to be in poor condition in Rooms B9 and B12 during the 2022 Reassessment.**

Photo 3: View of asbestos-containing vinyl floor tile observed in Room B15B.

- ACMs identified to be in poor condition must be repaired/removed immediately, following Type 1/2/3 asbestos abatement work procedures as detailed in O. Reg. 278/05 and disposed of as asbestos waste under O. Reg. 347;

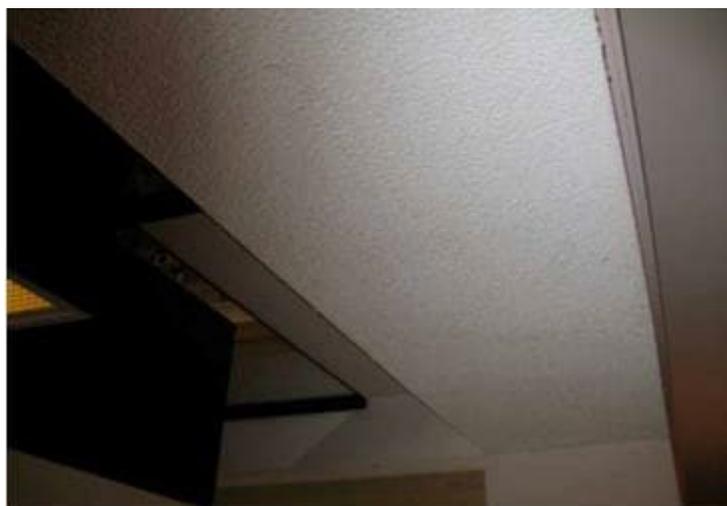
Previously identified A ceiling texture coat was observed throughout the subject building. This material was found to **contain 10% Chrysotile asbestos**. This material is considered to be friable and observed to be in good condition.

Photo 4: View of asbestos-containing ceiling texture coat observed in Room 100A.

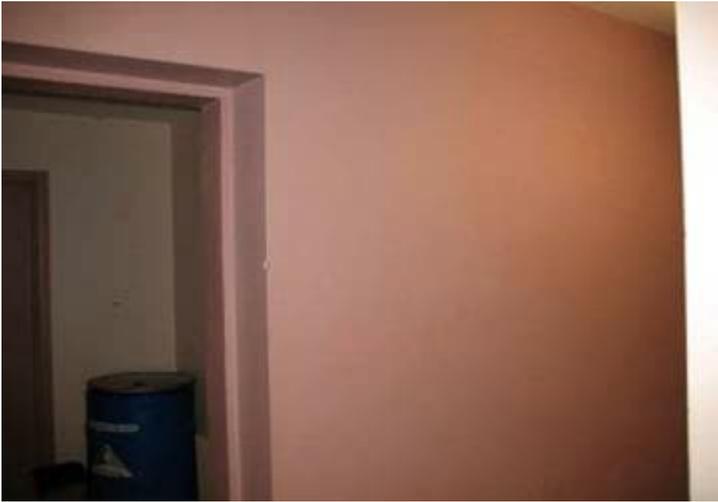
The paint finishes highlighted in pink in the above table are considered lead-containing paints or surface coatings with concentrations greater than 0.1% lead by weight. These paint finishes were observed to be in good condition.

Photo 5: View of dark purple lead-containing paint observed on the wall in Room B1.

Paints identified to contain lead that are in good condition and do not pose a risk to workers or occupants can be managed in place.

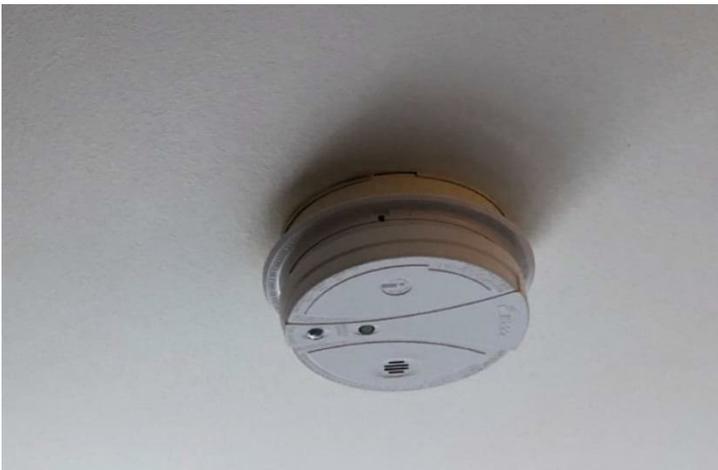
A visual assessment of the subject building was conducted to determine if any electrical components containing radioactive materials were present. Smoke detectors were observed throughout the subject building, which contained small quantities of radioactive material.

Photo 6: Typical view of smoke detectors containing radioactive materials.

The radioactive sources in smoke alarms are sealed and contained within a metal case inside the smoke detector and must not be damaged or tampered with. These materials do not pose a hazard as long as they remain contained and properly disposed of at the time of removal or replacement.

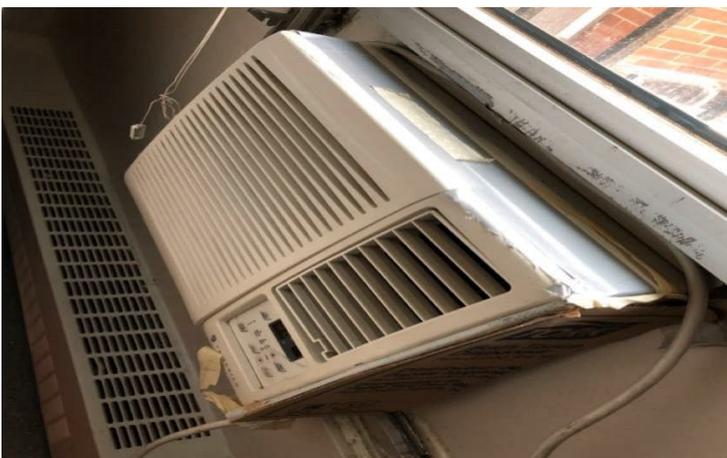
A visual assessment for equipment potentially containing ODSs and other halocarbons was conducted. MPL observed equipment such as refrigerators and air conditioners which contain or are suspected of containing ODSs or other halocarbons.

Photo 7: Typical view of ODS containing air-conditioning unit.
