# HAZARDOUS MATERIALS SURVEY AND 2023 REASSESSMENT

## 600 KING EDWARD AVENUE, OTTAWA, ON

Project No.: Z2021101-HZ / CCC-230252-00

January 29, 2024

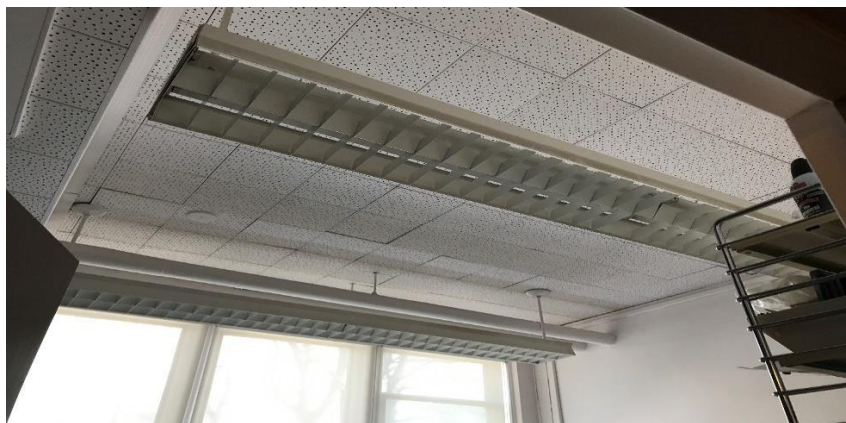
**Photo 1:** View of non-asbestos ceiling tile (1'x1') in Room 101.

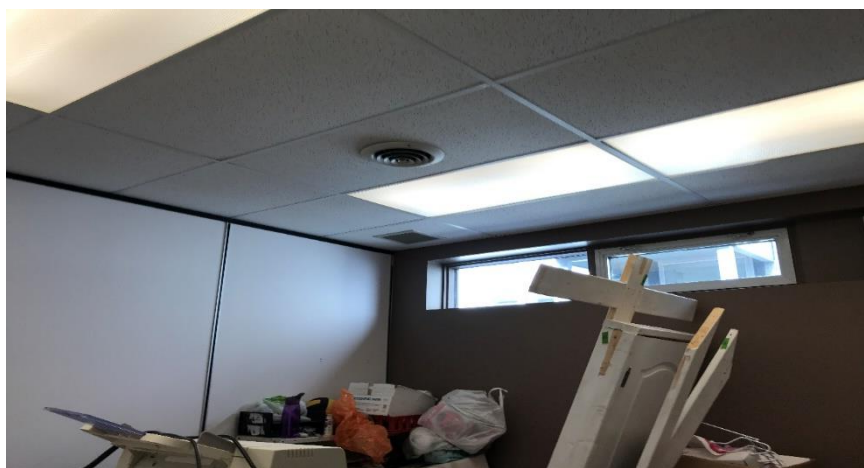
**Photo 2:** View of non-asbestos- 2'x4" Ceiling Tile in Room 119.

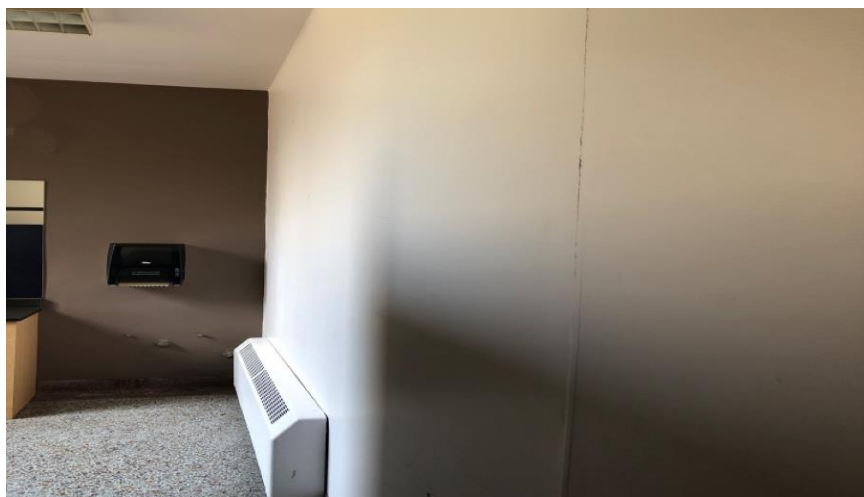
Drywall joint compound was observed throughout the subject building. The laboratory analytical results of drywall joint compound samples collected from Room 102, 102A, 105, 201, 201A, 307A and 307D indicate that this material **contains 2% Chrysotile asbestos**. Since drywall joint compound is a homogeneous material, all areas must be treated as asbestos-containing unless additional bulk sampling and analysis proves otherwise. **This material was observed in good condition, with select areas in fair and poor condition which were observed during the 2023 Reassessment.**

**Photo 3:** View of asbestos-containing drywall joint compound observed to be in fair condition in Room 202

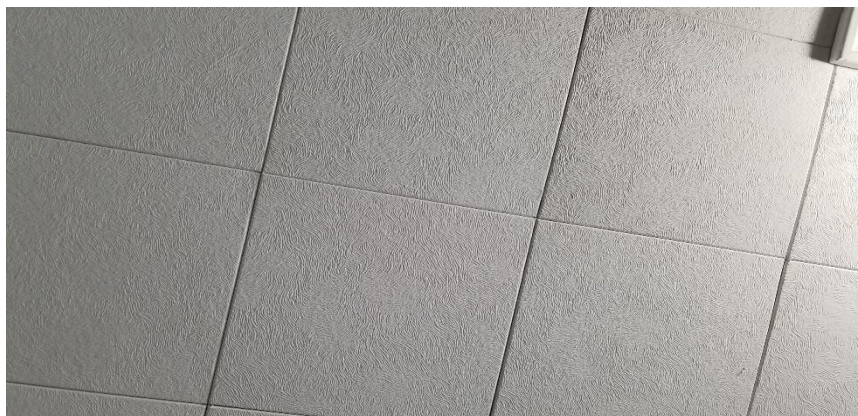
**Photo 4:** View of non-asbestos ceiling tiles (1' x 1') observed in Room 102.

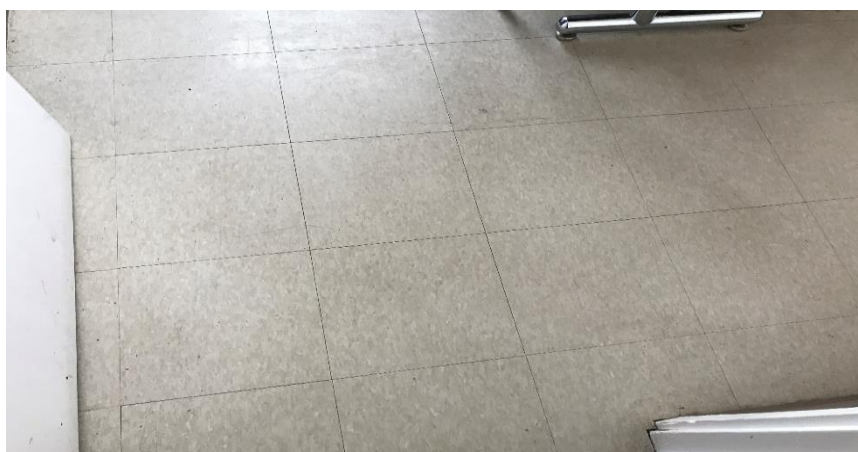
- Vinyl floor tiles (12" x 12" - White with Grey mix) were observed throughout the subject building. The laboratory analytical results of the vinyl floor tile samples previously collected from Room 105, 109 and 201D indicate that this material does not contain asbestos. The associated mastic (black) was also found not to contain asbestos.
- Vinyl floor tiles (12" x 12" - Grey with Light and Dark marks) were observed in Room 110. The laboratory analytical results of the vinyl floor tile samples previously collected from Room 110 indicate that this material does not contain asbestos.
- Previously identified asbestos-containing vinyl floor tiles (12"x12" - Grey W/ White flakes) was observed in Room 209. This material contains **8.7% Chrysotile asbestos**. This material is considered to be non-friable and was observed to be in good condition.

**Photo 5:** View of asbestos-containing 12"x12" vinyl floor tile in Room 201

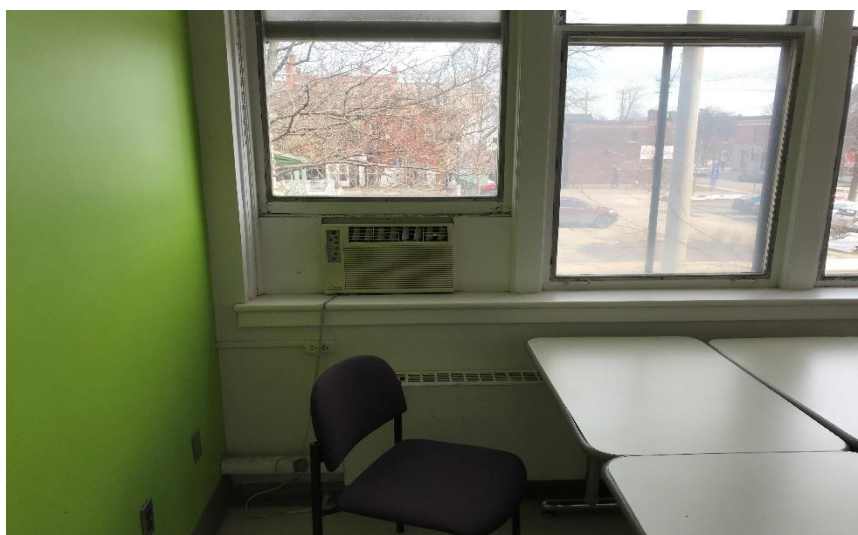
A visual assessment for equipment potentially containing ODSs and other halocarbons was conducted. Equipment containing ODSs or other halocarbons was observed in the subject building.

**Photo 6:** View of air conditioning unit containing ozone-depleted substance in Room 201

Please refer to Appendix F – Hazardous Materials Checklist for equipment conditions, approximate quantities (where applicable), and recommended actions.

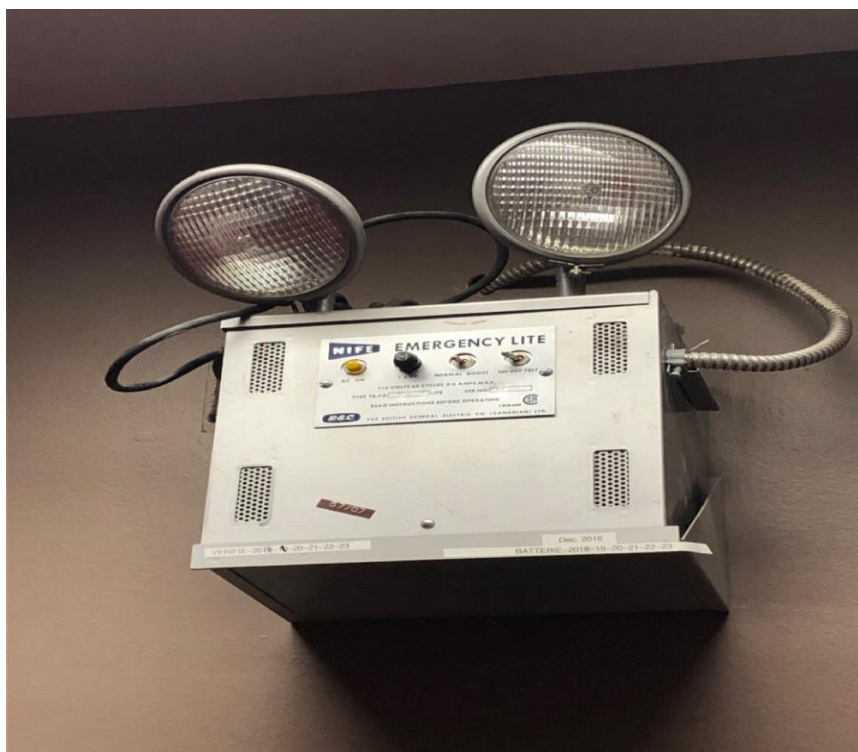
MPL identified lead-containing acid battery packs throughout the subject building. These battery packs were observed on walls and above exits within the subject building.

**Photo 7:** View of lead containing Emergency light in Room 207

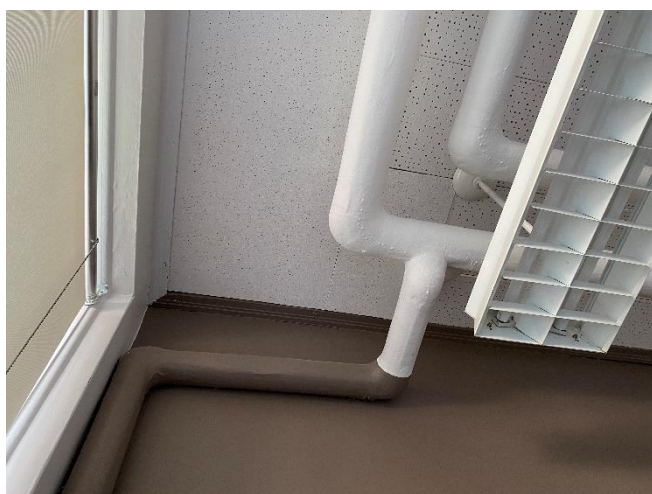
Previously identified mechanical pipe elbows/fittings insulation was observed in Rooms 101 (Previously 111), 102, 102B, 108, and 110. The laboratory analytical results of samples previously collected indicate that this material contains **15% Chrysotile asbestos**. This material is considered to be friable and was observed to be in good condition.

**Photo 8:** View of asbestos-containing mechanical pipe insulation on fittings/elbow/straight observed to be in good condition in Room 102B during the 2023 Reassessment.

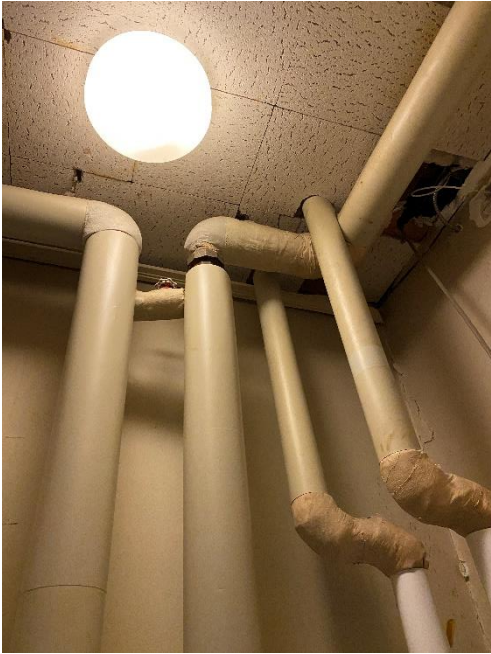
**Photo 9:** View of asbestos-containing mechanical pipe insulation on fittings/elbow/straight observed to be in good condition in Room 110 during the 2023 Reassessment.

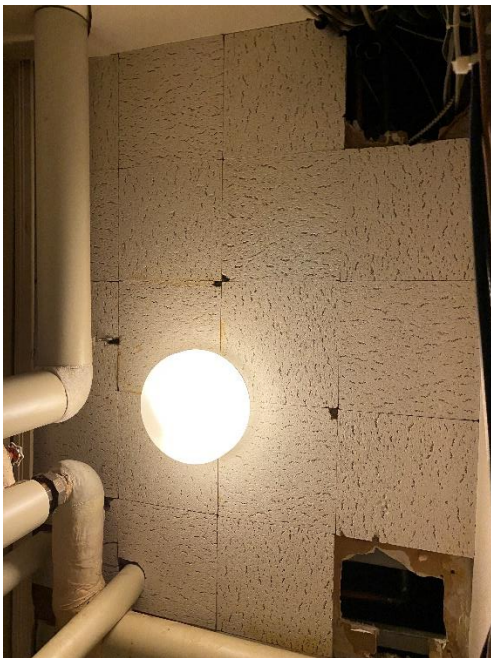
**Photo 10:** View of asbestos-containing drywall joint compound on ceiling observed to be in poor condition in Room 110 during the 2023 Reassessment.
