# HAZARDOUS MATERIAL SURVEY AND 2023 REASSESSMENT 600 PETER MORAND CRESCENT, OTTAWA, ON

Project No.: Z2021101HZ / CCC-230252-00

University of Ottawa

McIntosh Perry Limited (MPL)

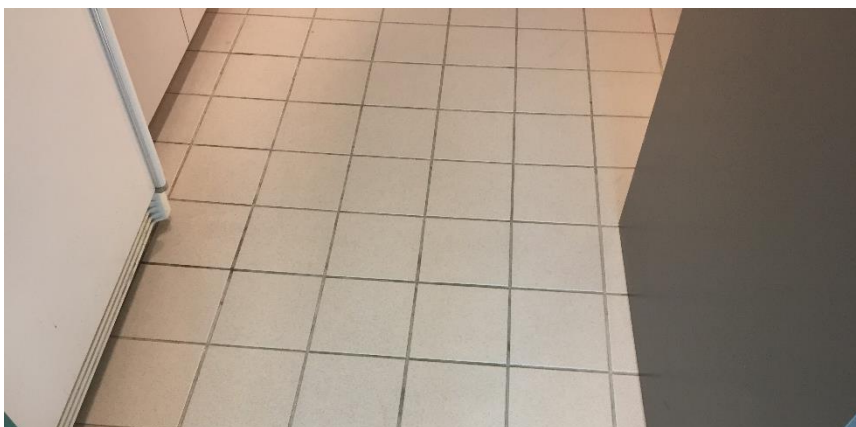
To avoid damage and compromising the integrity of the structure, no bulk samples of the ceramic wall/floor tile grout were collected. Prior to renovation/demolition, ceramic tile grout should be examined and tested for asbestos content. Ceramic wall/floor tile grout should therefore be considered to contain asbestos until bulk samples and analysis proves otherwise.

Photo 3: Typical view of ceramic floor tile grout suspected of containing asbestos.

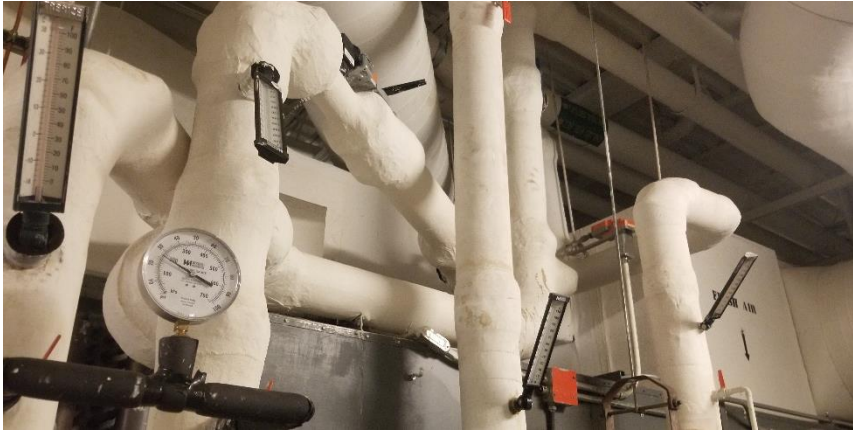
MPL observed thermometers containing liquid mercury within the subject building.

MPL observed pressure gauges containing liquid mercury within the subject building.

Photo 4: View of mercury-containing pressure gauges and thermometers observed in Room 400.

Please refer to Appendix F – Hazardous Materials Checklist for equipment conditions, quantities (where applicable), and recommended actions.

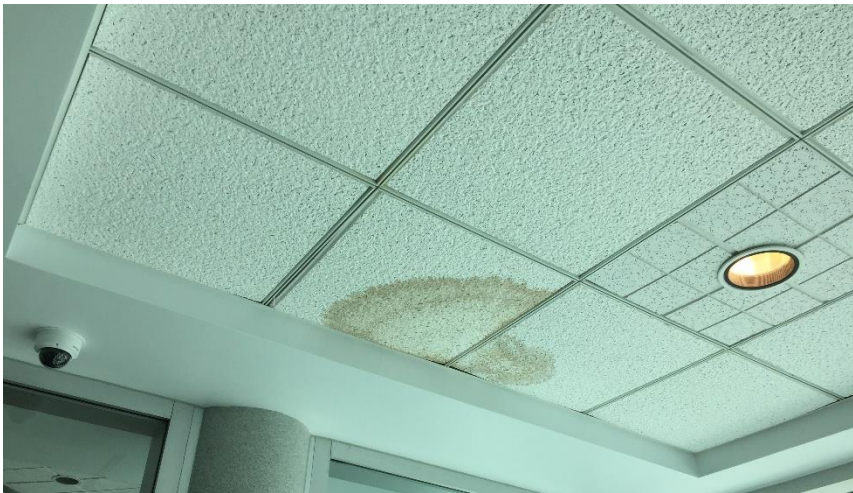
Photo 5: View of water damaged ceiling tiles observed in Room 100G.

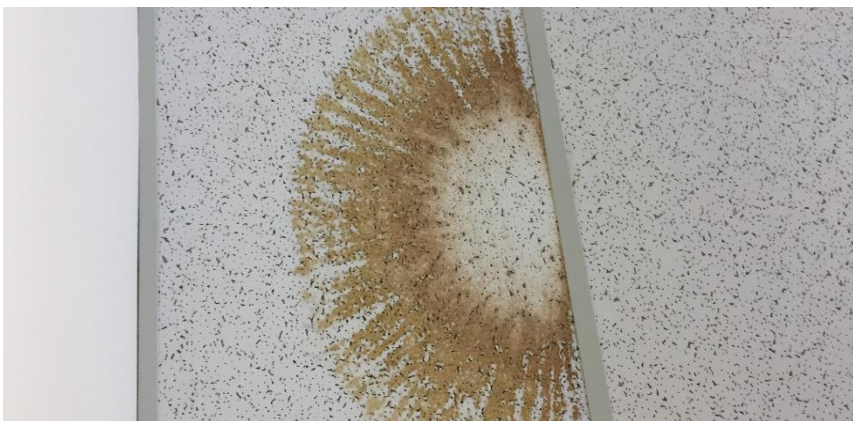
Photo 6: View of water damaged ceiling tiles observed in Room 100G.
