HAZARDOUS MATERIALS SURVEY AND 2023 REASSESSMENT 613 KING EDWARD AVENUE, OTTAWA, ON

Project No.: Z2021102HZ/ CCC-230252-00

University of Ottawa

McIntosh Perry Limited (MPL)

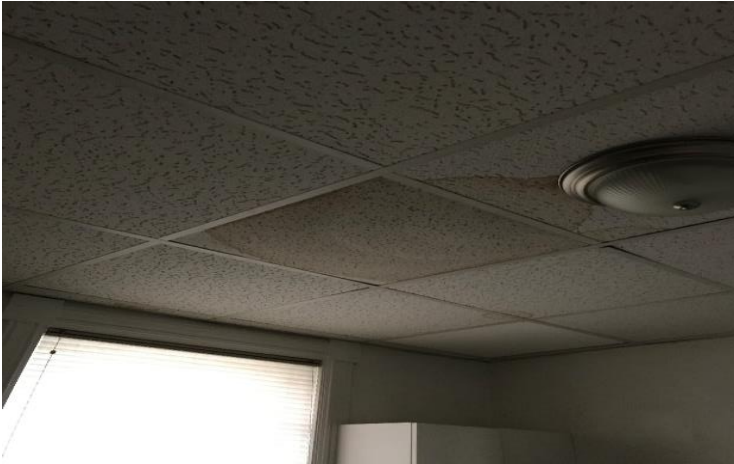
A visual survey of the subject building was conducted to determine if water damage was present. Select areas were identified throughout the subject building where materials were affected by water damage.

Photo 1: View of water damaged ceiling tiles (2'x2') observed in the kitchen within the subject building.

Water-stained/damaged ceiling tiles observed throughout the subject building should be replaced as part of regular maintenance, and the underlying cause of the water leakage should be identified and repaired.

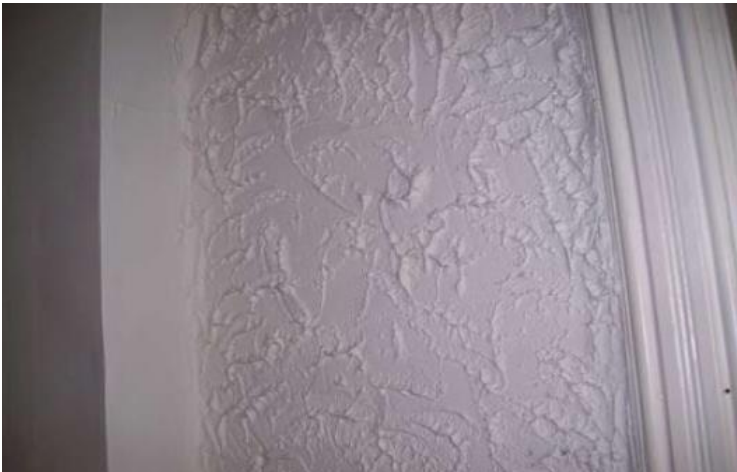
Wall texture coat (Stucco) was observed and sampled in the front room on the 1st floor of the subject building. The laboratory analytical results indicate that this material does not contain asbestos.

Photo 2: View of the non-asbestos-containing texture coat observed in the front room on the 1st floor of the subject building.

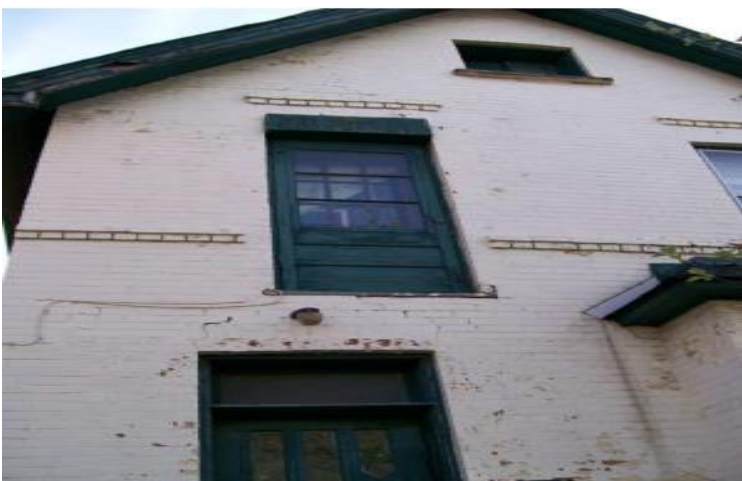
The paint finishes highlighted in pink in the above table are considered lead-containing paints or surface coatings with concentrations greater than 0.1% lead by weight. These paint finishes were observed to be in good condition, except for select areas that were observed in poor condition.

Photo 3: View of green and white lead-containing paint observed to be in poor condition on the exterior of the subject building.

Paints identified to contain lead that is in poor condition must be immediately repaired and/or stabilized following a minimum Type 1/2 lead abatement procedures as per OMOL “Lead on Construction Project” dated April 2011.
