HAZARDOUS MATERIALS SURVEY AND 2023 REASSESSMENT 615 KING EDWARD AVENUE, OTTAWA, ON

Project No.: Z2021102HZ / CCC-230252-00

University of Ottawa

McIntosh Perry Limited (MPL)

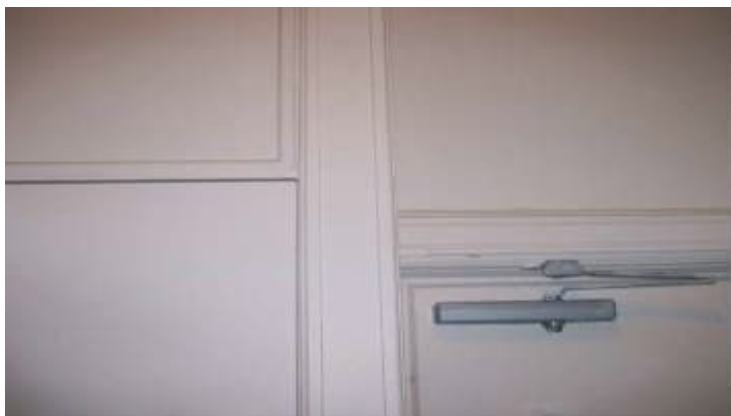
The paint finishes highlighted in pink in the above table are considered lead-containing paints or surface coatings with concentrations greater than 0.1% lead by weight. These paint finishes were observed to be in good condition.

Photo 1: View of lead-containing white paint observed to be in good condition in the front entrance of the subject building.

Paints identified to contain lead that are in good condition and do not pose a risk to workers or occupants can be managed in place.

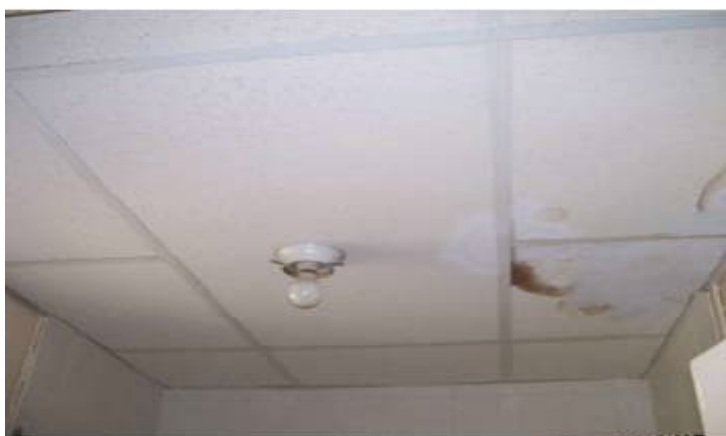
A visual survey of the subject building was conducted to determine if water damage was present. **Select areas were identified throughout the subject building where materials were affected by water damage.**

Photo 2: View of water damaged ceiling tiles observed in the bathroom (Room 106) on the 1st floor of the subject building.

Water-stained/damaged ceiling system materials observed in select areas throughout the subject building should be replaced as part of regular maintenance, and the underlying cause of the water leakage should be identified and repaired;

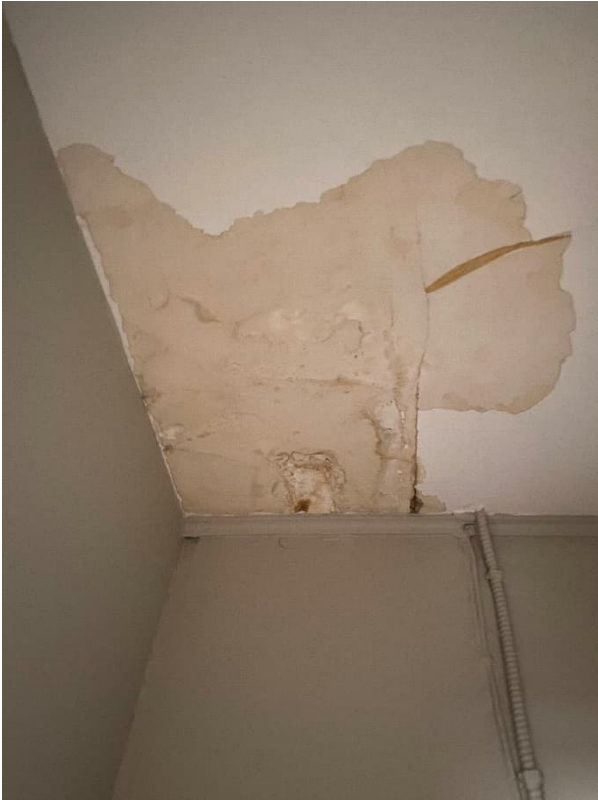
Photo 3: View of water damaged ceiling observed within Apartment 2 of the subject building.

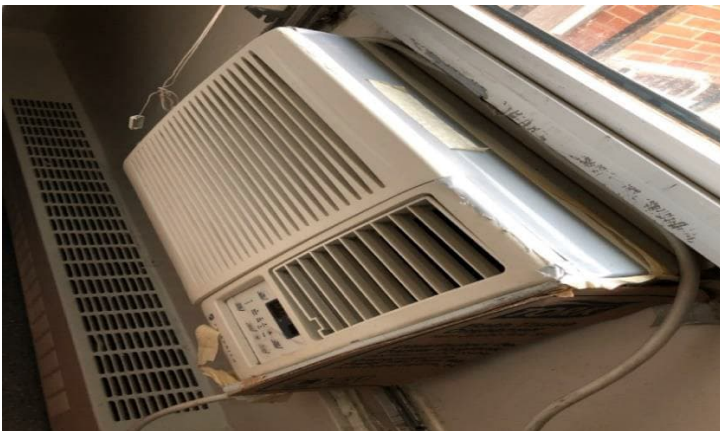
A visual assessment for equipment potentially containing ODSs and other halocarbons was conducted. MPL observed equipment such as refrigerators and air conditioners which contain or are suspected of containing ODSs or other halocarbons.

Photo 4: Typical view of ODS containing air-conditioning unit.
