HAZARDOUS MATERIALS SURVEY AND 2023 REASSESSMENT

631 KING EDWARD AVENUE, OTTAWA, ON

Project No.: 0Z2021101HZ / CCC-230252-00

REASSESSMENT SURVEY 2023

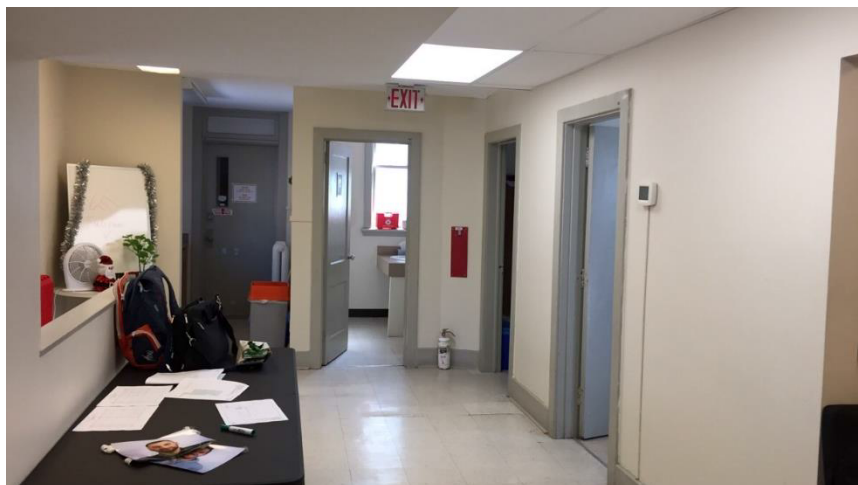
Photo 1: Representative view of the general finishes observed throughout the subject building.

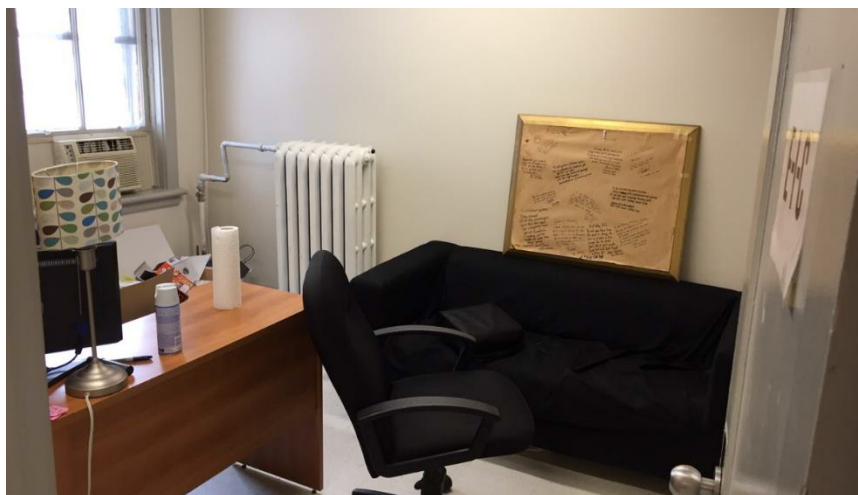
Photo 2: Representative view of the general finishes observed throughout the subject building.

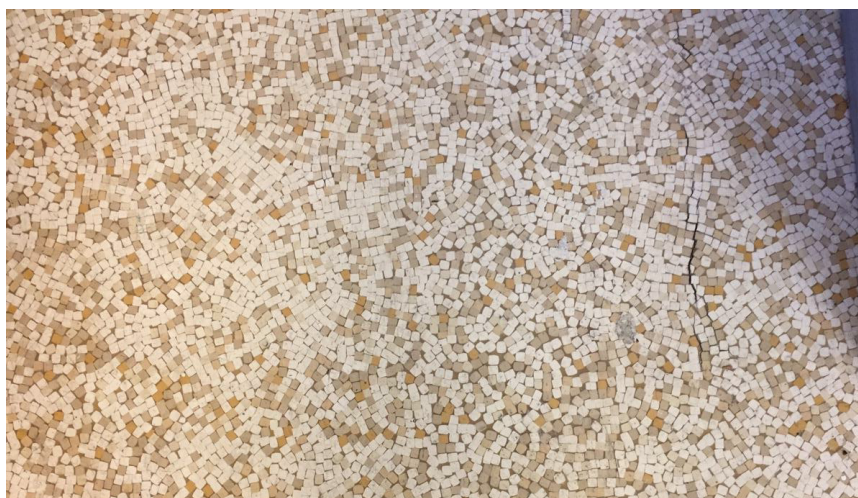
Previously identified asbestos-containing vinyl sheet flooring (White with Brown Squares) was observed in Room 103. This material **contains 3.2% Chrysotile asbestos**. This material is considered to be non-friable and was observed in good condition.

Photo 3: View of the asbestos-containing vinyl sheet flooring (White with Brown Squares) observed in Room 103.

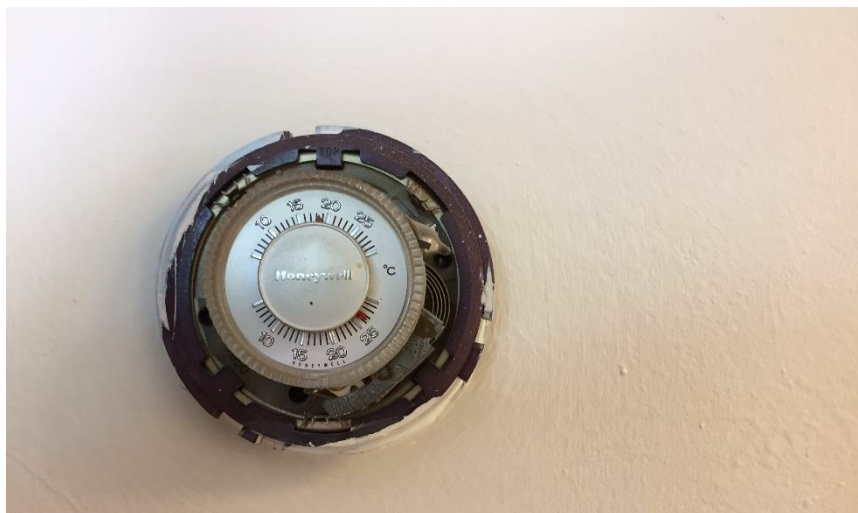
MPL observed a thermostat manufactured by Honeywell containing liquid mercury in Room 103.

Photo 4: View of the Honeywell thermostat containing liquid mercury, observed in Room 103.

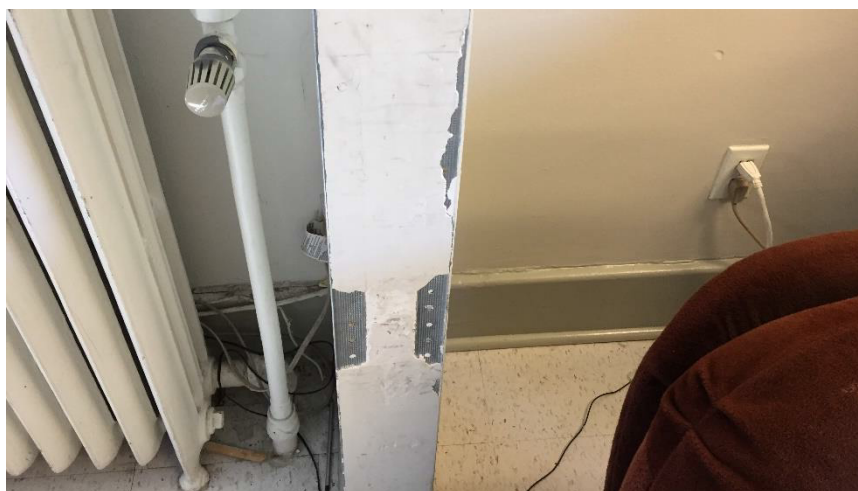
Previously identified asbestos-containing drywall joint compound was observed throughout the subject building. This material **contains 2% Chrysotile asbestos**. Asbestos-containing joint compound was also identified in plaster samples collected in Room 103. This material **contains 2% Chrysotile asbestos** and is suspected to have been used for minor repair work on damaged plaster finishes. Since drywall joint compound is a homogeneous material, all areas must be treated as asbestos-containing unless additional bulk sampling and analysis proves otherwise. **This material was observed in good condition, except for select areas which were observed in fair condition during the 2023 Reassessment.**

Photo 5: View of the poor condition asbestos-containing drywall joint compound observed in Room 207.

- Asbestos-containing materials identified to be in poor condition must be repaired/removed immediately, following Type 1/2/3 asbestos abatement work procedures as detailed in O. Reg. 278/05 and disposed of as asbestos waste under O. Reg. 347;

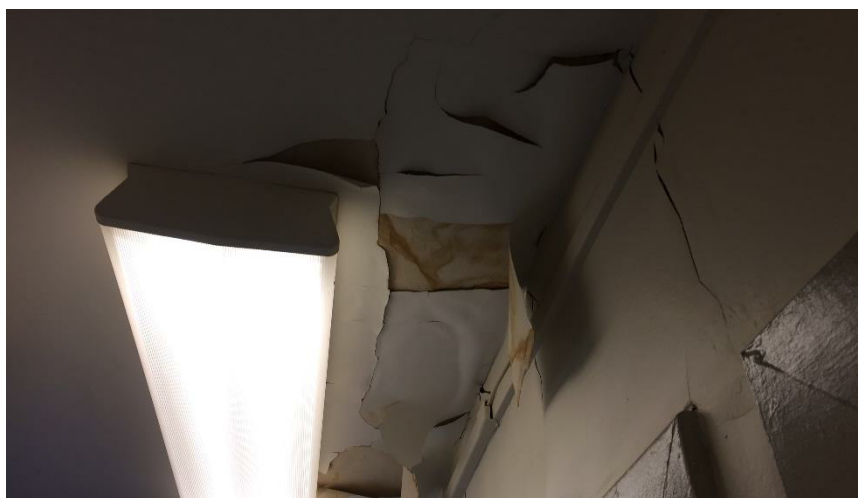
The paint finishes highlighted in blue in the above table were determined to contain low concentrations of lead which are less than or equal to 0.1%. These paint finishes were observed to be in good condition, with the exception of select areas which were observed in poor condition.

Photo 6: View of the poor condition lead paint (White) and water damaged drywall observed in Room 301

Paints identified to contain lead that are in poor condition must be immediately repaired and/or stabilized following a minimum Type 1/2 lead abatement procedures as per OMOL “Lead on Construction Project” dated April 2011.

Water stained/damaged building materials (i.e. drywall with joint compound) that are also determined to contain asbestos must be repaired/replaced following appropriate asbestos abatement procedures as outlined in O.Reg. 278/05.

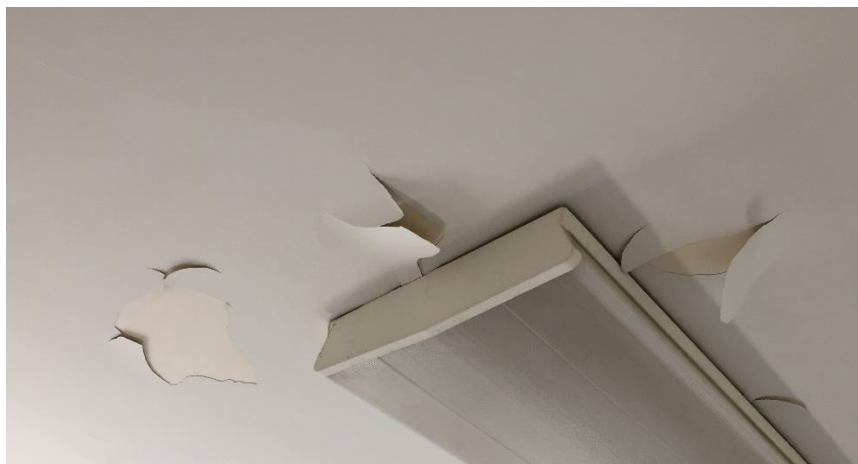
Photo 7: View of the poor condition lead paint (White) observed in Room 307

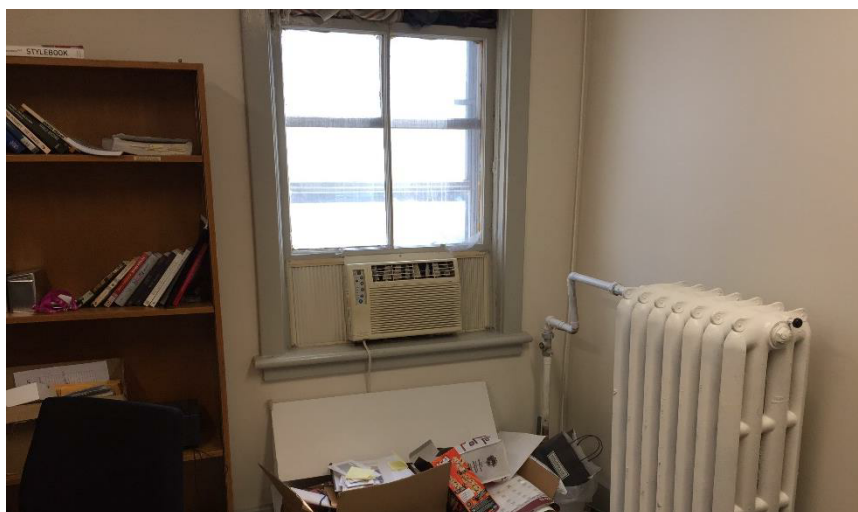
A visual assessment for equipment potentially containing ODSs and other halocarbons was conducted. Equipment containing ODSs or other halocarbons was observed in the subject building.

Photo 8: View of the equipment containing ozone depleting substances, observed throughout the subject building.

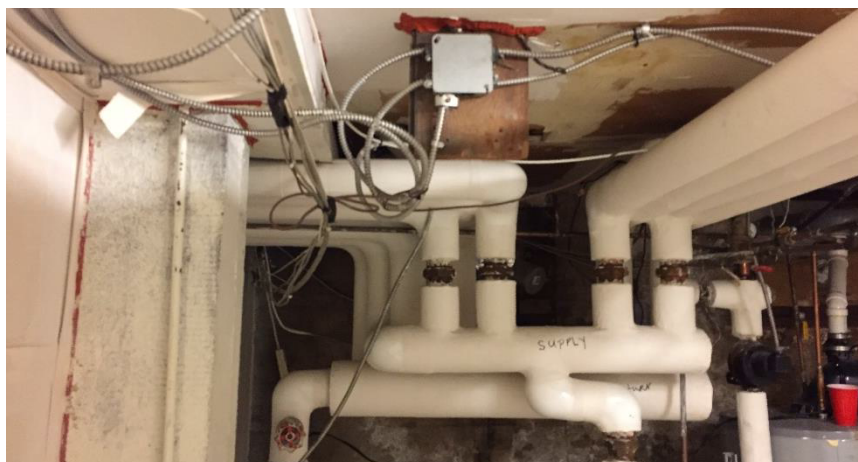
Photo 9: View of the fiberglass insulation observed in Room 005.

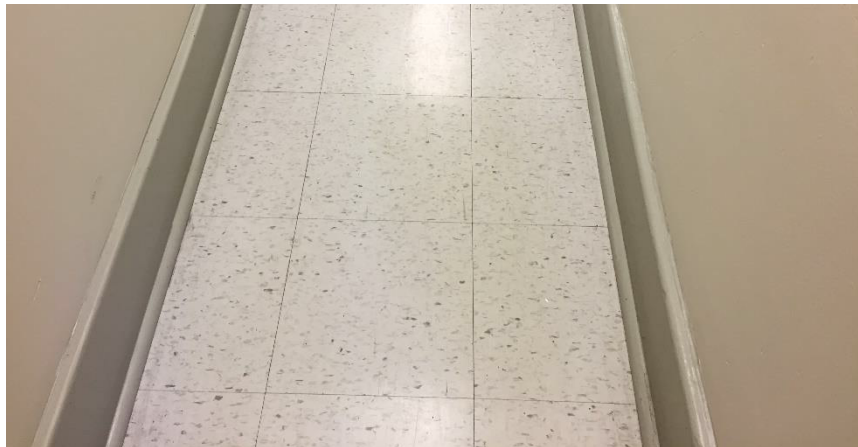
- Vinyl floor tiles (12" x 12"- White with Light and Dark Grey Flakes) were observed and previously sampled in Room 102. The laboratory analytical results indicate that this material does not contain asbestos. The associated mastic (Black) was also determined not to contain asbestos.

Photo 10: View of the non-asbestos containing vinyl floor tiles (12"x12" White with Light and Dark Grey Flakes) observed throughout the subject building.
