HAZARDOUS MATERIALS SURVEY AND 2023 REASSESSMENT 647 KING EDWARD AVENUE, OTTAWA, ON

Project No.:0Z2021101-HZ / CCC-230252-00

University of Ottawa

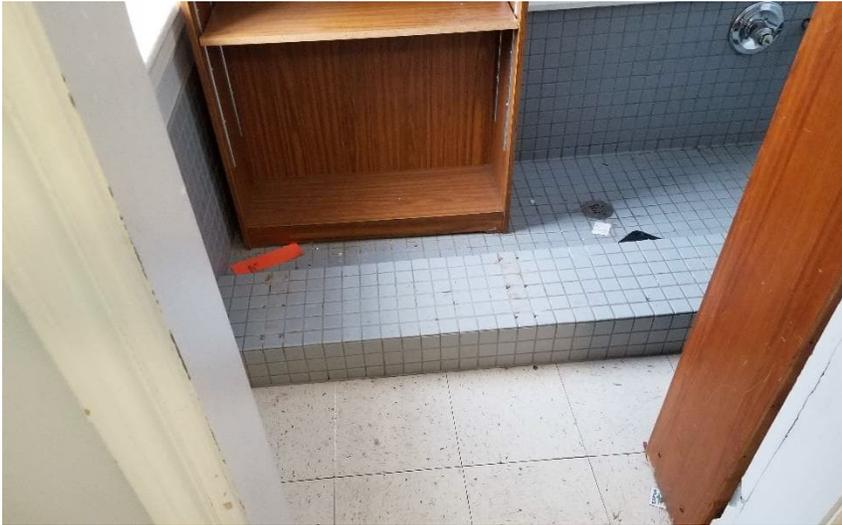
Vinyl floor tiles (12" x 12", Grey with White Flakes) were observed in Rooms 105, 201, 203 and 205. The laboratory analytical results of the vinyl floor tile samples collected from Room 205 indicate that this material does not contain asbestos. The associated mastic (black) and caulking (white) did not contain asbestos.

Ceramic wall/floor tile grout was observed throughout the subject building, in Room 105 and 205 (throughout the shower areas). To avoid damage and compromising the integrity of the material, no bulk samples of the ceramic wall/ tile grout were collected. Prior to removal and/or replacement, ceramic tile grout should be examined and tested for asbestos content. Ceramic wall/tile grout should be considered to contain asbestos until bulk samples and analysis until proven otherwise.

Photo 1: View of non-asbestos vinyl floor tiles (12" x 12") and ceramic floor tile grout suspected of containing asbestos in Room 205.

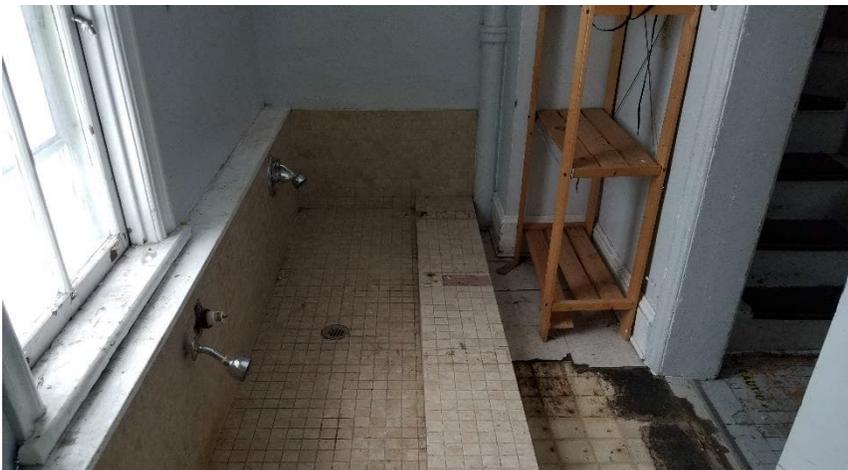
Vinyl Sheet Flooring (white with grey flakes) was observed in Room 105. The laboratory analytical results of the Vinyl Sheet Flooring samples collected from Room 105 indicate that this material does not contain asbestos. The associated mastic/backing material (beige) did not contain asbestos.

Photo 2: View of non-asbestos vinyl sheet flooring underneath vinyl floor tiles in Room 105.

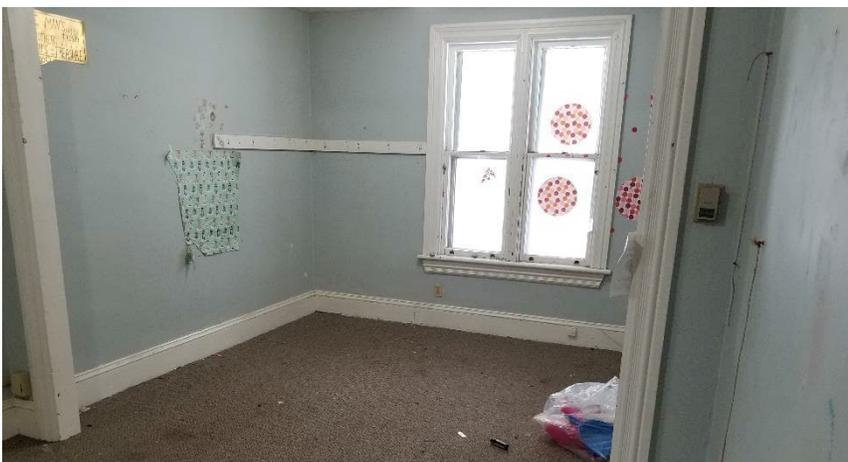
Drywall joint compounds were observed in Rooms 205, 204, 204A, 206, 203, 206A, 103A, 200, 202, 202A, 201, 200A, 100A, 105, 101, 100 and 102. The laboratory analytical results of drywall joint compound samples collected from Room 101 indicate that this material **contains 2% Chrysotile asbestos**. Since drywall joint

compound is a homogeneous material, all areas must be treated as asbestos-containing unless additional bulk sampling and analysis until proven otherwise. This material was observed to be in *fair* condition.

Photo 3: Typical view of asbestos-containing drywall joint compound observed throughout the subject building.

- ACMs identified as in fair condition should be either repaired (where possible) and/or closely monitored for signs of further deterioration. Depending on the type of material and location, these materials should be scheduled for removal if there is a potential risk of exposure to workers and/or occupants;

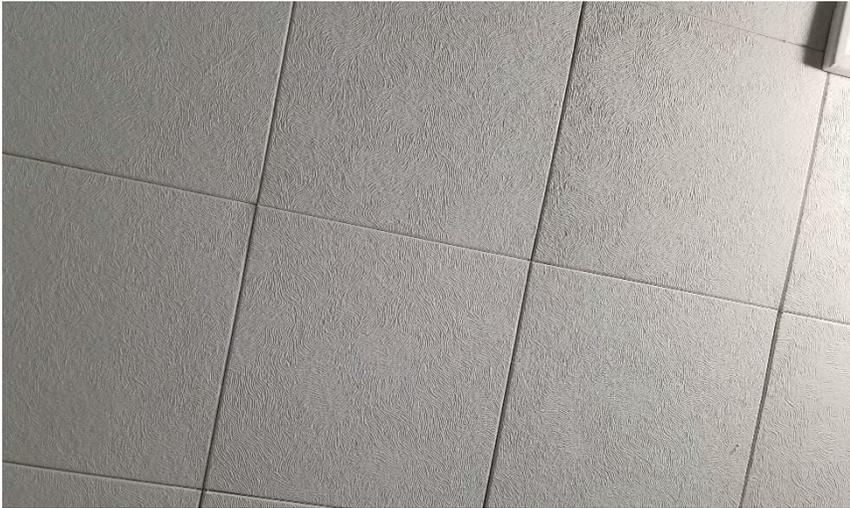
Suspended ceiling tiles (1' x 1', Wavy Pattern) were observed in Room 102. The laboratory analytical results of ceiling tile samples collected from Room 102 indicate that this material does not contain asbestos.

Photo 4: View of non-asbestos ceiling tiles (1' x 1') observed in Room 102.

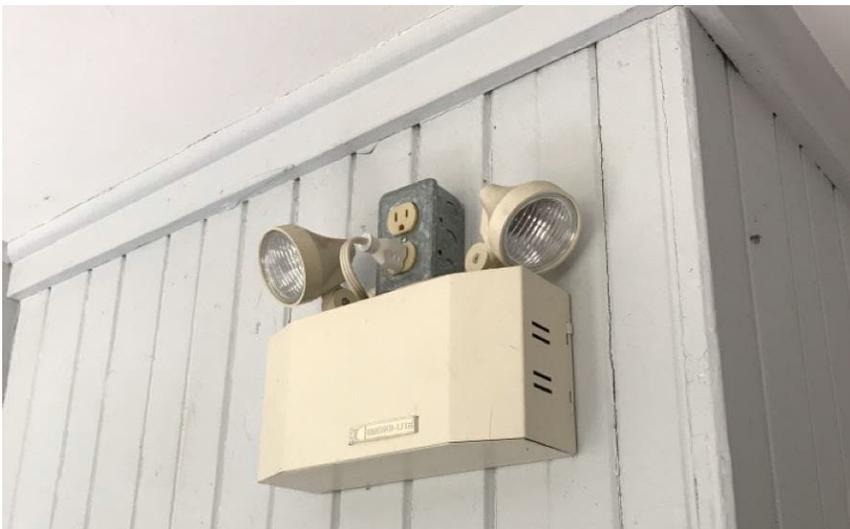
MPL identified lead-containing acid battery packs throughout the subject building. These battery packs were observed on walls and above exits throughout the subject building.

Photo 5: View of lead-containing batteries observed in Room 100.
