HAZARDOUS MATERIALS SURVEY AND 2023 REASSESSMENT POWER PLANT - 720 KING EDWARD AVENUE, OTTAWA, ON

Project No.: 0Z2021101HZ / CCC-230252-00

University of Ottawa

McIntosh Perry Limited (MPL)

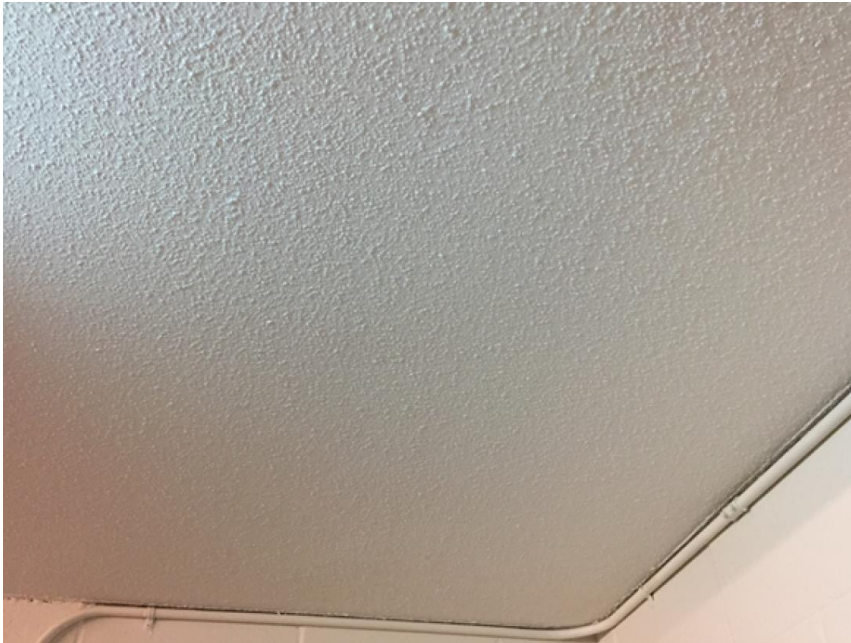
Samples 1.1-1.3

Ceiling texture coat (White) was observed and previously sampled in Rooms M03 and M10. This material **contains 2% Chrysotile asbestos**. This material is considered friable and was observed in good condition.

Photo 1: View of asbestos-containing textured ceiling observed in Room M03, M10, M11, and M12 of Subject Building.

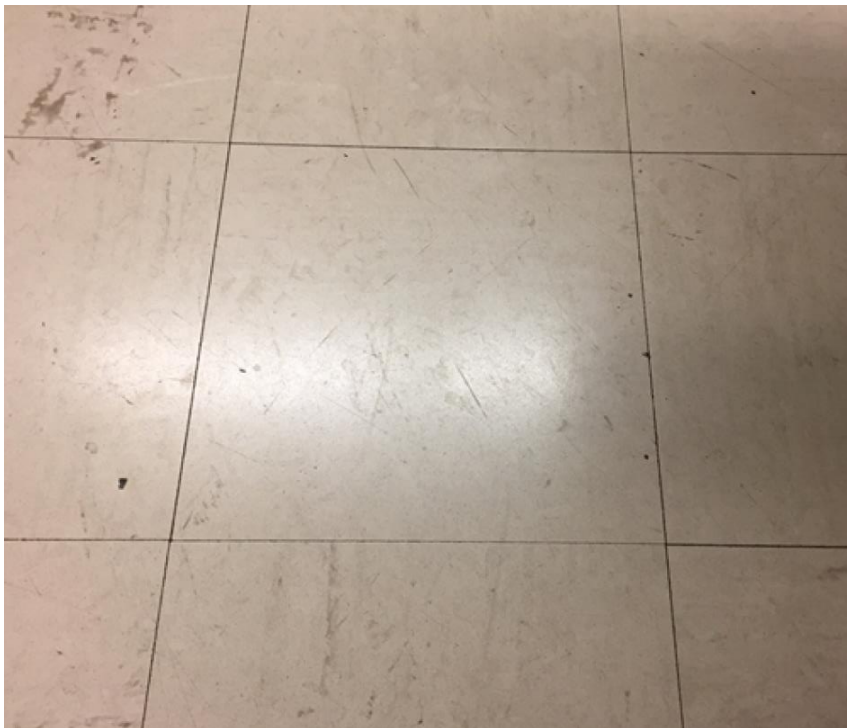
Samples 2.1-2.3

- Vinyl floor tiles (12" x 12" – Beige w/ Grey Streaks) were observed and previously sampled in Room M12. This material **contains 2% Chrysotile asbestos**. This material is considered non-friable and was observed in good condition. The associated mastic (Black) was determined not to contain asbestos.
- Vinyl floor tiles (12" x 12" – White w/ Grey Mix) were observed and previously sampled in Room M006. The laboratory analytical results of the samples collected indicate that this material does not contain asbestos. The associated mastic (Black) was also determined not to contain asbestos.

Photo 2: View of asbestos-containing vinyl floor tiles observed in Room M12 of Subject Building.

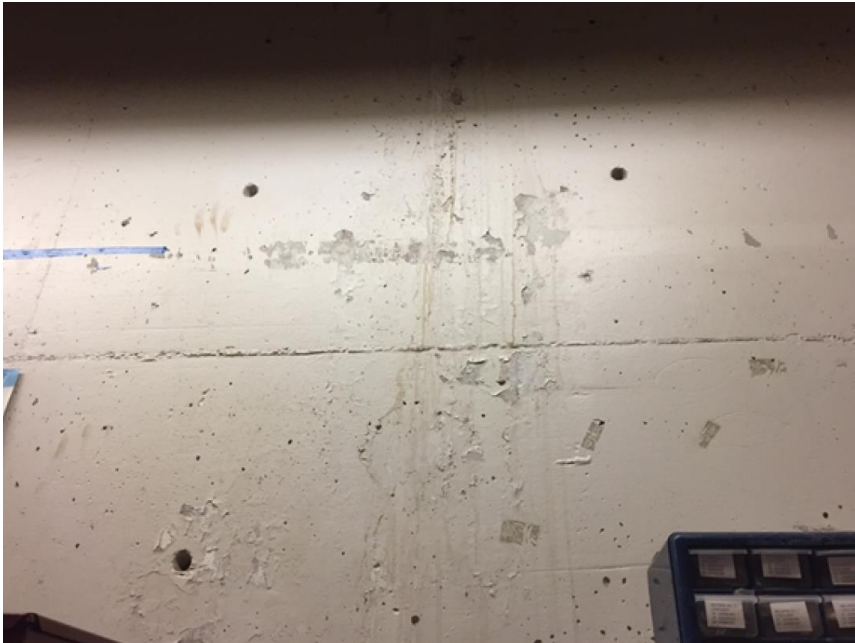
Sample PB1

The paint finishes highlighted in pink in the above table are considered lead-containing paints or surface coatings with concentrations greater than 0.1% lead by weight. These paint finishes were observed to be in good condition, with the exception of select areas which were observed in poor condition.

Photo 3: View of poor condition white wall paint observed in Room M13.

Paints identified to contain lead that are in poor condition must be immediately repaired and/or stabilized following a minimum Type 1/2 lead abatement procedures as per OMOL “Lead on Construction Project” dated April 2011.

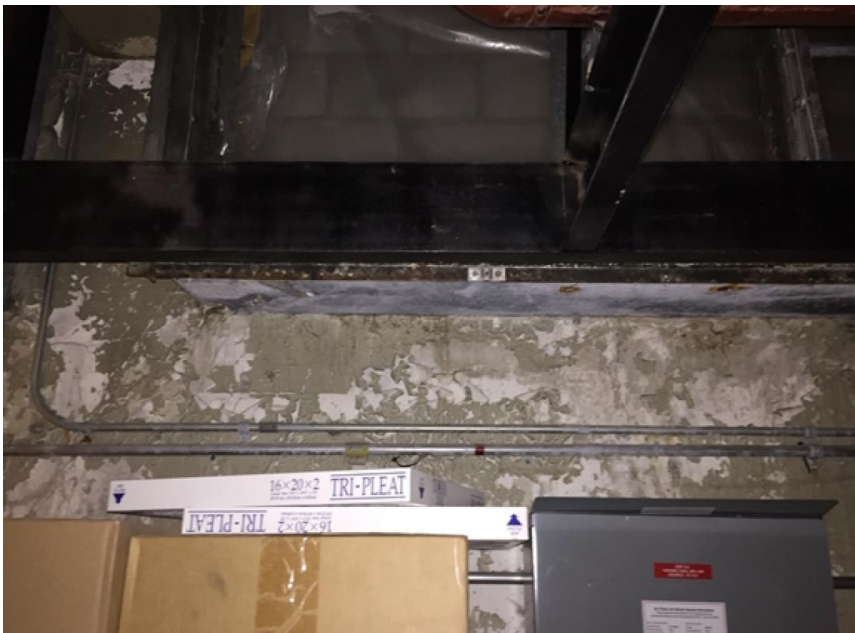
Sample PB6

Photo 4: View poor condition grey wall paint observed in Room M09.

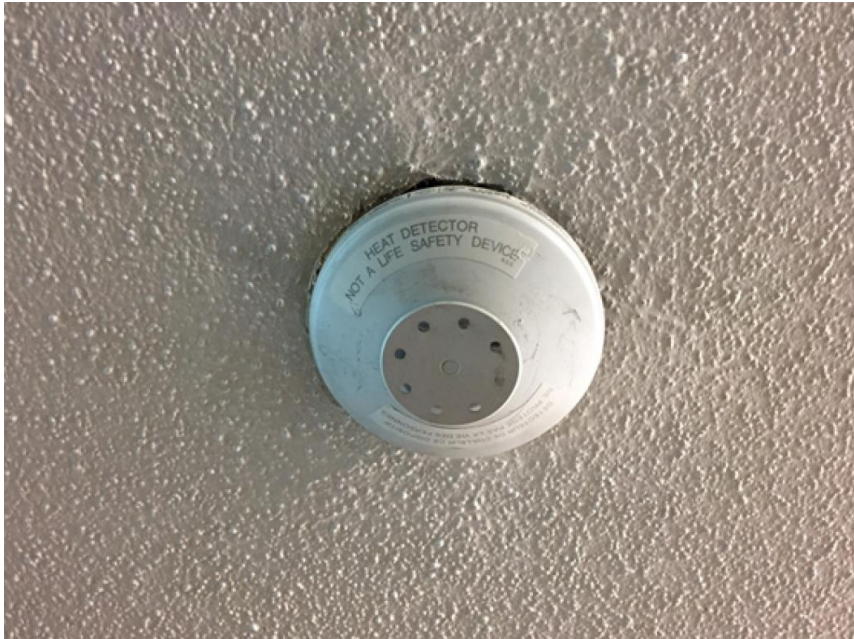
Photo 5: View of Radioactive Smoke Detector observed in Room M03 of Subject Building.

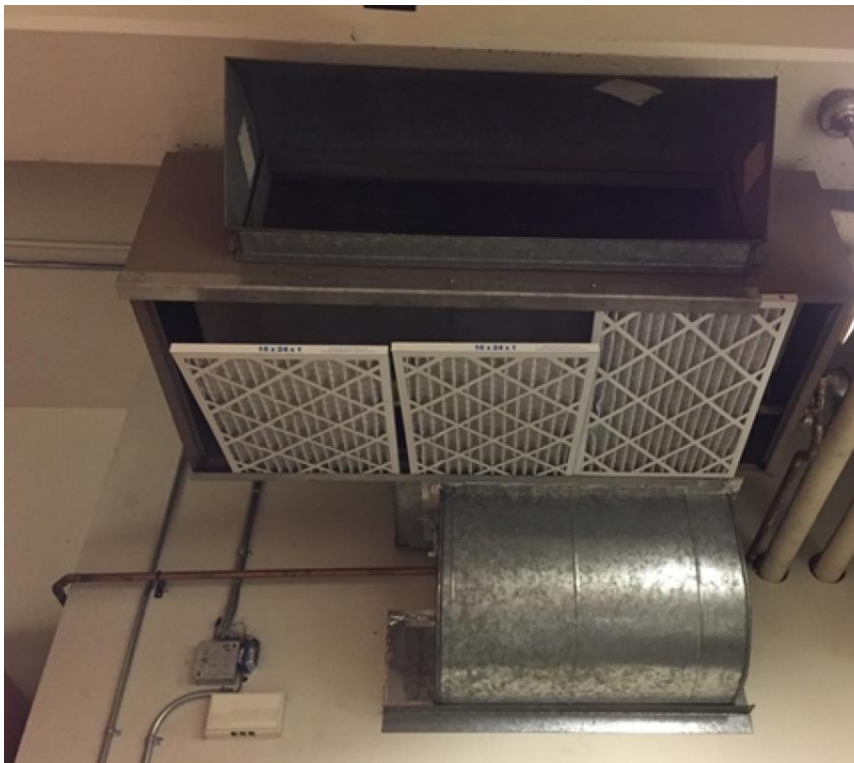
Photo 6: View of ODS Air Conditioning Unit observed in Room M13A of Subject Building.

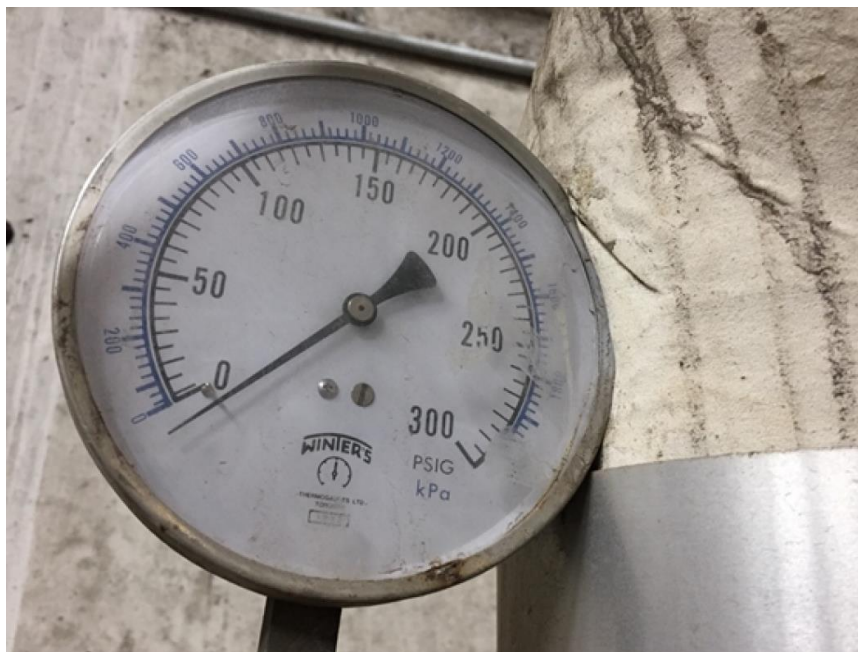
Photo 7: View of Winters' Pressure Gauge observed in Room 008 of Subject Building.
