HAZARDOUS MATERIALS SURVEY AND 2023 REASSESSMENT 72 TEMPLETON STREET, OTTAWA, ON

Project No.: Z2021101HZ/ CCC-230252-00

Prepared for:

University of Ottawa

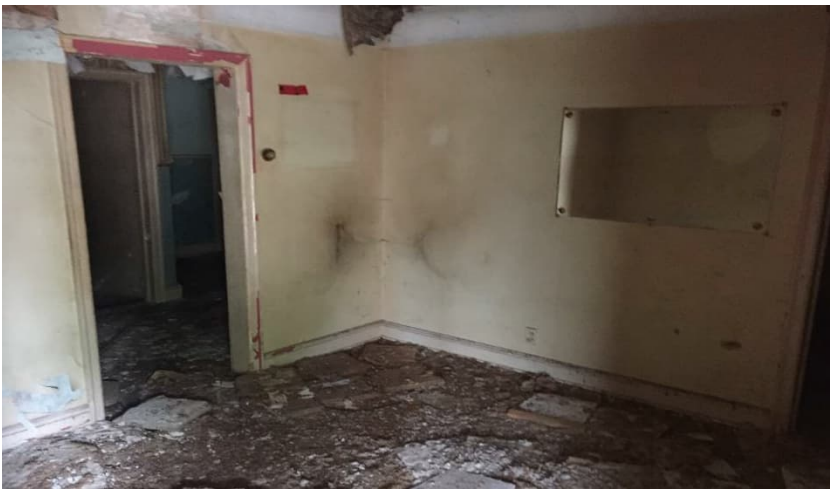
Photo 2: Typical view of damaged building materials observed within the subject building.

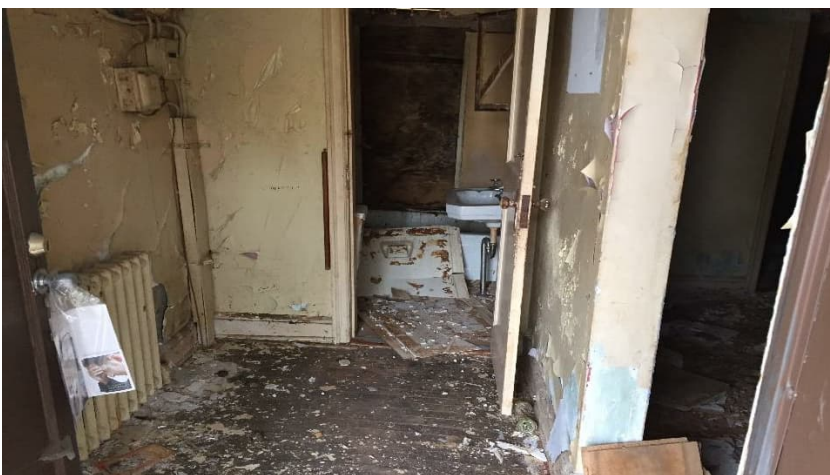
Photo 3: Typical view of damaged building materials observed within the subject building.

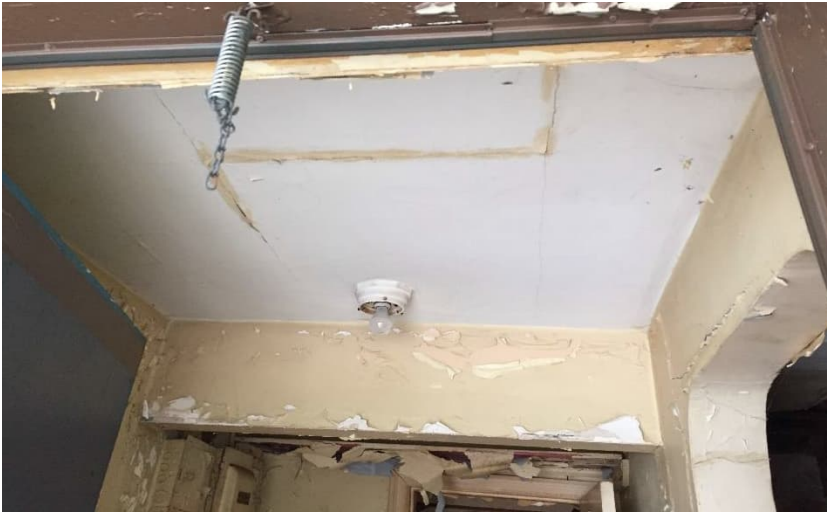
The paint finishes highlighted in pink in the above table are considered lead-containing paints or surface coatings with concentrations greater than 0.1% lead by weight. These paint finishes were observed to be in good condition. These paint finishes were observed to be in good condition, except for select areas that were observed in poor condition.

Photo 4: View of brown lead-containing paint and low concentrations of lead beige paint observed to be damaged near the entrance of the subject building.

Paints identified to contain lead that is in poor condition must be immediately repaired and/or stabilized following a minimum Type 1/2 lead abatement procedures as per OMOL “Lead on Construction Project” dated April 2011.

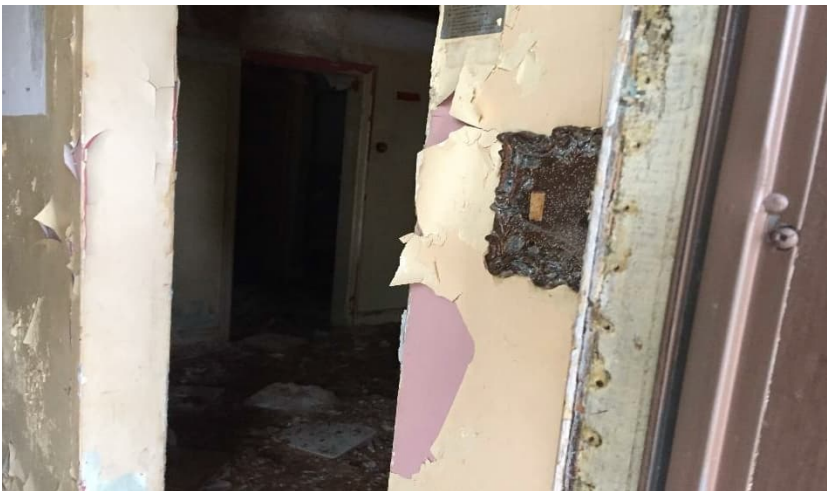
Photo 5: View of brown and purple lead-containing paint and low concentrations of lead beige paint observed to be damaged near the entrance of the subject building.

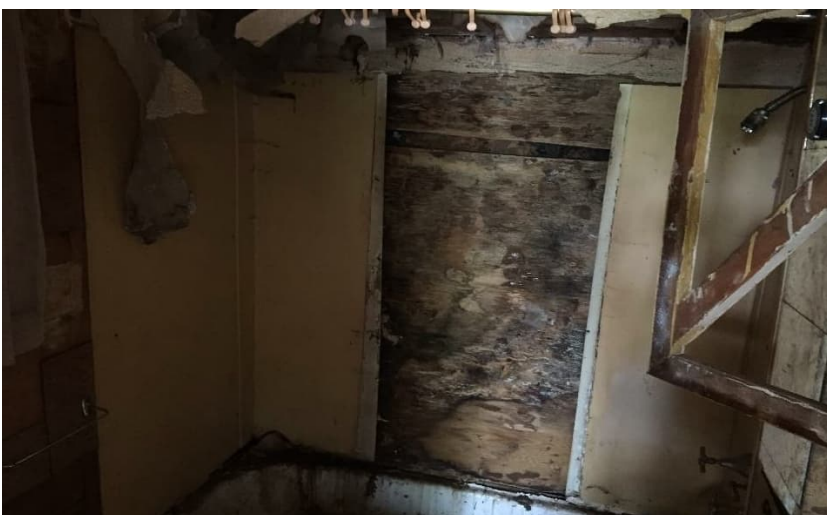
A visual survey of the subject building was conducted to determine if water damage was present. MPL identified select areas throughout the subject building where materials were affected by water damage.

Photo 6: View of suspected mould growth observed on the plywood in the washroom.
