HAZARDOUS MATERIALS SURVEY AND 2023 REASSESSMENT 74 TEMPLETON STREET, OTTAWA, ON

Project No.: Z2021101HZ/ CCC-230252-00

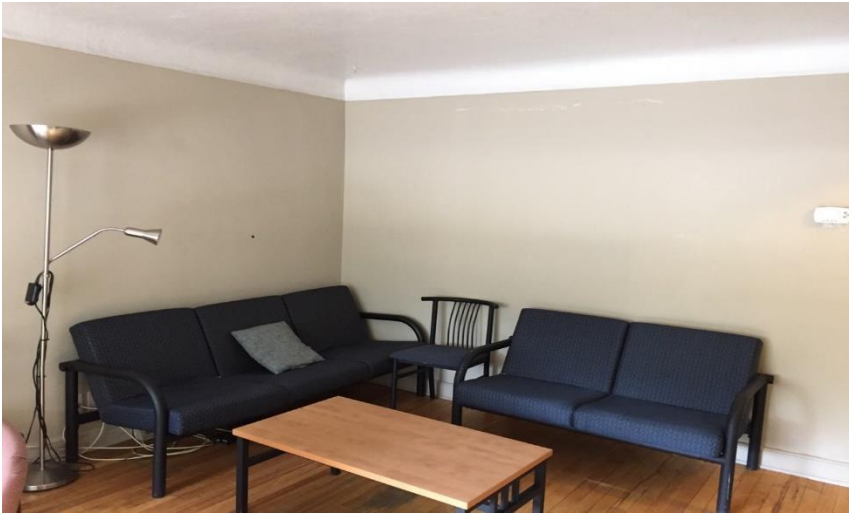
Photo 1: A view of asbestos-containing drywall joint compound and plaster was observed within the subject building.

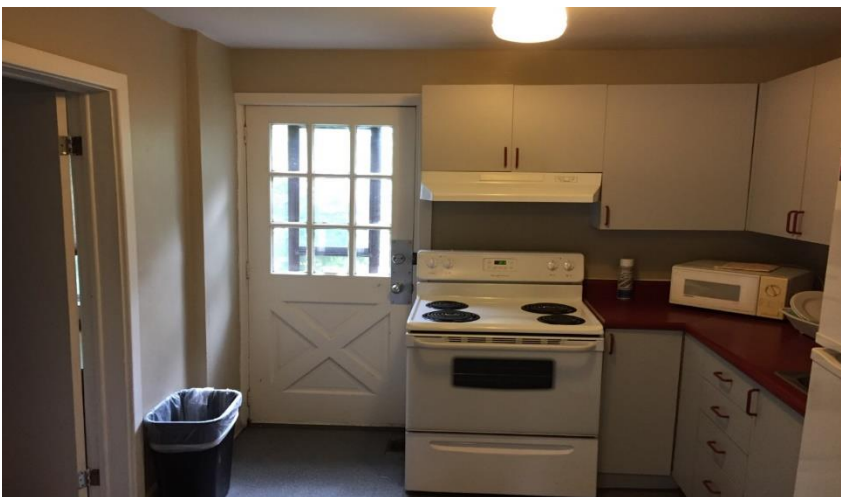
Photo 2: A view of asbestos-containing drywall joint compound and plaster was observed within the subject building.

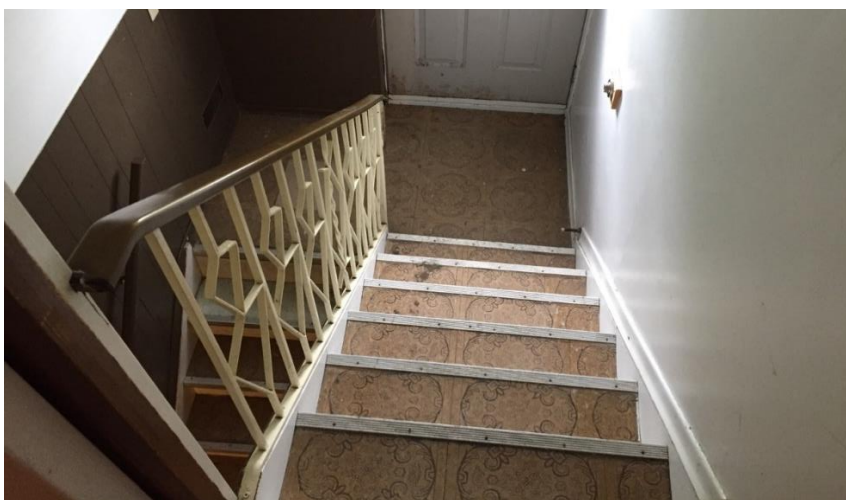
Photo 3: A view of asbestos-containing vinyl floor tiles (Beige with Design) observed in Room 100A.

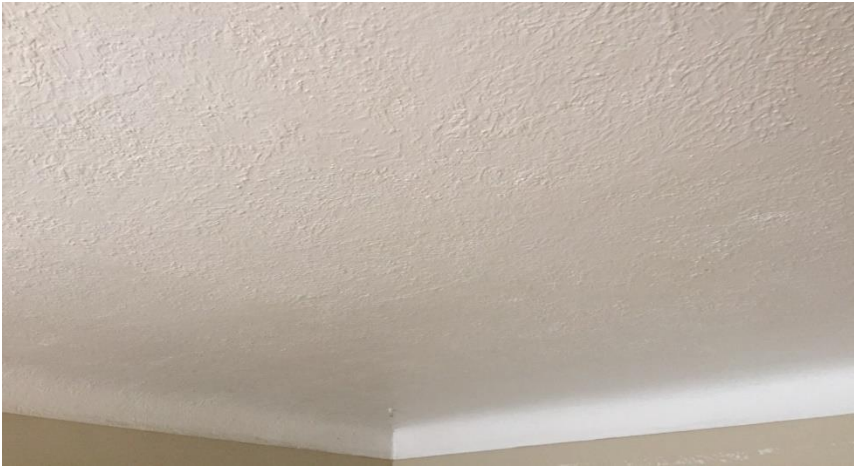
Photo 4: View of previously identified asbestos-containing ceiling texture coat observed in Room 103.

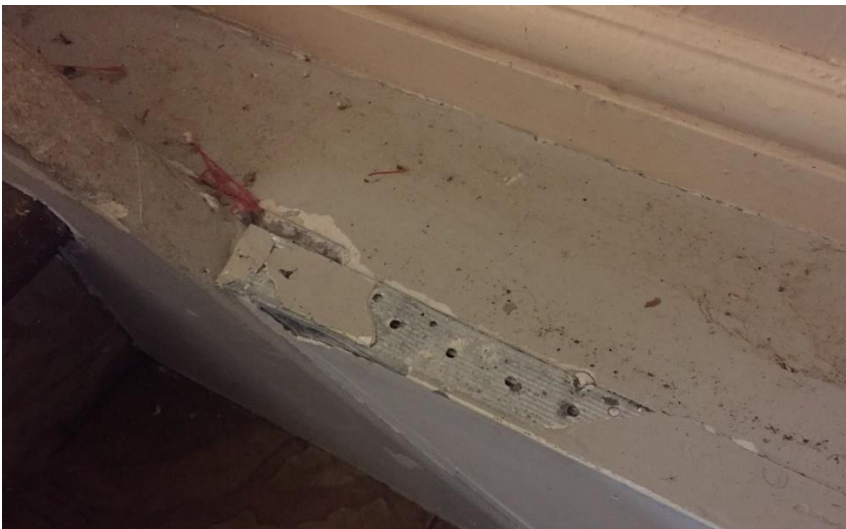
Photo 5: View of damaged asbestos-containing drywall joint compound observed in Room 00.

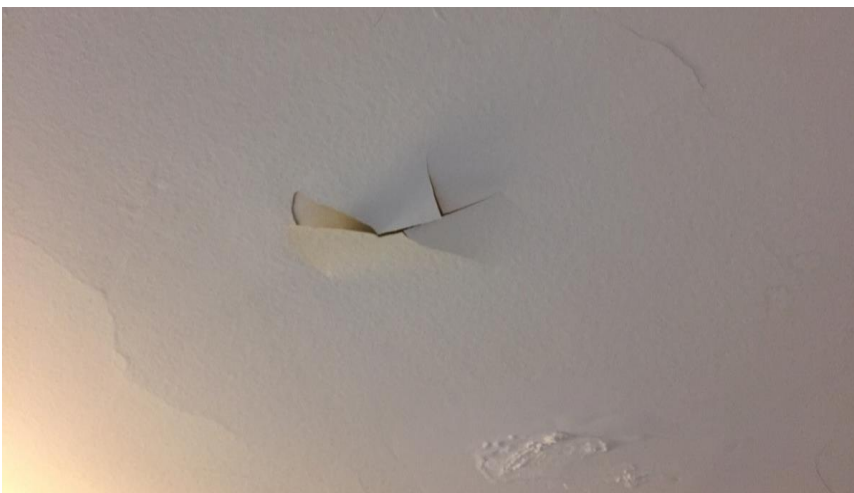
Photo 6: View of damaged low levels of lead white paint observed on the ceiling of Room 101.

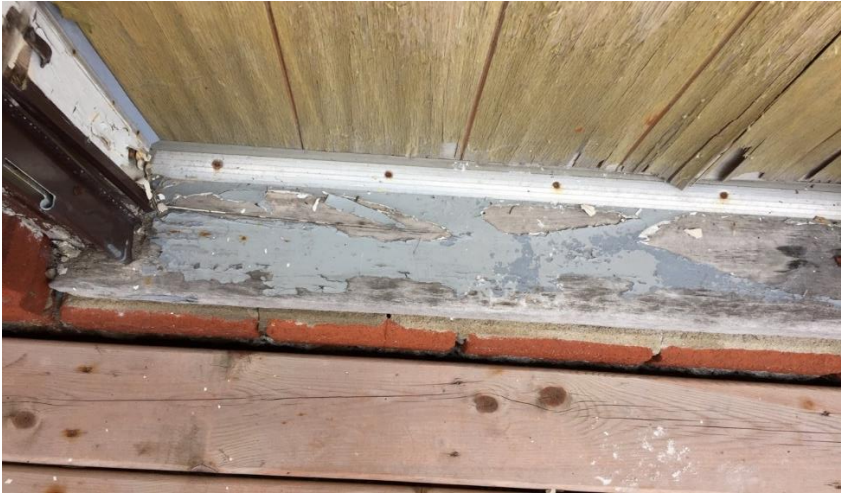
Photo 7: View of damaged lead-containing grey paint observed on the exterior front porch.

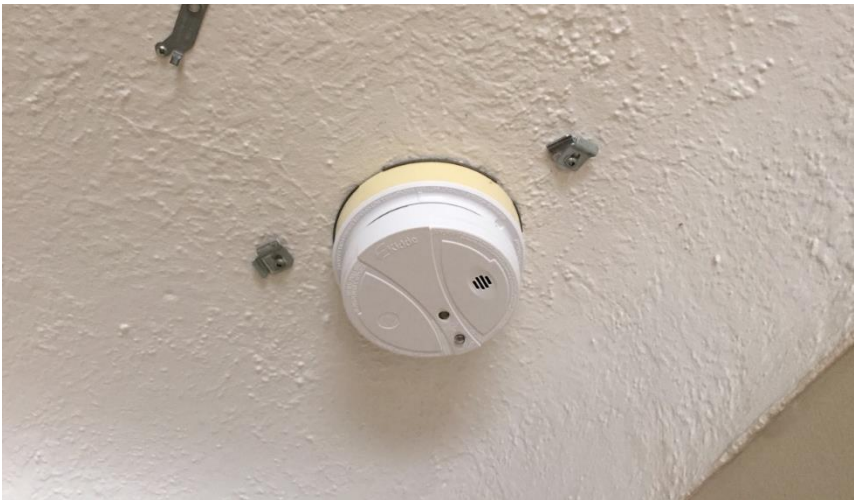
Photo 8: A typical view of radioactive smoke detector observed throughout the subject building.

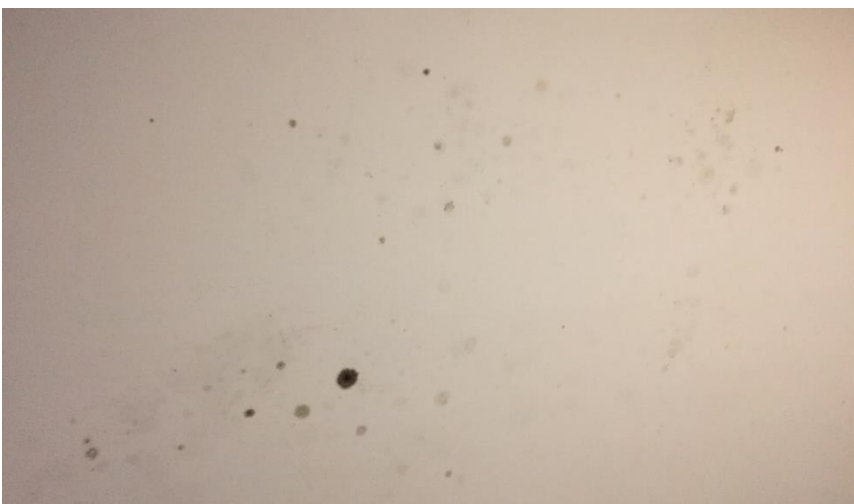
Photo 9: View of suspect mould growth observed on asbestos-containing drywall in Room 03.
