HAZARDOUS MATERIALS SURVEY AND 2023 REASSESSMENT 76 TEMPLETON STREET, OTTAWA, ON

Project No.: Z2021102HZ/ CCC-230252-00

University of Ottawa

McIntosh Perry Limited (MPL)

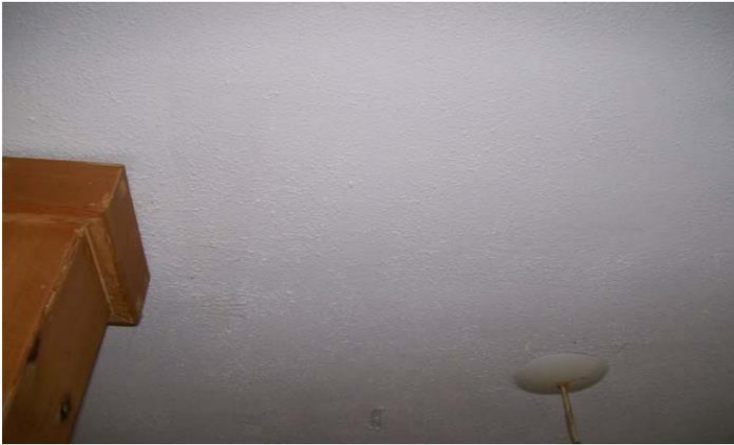
- Texture coat (Smoother Stipple) was observed and sampled in the main room (Room 101) on the 1st floor of the subject building. The laboratory analytical results of the texture coat samples collected indicate that this material **contains 1% Chrysotile asbestos**. This material is considered to be friable and was observed to be in good condition.
- Texture coat (Rougher Stipple) was observed and sampled in the hallway (Room 100). The laboratory analytical results of the texture coat samples indicate that this material does not contain asbestos.

Photo 1: A view of asbestos-containing texture coat observed in the main room on the 1st floor of the subject building.

- Materials identified to contain asbestos that are in good condition and do not pose a risk to workers or occupants can be managed in place. Prior to renovation/demolition activities that may disturb the ACMs, these materials must be removed following appropriate Type 1/2/3 asbestos abatement work procedures as detailed in O. Reg. 278/05 and disposed of as asbestos waste under O. Reg. 347;

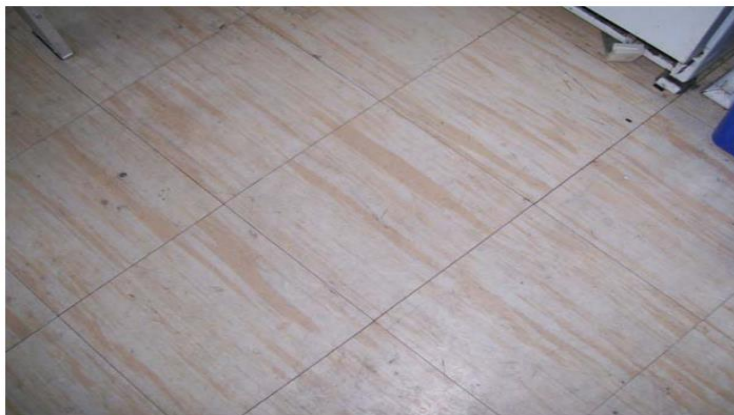
- Vinyl floor tile (12"x12", Beige/Brown) was observed and sampled in the main room (Room 101) on the 1st floor of the subject building. The laboratory analytical results of vinyl floor tile samples collected indicate that this material does not contain asbestos. The associated mastic (Black) was also determined not to contain asbestos.
- Vinyl floor tiles (12"x12", Grey, White and Black) were observed and sampled in the kitchen (Room 102) on the 1st floor of the subject building. The laboratory analytical results of vinyl floor tile samples collected indicate that this material does not contain asbestos. The associated mastic (Clear) was also determined not to contain asbestos.

Photo 2: A view of non-asbestos-containing vinyl floor tile was observed in the main room on the 1st floor of the subject building.

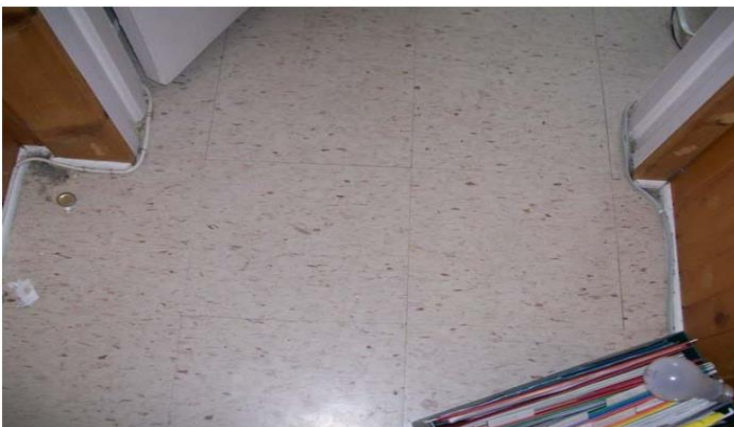
Photo 3: A view of non-asbestos-containing vinyl floor tile was observed in the kitchen on the 1st floor of the subject building.
