# HAZARDOUS MATERIALS SURVEY AND 2023 REASSESSMENT 78 TEMPLETON STREET, OTTAWA, ON

Project No.: Z2021102HZ / CCC-230252-00

University of Ottawa

McIntosh Perry Limited (MPL)

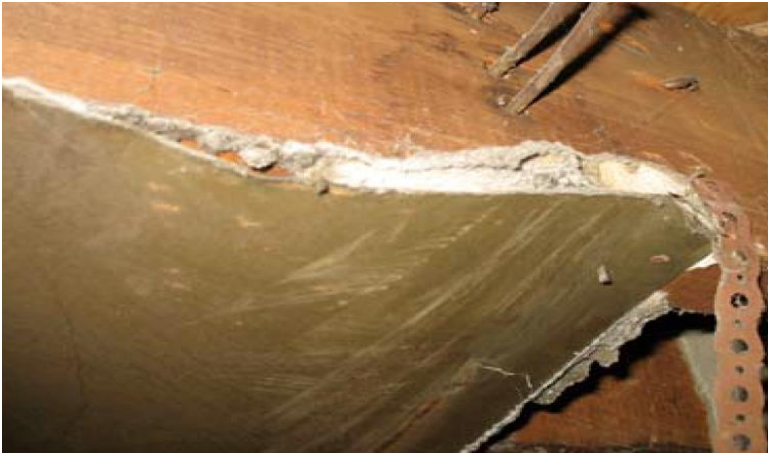
Previously identified paper duct insulation was observed and sampled in Room 003 in the basement of the subject building. This material was found to **contain 60% Chrysotile asbestos**. This material is considered to be friable and observed to be in good condition.

**Photo 2:** A view of asbestos-containing paper duct insulation observed in the basement of the subject building.

- Materials identified to contain asbestos in good condition and not pose a risk to workers or occupants can be managed in place. Prior to renovation/demolition activities that may disturb the ACMs, these materials must be removed following appropriate Type 1/2/3 asbestos abatement work procedures as detailed in O. Reg. 278/05 and disposed of as asbestos waste under O. Reg. 347;

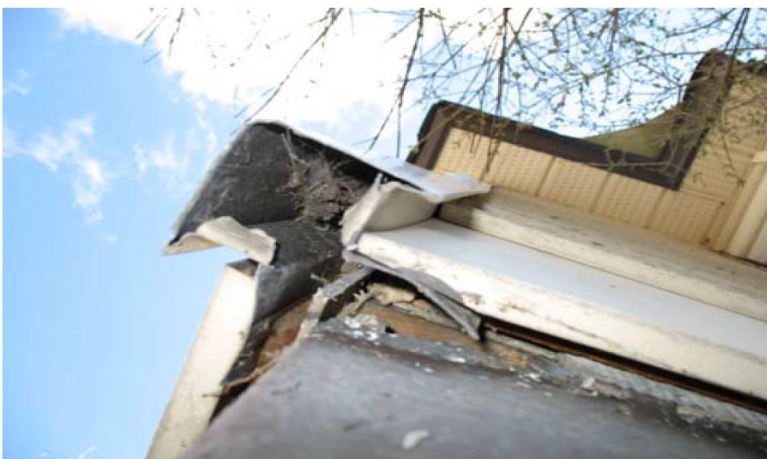
Previously identified transite siding was observed and sampled underneath the exterior metal siding. This material was found to **contain 15% Chrysotile asbestos**. This material is considered to be non-friable and was observed to be in good condition.

**Photo 3:** A view of asbestos-containing transite siding observed underneath the metal siding on the exterior of the subject building.
