# HAZARDOUS MATERIALS SURVEY AND 2023 REASSESSMENT SURVEY

## 161 LOUIS-PASTEUR PRIVATE, OTTAWA, ON

Project No.: Z1920014HZ / CCC-230252-00

February 12, 2024

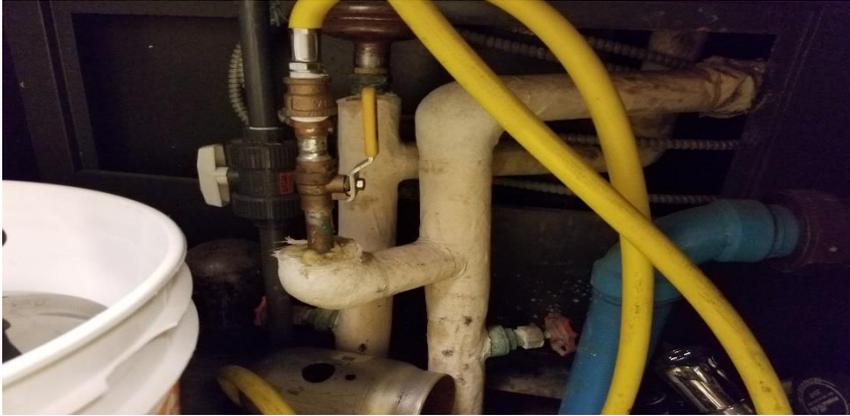
**Photo 1:** View of asbestos-containing parging cement on fitting observed to be in fair condition underneath the sink in D320.

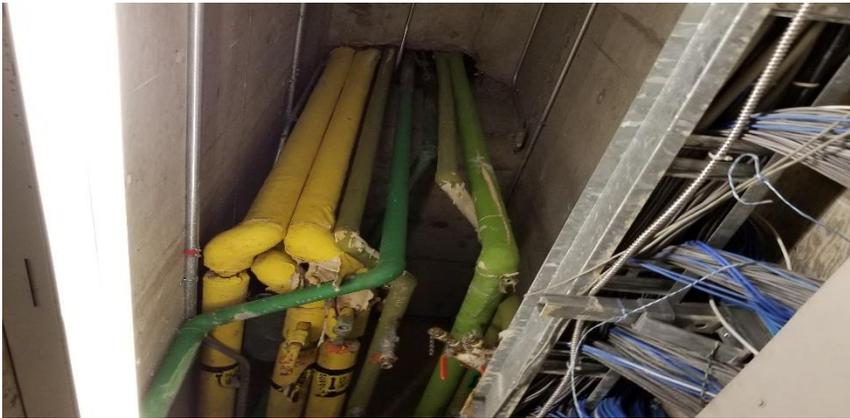
**Photo 2:** View of asbestos-containing parging cement on fittings observed to be in poor condition in Room C012B.

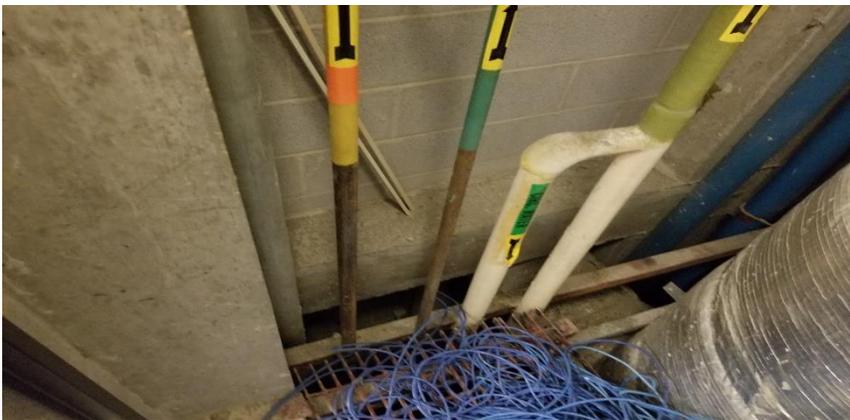
**Photo 3:** View of asbestos-containing parging cement on pipe fittings observed to be in good condition in Room B408A.

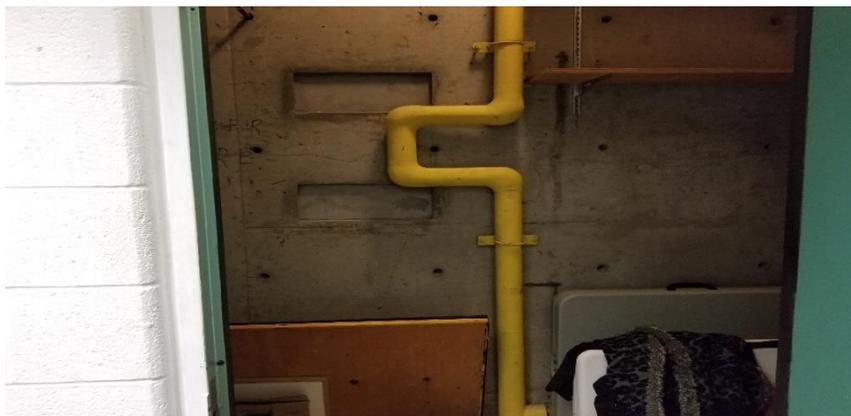
**Photo 4:** View of asbestos-containing paring cement on pipe fittings observed to be in good condition in Room B305A.

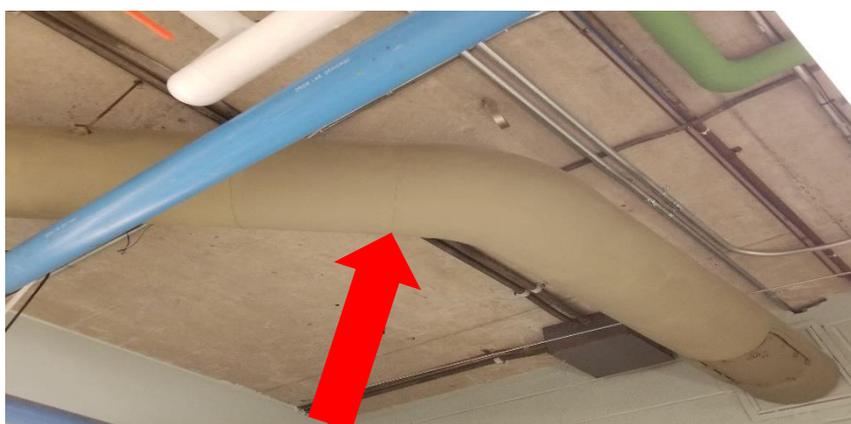
**Photo 5:** View of asbestos-containing duct insulation observed to be in good condition in Room D320.

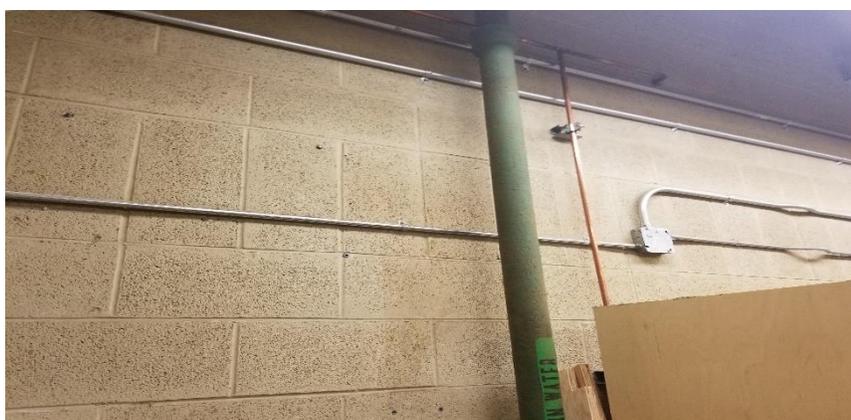
**Photo 6:** View of asbestos-containing transite pipe observed to be in good condition in E012.

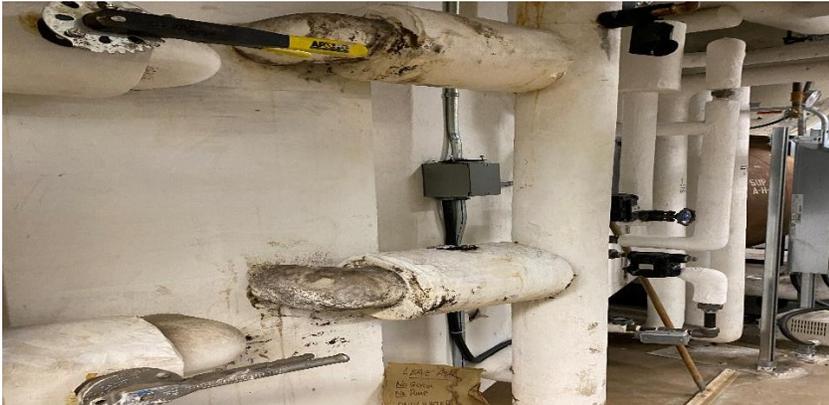
**Photo 7:** View of mould/water damaged mechanical pipe straights observed in E101.

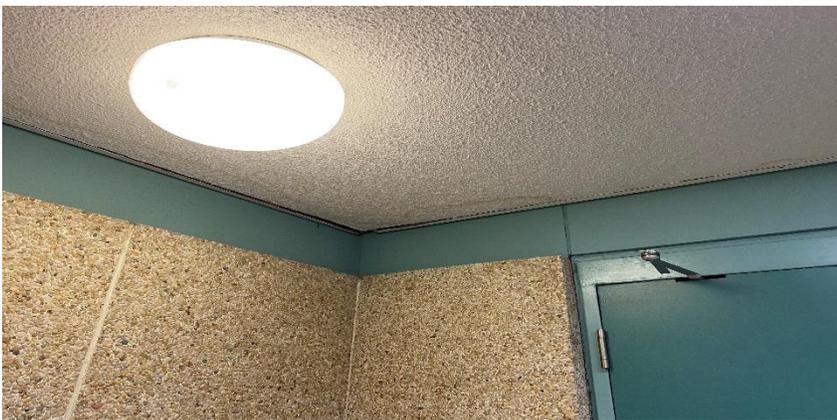
**Photo 8:** View of poor condition presumed asbestos ceiling texture finish observed in the Hallways outside of A502.

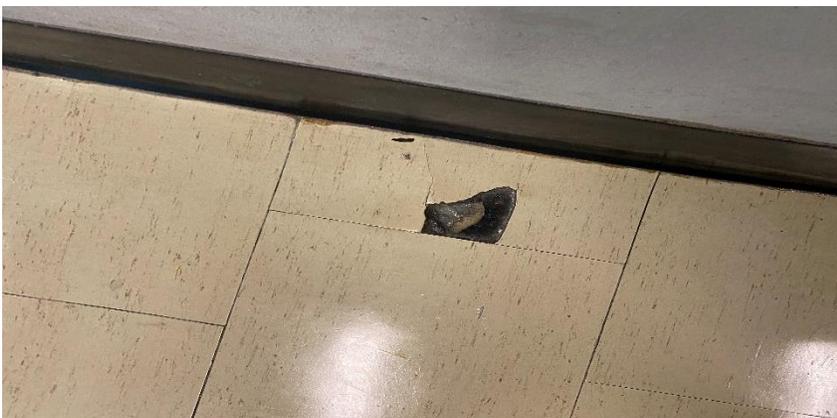
**Photo 9:** View of fair condition ACM Vinyl Floor Tile (12"x12"-White with Grey Flakes) observed in Location A710.

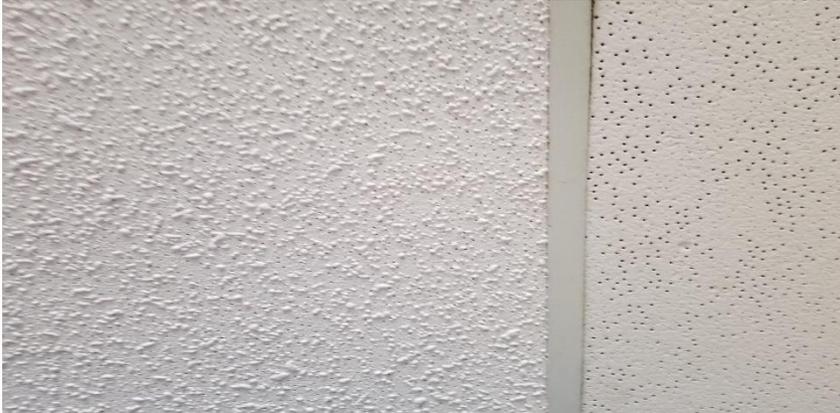
- Ceiling Tile (1'x1') was previously observed and sample from Room E018A. This material was analyzed and determined not to contain asbestos.
- Suspended ceiling tiles (Pinholes with Texture) were previously observed and sampled in Room B109C. The laboratory analytical results of ceiling tile samples collected indicate that this material does not contain asbestos.

- Suspended ceiling tiles (Pinholes with Varying sizes) were previously observed and sampled in Room B109C. The laboratory analytical results of ceiling tile samples collected indicate that this material does not contain asbestos.

**Photo 10:** View of non-asbestos ceiling tiles: Pinholes with texture (left) and Pinholes with varying sizes (right) observed in B109C.

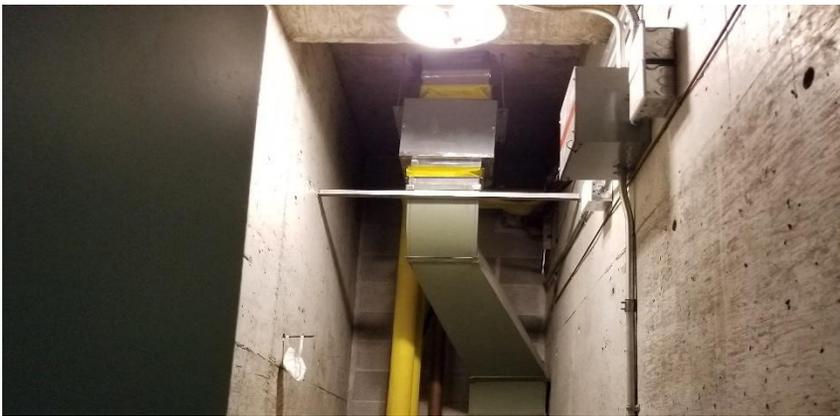
Flexible duct connectors were observed in Room C503. This material was visually identified as rubber and therefore not suspected of containing asbestos.

**Photo 11:** View of non-asbestos containing flexible duct connector observed in Room C503.

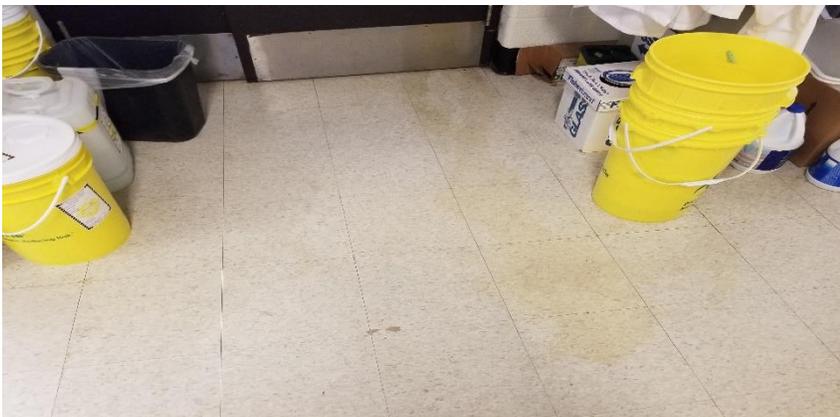
**Photo 12:** View of non-asbestos containing vinyl floor tiles (12"x12"-White with Grey Flakes) observed in Room D511.

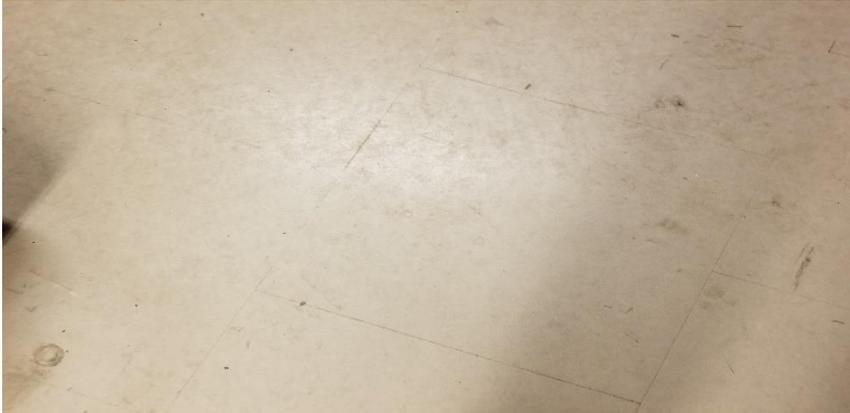
**Photo 13:** View of non-asbestos containing vinyl floor tiles (12"x12"-Grey ) observed in Room E018B.

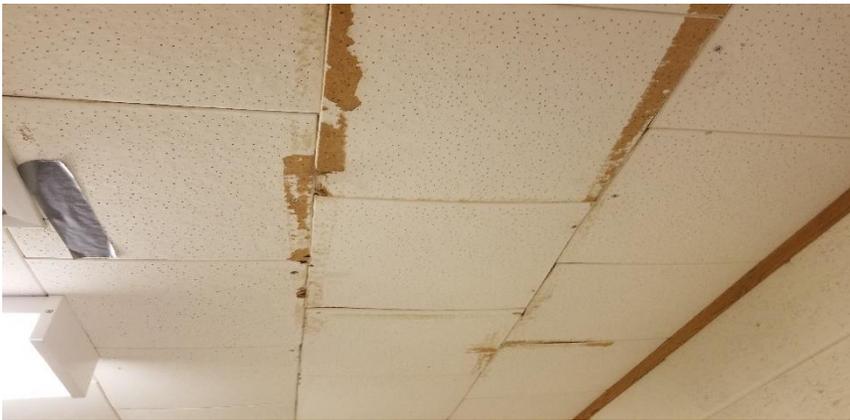
- Acoustic ceiling tiles (Brown) were previously observed screwed onto the ceiling in Room E018B. The laboratory analytical results of ceiling tile samples collected indicate that this material does not contain asbestos.

**Photo 14:** View of non-asbestos screwed on ceiling tiles observed in Room E018B.
