# HAZARDOUS MATERIALS SURVEY AND 2023 REASSESSMENT D'ORIO HALL, OTTAWA, ON

Project No.: Z2021101HZ / CCC-230252-00

University of Ottawa

McIntosh Perry Limited (MPL)

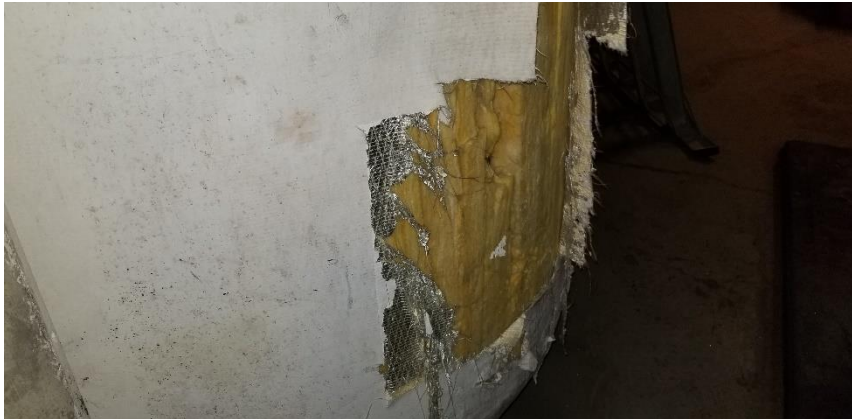
Mechanical pipe straight insulation was observed throughout the subject building. MPL made several incisions throughout to investigate its composition, and it was visually identified as fibreglass and, therefore, not suspected of containing asbestos.

**Photo 1:** Representative view of the non-asbestos-containing mechanical insulation observed throughout the subject building.

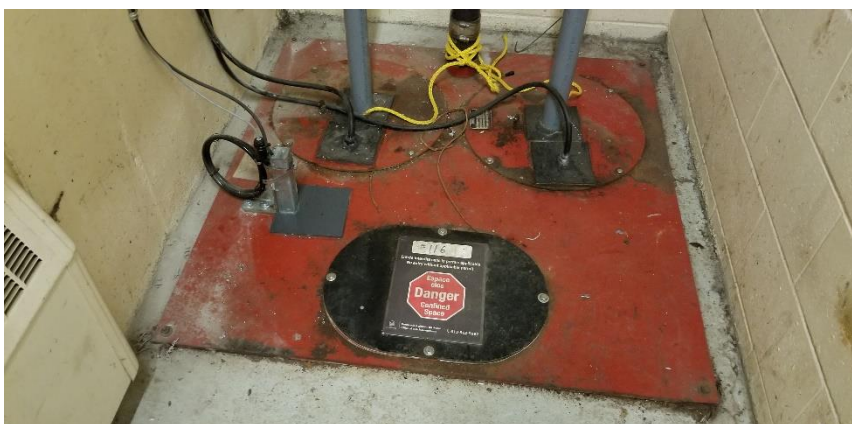
**Photo 3:** View of the sump pump suspected of containing a float switch with mercury liquid in Room 004A.

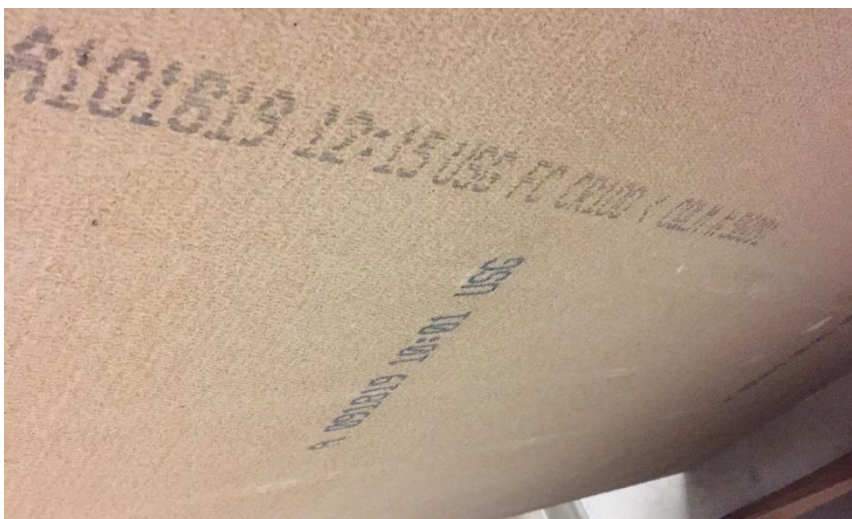
**Photo 5:** View of the non-asbestos-containing ceiling tiles observed in Room 316.

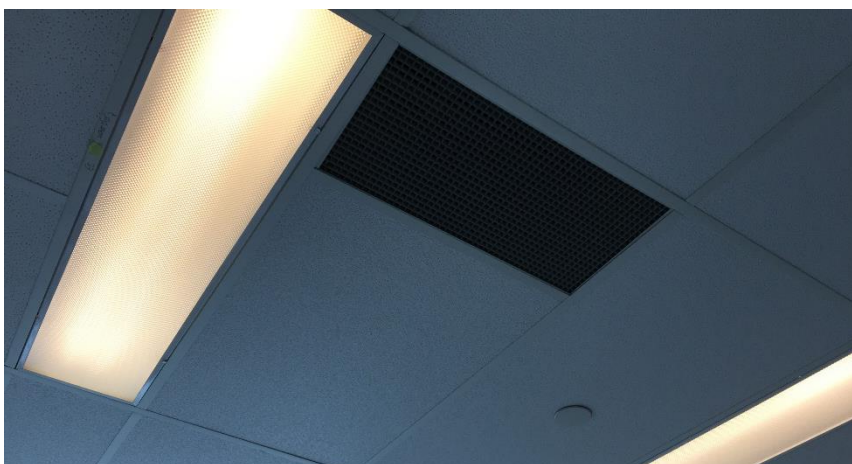
**Photo 6:** Representative view of the fluorescent light fixtures containing mercury vapour observed throughout the subject building.

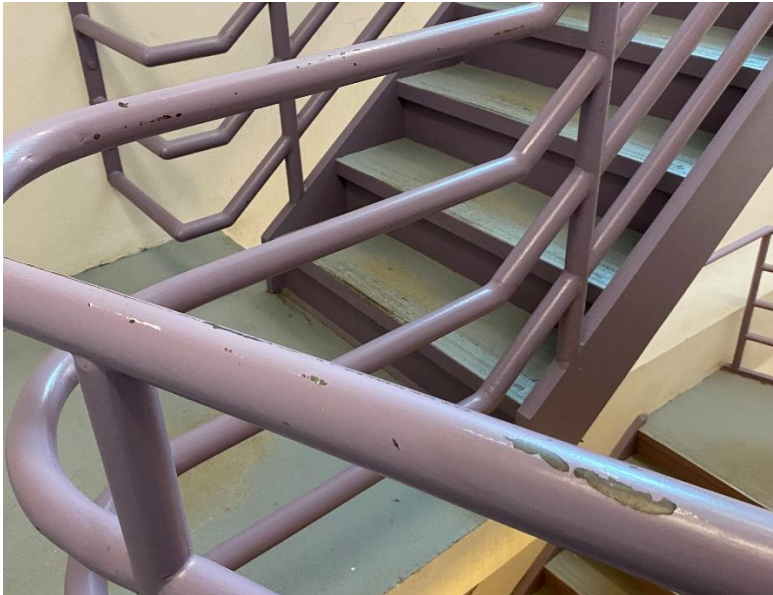
The paint finishes highlighted in pink in the above table are considered lead-containing paints or surface coatings with concentrations greater than 0.1% lead by weight. These paint finishes were observed to be in good condition.

**Photo 7:** View of lead-containing hand railing paint (Purple) observed to be in good condition located throughout the staircase.

Paints identified to contain lead that are in good condition and do not pose a risk to workers or occupants can be managed in place.
