HAZARDOUS MATERIALS SURVEY AND 2023 REASSESSMENT FAUTEUX HALL, 57 LOUIS-PASTEUR PRIVATE, OTTAWA, ON

Project No.: Z1920014HZ / CCC-230252-00

Re: Fauteux Hall, University of Ottawa - 57 Louis-Pasteur Private
Hazardous Materials Survey and 2023 Reassessment
McIntosh Perry Limited Reference No. Z1920014HZ / CCC-230252-00

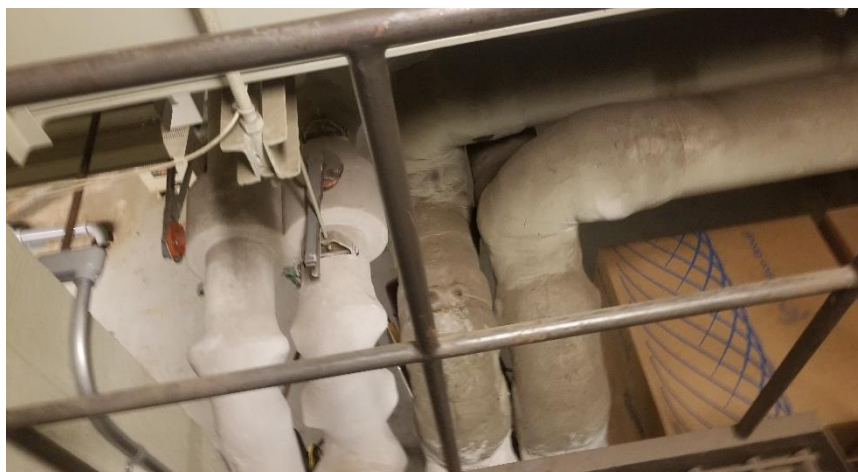
Previously identified paring cement mechanical pipe elbows/fittings were observed in Room 142, and 600. This material **contains 35% Chrysotile asbestos** and is considered to be friable. This material was observed to be in good condition.

Photo 2: View of the asbestos-containing parging cement elbows observed in good condition throughout Room 600.

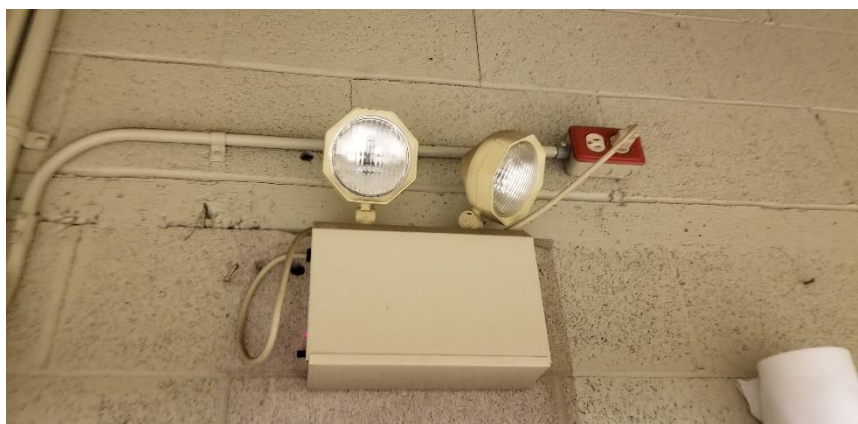
MPL identified one (1) lead-containing acid battery pack in Room 600 observed in good condition.

Photo 3: View of the lead battery packs associated with emergency lighting observed in Room 600.

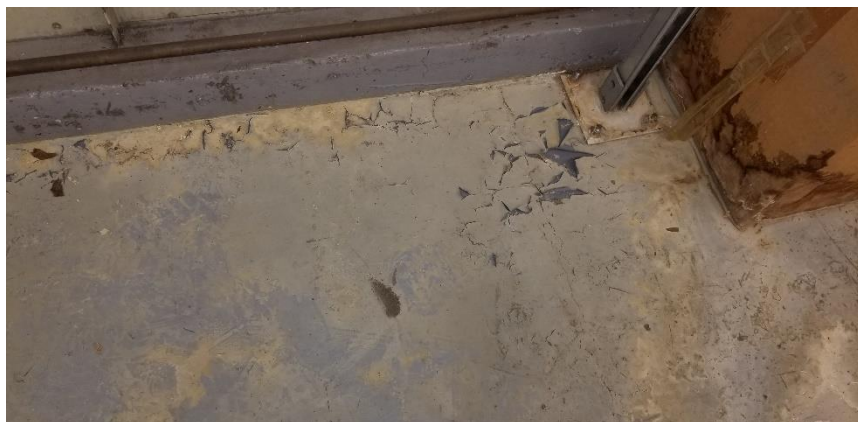
Photo 4: View of the poor condition lead floor paint (Grey) observed throughout Room 600.

Paints identified to contain lead that are in poor condition must be immediately repaired and/or stabilized following a minimum Type 1/2 lead abatement procedures as per OMOL “Lead on Construction Project” dated April 2011.

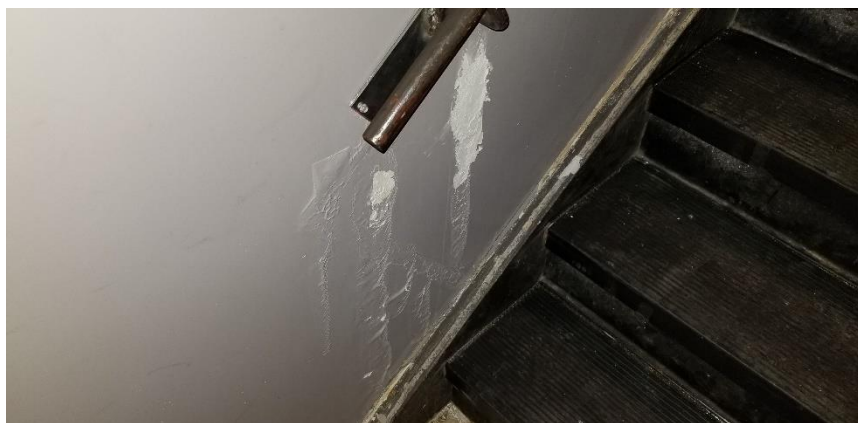
Photo 5: View of the water damaged drywall observed in Room 600.

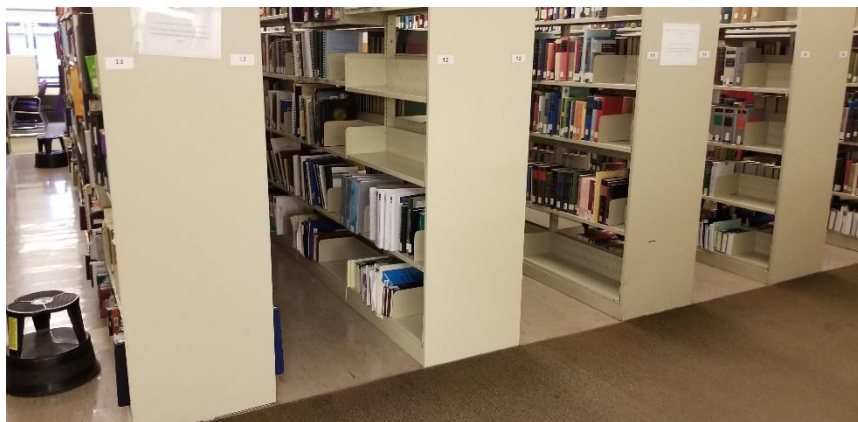
Photo 7: Representative view of Room 523, with asbestos-containing vinyl floor tiles (12"x12" – Brown w/ Brown Stripes).

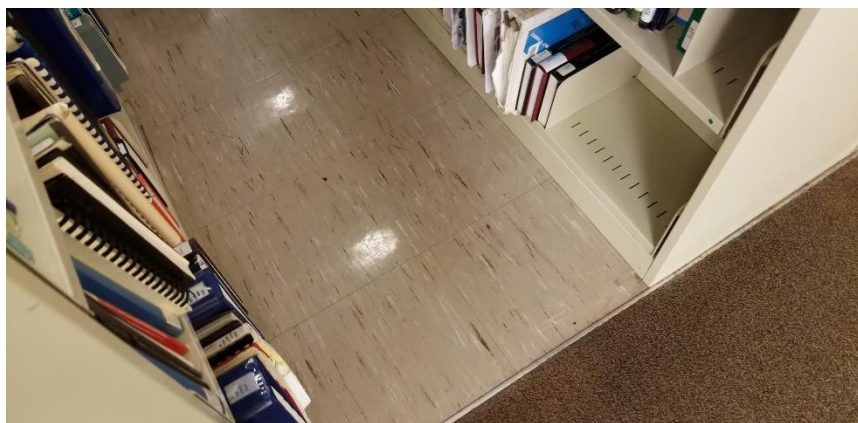
Photo 8: View of the asbestos-containing vinyl floor tiles (12"x12" – Brown w/ Brown Stripes) observed in good condition in Room 523.

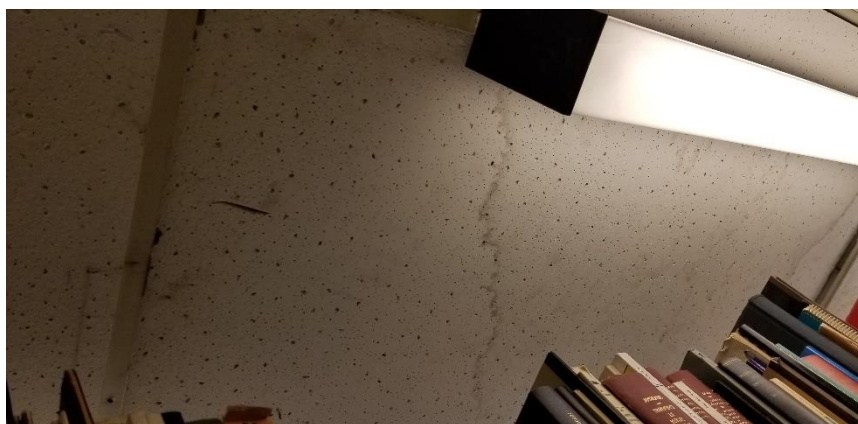
Photo 9: View of the asbestos-containing ceiling tiles - 2'x4' Pinholes w/ Triangular Fissures observed in fair condition in Room 523.

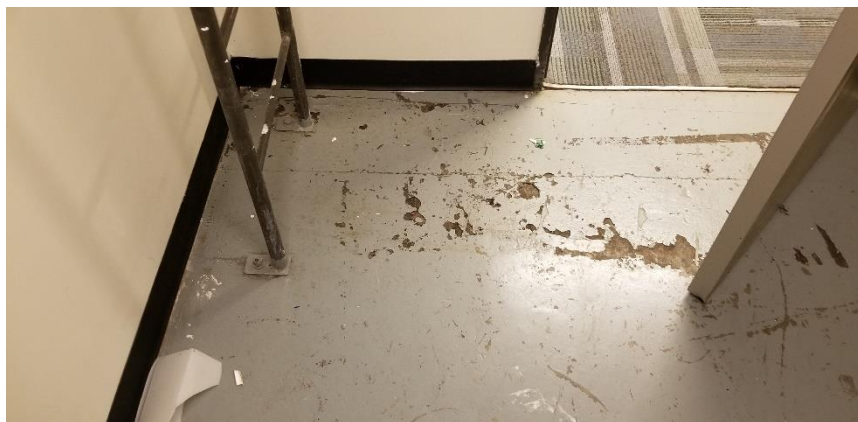
Photo 10: View of the poor condition lead floor paint (Grey) observed throughout Room 525E.

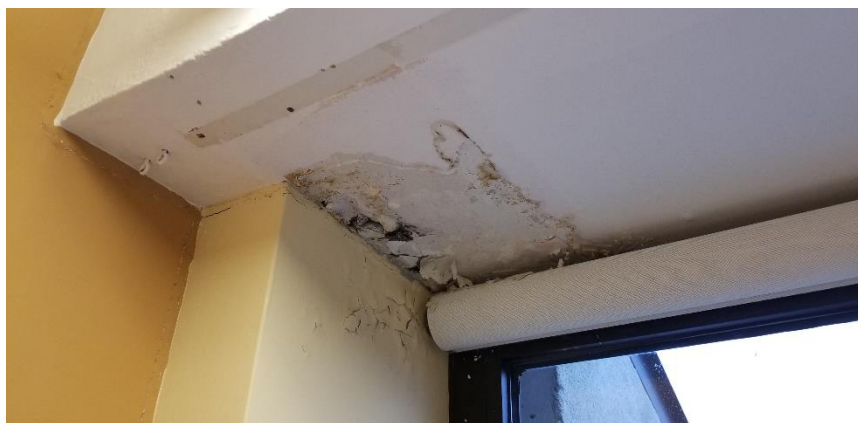
Photo 11: View of the water damaged drywall observed in Room 528.

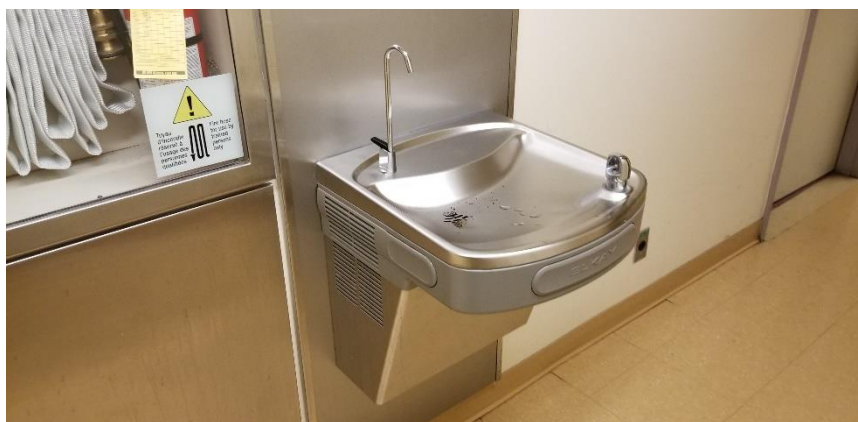
Photo 12: Representative view of the water fountains observed throughout the subject building, containing ODSs.

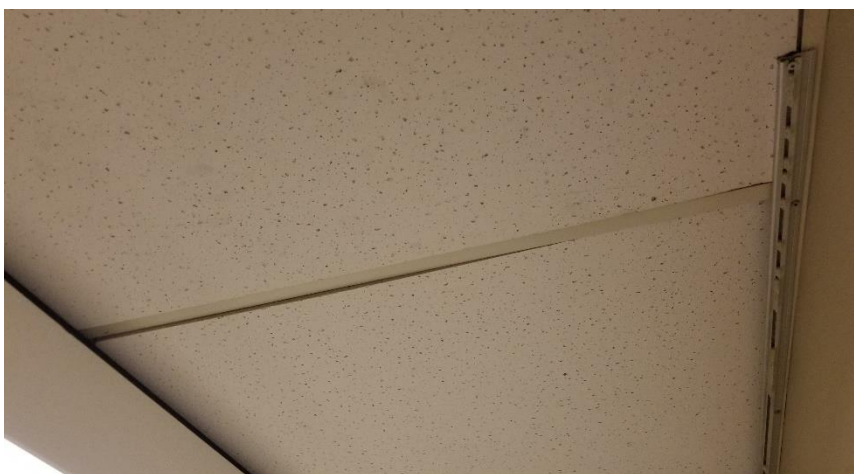
Photo 15: View of the asbestos containing ceiling tiles - 2'x4' Pinholes w/ Triangular Fissures observed in good condition in Room 424.

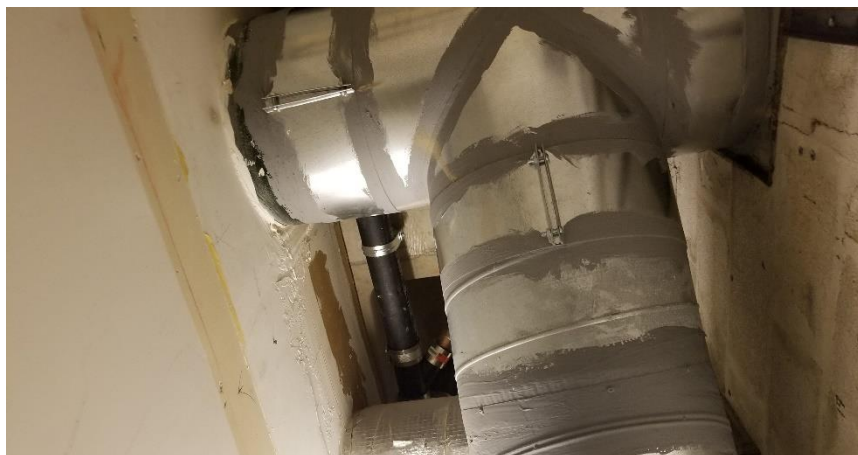
Photo 17: View of the non-asbestos containing caulking (Grey) observed in 371A.

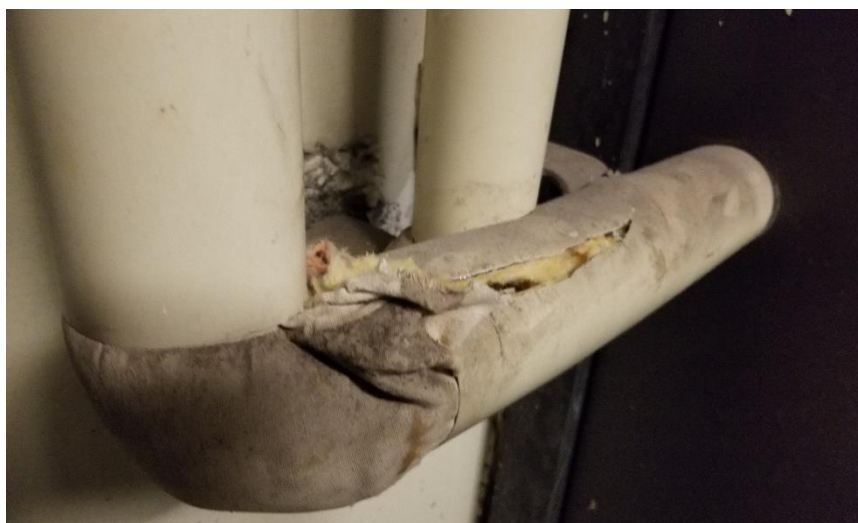
Mechanical pipe straight insulation was observed in Room 129, 138, 140, 141, 144, 202, 202A-1, 226, 230, 241, 348, 600, and 605. MPL previously made several incisions throughout to investigate its composition, and it was visually identified as fiberglass, and therefore not suspected of containing asbestos.

Photo 18: View of the non-asbestos fiberglass pipe straight insulation observed in Room 348.

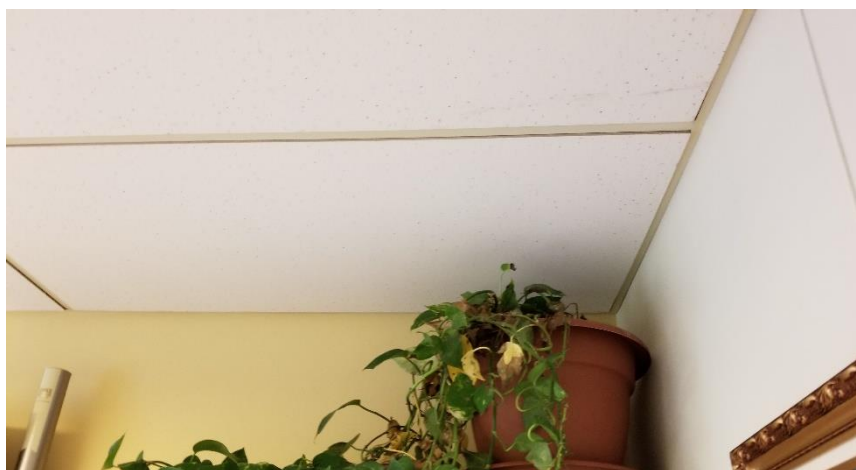
- Suspended ceiling tiles (2'x4' – Pinholes & Triangular Fissures) were observed and previously sampled in Room 306. The laboratory analytical results of samples previously collected from indicate that this material **contains 1% Chrysotile asbestos**. This material appears to be visually similar to the previously identified asbestos-containing ceiling tiles (White w/ Dots) which was observed in Rooms 109, 109A, 110, 100H, 111, 112, 116, 120, 122, 306, 307, 309, 323, 325, 327, 329, 331, 333, 334, 338, 407, 408, 409, 411, 414A, 414B, 414C, 422, 423, 424, 426, 431A, 432, 432A, and 523. This material was observed in good condition with the exception of select areas that were observed in good and fair condition.

Photo 20: View of the asbestos containing ceiling tiles - 2'x4' Pinholes w/ Triangular Fissures observed in good condition in Room 306.

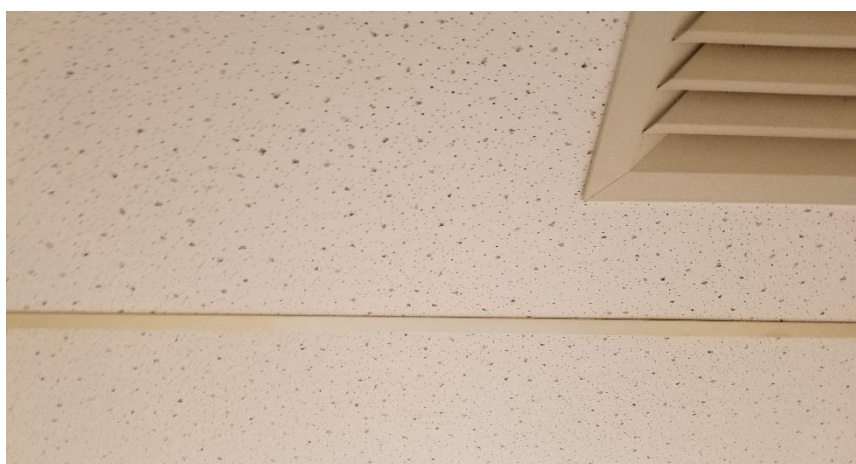
Photo 21: View of the asbestos containing ceiling tiles - 2'x4' Pinholes w/ Triangular Fissures observed in good condition in Room 327.

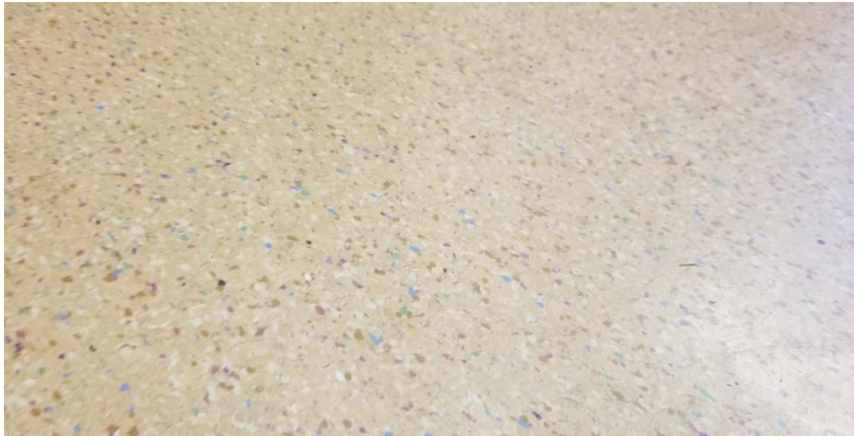
Photo 22: View of the non-asbestos VFT (12"x12" - Pink w/ Multicolour Streaks) observed in Room 223.

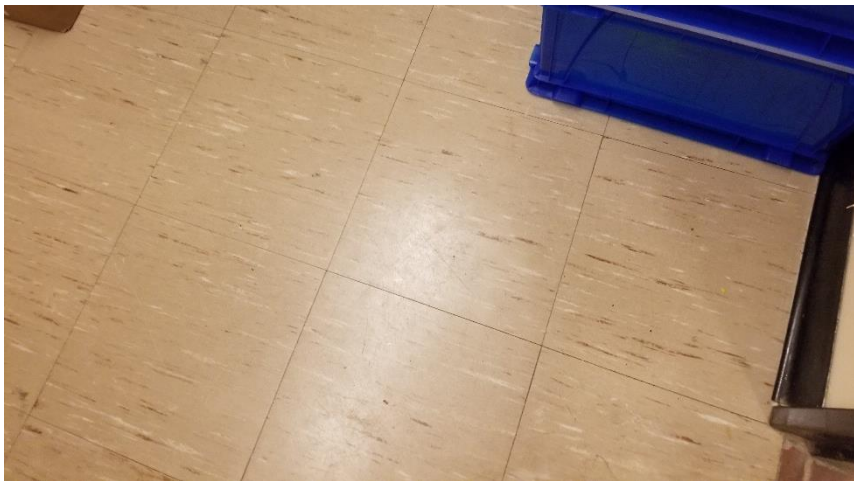
Photo 23: View of the asbestos-containing vinyl floor tiles (12"x12" – Brown w/ Brown Stripes) observed in good condition in Room 224.
