HAZARDOUS MATERIALS SURVEY AND 2023 REASSESSMENT 30 MARIE CURIE (GENDRON), OTTAWA, ON

Project No.:0Z2021101HZ / CCC-230252-00

University of Ottawa

March 8, 2024

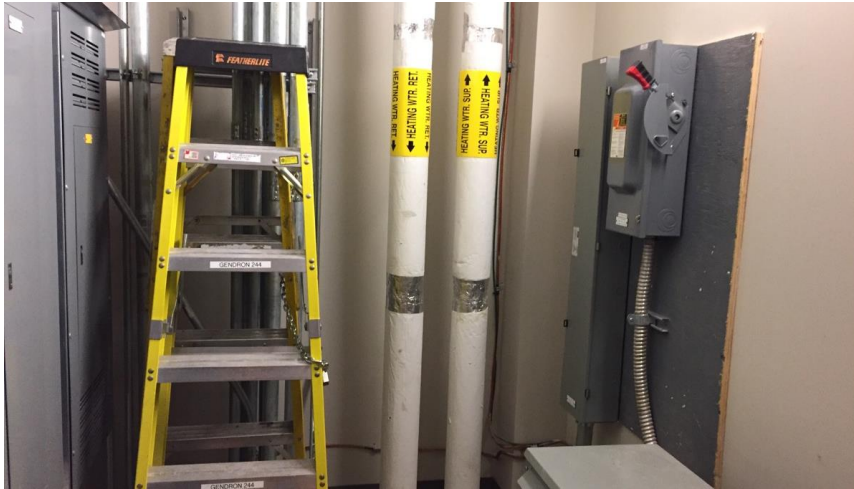
Mechanical pipe straight insulation was observed throughout the subject building. MPL previously made several incisions throughout to investigate its composition, and it was visually identified as fiberglass, and therefore not suspected of containing asbestos.

Photo 4: Representative view of the non-asbestos containing mechanical insulation observed throughout the subject building.

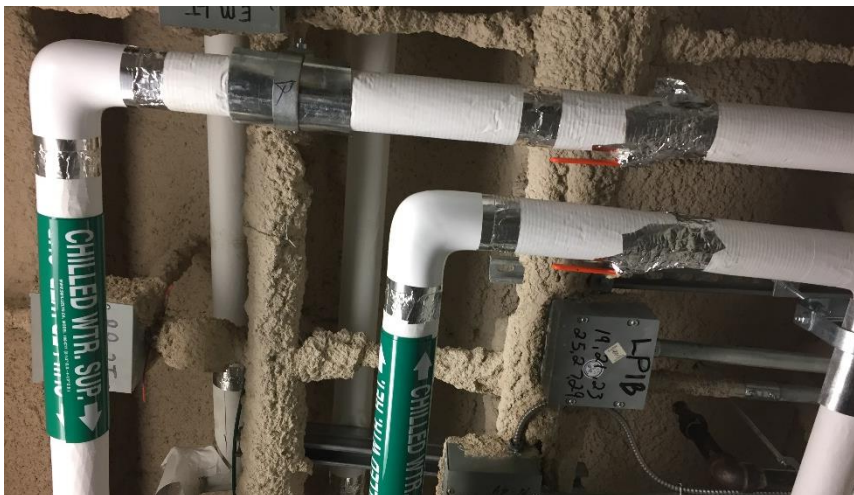
Sprayed fireproofing (Grey) was observed and sampled in Room 540. The laboratory analytical results of the samples collected indicate that this material does not contain asbestos.

Photo 5: View of the non-asbestos sprayed fireproofing observed throughout the subject building.

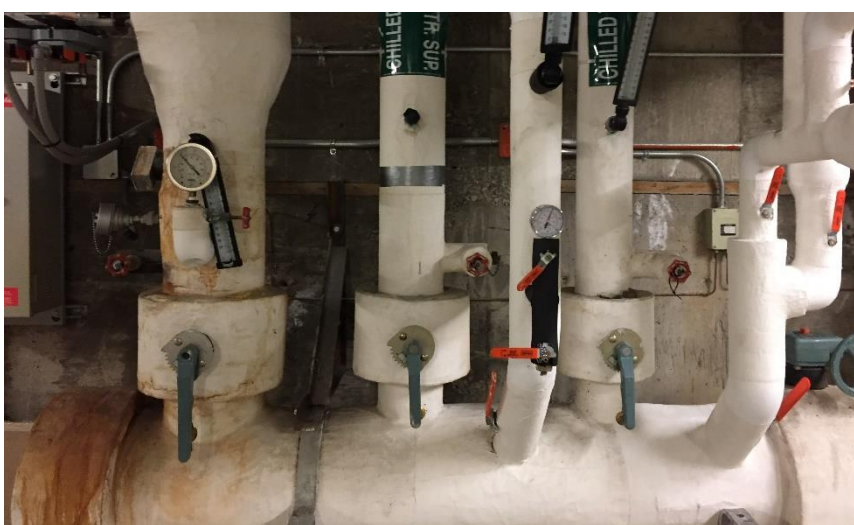
Mechanical pipe elbows/fittings insulation was observed throughout the subject building. MPL previously made several incisions throughout to investigate its composition, and it was visually identified as fiberglass, and therefore not suspected of containing asbestos.

Photo 6: Representative view of the non-asbestos containing mechanical insulation observed throughout the subject building.

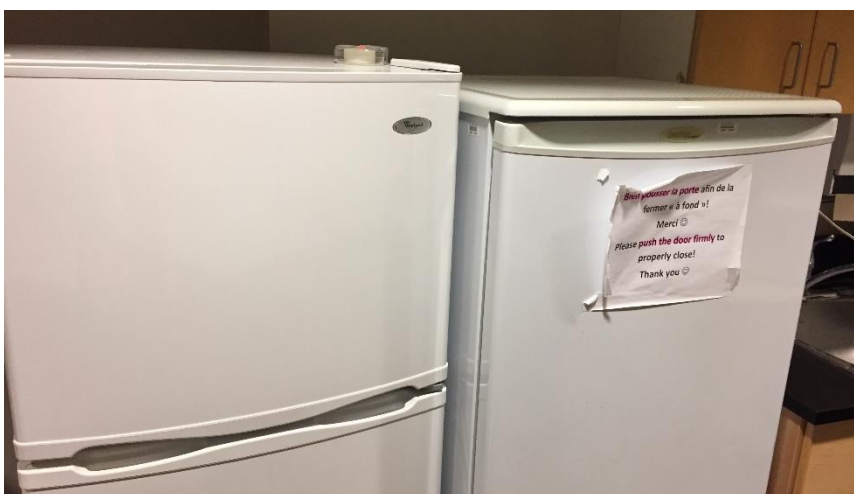
A visual assessment for equipment potentially containing ODSs and other halocarbons was conducted. Equipment containing ODSs or other halocarbons was observed in the subject building.

Photo 9: Representative view of the equipment containing ODS's observed throughout the subject building.

Please refer to Appendix F – Hazardous Materials Checklist for equipment conditions, approximate quantities (where applicable), and recommended actions.

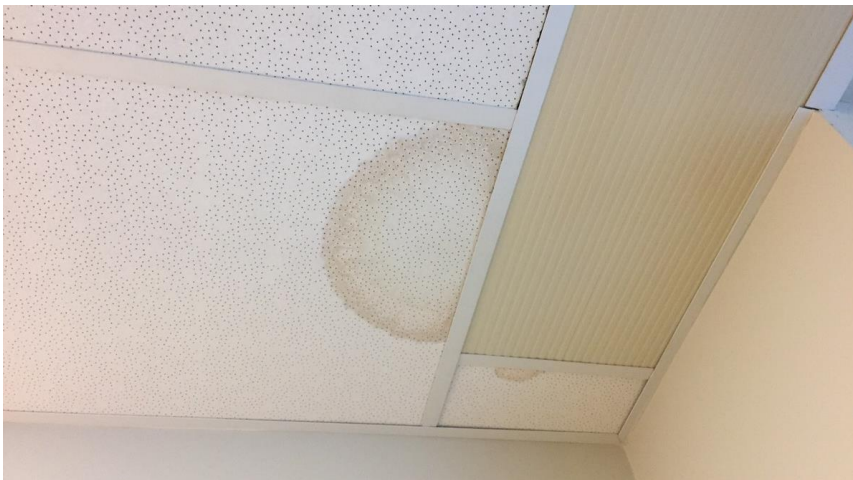
A visual survey of the subject building was conducted to determine if any water damaged was present. MPL identified ceiling tiles throughout the subject building which were affected by water damage.

Photo 11: Representative view of the water damaged ceiling tiles observed in select areas of the subject building.

Water stained/damaged ceiling tiles observed throughout the subject building should be replaced as part of regular maintenance and the underlying cause of the water leakage should be identified and repaired.
