HAZARDOUS MATERIALS SURVEY AND 2023 REASSESSMENT HAGEN HALL, 115 SERAPHIN-MARION PRIVATE, OTTAWA, ON

Project No.: Z1920014HZ / CCC-230252-00

University of Ottawa

McIntosh Perry Limited (MPL)

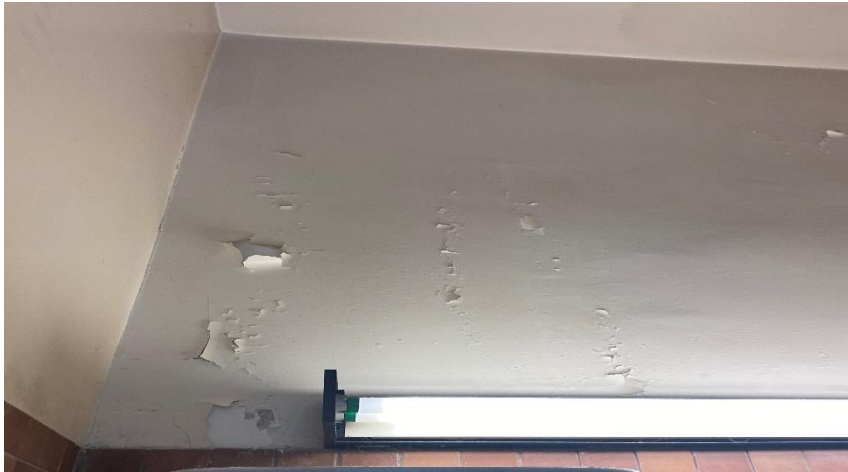
Photo 4: View of the water damaged ceiling and wall paint identified in Room 101A.

- Please refer to Appendix F – Hazardous Materials Checklist for equipment conditions, approximate quantities (where applicable), and recommended actions.
- Water stained/damaged ceiling tiles observed throughout the subject building should be replaced as part of regular maintenance and the underlying cause of the water leakage should be identified and repaired;
- Water stained/damaged ceiling tiles that are also determined to contain asbestos must be replaced following appropriate asbestos abatement procedures as outlined in O.Reg. 278/05.

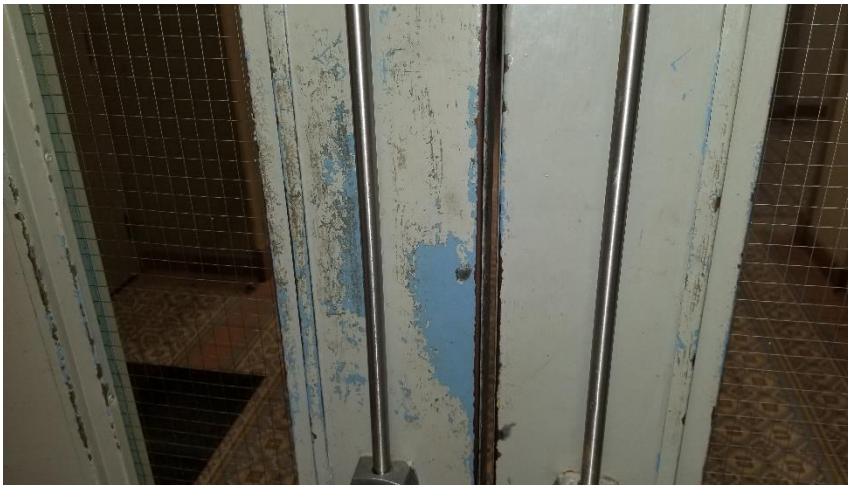
Photo 5: View of the poor condition lead paint (Blue) observed on the doors of Room 106.

Paints identified to contain lead that are in poor condition must be immediately repaired and/or stabilized following a minimum Type 1/2 lead abatement procedures as per “Lead on Construction Project” dated April 2011.

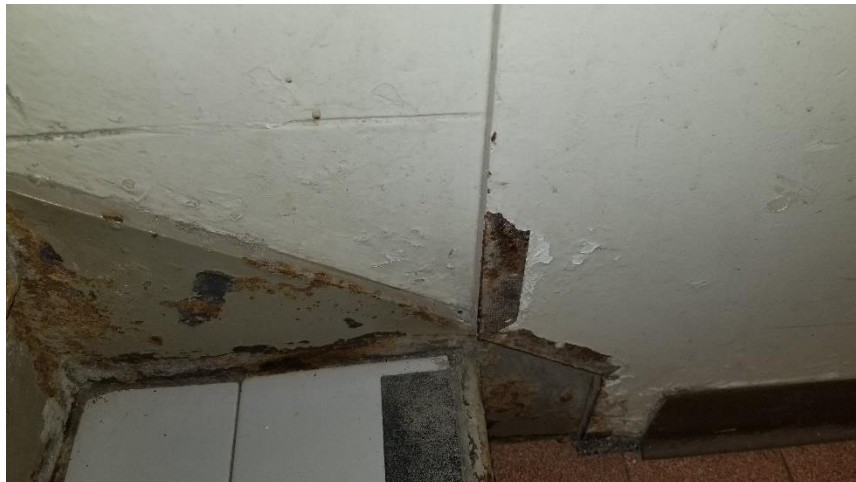
Previously identified asbestos-containing drywall joint compound was observed throughout the subject building. The laboratory analytical results of drywall joint compound samples previously collected throughout the 1st and 2nd level indicated that this material **contains 2% Chrysotile asbestos**. Since drywall joint compound

is a homogeneous material, all areas must be treated as asbestos-containing unless additional bulk sampling and analysis proves otherwise. This material was observed to be in good condition with the exception of select areas that were observed in **poor condition during the 2023 Reassessment Survey**.

Photo 7: View of the poor condition asbestos-containing drywall joint compound observed in Room 106.

- Asbestos-containing materials identified to be in poor condition must be repaired/removed immediately, following Type 1/2/3 asbestos abatement work procedures as detailed in O. Reg. 278/05 and disposed of as asbestos waste under O. Reg. 347;

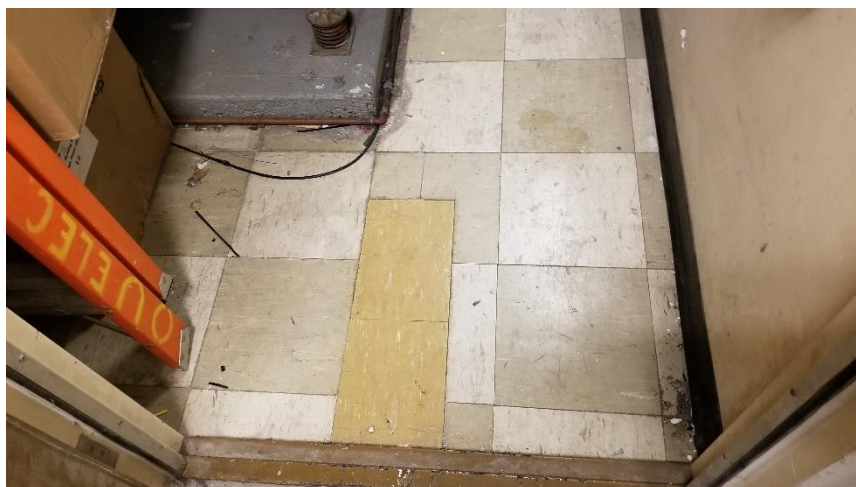
- Previously identified asbestos-containing vinyl floor tiles (12"x12" – Grey w/ Streaks) were observed in Room 107J. This material **contains 2% Chrysotile asbestos** and is considered to be non-friable.

- Previously identified asbestos-containing vinyl floor tiles (12"x12" – Beige w/ Streaks) were observed in Room 107J. This material **contains 1% Chrysotile asbestos** and is considered to be non-friable.

Photo 9: View of the asbestos-containing vinyl floor tiles: (12"x12" – Gold w/ White Streaking), (12"x12" – Grey w/ Streaks), and (12"x12" – Beige w/ Streaks) observed in Room 107J.

Material not observed in this location during 2022 Reassessment.

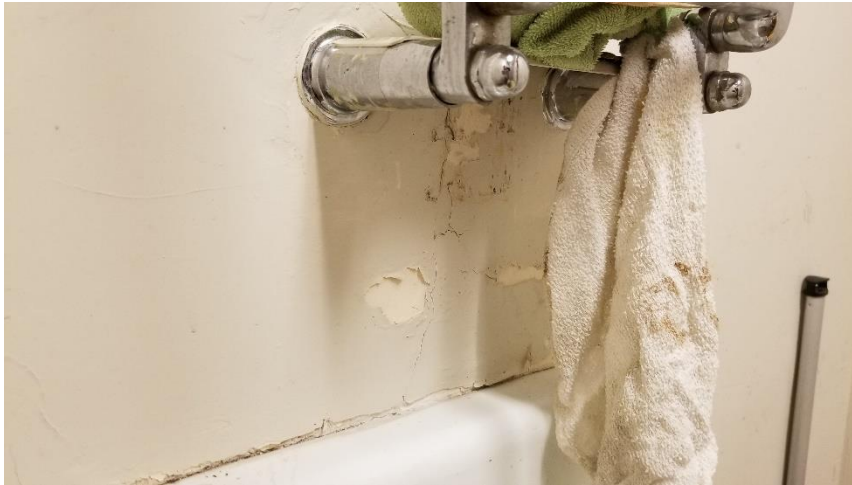
Photo 10: View of the poor condition lead wall paint (Beige) observed in Room 201C.

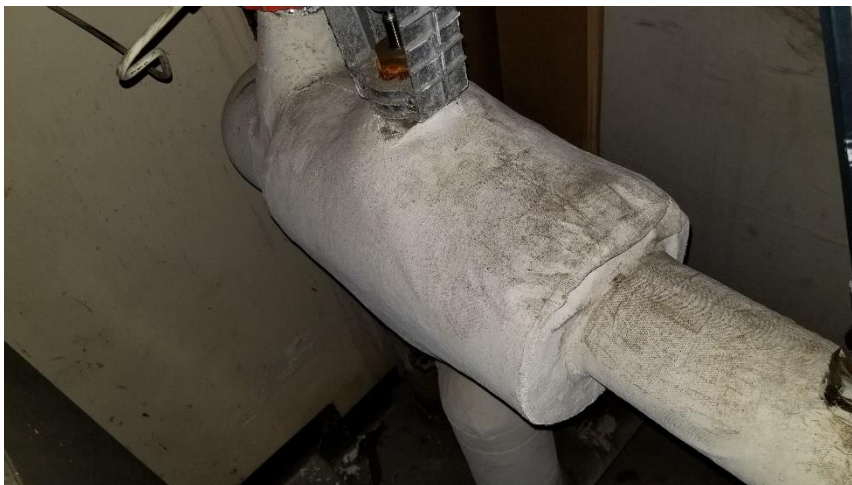
Mechanical pipe straight insulation was observed in Room 107F and 207. MPL made several incisions throughout to investigate its composition, and it was visually identified as fiberglass, and therefore not suspected of containing asbestos.

Mechanical pipe elbow/fitting insulation was observed in Room 107F and 207. MPL made several incisions throughout to investigate its composition, and it was visually identified as fiberglass, and therefore not suspected of containing asbestos.

Photo 12: View of the fiberglass mechanical pipe fitting and pipe straight insulation observed throughout the subject building.

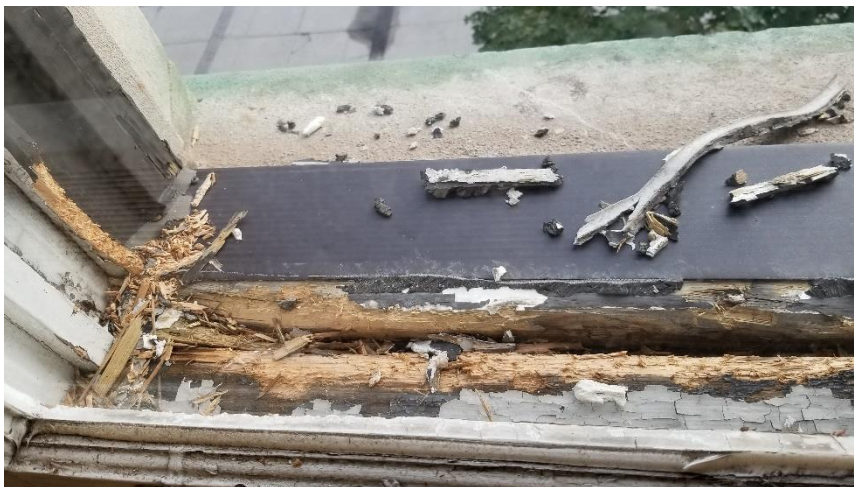
Photo 14: View of the poor condition lead window frame paint (White) observed in Room 302.

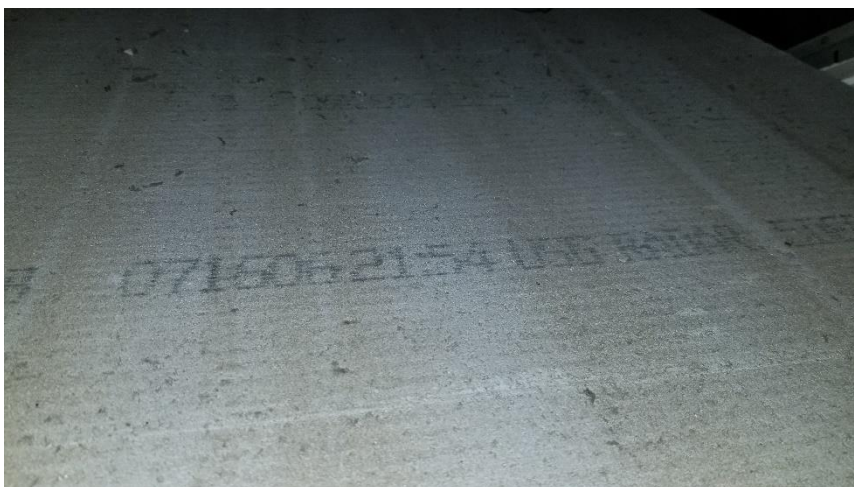
- Suspended ceiling tiles (2'x4' Pinholes & Small Fissures) were observed throughout the 1st Level. The date stamp on the back of these ceiling tiles indicated that they were manufactured in 2006 and therefore, this material is not considered to contain asbestos.
- Previously identified suspended ceiling tiles (2'x4' – White w/ Small Pinholes) were observed in Room 104D, 200A, 200D, 302, 304, 306, and 307. This material **contains 2% Amosite asbestos**. This material was observed in good condition, with select areas observed to be in fair condition. **This material was not observed in Rooms 100 and 106 during the 2023 Reassessment Survey**.

Photo 15: View of the date stamped suspended ceiling tiles (2'x4' – Pinholes & Small Fissures) observed throughout the subject building.

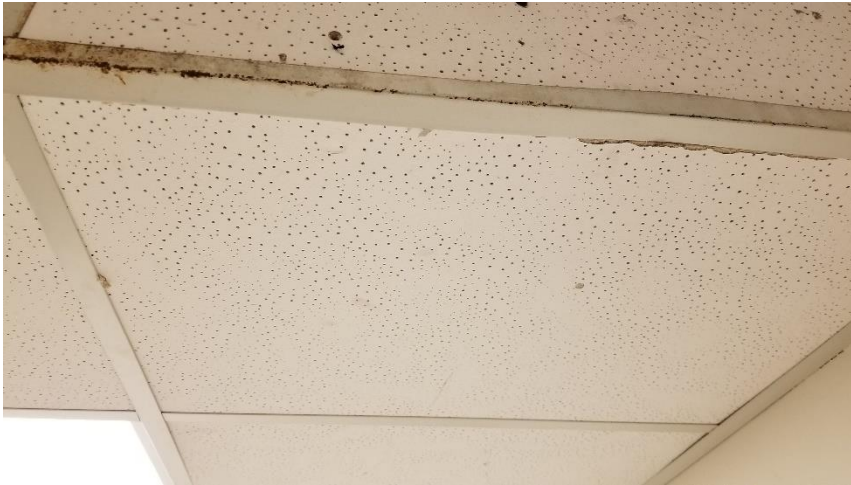
Photo 16: View of the asbestos-containing ceiling tiles (2'x4' White w/ Small Pinholes) observed in Room 106.
