HAZARDOUS MATERIALS SURVEY AND 2023 REASSESSMENT LEBLANC RESIDENCE, OTTAWA, ON

Project No.: Z2021102HZ / CCC-230252-00

McIntosh Perry Limited (**MPL**) was retained by the University of Ottawa, to complete a Hazardous Materials Survey for the residence building located at 45 Louis-Pasteur Private, Ottawa, ON. MPL was also retained to reassess the condition of hazardous building materials found. The survey was conducted on July 20th to 27th, 2020. The reassessment was completed on August 15th, 2023.

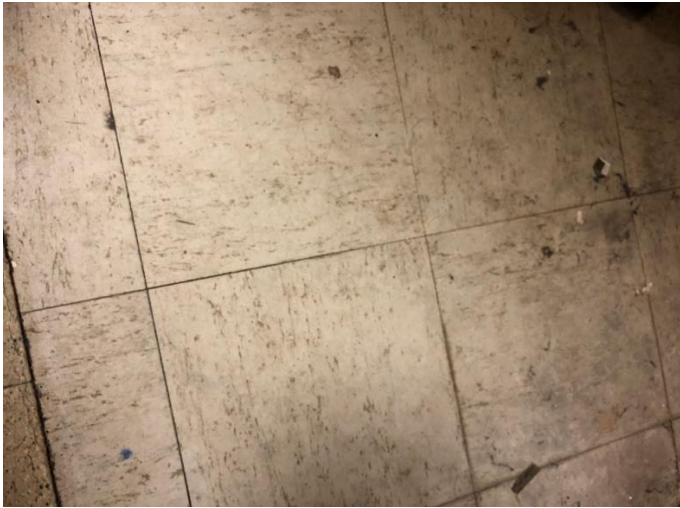
- Vinyl floor tiles (9"x9" – White with Grey Streaks) were observed and previously sampled in Rooms 231, 331, and 441. This material **contains 3% Chrysotile asbestos** and is considered to be non-friable. This material was observed to be in good condition. The associated mastic (black) was found not to contain asbestos.
- Vinyl floor tiles (12"x12" – Grey Marble) were observed and previously sampled in Room 327. The laboratory analytical results of the vinyl floor tile samples collected indicated that this material does not contain asbestos. The associated mastic (yellow) was found not to contain asbestos.
- Vinyl floor tiles (12"x12" – Green) were observed and previously sampled in Room 301 and 401. The laboratory analytical results of the vinyl floor tile samples collected indicate that this material does not contain asbestos.

Photo 4: View of asbestos-containing vinyl floor tiles (9"x9" - white with beige streaks observed in Room 101

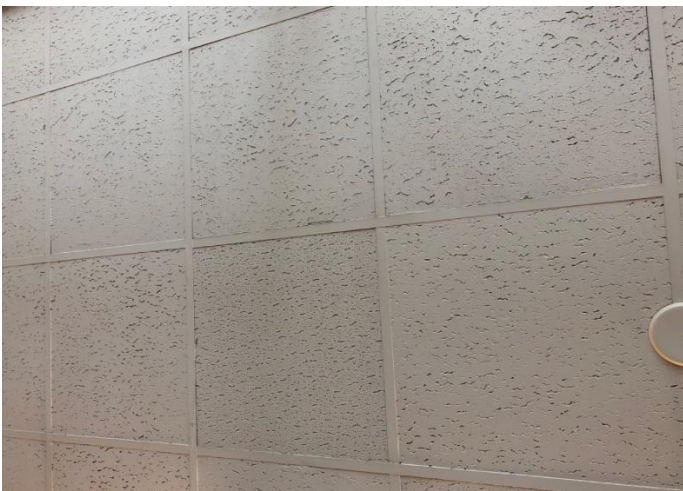
Previously identified ceiling tiles (2'x2' - white with dots and squiggle pattern) was observed within the subject building. The laboratory analytical results indicate that this material **contains 1% Amosite asbestos and 1% Chrysotile asbestos**. This material is considered to be friable and was observed to be good condition.

Photo 5: View of asbestos-containing suspended ceiling tiles (2'x2' - white with dots and squiggle pattern) observed in Room 140.

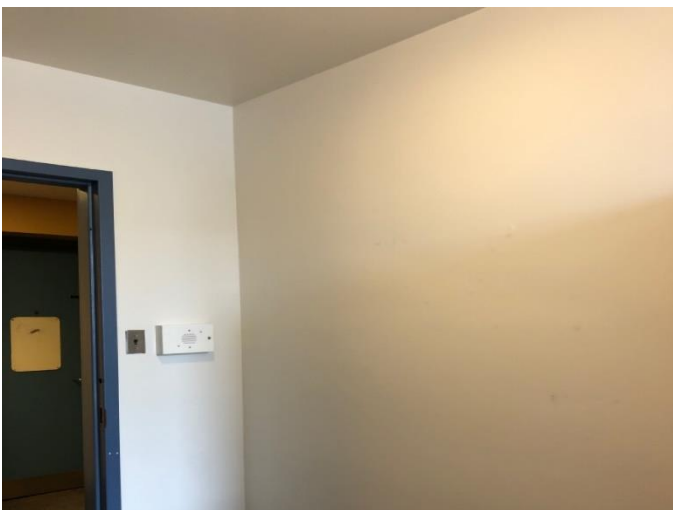
Drywall joint compound was observed throughout the subject building. The laboratory analytical results of drywall joint compound samples previously collected from Rooms 116A and 116X indicate that this material **contains 2% Chrysotile asbestos**. Since drywall joint compound is a homogeneous material, all areas must be treated as asbestos-containing unless additional bulk sampling and analysis proves otherwise. This material was observed in good condition.

Photo 6: View of asbestos-containing drywall joint compound observed throughout the subject building.

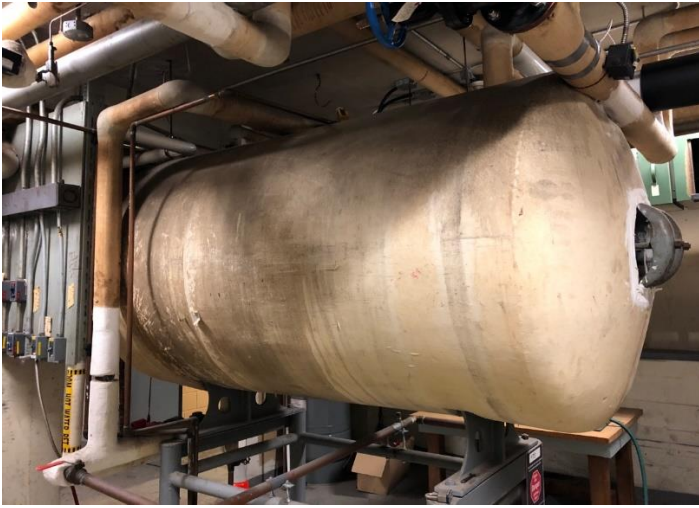
Previously identified tank insulation was observed in Room 014 within the subject building. The laboratory analytical results indicate that this material **contains 60% Chrysotile asbestos**. This material is considered to be friable and was observed to be good condition.

Photo 7: View of asbestos-containing tank insulation observed in Room 014.

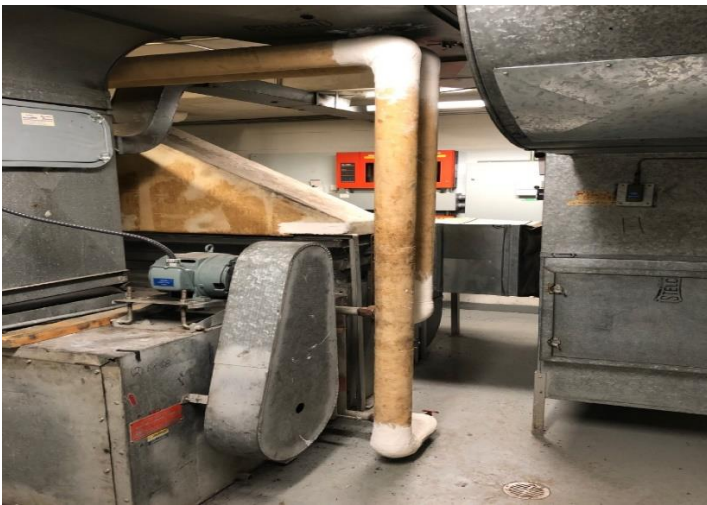
Previously identified mechanical pipe elbow/fitting insulation was observed within the basement of the subject building. The laboratory analytical results indicate that this material **contains 70% Chrysotile asbestos**. This material is considered to be friable and was observed to be good condition.

Photo 8: View of asbestos-containing pipe fitting insulation observed in Room 012.

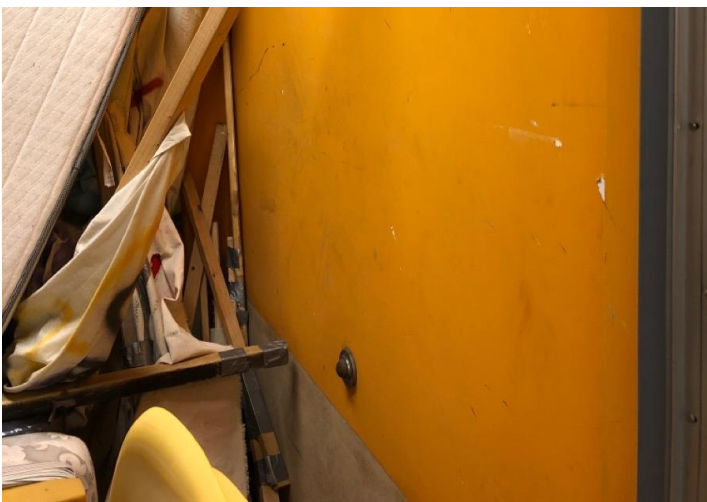
The paint finishes highlighted in pink in the above table are considered lead-containing paints or surface coatings with concentrations greater than 0.1% lead by weight. These paint finishes were observed to be in good condition with the exception of select areas that were observed in poor condition.

Photo 9: View of lead-containing orange paint observed in Room 055.

Paints identified to contain lead that are in poor condition must be immediately repaired and/or stabilized following a minimum Type 1/2 lead abatement procedures as per OMOL “Lead on Construction Project” dated April 2011.

Paints identified to contain lead that are in fair condition should be either repaired (where possible) and/or closely monitored for signs of further deterioration.

Paints identified to contain lead that are in good condition and do not pose a risk to workers or occupants can be managed in place.

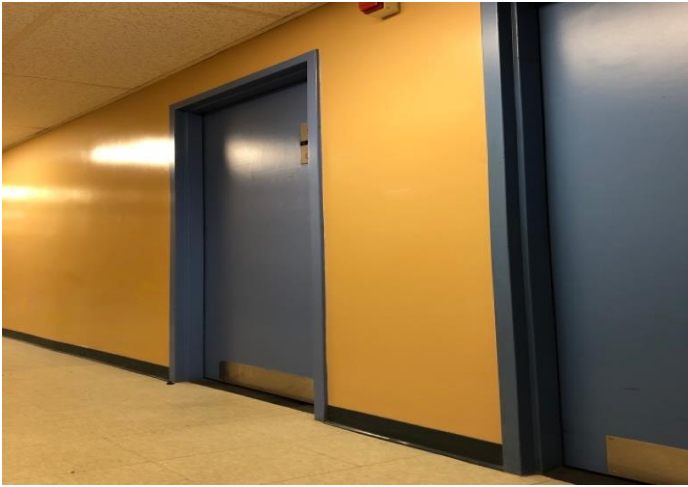
Photo 10: View of lead-containing blue paint observed in Room 145.

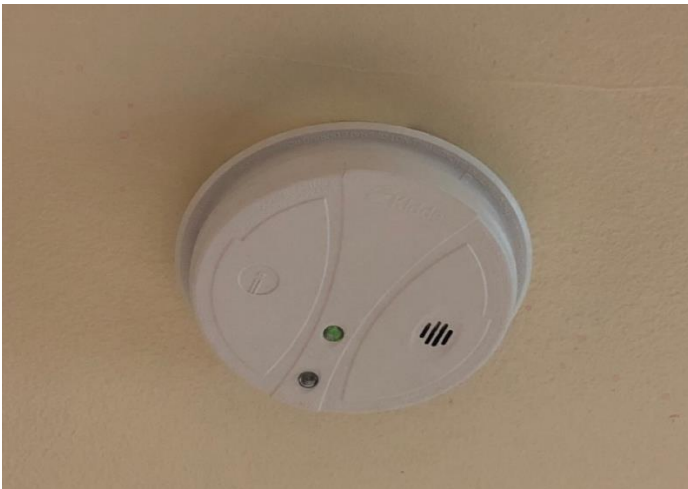
A visual assessment of the subject building was conducted to determine if any electrical components containing radioactive materials were present. MPL observed Kidde brand smoke detectors, which contains small quantities of radioactive material.

Photo 11: Typical view of smoke detectors containing radioactive materials.

The radioactive sources in smoke alarms are sealed and contained within a metal case inside the smoke detector and must not be damaged or tampered with. These materials do not pose a hazard as long as they remain contained and properly disposed at the time of removal or replacement.

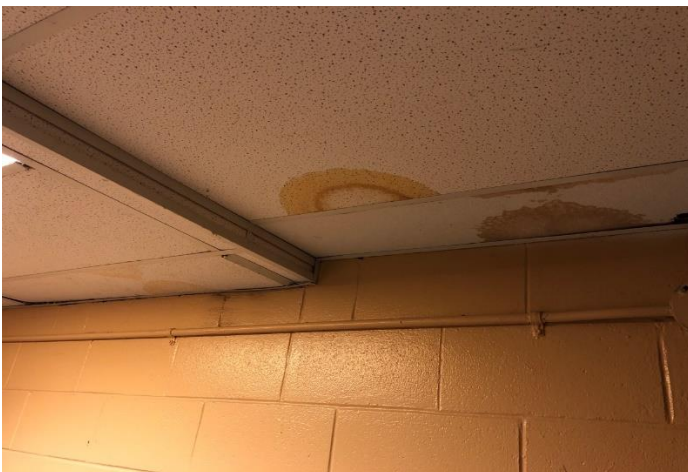
A visual survey of the subject building was conducted to determine if any mould was present. MPL identified ceiling tiles where materials were affected water damage

Photo 12: View of water damaged ceiling tiles observed in Room 046.

Water stained/damaged ceiling tiles observed throughout the subject building should be replaced as part of regular maintenance and the underlying cause of the water leakage should be identified and repaired.

Water stained/damaged ceiling tiles that are also determined to contain asbestos must be replaced following appropriate asbestos abatement procedures as outlined in O.Reg. 278/05.
