HAZARDOUS MATERIALS SURVEY AND 2023 REASSESSMENT MARCHAND RESIDENCE, OTTAWA, ON

Project No.: Z2021102HZ / CCC-230252-00

University of Ottawa

March 12, 2024

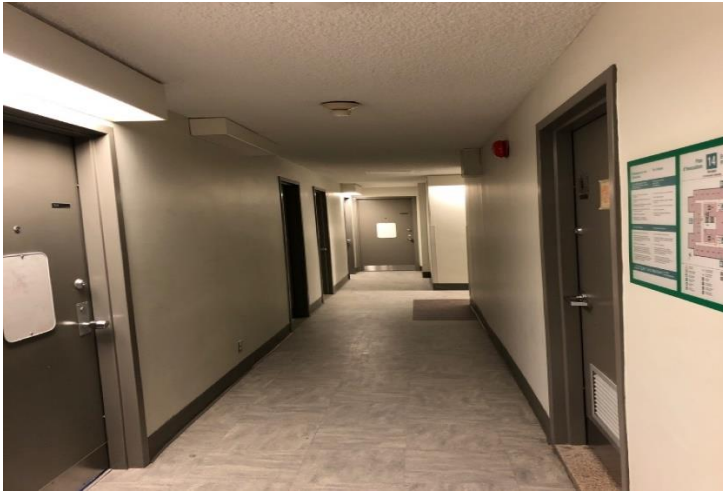
Photo 1: View of typical finishes observed at the building located at 110 University Private.

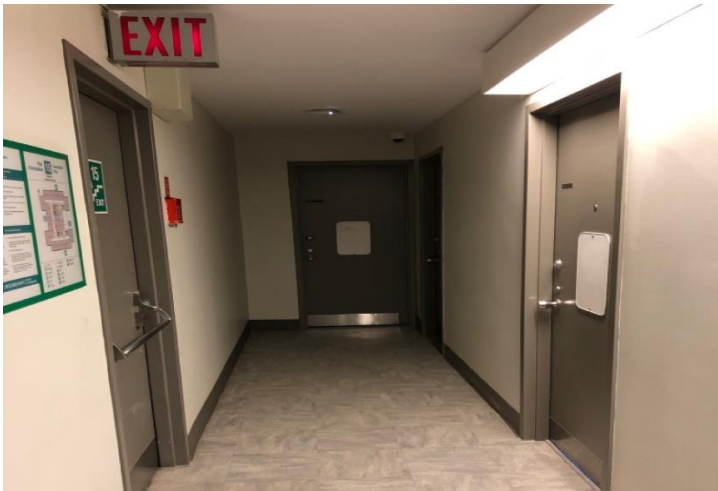
Photo 2: View of typical finishes observed at the building located at 110 University Private.

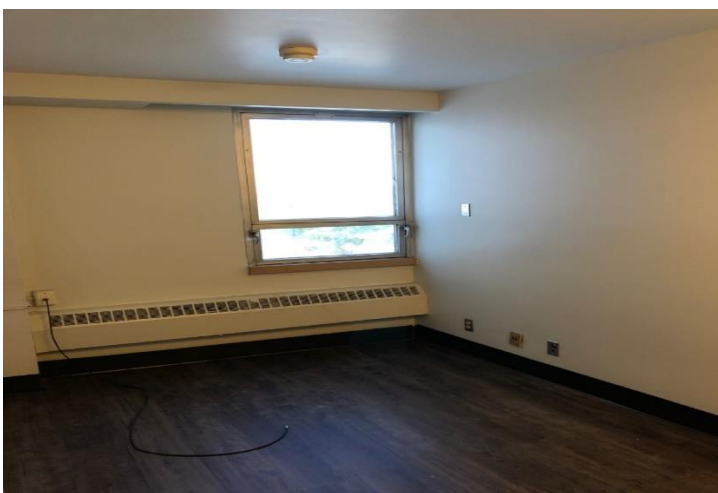
Photo 3: View of typical finishes observed at the building located at 110 University Private.

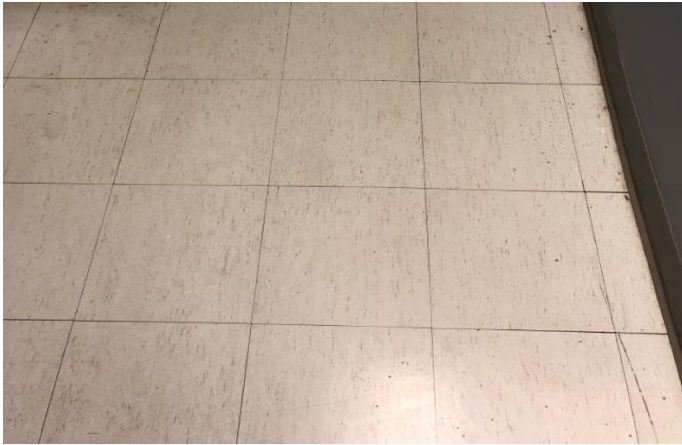
- Vinyl floor tiles (12"x12"- White with Grey Streaks) were observed in rooms 328, 528, 728, 928, 1128, 1328, 1524, and 1528. The laboratory analytical results of the vinyl floor tile samples previously collected from indicate that this material does not contain asbestos. This material **contains 5% Chrysotile asbestos** and is considered to be non-friable. This material was observed to be in good condition. The associated mastic (black) was found not to contain asbestos.

Photo 4: View of asbestos-containing vinyl floor tiles (12"x12"-white with grey streaks) observed in the Room 1524.

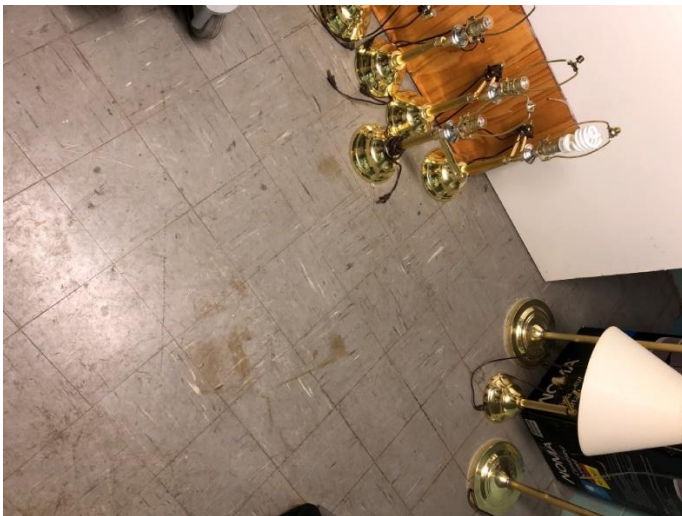
- Vinyl floor tiles (9"x9"-Grey with Grey/White Streaks) were observed in rooms 06, 012, 013, 014, 016, and 018. The laboratory analytical results of the vinyl floor tile samples previously collected from indicate that this material does not contain asbestos. This material **contains 3% Chrysotile asbestos** and is considered to be non-friable. **This material was observed to be removed in rooms 06 during the 2023 Reassessment Survey**. This material was observed to be in good and fair condition in the remaining locations. The associated mastic (black/yellow) was found not to contain asbestos.

Photo 5: View of asbestos-containing vinyl floor tiles (9"x9"- grey with grey/white streaks) observed in Room 012.

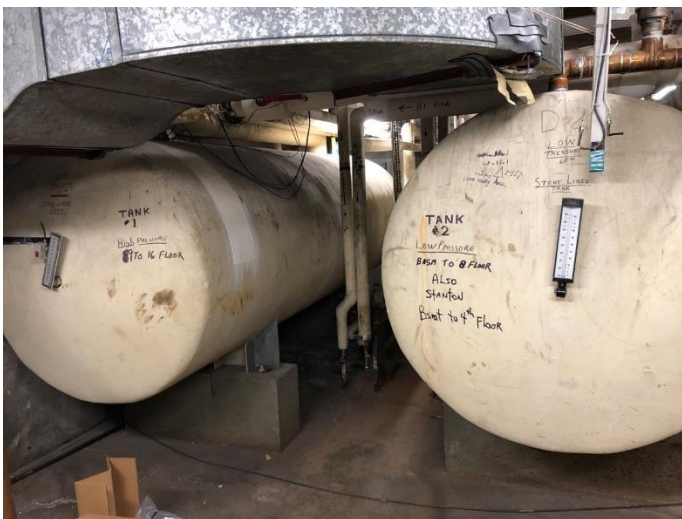
Previously identified tank insulation was observed in Room 05, 07 and 1601. The laboratory analytical results indicate that this material contains between **65-75% Chrysotile asbestos**. **This material is considered to be friable and was observed to be in poor condition (<1 m²) during the 2023 Reassessment Survey.**

Photo 6: View of asbestos-containing boiler tank insulation observed in Room 05.

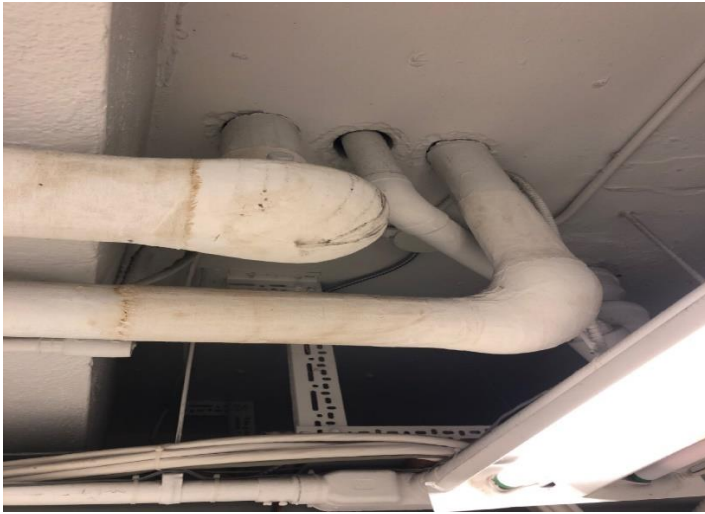
Previously identified pipe elbow/fitting insulation was observed throughout the subject building. The laboratory analytical results indicate that this material contains **70% Chrysotile asbestos**. This material is considered to be friable and was observed in good and poor condition.

Photo 7: View of asbestos-containing pipe fitting insulation observed in Room 017.

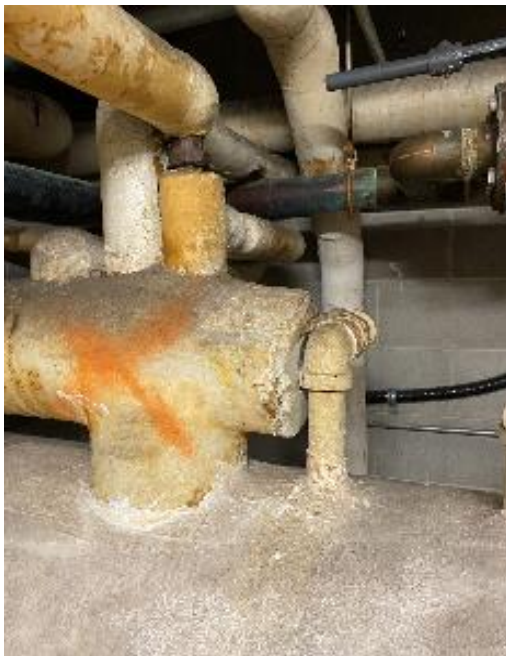
Photo 8: View of asbestos-containing mechanical insulation observed to be in poor condition in Room 105.

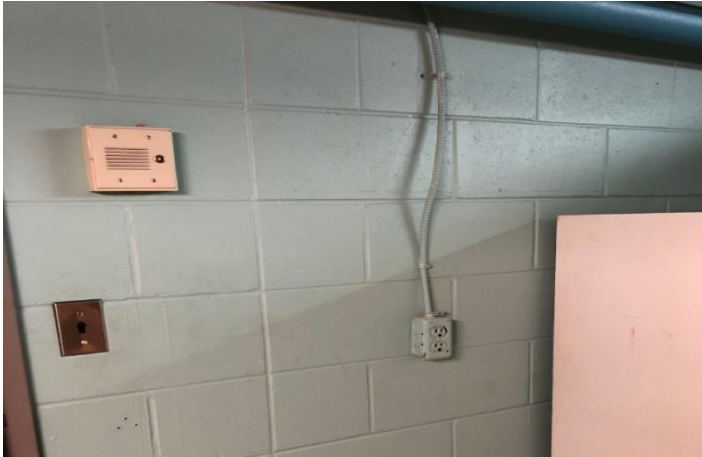
The paint finishes highlighted in blue in the above table were determined to contain low concentrations of lead which are less than or equal to 0.1%. These paint finishes were observed to be in good condition.

Photo 9: View of light blue paint containing low levels of lead observed on the wall in Room 012.

Paints identified to contain lead that are in good condition and do not pose a risk to workers or occupants can be managed in place.

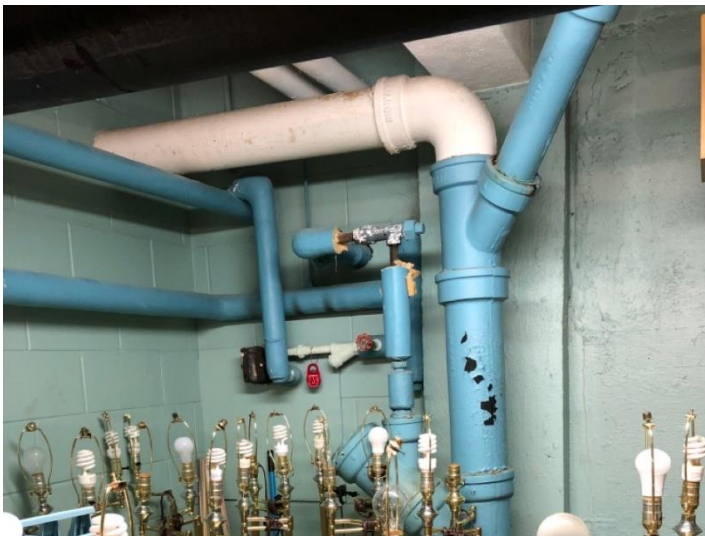
Photo 10: View of lead-containing teal paint in Room 013 observed to be in poor condition.

Paints identified to contain lead that are in poor condition must be immediately repaired and/or stabilized following a minimum Type 1/2 lead abatement procedures as per OMOL “Lead on Construction Project” dated April 2011.

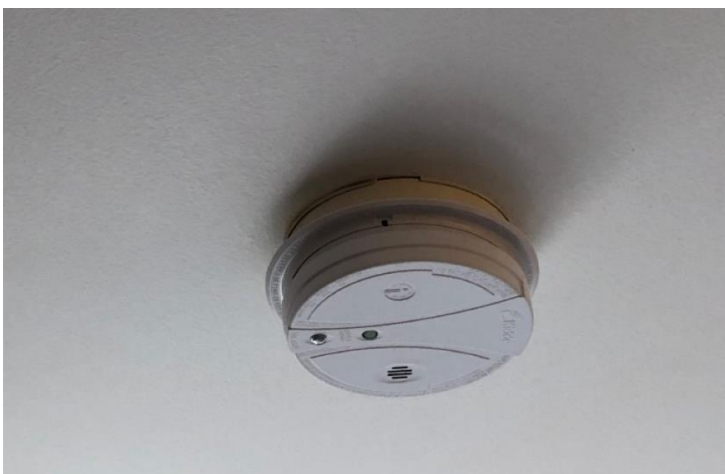
Photo 11: Typical view of smoke detectors containing radioactive materials.

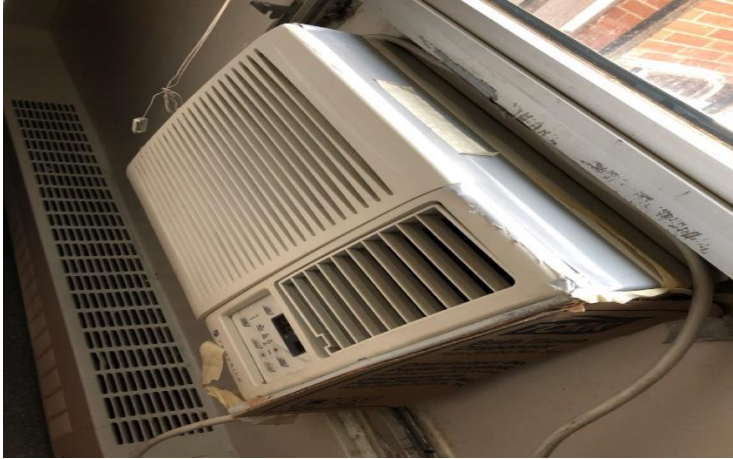
Photo 12: Typical view of ODS containing air-conditioning unit.
