# HAZARDOUS MATERIAL SURVEY AND 2023 REASSESSMENT MONTPETIT HALL - 125 UNIVERSITY PRIVATE, OTTAWA, ON

Project No.: Z2021101HZ / CCC-230252-00

University of Ottawa

McIntosh Perry Limited (MPL)

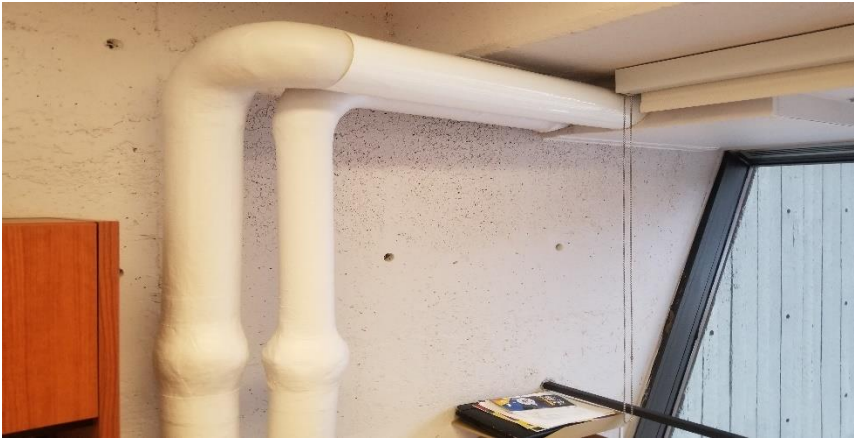
Previously identified asbestos-containing parging cement mechanical insulation on pipe elbows/fittings were observed in Rooms 0012, 002, 003B, 002A, 007B, 007A, 009, 0012, 011, 02C, 022, 023, 024, 050, 051, 213, 200, 205A, 216, 306B, 311D, 316A. This material was previously sampled was determined to **contain between 5-60% Chrysotile asbestos** and is considered to be friable. This material was observed to be in good condition with the exception of select areas observed to be in poor condition.

**Photo 1:** View of asbestos-containing pipe fitting insulation observed in Room 306B.

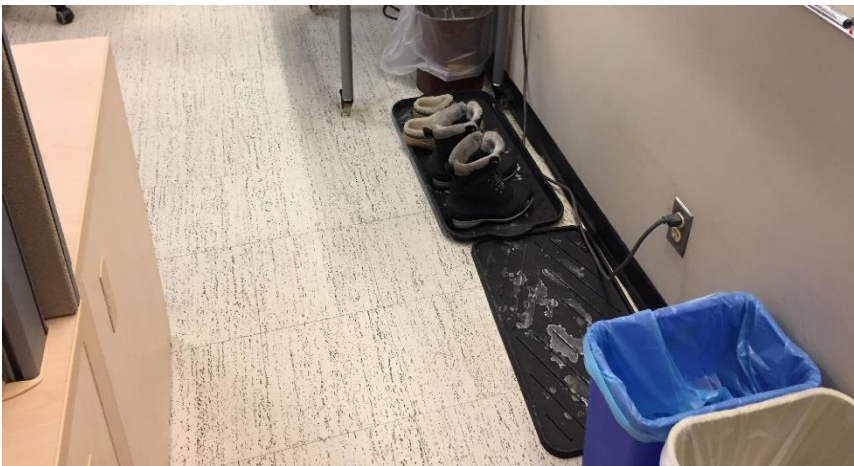
- Previously identified asbestos-containing vinyl floor tiles (12" x 12" – White with Black Dots) were observed in Room 300, 301C, 302, 304A 428 and 400. This material **contains 39% Chrysotile asbestos** and is considered to be non- friable. This material was observed to be in good condition.

**Photo 2:** View of asbestos-containing vinyl floor tiles observed in Room 428.

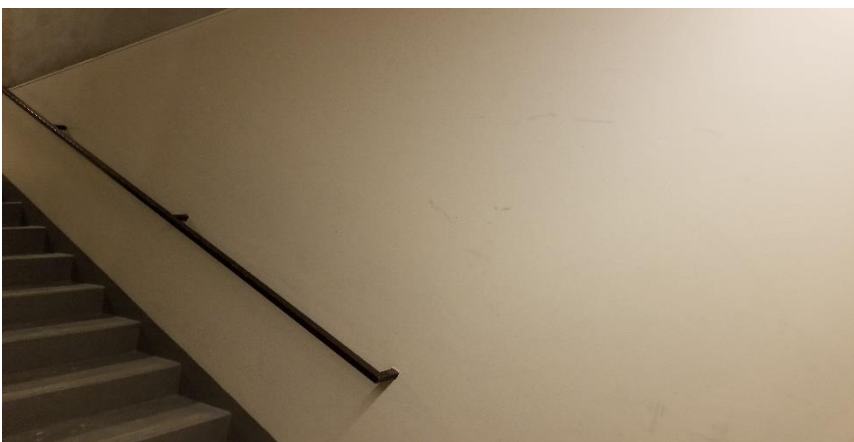
Previously identified asbestos-containing drywall joint compound was observed in Room 404. This material **contains 2% Chrysotile asbestos**. Since drywall joint compound is a homogeneous material, all areas must be treated as asbestos-containing unless additional testing confirms otherwise. This material was observed in good condition.

**Photo 3:** Typical view of asbestos-containing drywall observed throughout the subject building.

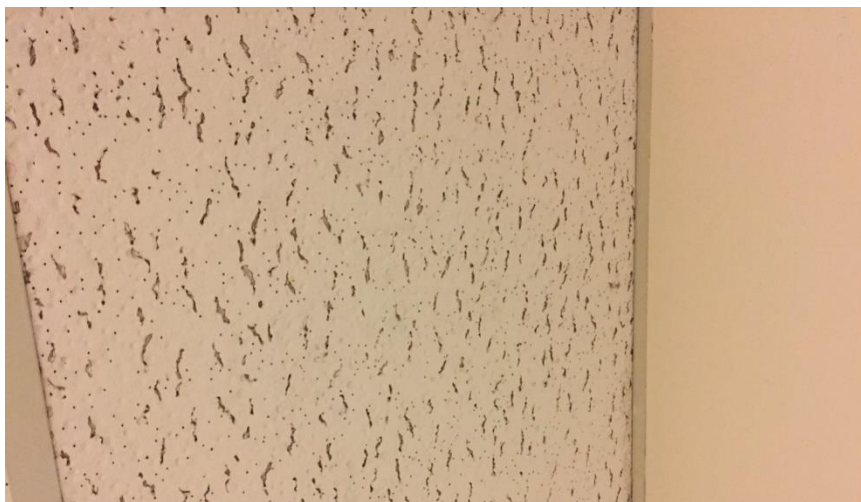
- Suspended ceiling tiles (2'x4' – Pinholes with Wavy Fissures) were observed and previously sampled in Room 415, 405 and 405A. The laboratory analytical results indicate that this material **contains 0.5% Amosite asbestos**. This material was observed to be in good condition.

**Photo 4:** View of asbestos-containing suspended ceiling tiles observed in Room 415.

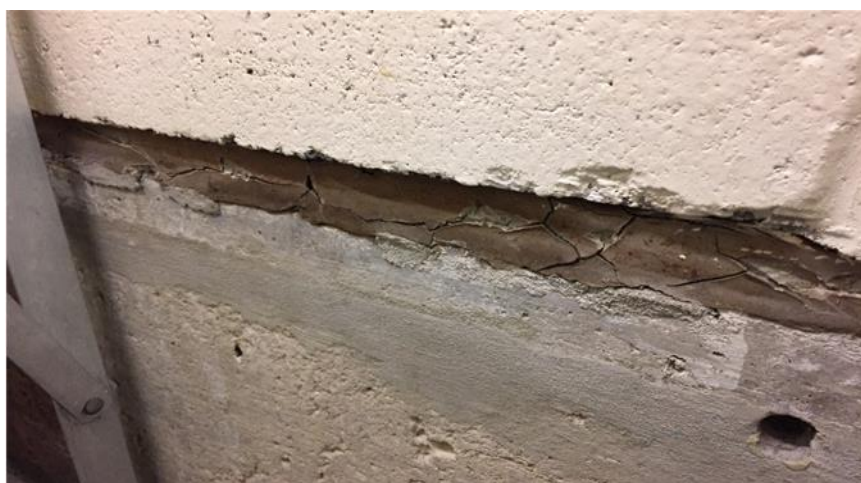
**Photo 5:** View of asbestos-containing wall caulking (tan) observed in Room 0024.

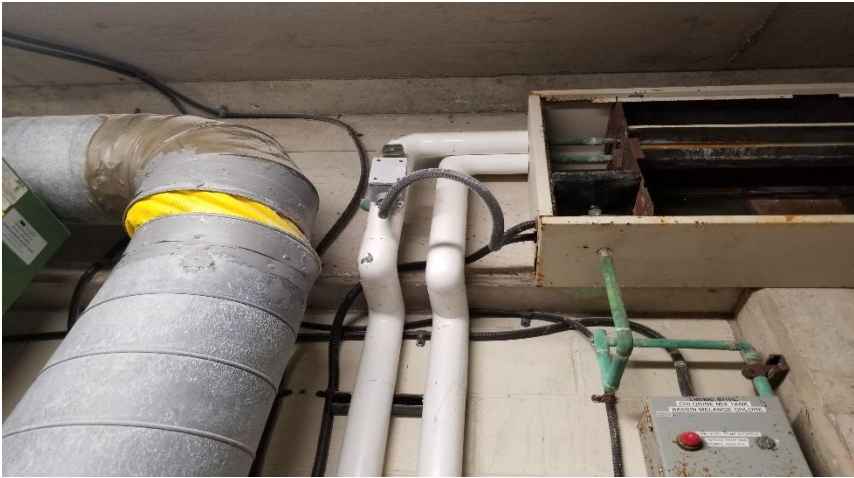
To avoid damage and compromising the integrity of the structure, no bulk samples of the flexible duct connector in Room 020C were collected. Prior to renovation/demolition, flexible duct connector should be examined and tested for asbestos content. Flexible duct connector should therefore be considered to contain asbestos until bulk samples and analysis proves otherwise.

**Photo 6:** View of flexible duct connector observed in Room 020C suspected to contain asbestos.

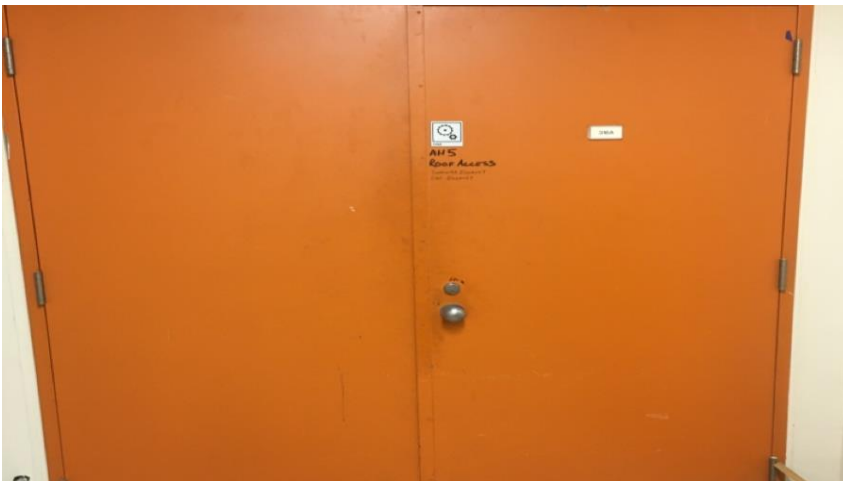
**Photo 7:** View of orange lead-containing paint observed on the door of Room 316.

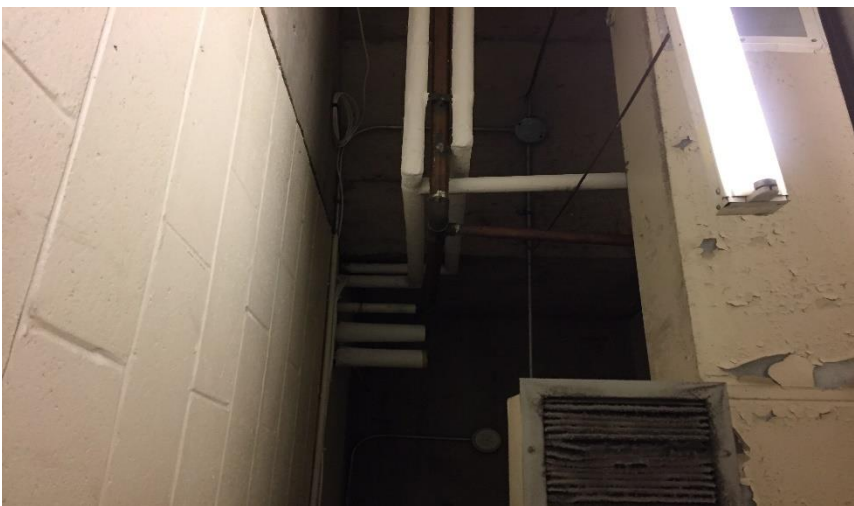
**Photo 8:** View of lead containing beige paint observed to be in poor condition in Room 023A.

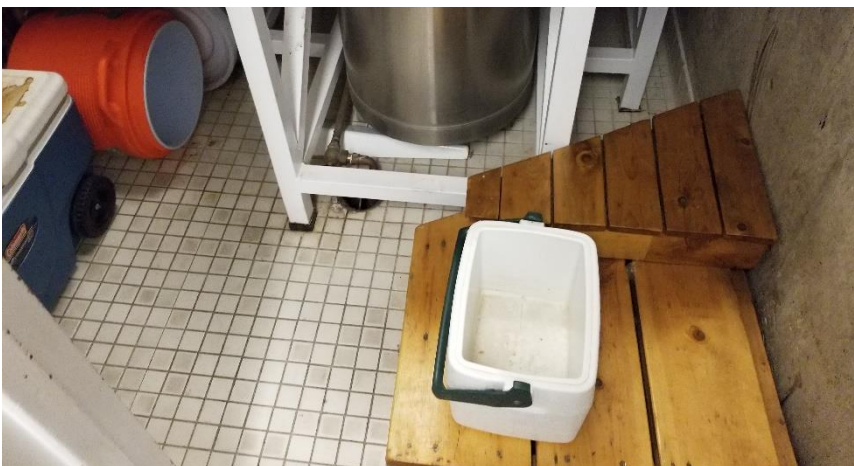
**Photo 11:** View of ceramic floor tiles grout observed throughout the subject building suspect to contain asbestos.

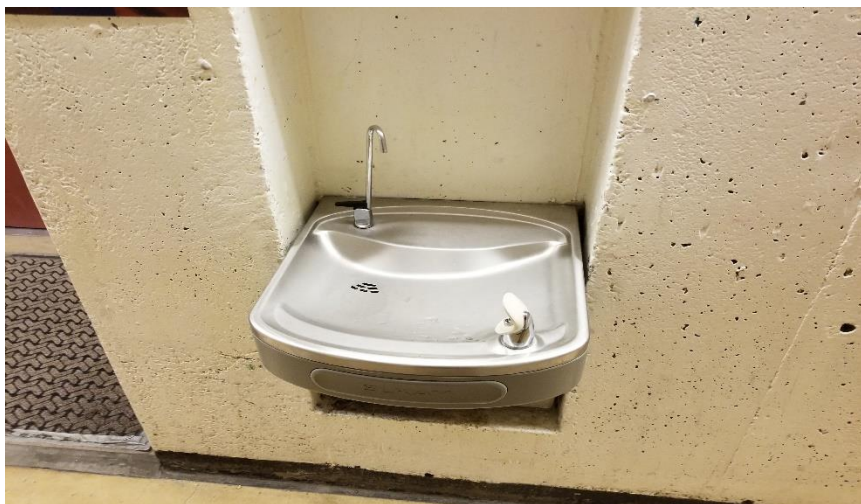
**Photo 12:** Typical view ODS containing water fountains observed throughout the subject building.

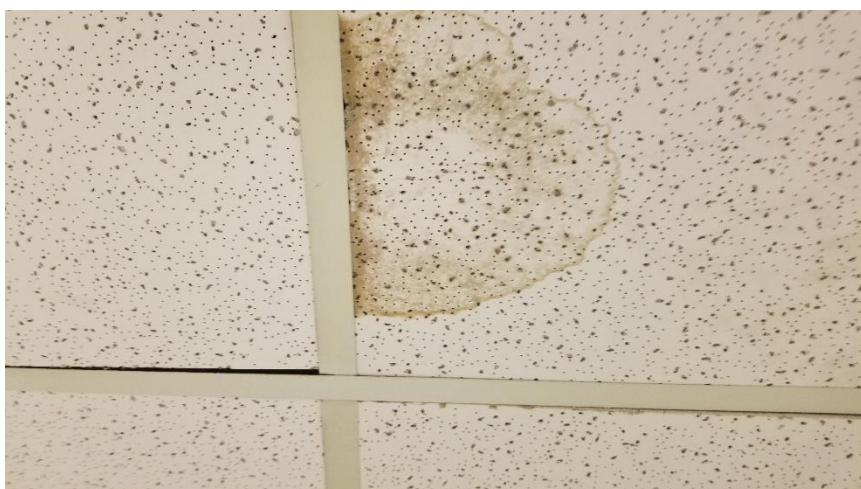
- ACM Caulking materials (Tan and Grey) were observed to be in Good and Fair Condition in select areas of the subject building.
- Water damaged materials were observed in room 039B in the subject building.

**Photo 13:** View of water damaged suspended ceiling tile observed in Room 039B.
