HAZARDOUS MATERIALS SURVEY AND 2023 REASSESSMENT MORISSET HALL, 65 UNIVERSITY PRIVATE, OTTAWA, ON

Project No.: Z1920014HZ / CCC-230252-00

Re: Morisset Hall, University of Ottawa - 65 University Private
Hazardous Materials Survey and 2023 Reassessment
McIntosh Perry Limited Reference No. Z1920014HZ / CCC-230252-00

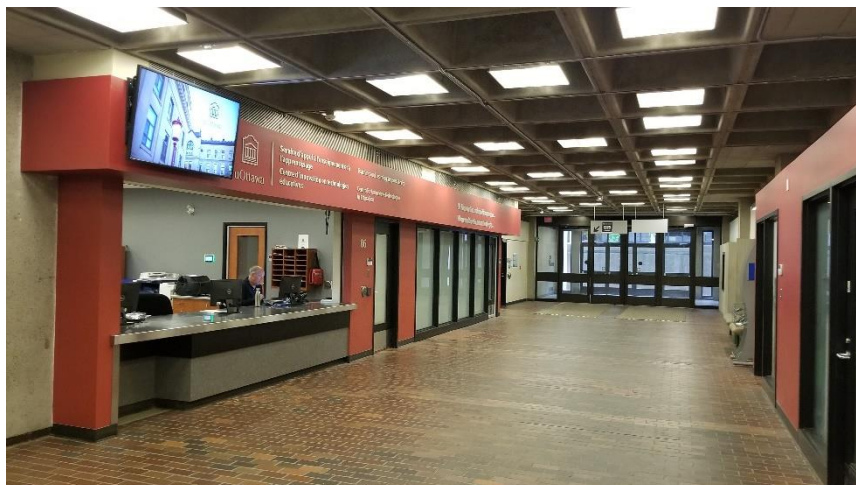
Photo 1: Representative view of the finishes observed throughout Room 02.

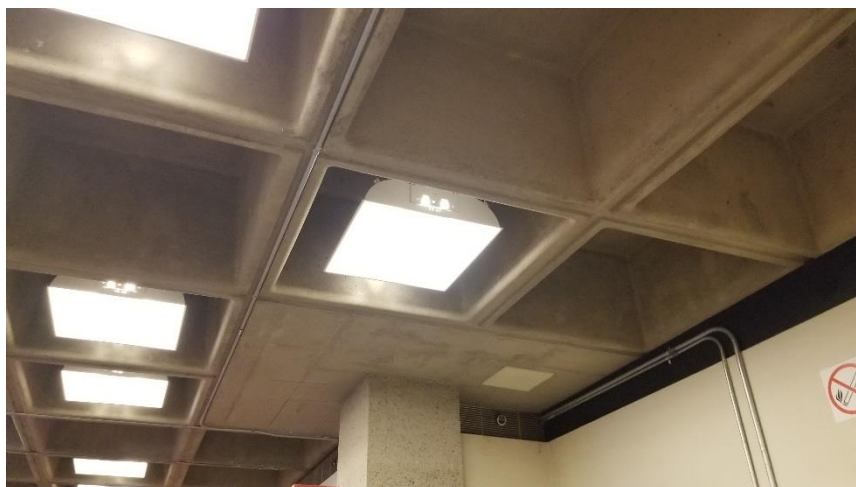
Photo 2: Representative view of the concrete ceilings observed throughout the 0 Level.

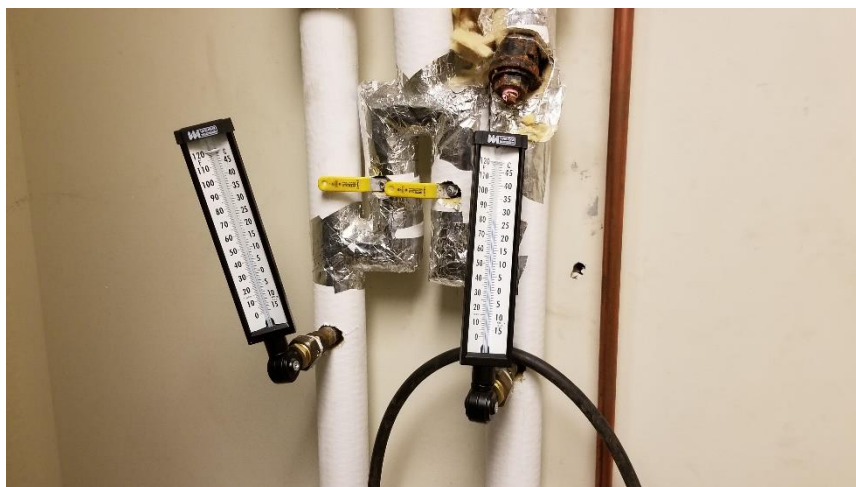
Photo 3: Representative view of the pressure gauges containing liquid mercury observed in Room 038E.

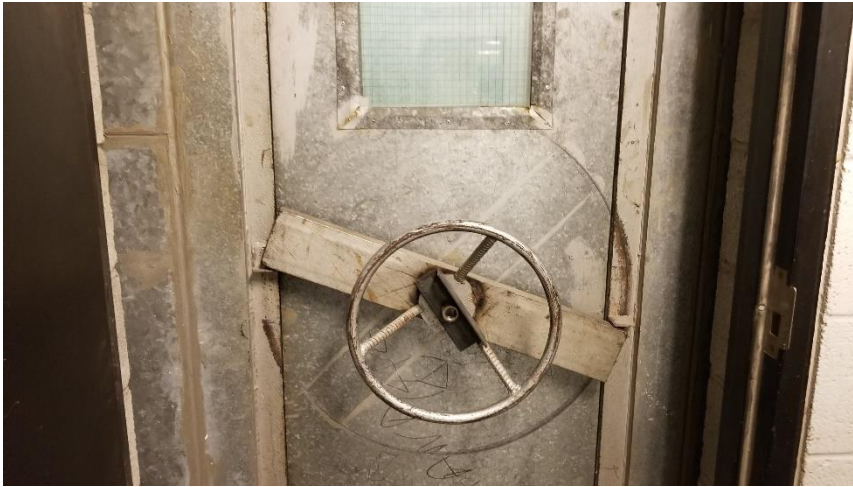
Photo 4: Representative view of the AHU unit doors, with non-asbestos containing thermal insulation in Room 0042.

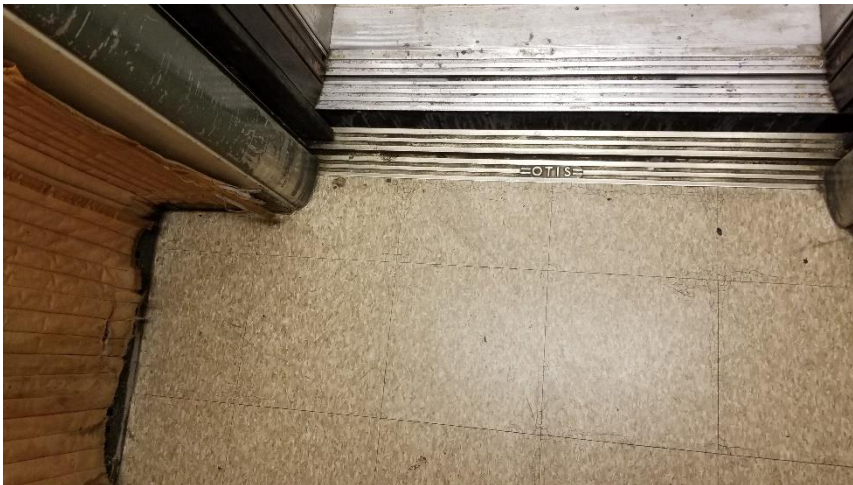
- Vinyl floor tiles (12"x12"- Brown w/ White Spots) were observed and previously sampled in Room 007D. The laboratory analytical results of the samples collected indicated that this material does not contain asbestos. The associated mastic (Black) was also determined not to contain asbestos.

Photo 5: View of the non-asbestos vinyl floor tiles (12"x12"- Brown w/ White Spots) were observed and sampled in Room 007D.

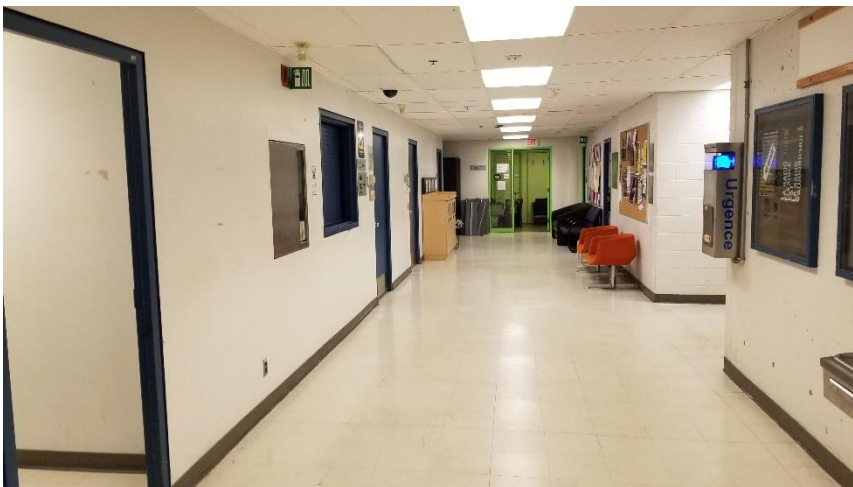
Photo 6: Representative view of Room 001, containing asbestos vinyl floor tiles (12"x12" – White w/ Brown Flakes).

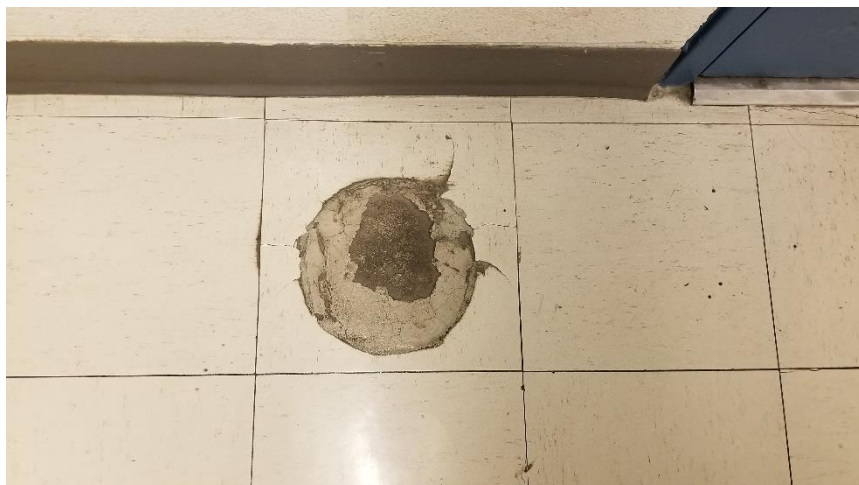
- ACM Vinyl Floor Tiles was observed to be in Good Condition in various locations throughout the facility except for rooms 001 which was found to be in Poor condition within the subject building.

Photo 7: Previously identified vinyl floor tiles (12"x12" – White w/ Brown Flakes) observed in poor condition in Room 001.

- Asbestos-containing materials identified to be in poor condition must be repaired/removed immediately, following Type 1/2/3 asbestos abatement work procedures as detailed in O. Reg. 278/05 and disposed of as asbestos waste under O. Reg. 347;

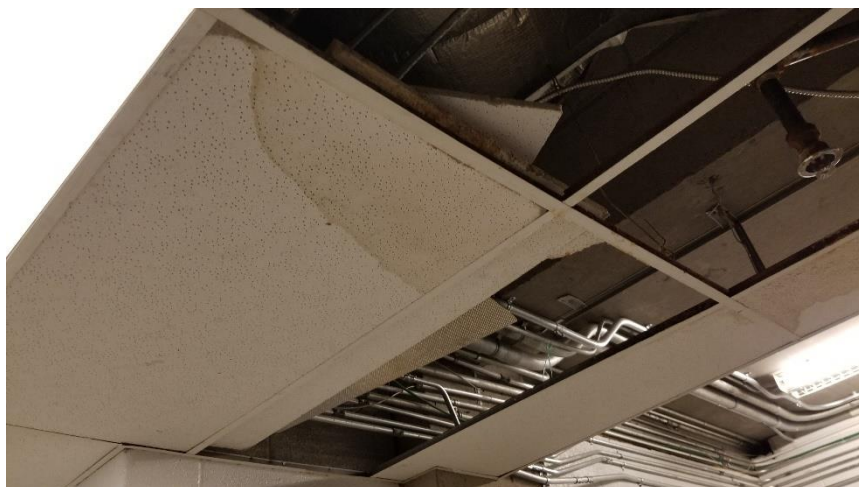
- Suspended ceiling tiles (2'x4' – Pinholes w/ Large Fissures) were observed in Room 001A. The date stamp on the back of these tiles indicated that they were manufactured in 1995 and therefore, this material is not considered to contain asbestos.

Photo 8: View of the suspended ceiling tiles (2'x4' – Pinholes w/ Large Fissures) observed to be manufactured in 1996 in Room 001A. Water staining was observed on select tiles.

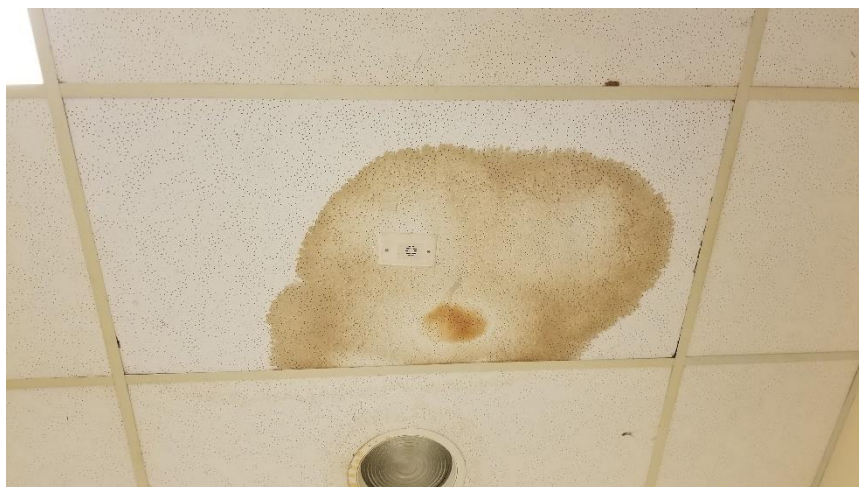
Photo 9: View of the water damaged asbestos-containing ceiling tile observed in Room 0021.

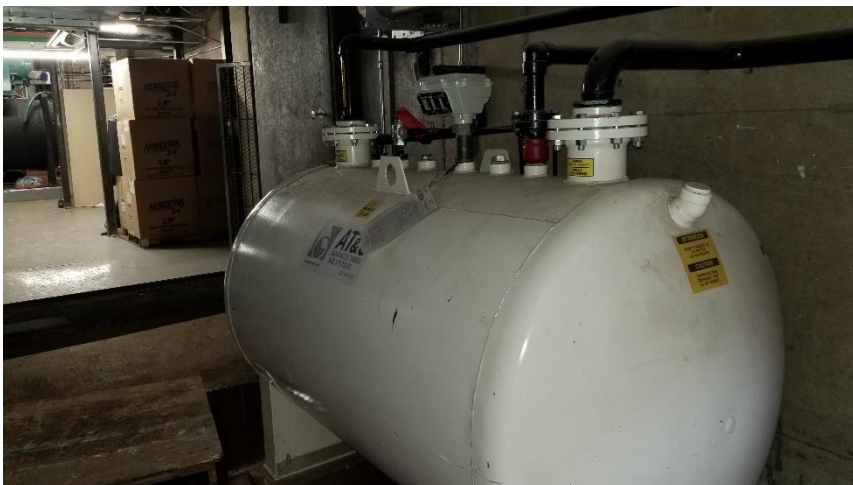
Photo 12: View of the above ground diesel tank observed in Room 0042D.

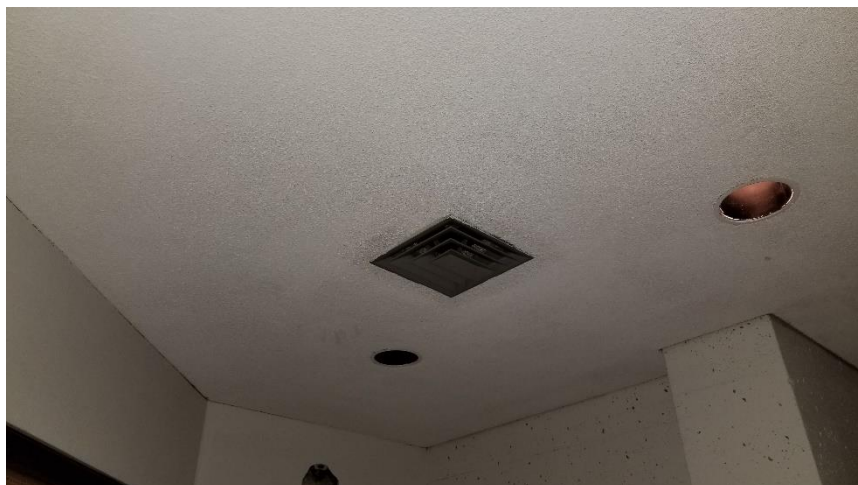
Ceiling texture coating was observed in Room 217 and 218A and previously sampled in Room 218C. This material **contains 10% Chrysotile asbestos** and is considered to be friable. This material was observed to be in good condition.

Photo 13: View of the asbestos-containing textured ceiling observed in good condition in Room 218A.

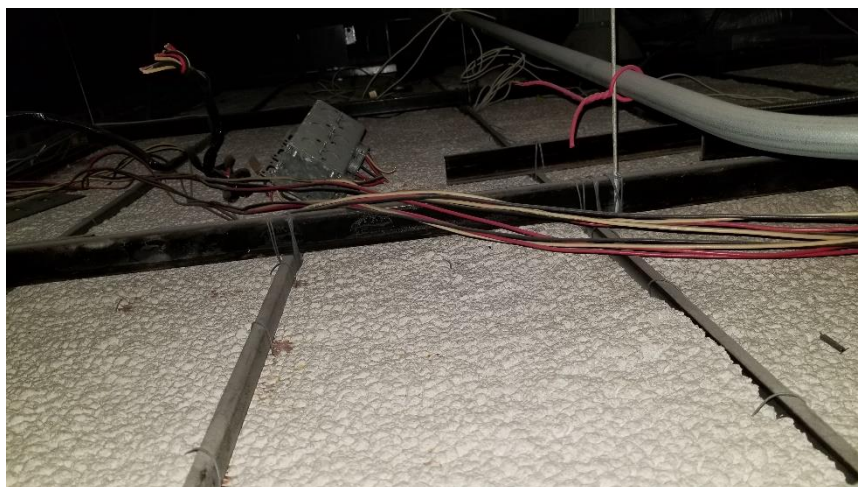
Photo 14: View of the ceiling space above the asbestos-containing ceiling plaster observed in Room 218.

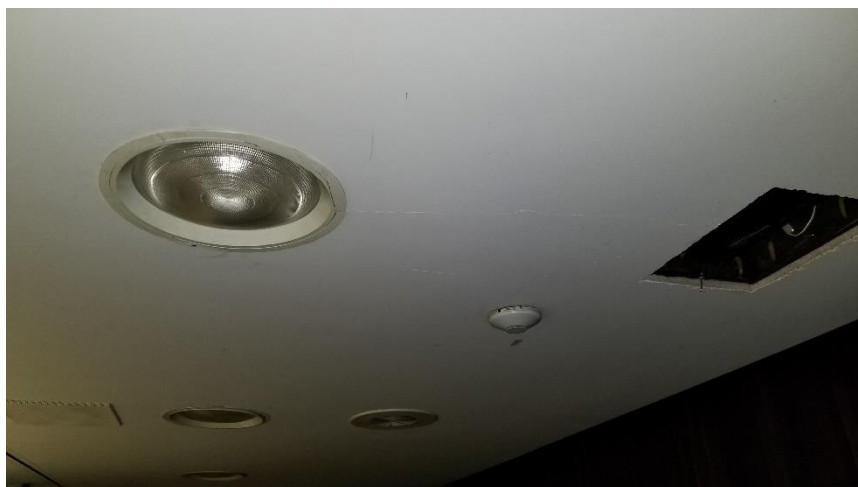
Ceiling plaster was observed throughout the second floor of the subject building and sampled in Room 218. The laboratory analytical results of the ceiling plaster samples previously collected indicated that this material **contains 1% Tremolite asbestos**.

Since plaster is a homogeneous material, all areas must be treated as asbestos-containing unless additional testing confirms otherwise. This material is considered to be friable and was observed in good condition with the exception of select areas which were observed in poor condition.

Photo 15: View of the asbestos-containing ceiling plaster observed in Room 218D, with poor condition areas.

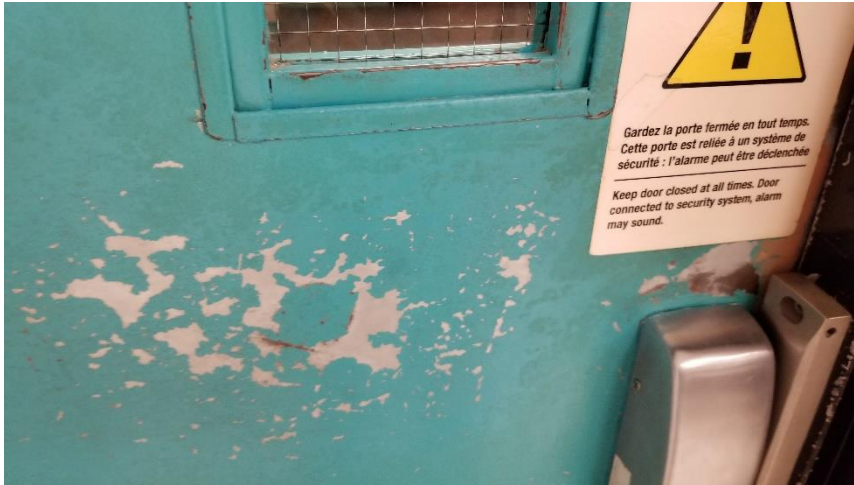
Photo 16: View of the lead containing blue door paint observed in poor condition in Room 217.

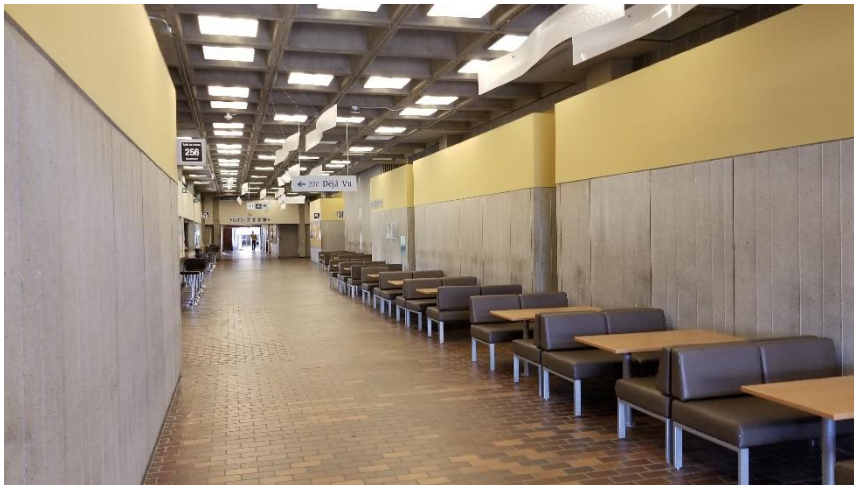
Photo 17: Representative view of the interior finishes observed throughout Room 202.

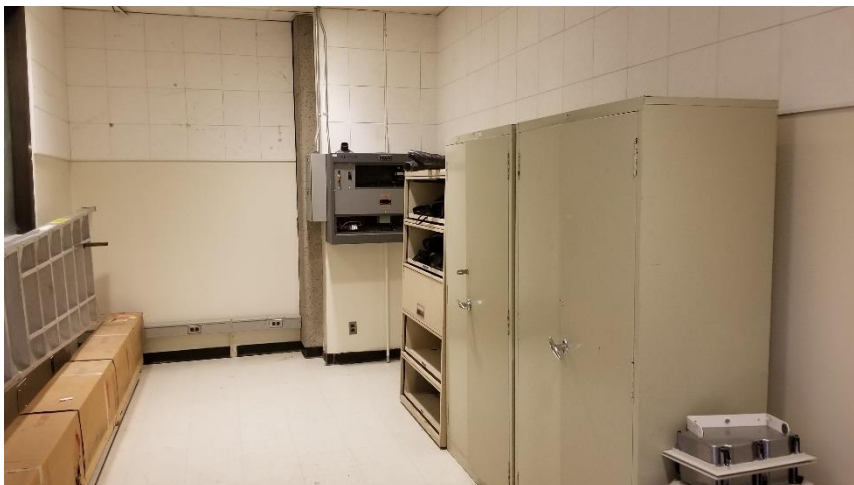
- Acoustic glue-on wall tiles (1'x1' w/ Uniform Holes) were observed and previously sampled in Room 220. The laboratory analytical results indicate that this material **contains 1% Amosite asbestos**. The associated mastic (Brown) was determined not to contain asbestos. Visually similar acoustic glue-on wall tiles (1'x1' w/ Uniform Holes) were observed and previously sampled in Room 255. This material **contains 5% Amosite and 2% Chrysotile asbestos**. This material was observed in good condition, with the exception of select areas that were observed in poor condition.

Photo 18: View of the asbestos-containing glue-on acoustic walls tiles observed in good condition in Room 255.

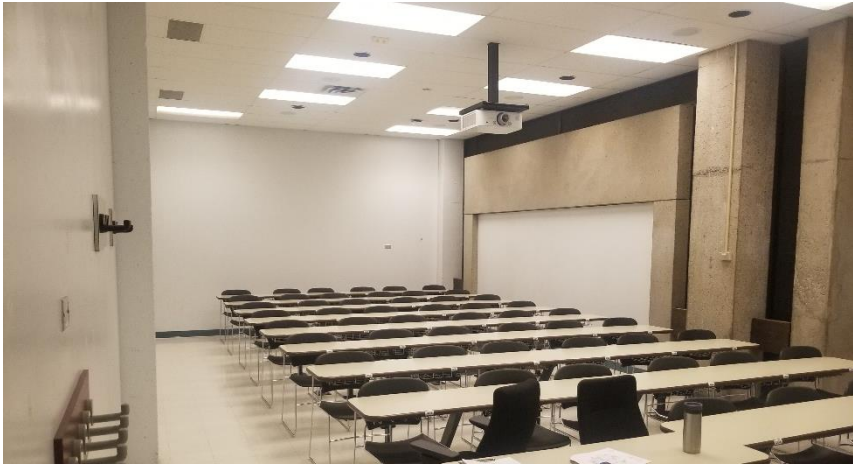
Photo 19: Representative view of classroom finishes observed throughout Level 2.

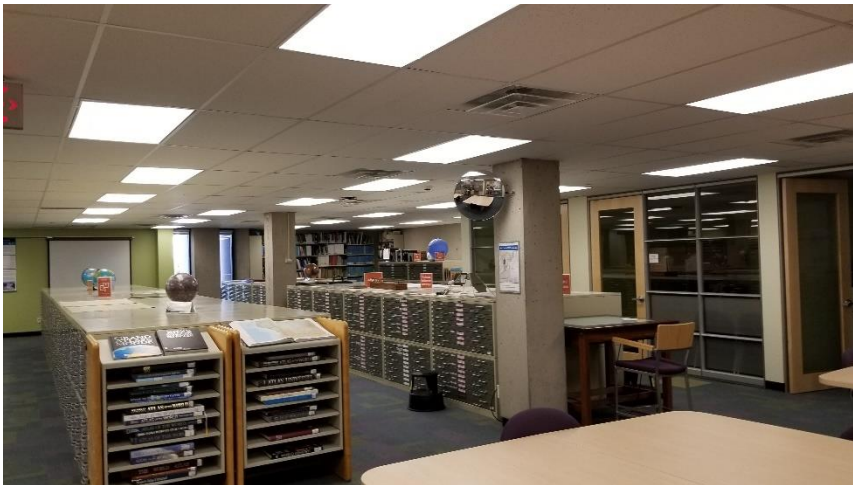
Photo 20: Representative view of the finishes observed throughout Level 3 library area.

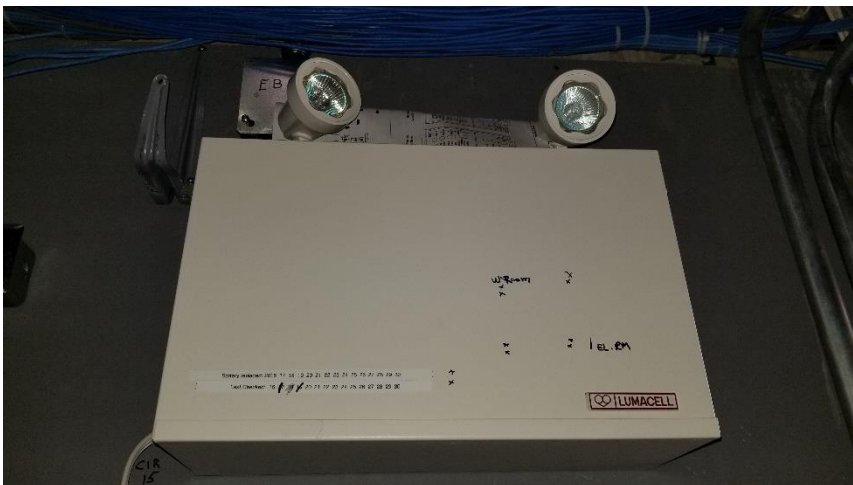
Photo 21: Representative view of the emergency lights containing lead batteries observed in Room 306.

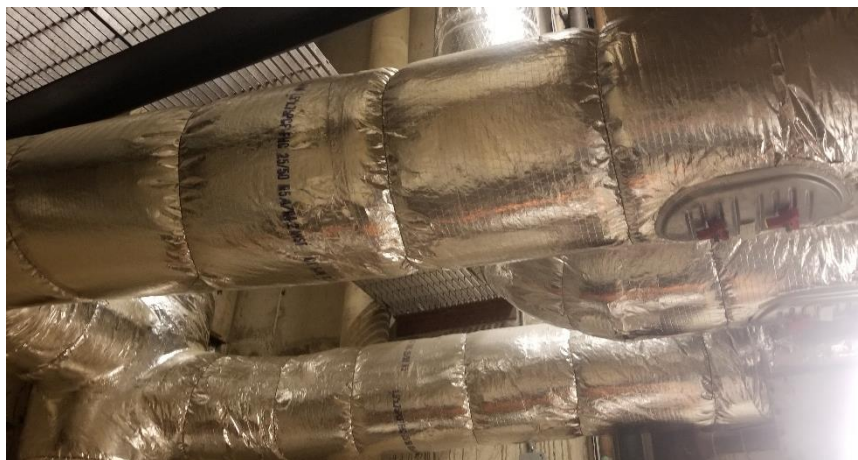
Mechanical pipe straight insulation was observed in Room 0042, 212, 402, 403, 431, 440, 400G, 503, 505, 506A, 509A, 510, 510A, 601A, 602, 608A, and 625A. MPL made several incisions throughout to investigate its composition, and it was visually identified as fiberglass, and therefore not suspected of containing asbestos.

Photo 22: Representative view of the fiberglass insulation observed in Room 431 and 431A.

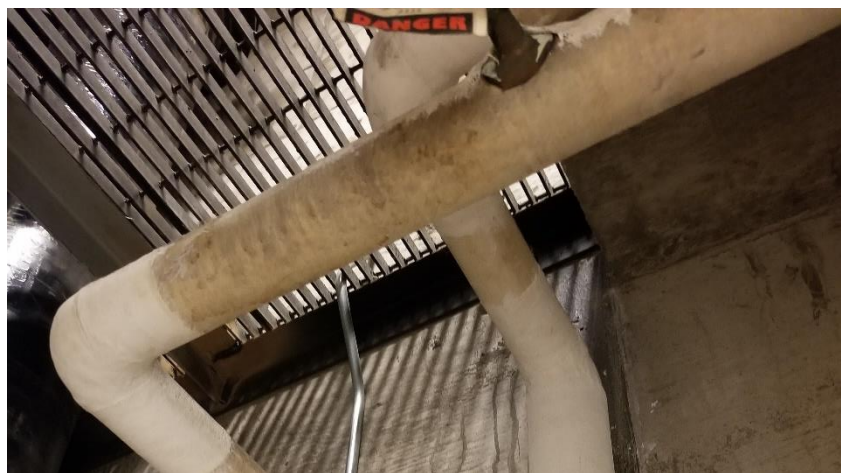
Photo 23: View of the asbestos-containing parging cement elbows observed in good condition in Room 506A.

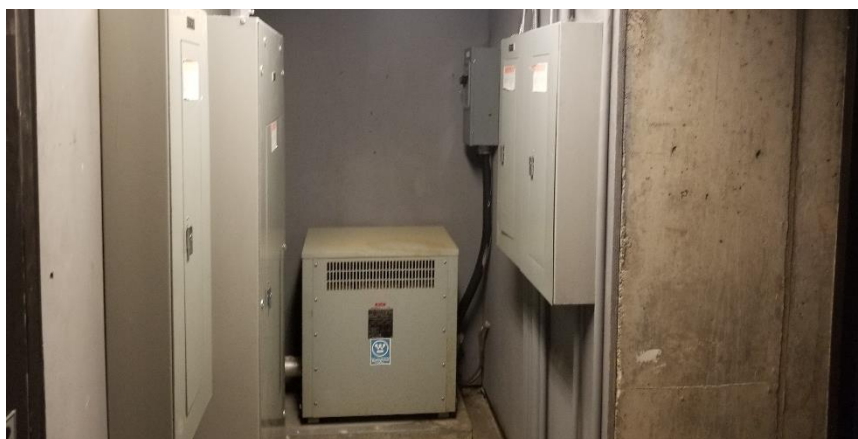
Photo 24: View of the dry-type Westinghouse transformers observed in Room 510.

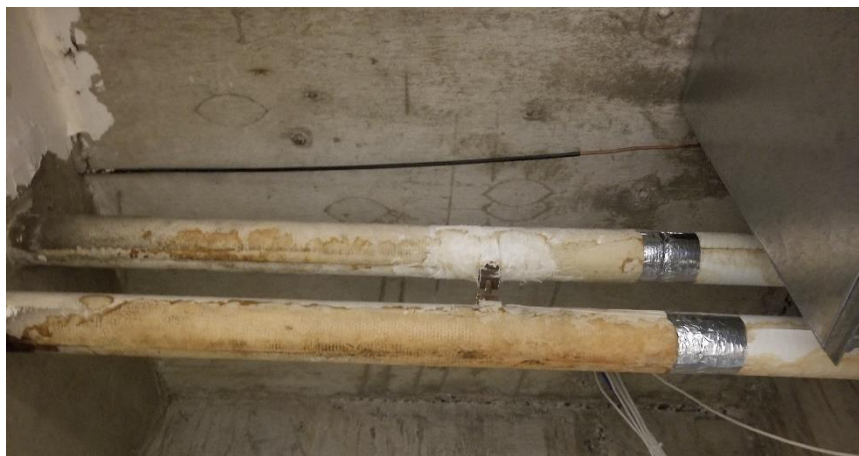
Photo 25: View of the water damaged fiberglass pipe straight insulation observed in Room 510A.

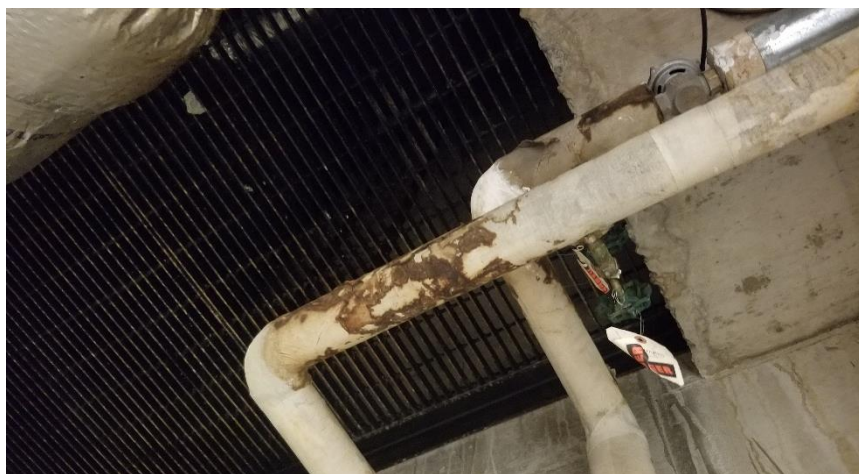
Photo 26: View of the water damaged asbestos-containing parging cement insulation observed in Room 510A.

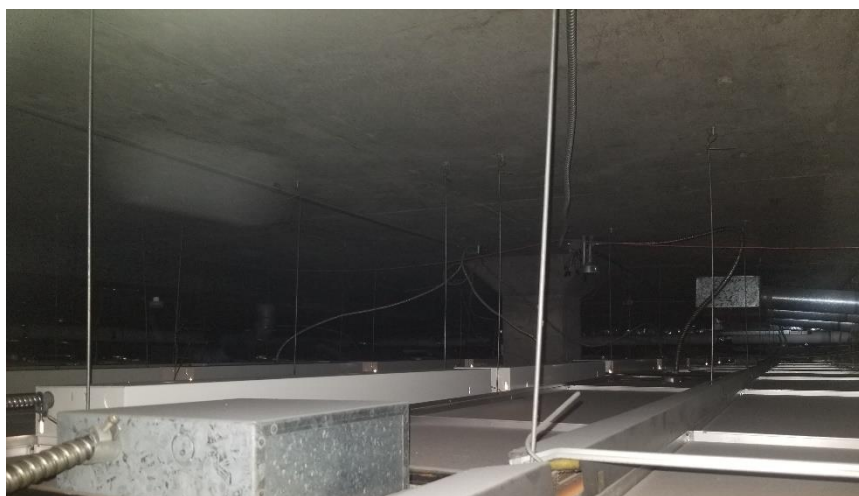
Photo 27: Representative view of the bare concrete ceiling finishes observed above suspended ceiling tiles in Room 600G.

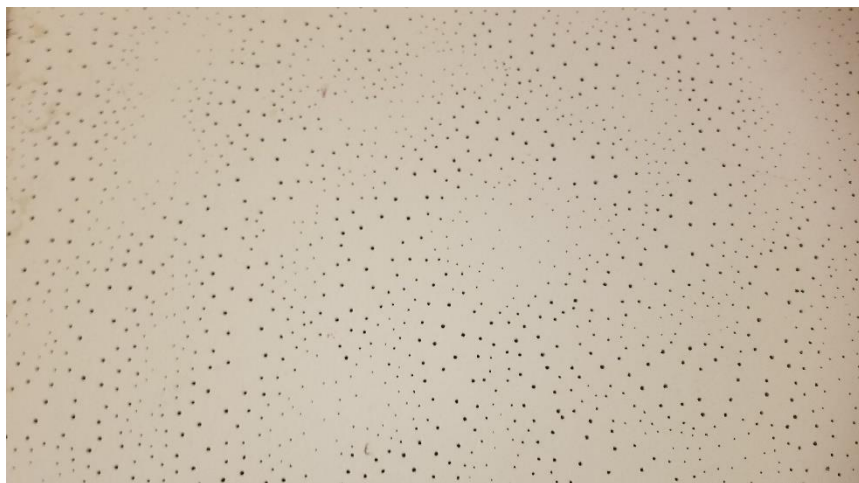
- Suspended ceiling tiles (2'x4' – Beige w/ Varying Pinholes) were observed and previously sampled in Room 600G. The laboratory analytical results of the samples collected in Room 600G indicate that this material contains **1% Chrysotile asbestos**. Visually similar ceiling tiles were observed in Rooms 621, 502A, 418, 400F, 312, 302, 256, 250, 255, 221, 220, 130, 050, 043, 005, 0014, 0015, 0017, 0021, 0021A, 0025A, 0034, 0034A, 0035, 0040. This material was observed in good condition with the exception of select areas which were observed in poor condition.

Photo 28: View of the asbestos-containing ceiling tiles (Beige w/ Varying Pinholes) observed and sampled in Room 600G.

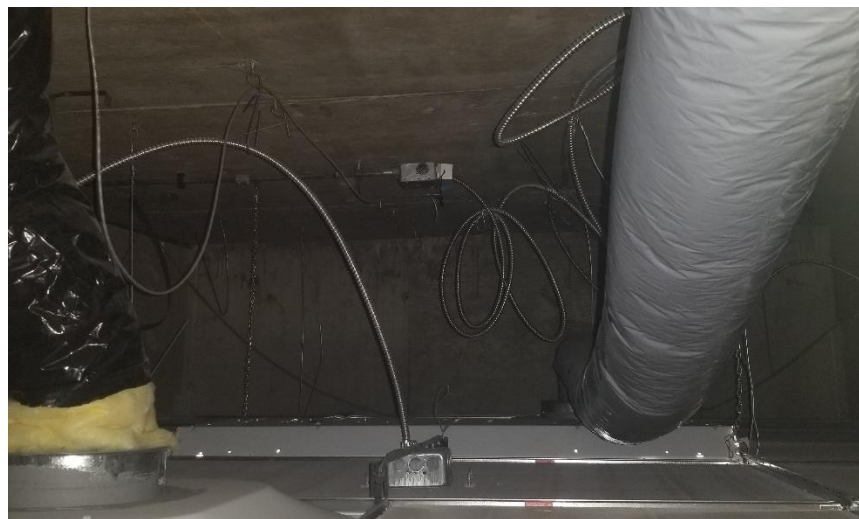
Photo 29: Representative view of the bare concrete ceiling finishes observed above suspended ceiling tiles in Room 602.

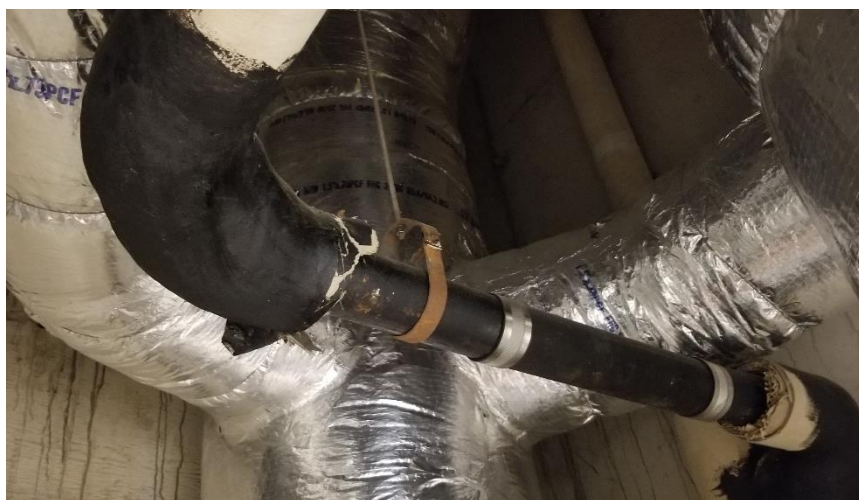
Photo 30: View of the poor condition asbestos-containing pipe straight insulation observed in Room 622A.

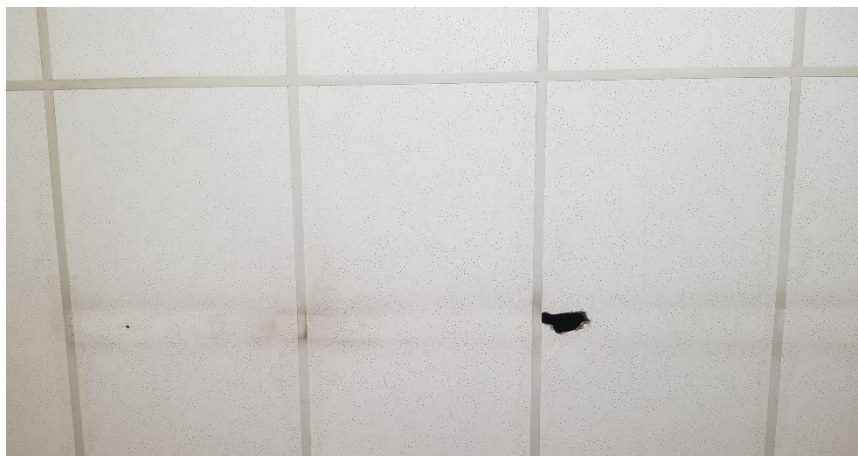
Photo 31: View of the asbestos-containing ceiling tiles (Beige w/ Varying Pinholes) observed with damages in Room 621.

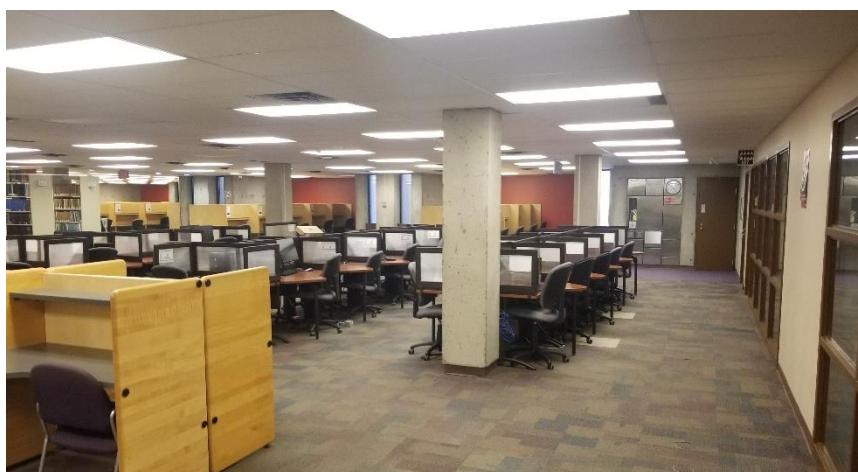
Photo 32: Representative view of the finishes observed throughout Level 6.

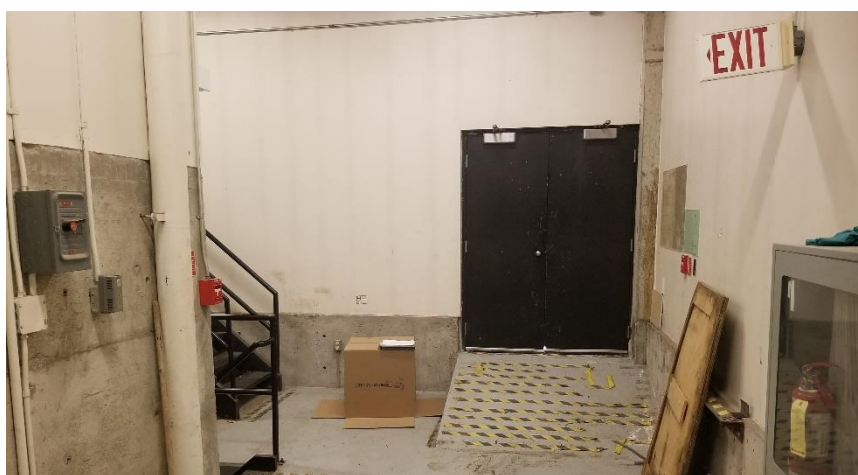
Photo 33: Representative view of the finishes observed in Room 703A.
