HAZARDOUS MATERIALS SURVEY AND 2023 REASSESSMENT

90 UNIVERSITY PRIVATE, OTTAWA, ON

Project No.: Z2021102HZ / CCC-230252-00

March 6, 2024

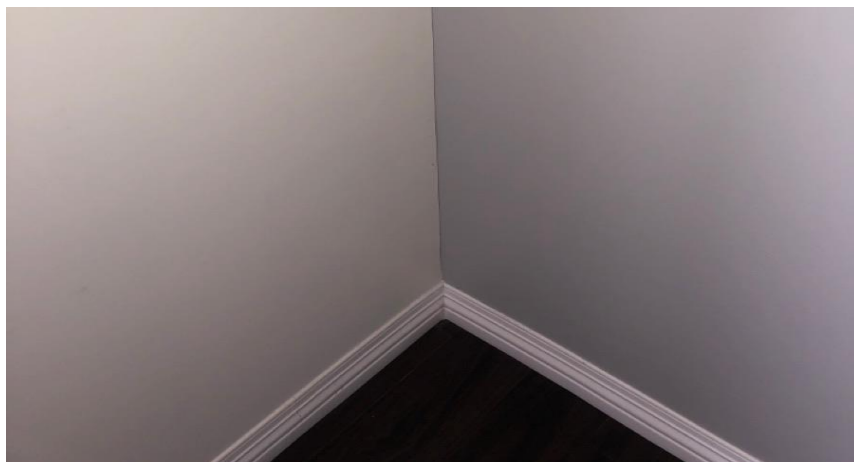
Photo 4: Typical view of light grey wall paint and white trim paint suspected of containing lead.

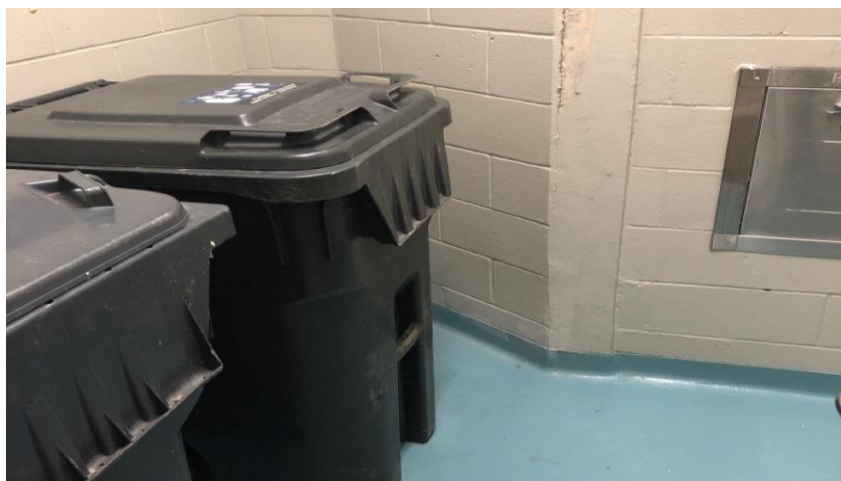
Photo 5: Typical view of teal floor paint and beige wall paint suspected of containing lead.

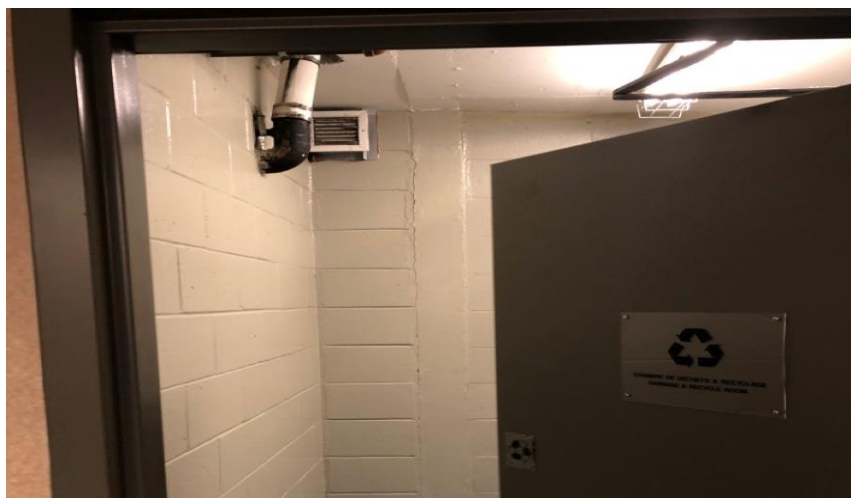
Photo 6: Typical view of light brown door and doorframe paint suspected of containing lead.
