# HAZARDOUS MATERIALS SURVEY AND 2023 REASSESSMENT ROGER GUINDON HALL, OTTAWA, ON

Project No.: Z1920014HZ / CCC-230252-00

Date: March 6, 2023

Re: Roger Guindon Hall, University of Ottawa - 451 Smyth Road  
Hazardous Materials Survey and 2023 Reassessment  
McIntosh Perry Limited Reference No. Z1920014HZ / CCC-230252-00

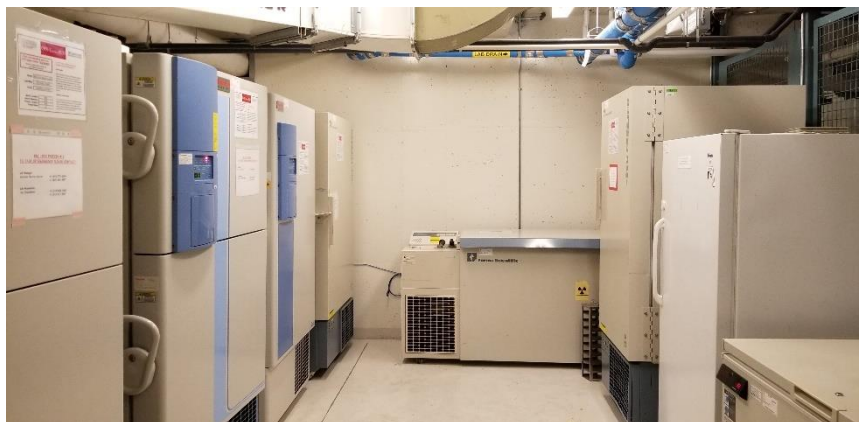
**Photo 1:** Representative view of refrigeration equipment observed in Room 0509, containing various ozone depleting substances.

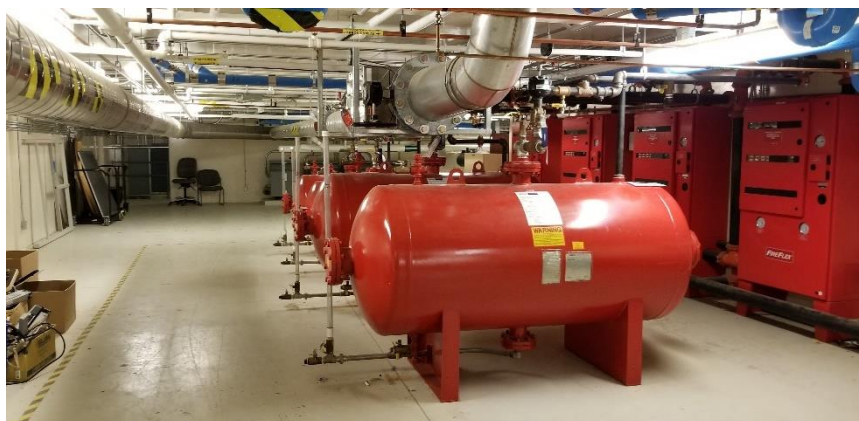
**Photo 2:** Representative view of the above ground foam tanks observed in Room 0507.

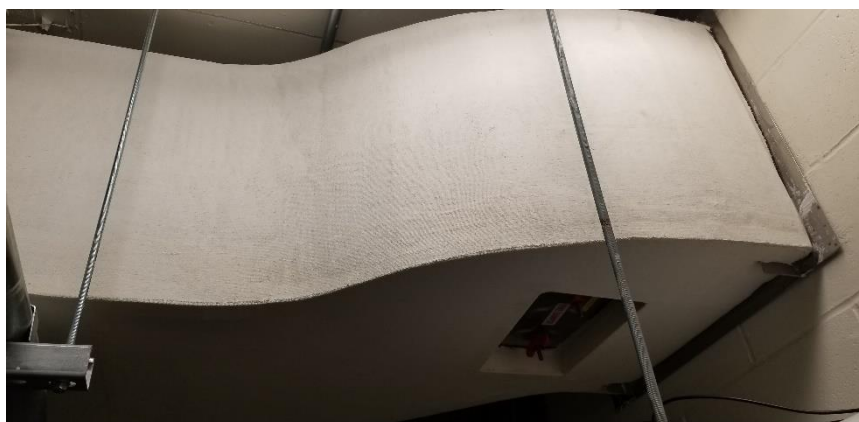
**Photo 3:** Representative view of the fiberglass insulation observed on HVAC ducts in Room 0515.

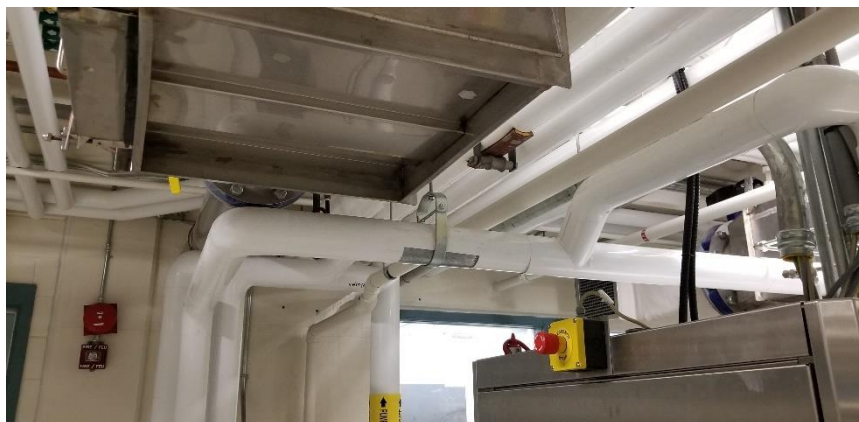
**Photo 4:** Representative view of the fiberglass insulation observed in Room 0516A/B.

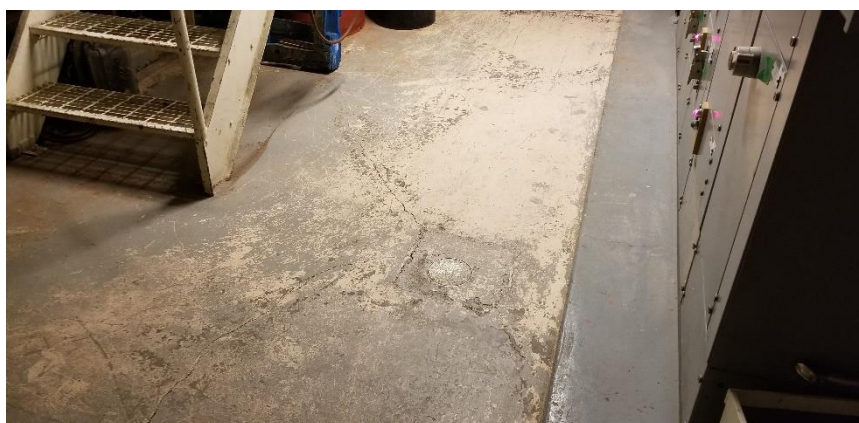
**Photo 5:** View of the poor condition lead floor paint (Grey) observed in Room 1138.

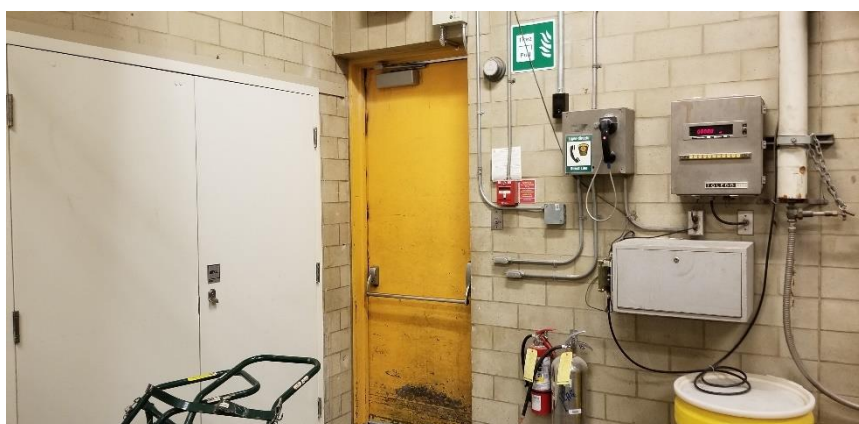
**Photo 6:** Representative view of the yellow lead paint observed in poor condition in Room 1129.

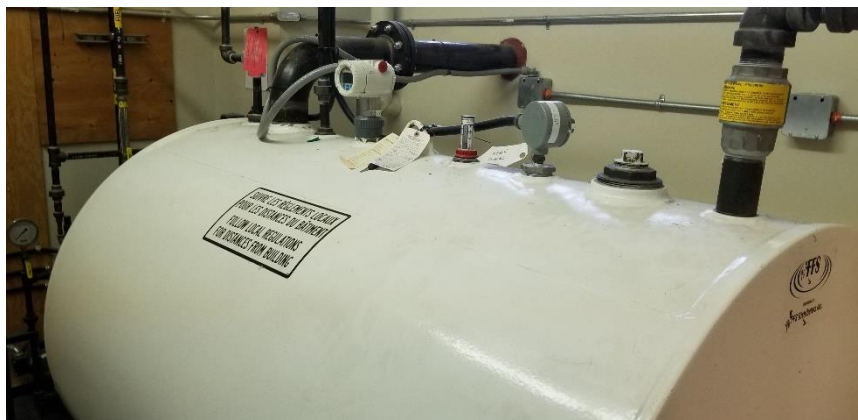
**Photo 7:** View of the above ground diesel storage tank observed in Room 1129C.

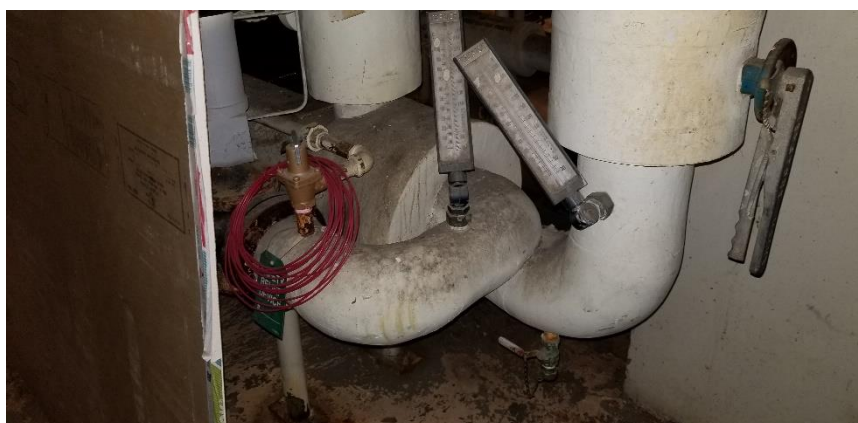
- Pipe elbow/fitting parging cement (Supply Line) was observed and previously sampled from Room 1138. The laboratory analytical results of the mechanical pipe elbow/fitting insulation samples collected indicated that this material does not contain asbestos.

**Photo 8:** Representative view of the non-asbestos pipe elbow/fitting insulation observed in Room 1138.

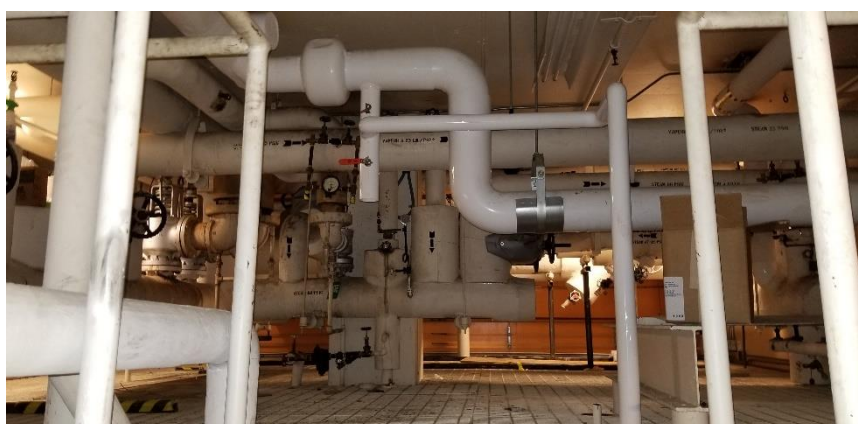
**Photo 9:** Representative view of the fiberglass insulation observed in Room 1138.

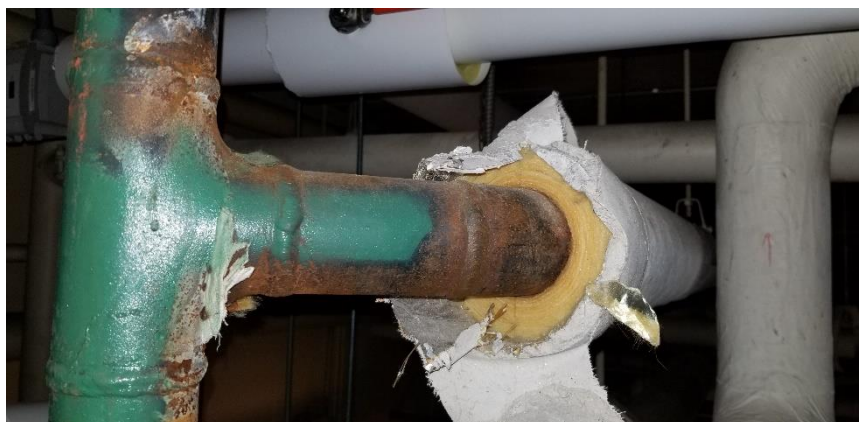
**Photo 10:** Representative view of the fiberglass insulation observed in Room 1138.

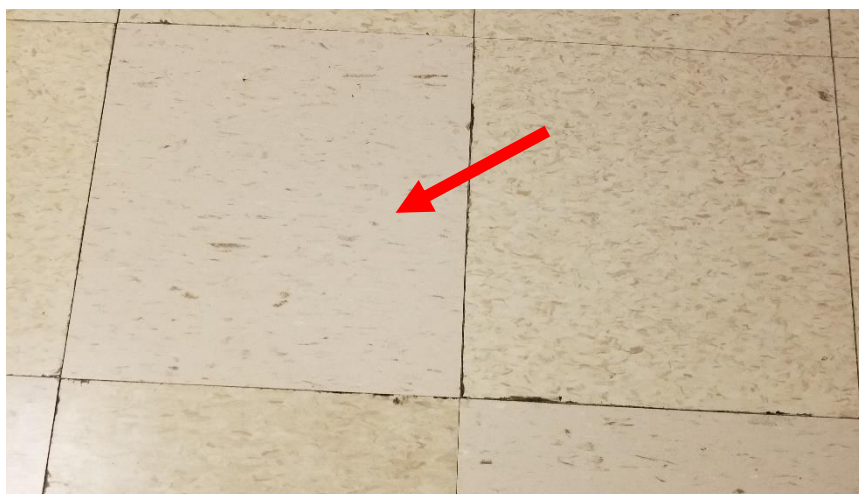
- Previously identified vinyl floor tiles (12"x12" Beige w/ Grey Flakes) were observed in Rooms 1114, 1121, 1300, 1304, 1306, 1310, 1319, 1321, 1102B, 1136A, 1136B, 1136E, 1300A, 1326F, 1210, 2108, 2200, 2205, 2209, 2217, 2218, 2219, 2216, 2231, 2232, 2233, 2234, 2237, 2242, 2246, 2247, 2005A, 2007, 2008, 2009, 2012, 2043A, 2048, 2048A, 2052, 2053, 2054, 2055, 2103A, 2103A1, 2108A, 2219B, 2242A, 2242B, 2049A, 3108, 3112, 3113, 3116, 3117, 3127, 3128, 3129, 3130, 3131, 3132, 3135, 3136, 3137, 3138, 3139, 3145, 3148, 3149, 3150, 3152, 3153, 3154, 3155, 3156, 3157, 3158, 3159, 3163, 3164, 3165, 3167, 3201, 3202, 3205, 3213, 3211H, 3217, 3218, 3224, 3228, 3230, 3232, 3242, 3248, 3004B, 3131A, 3165A, 3200E, 3202C, 3202D, 3248A, 3248B, 3252, 4105, 4107, 4109, 4114, 4115, 4116, 4125, 4127, 4129, , 4150, 4151, 4152, 4156, 4158, 4159, 4160, 4161, 4162, 4164, 4168, 4176, 4200B, 4203, 4207, 4211, 4216, 4223, 4230, 4231, 4233, 4235, 4246, 4250, 4252, 4253, 4255, 4264, 4107A, 4211A, and 4217. The laboratory analytical results of the vinyl floor tile samples collected indicate that this material **contains 7.2% Chrysotile asbestos**. MPL previously collected samples of visually similar vinyl floor tiles (12"x12" – Beige w/ Grey Flakes) were observed and sampled in Room 1136A. The laboratory analytical results of the samples collected indicated that this material **contains 1% Chrysotile asbestos**. This material is considered to be non-friable and material was observed to be in good condition, with the exception of select areas which were observed in fair condition. **Previously identified poor condition locations were observed to have been repaired during the 2022 Reassessment.**

**Photo 11:** Representative view of the asbestos containing VFT (12"x12" Beige w/ Grey Flakes) observed throughout the subject building.

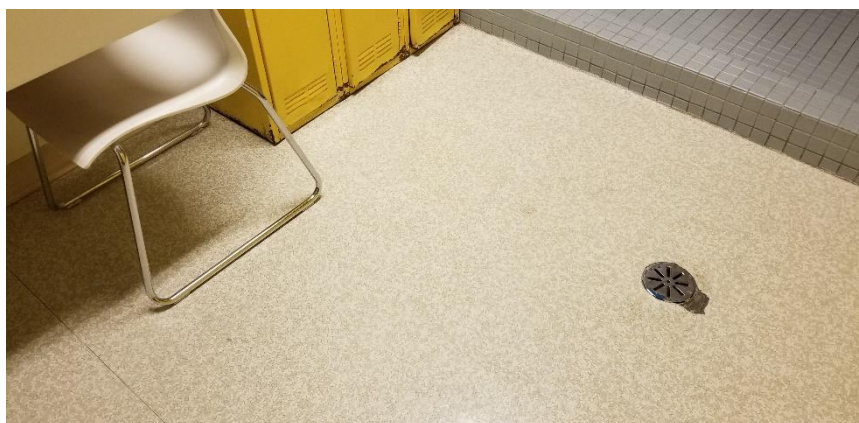
**Photo 12:** View of the non-asbestos vinyl sheet flooring (Beige Geometric Pattern) observed and sampled in Room 1113.

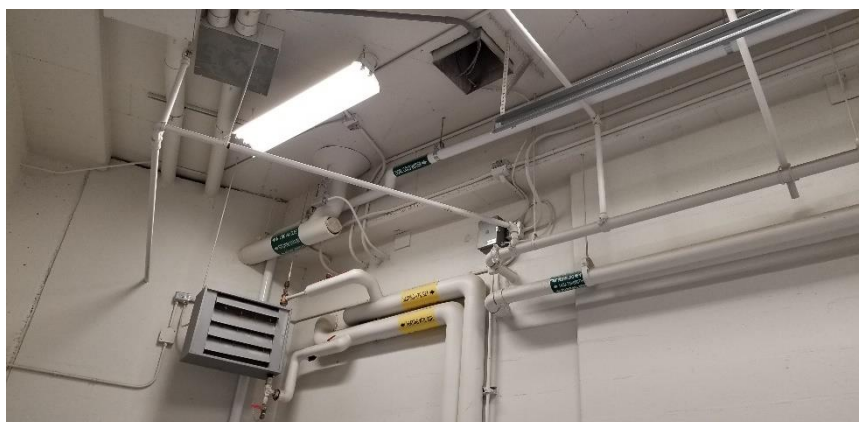
**Photo 15:** Representative view of the fiberglass insulation observed in Room 1506.

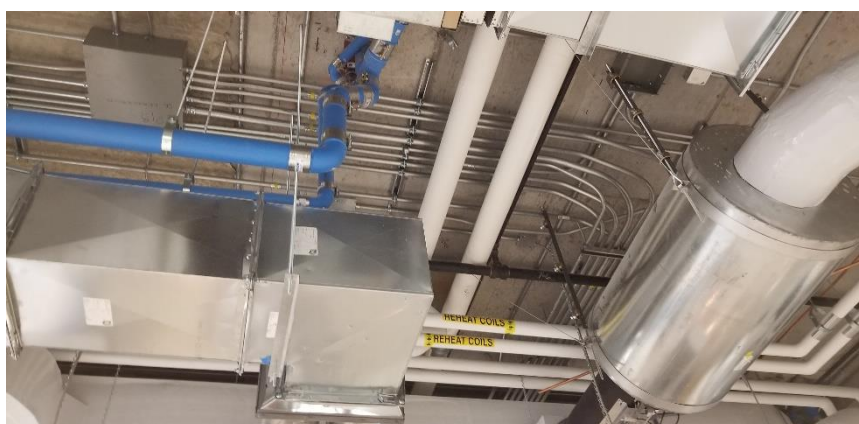
**Photo 18:** Representative view of the fiberglass insulation observed in Room 1500J.

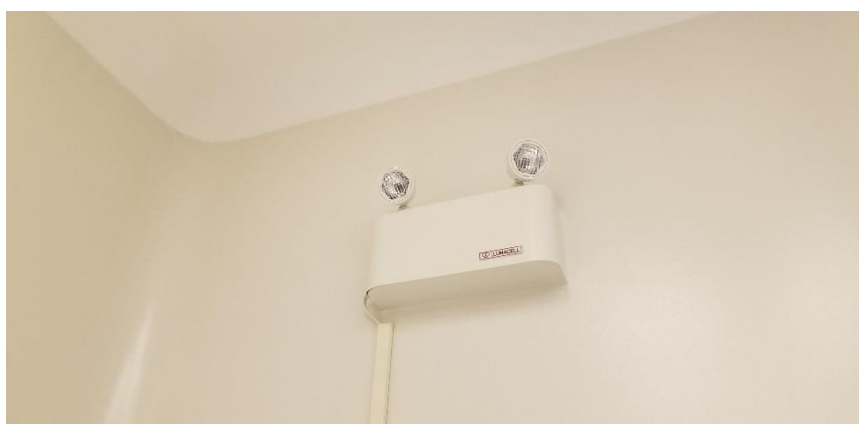
**Photo 21:** Representative view of the lead battery packs observed in Rooms 1326A & 1326C.

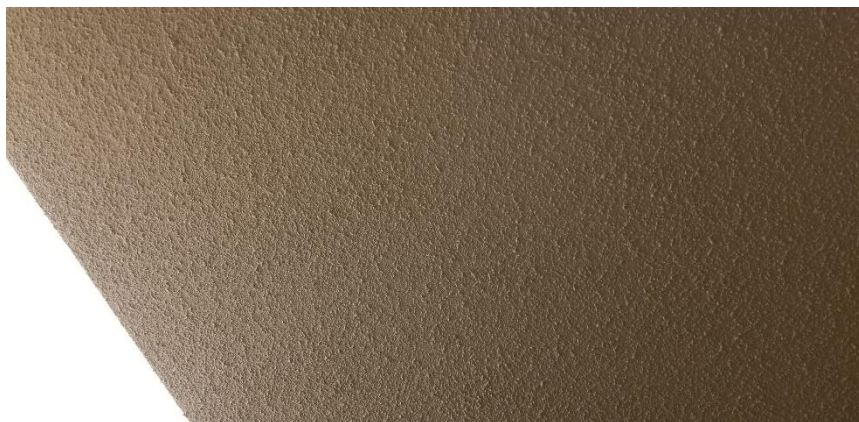
**Photo 25:** View of the non-asbestos containing ceiling texture coat observed in Room 2213B.

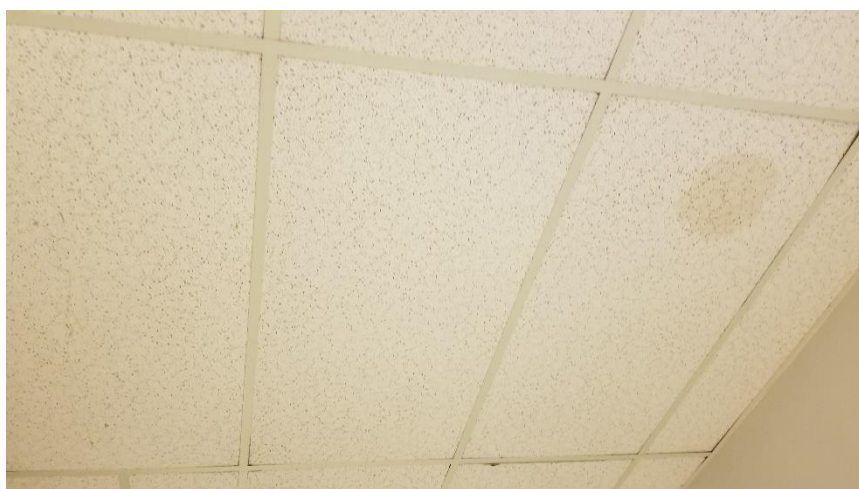
**Photo 26:** Representative view of water damaged ceiling tiles observed throughout the subject building.

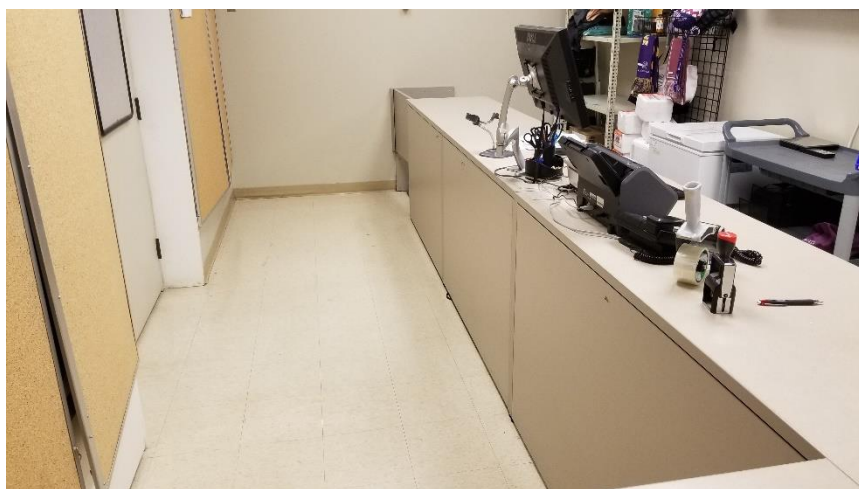
**Photo 27:** View of the non-asbestos VFT (12"x12" Beige w/ Brown Flakes) observed in Room 1129A.

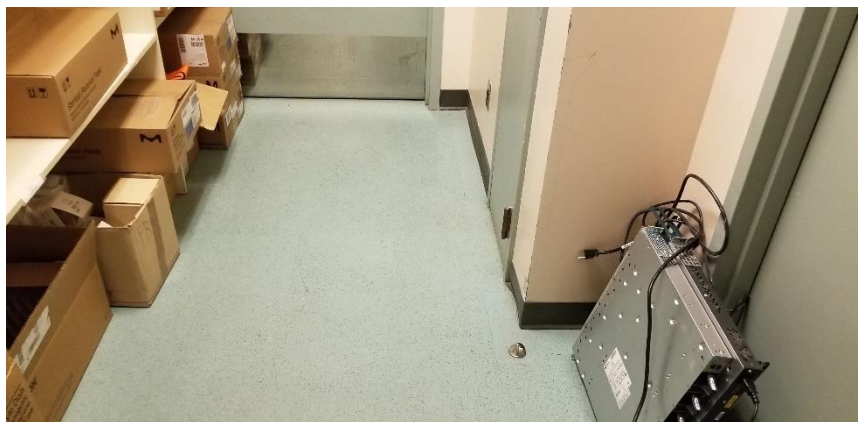
**Photo 28:** View of the non-asbestos VFT (12"x12" - Blue w/ Black Dots ) observed in Room 2482.

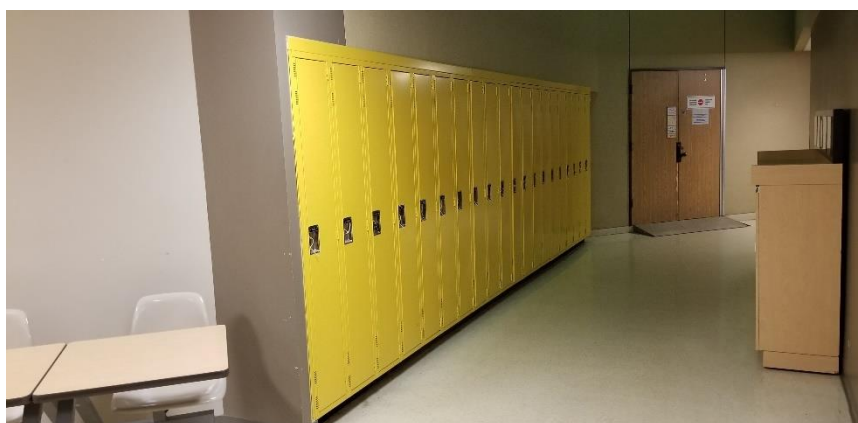
**Photo 29:** Representative view of the yellow lead paint observed on lockers throughout the subject building.

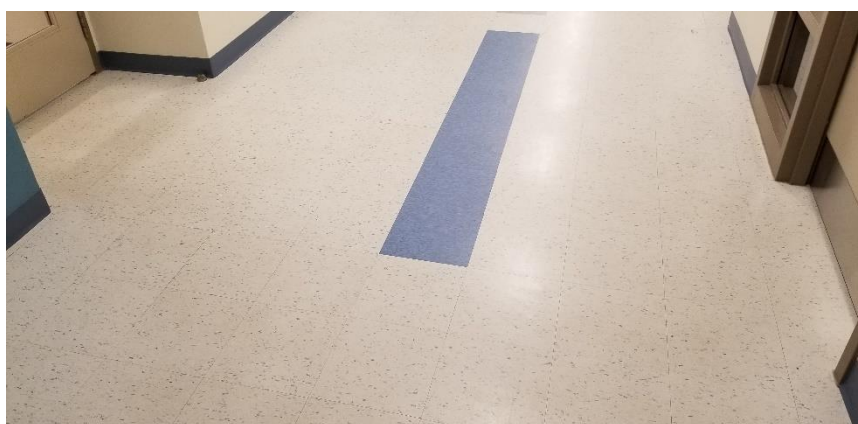
**Photo 30:** View of the non-asbestos containing vinyl floor tiles observed throughout the subject building.

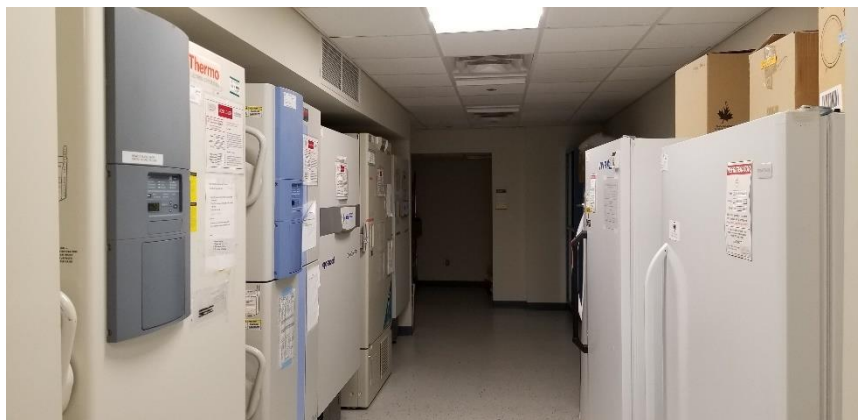
**Photo 31:** Representative view of the equipment observed throughout the third floor, containing ozone depleting substances.

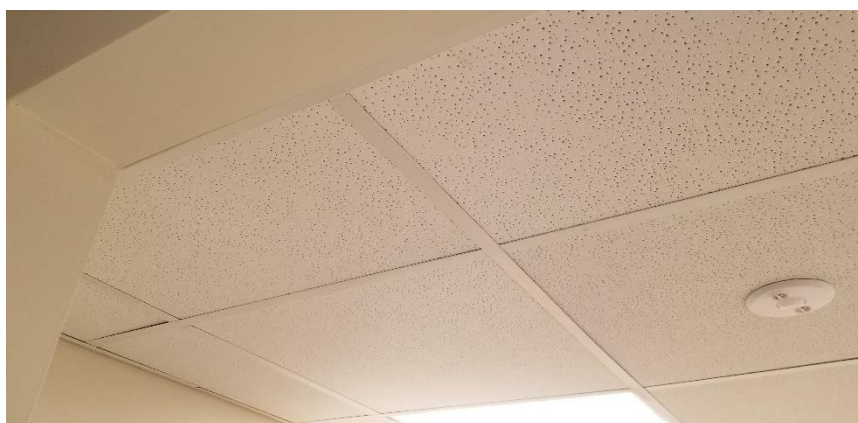
- Suspended ceiling tiles (2'x4' – Mixed Pinholes) were observed in Room 3105T. The date stamp on the back of these tiles indicated that they were manufactured in 2017 and therefore, this material is not considered to contain asbestos.

**Photo 32:** View of the non-asbestos containing ceiling tiles (2'x4' Mixed Pinholes) observed in 3105T and manufactured in 2016 and 2017.

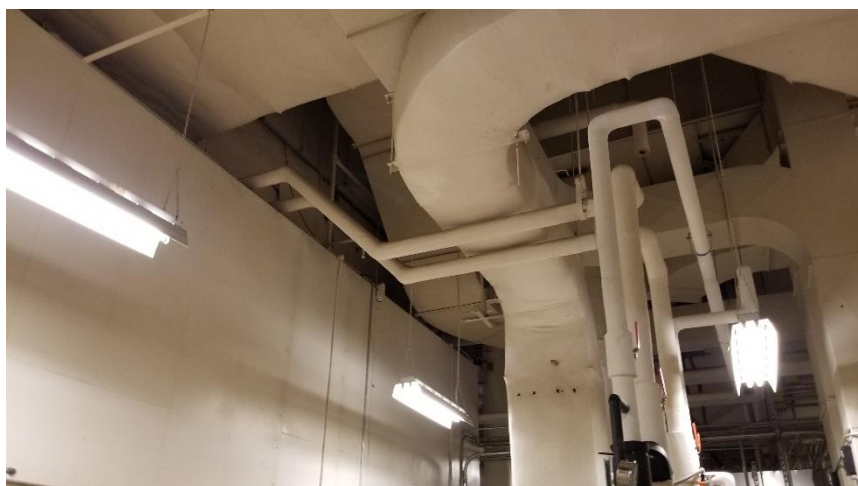
**Photo 33:** Representative view of the fiberglass mechanical insulation observed in Room 3003B.

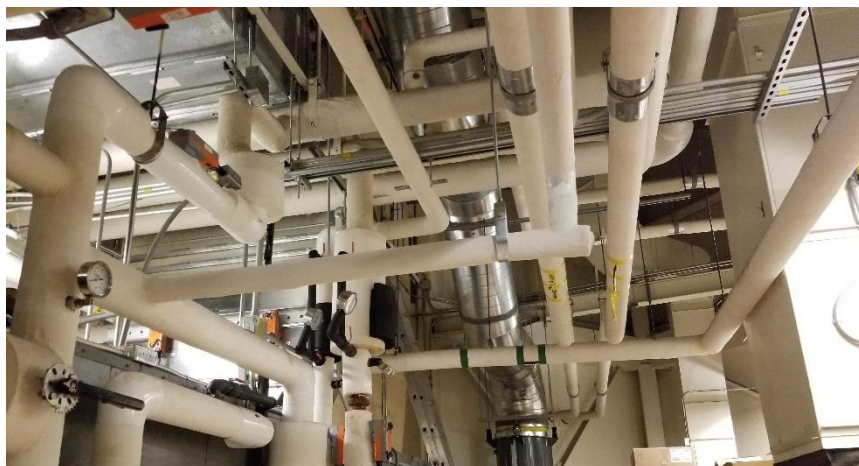
**Photo 34:** Representative view of the fiberglass mechanical insulation observed in Room 3003B.

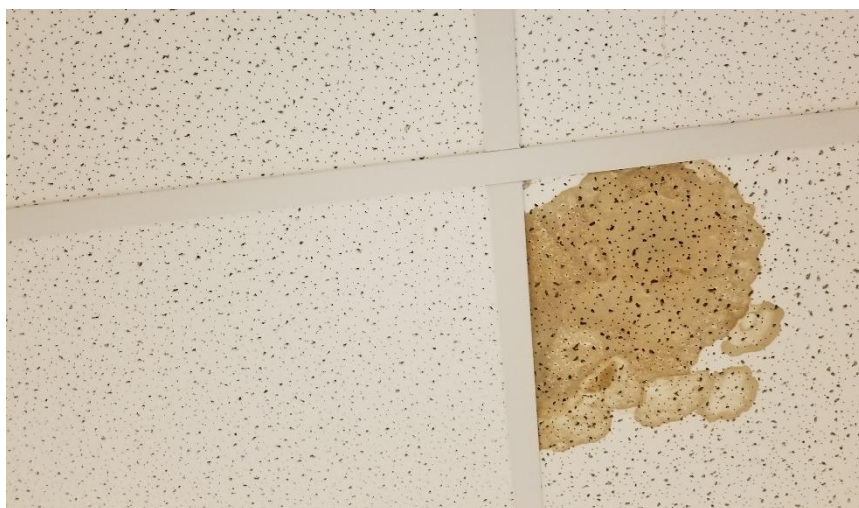
**Photo 35:** Representative view of water damaged ceiling tiles observed throughout the subject building.

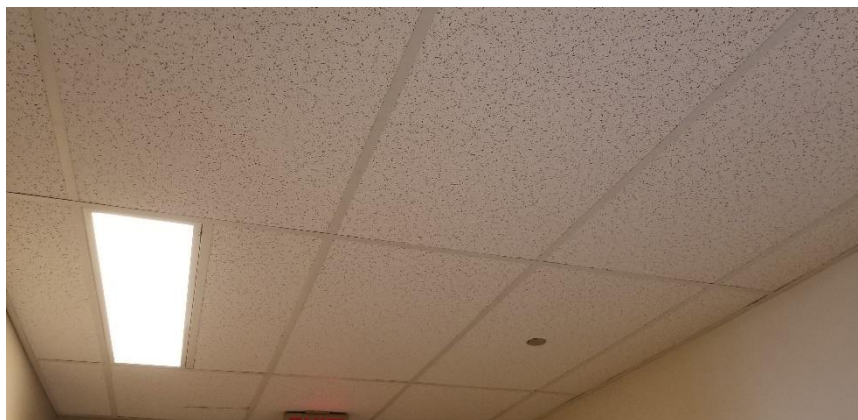
- Suspended ceiling tiles (2'x4' – Pinholes & Small Fissures) were observed in Room 4200A. The date stamp on the back of these tiles indicated that they were manufactured in 2013 and therefore, this material is not considered to contain asbestos.

**Photo 37:** View of the non-asbestos ceiling tiles (2'x4' – Pinholes & Small Fissures) observed in Room 4200A.

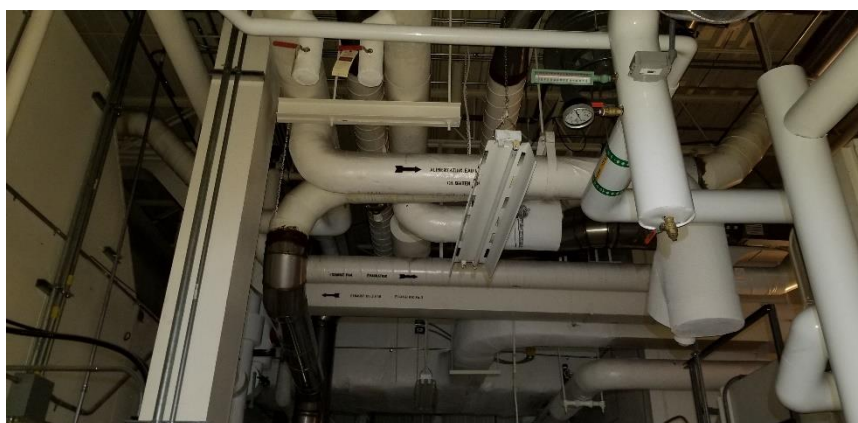
- Pipe elbow/fitting parging cement was observed and previously sampled from Rooms 5004 and 5002. The laboratory analytical results of the mechanical pipe elbow/fitting insulation samples collected indicated that this material does not contain asbestos.

**Photo 38:** Representative view of the fiberglass mechanical insulation observed in Room 5004.

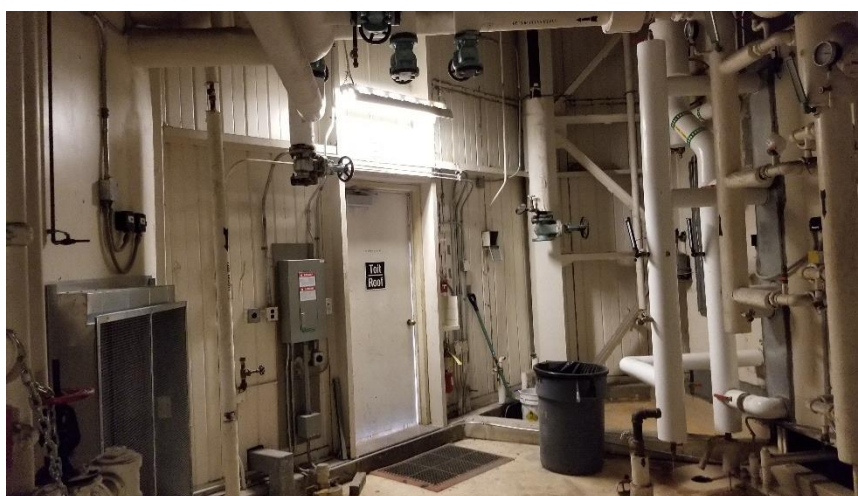
**Photo 39:** Representative view of the fiberglass mechanical insulation observed in Room 5004.

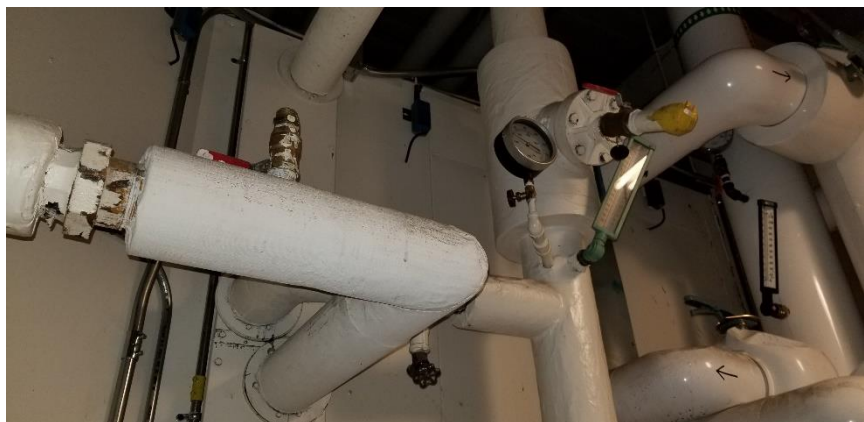
**Photo 40:** Representative view of the fiberglass mechanical insulation observed in Room 5002.

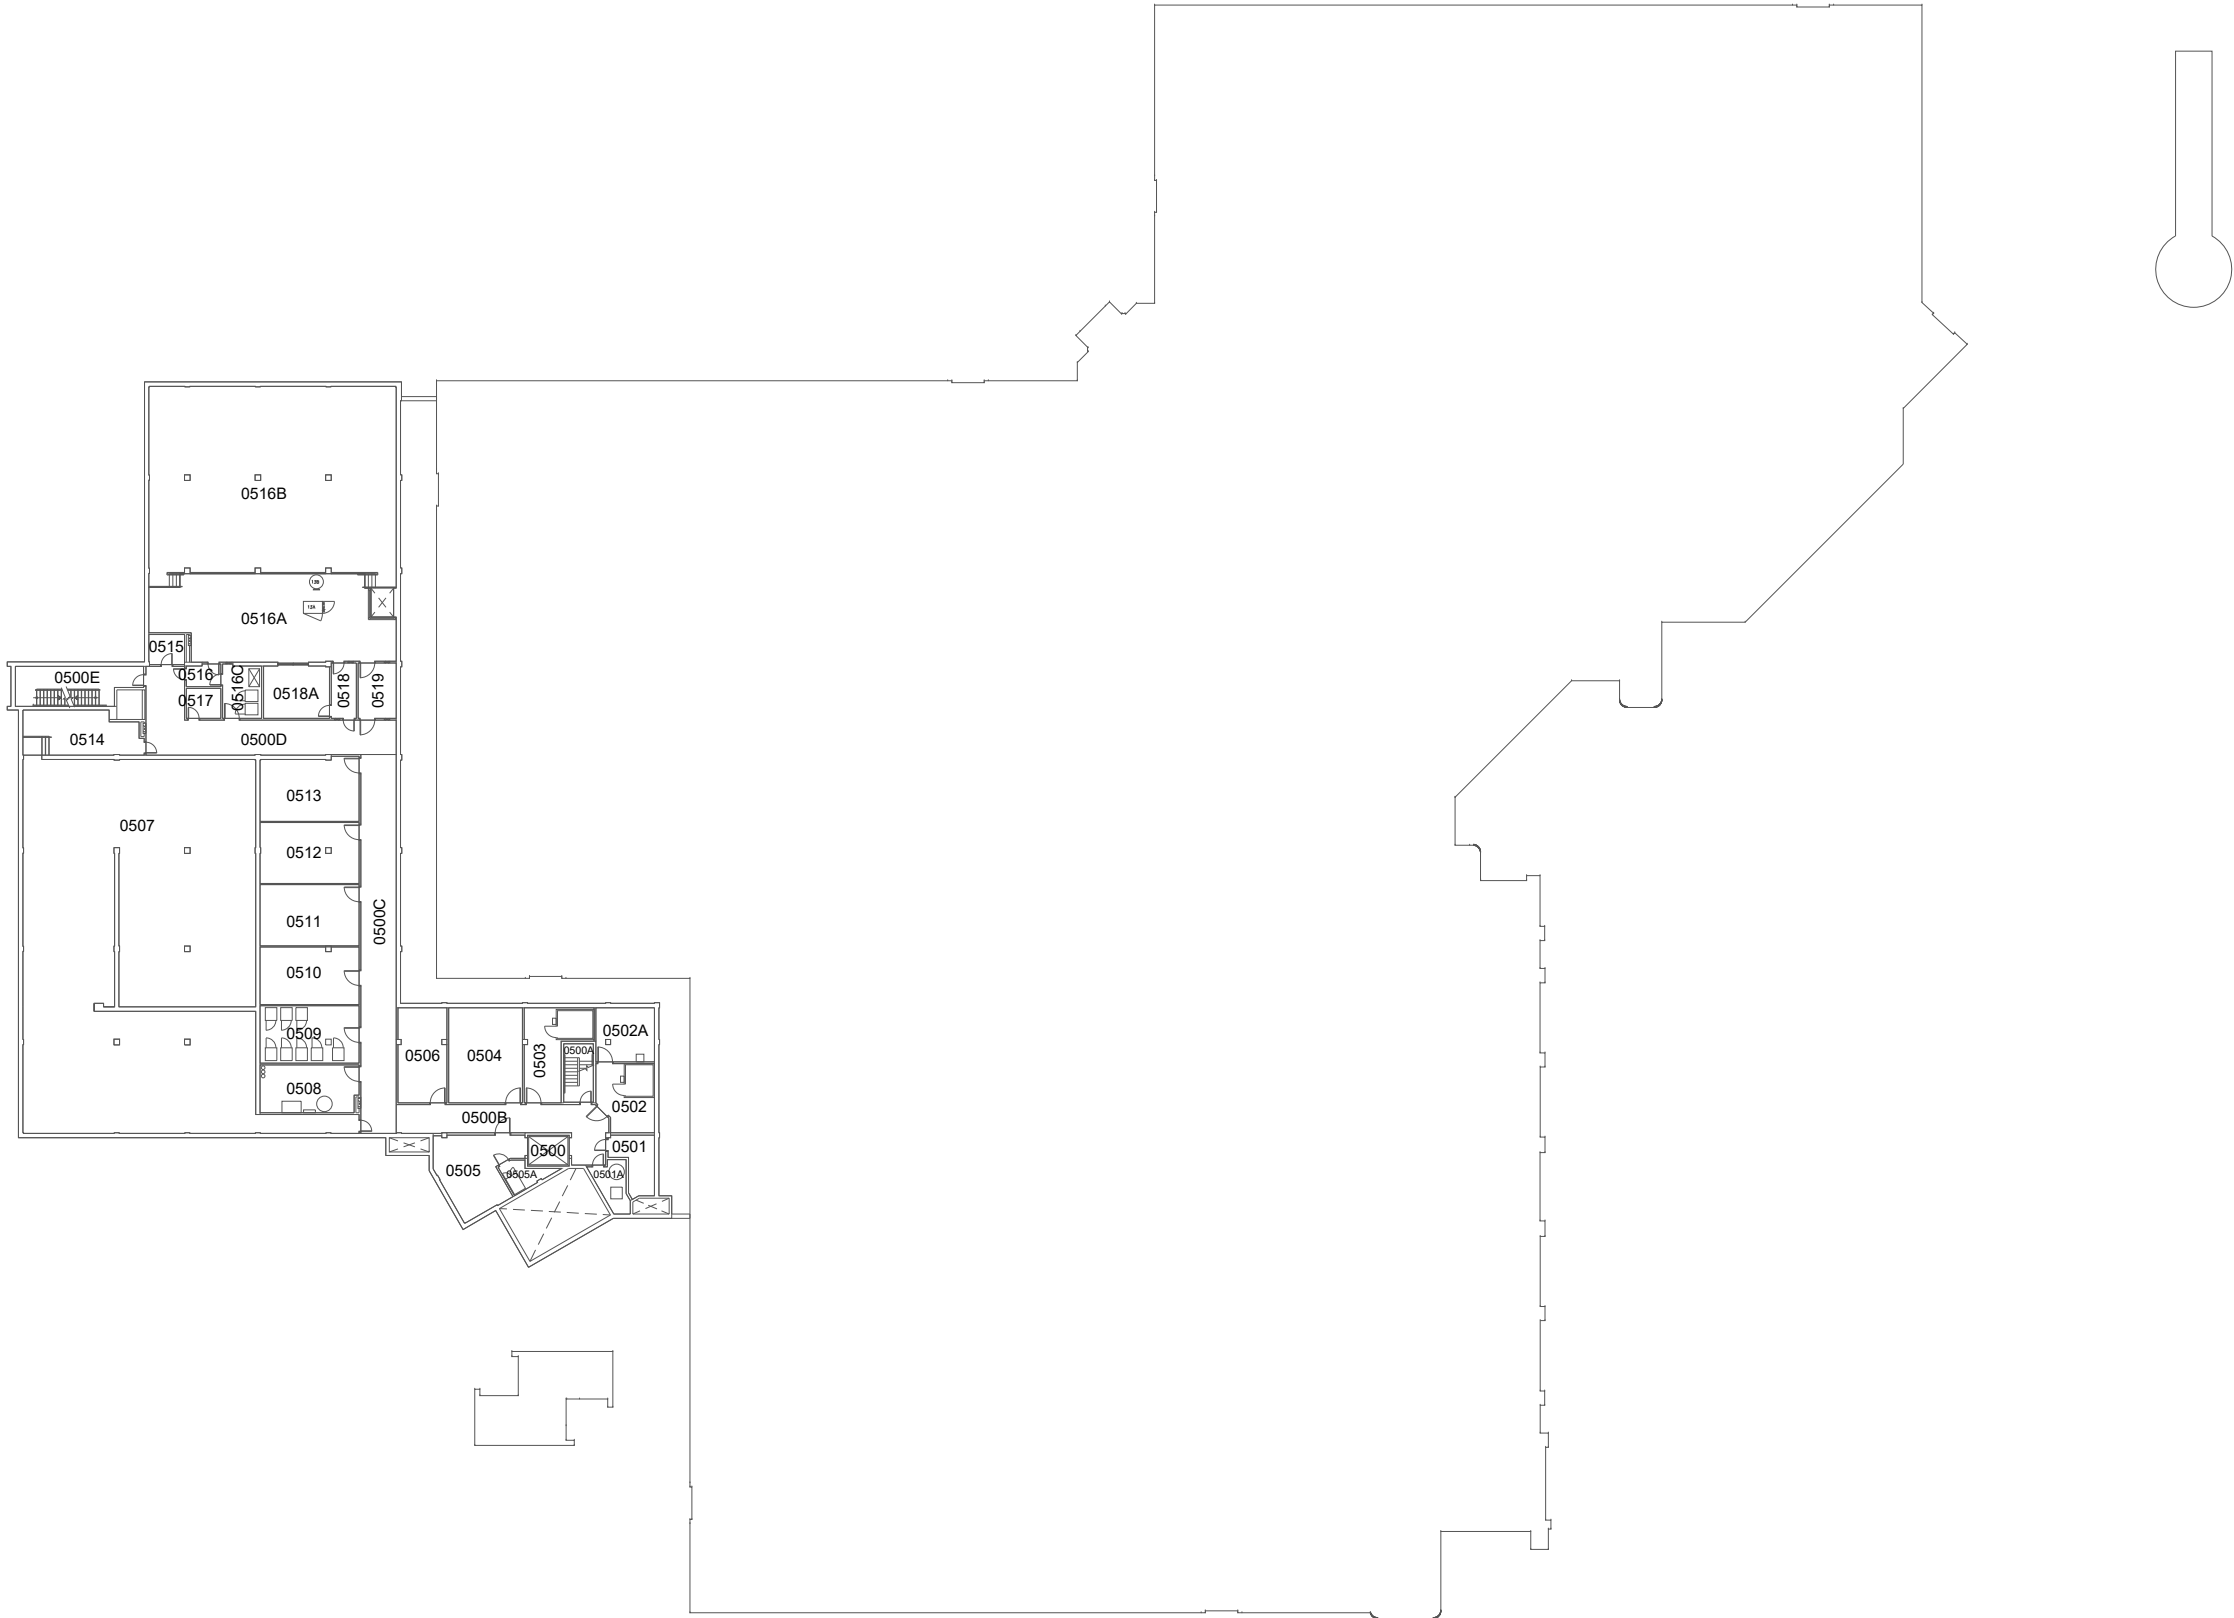
Édifice/Bldg ---- 050 ----	Niveau/Level: 0 ----
Échelle/Scale: 1:600	Revised: 1
Feuille/Sheet: A-0	08/09/2015 1 of/de 8

**Notes:**  
ACM Transite present in Fume Hoods

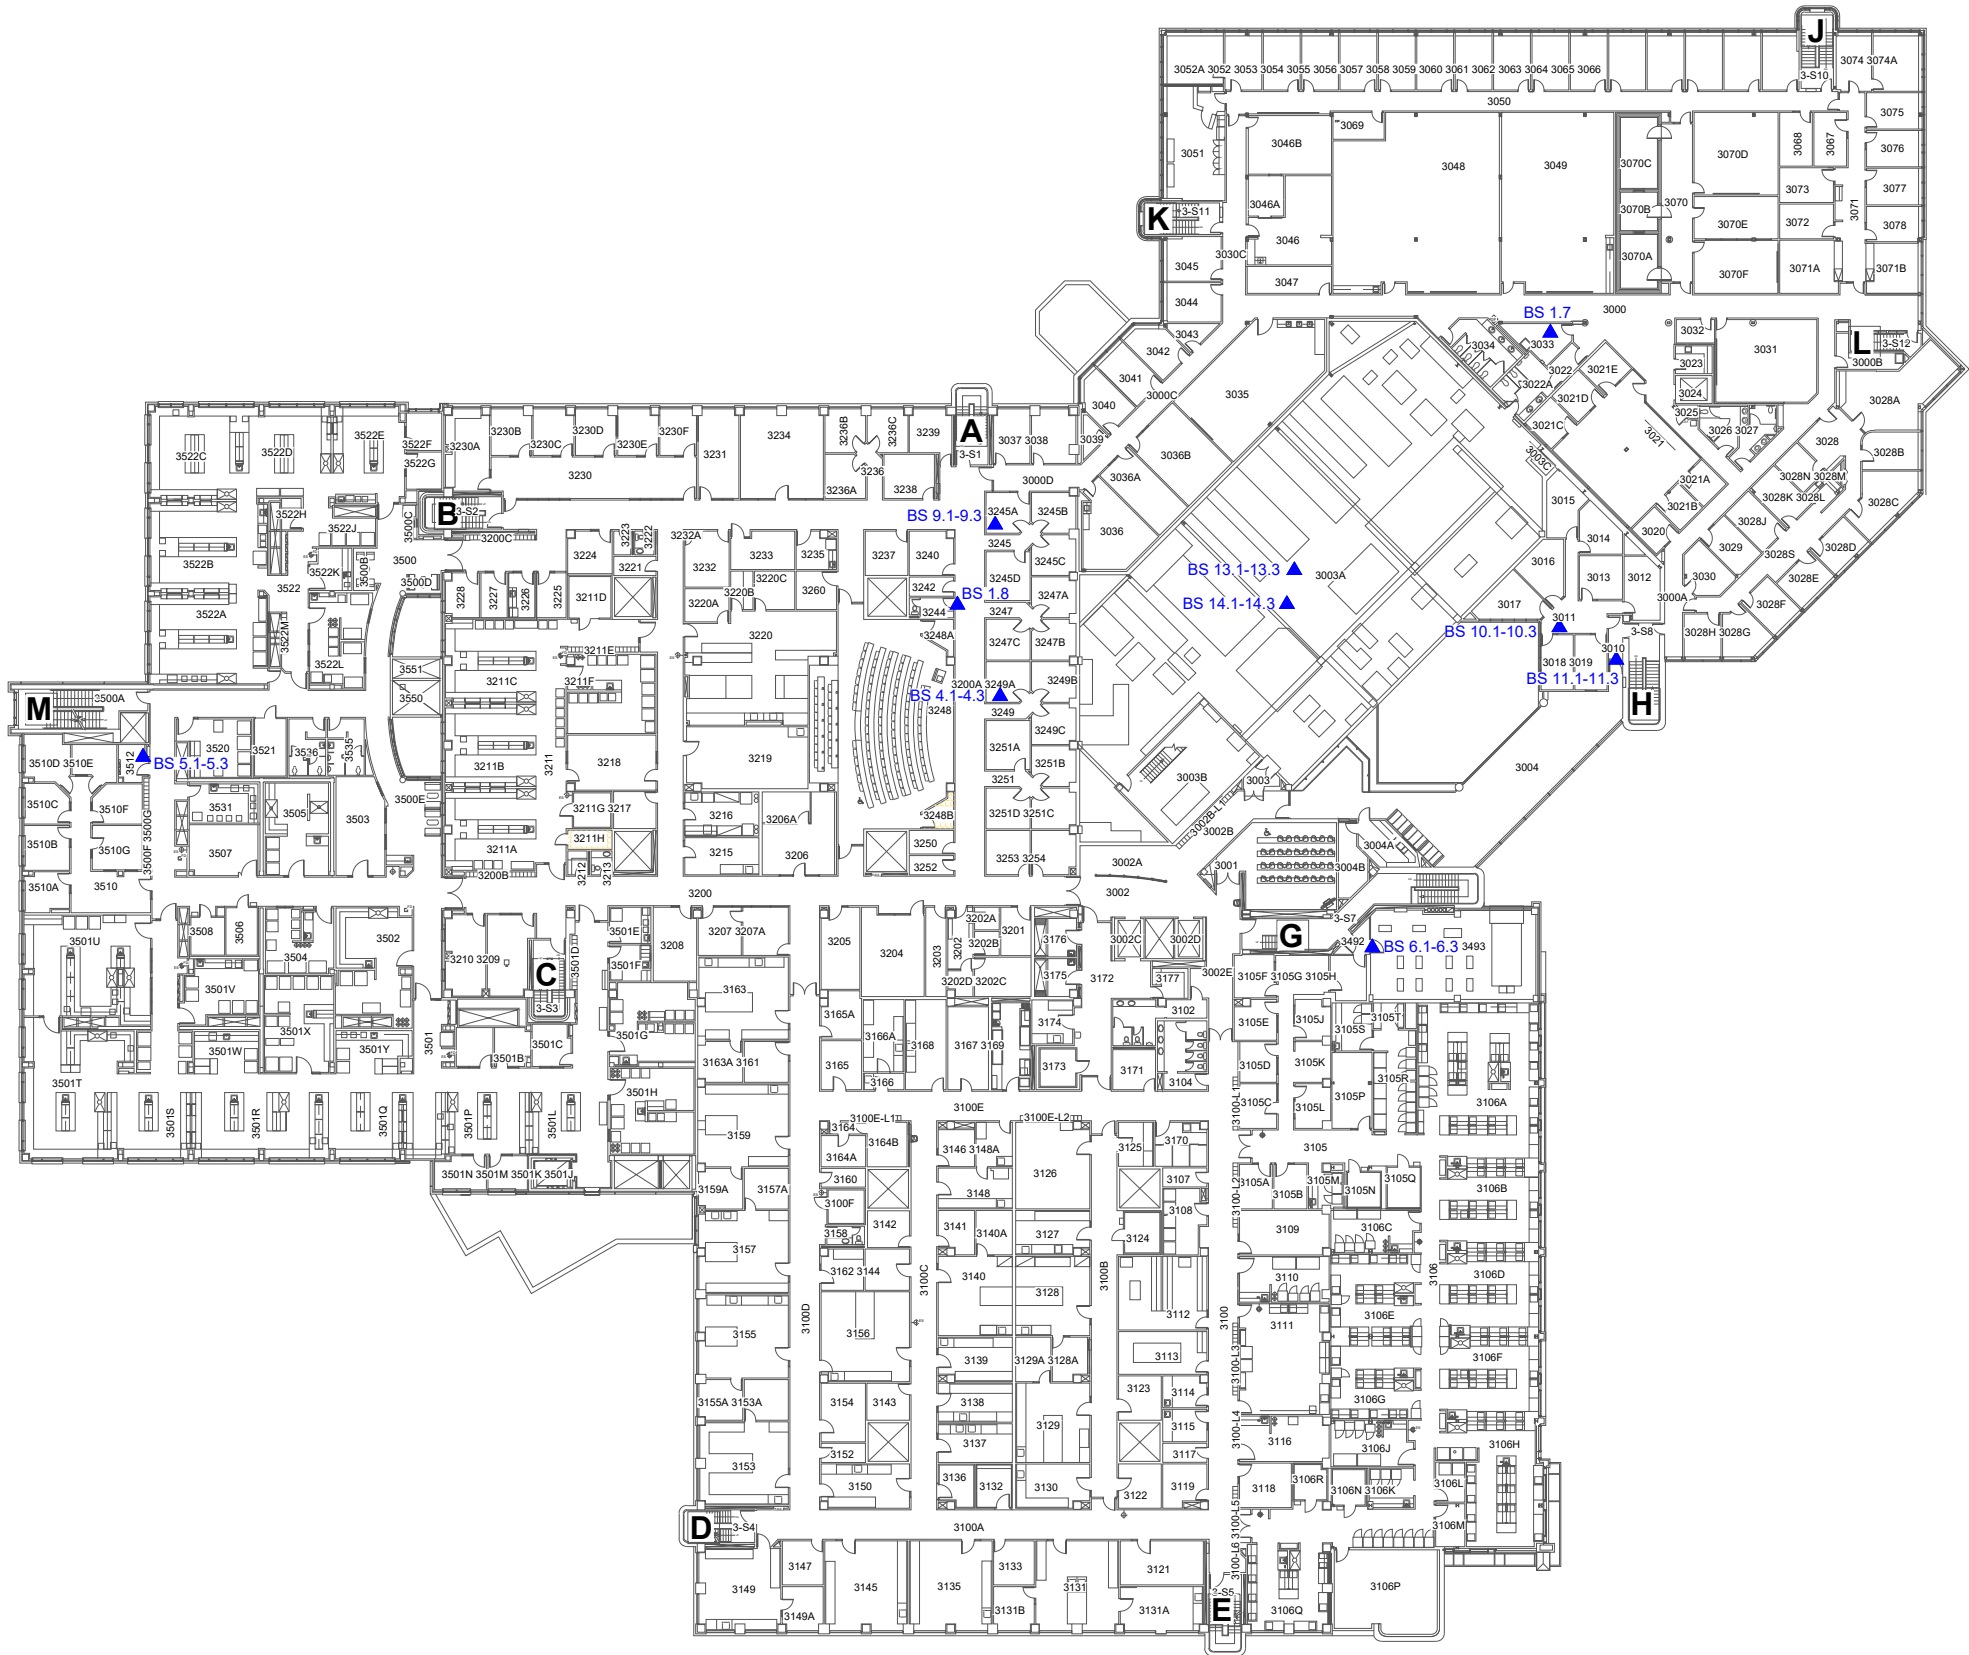
Dessin / Drawing: <b>SITE PLAN &amp; SAMPLE LOCATIONS</b>			
Édifice/Bldg ---- 050 ----	Niveau/Level: ---- 3 ----	Feuille/Sheet:  A-3	
Echelle/Scale: 1:600	Revision: 1	08/09/2015	5 of/de 8

**Legend:**  
▲ Asbestos Bulk Sample  
■ Lead Paint Sample  
**Notes:**  
ACM Transite present in Fume Hoods
