# HAZARDOUS MATERIALS SURVEY AND 2023 REASSESSMENT ROGER GUINDON HALL, OTTAWA, ON

Project No.: Z1920014HZ / CCC-230252-00

Date: March 6, 2023

Re: Roger Guindon Hall, University of Ottawa - 451 Smyth Road  
Hazardous Materials Survey and 2023 Reassessment  
McIntosh Perry Limited Reference No. Z1920014HZ / CCC-230252-00

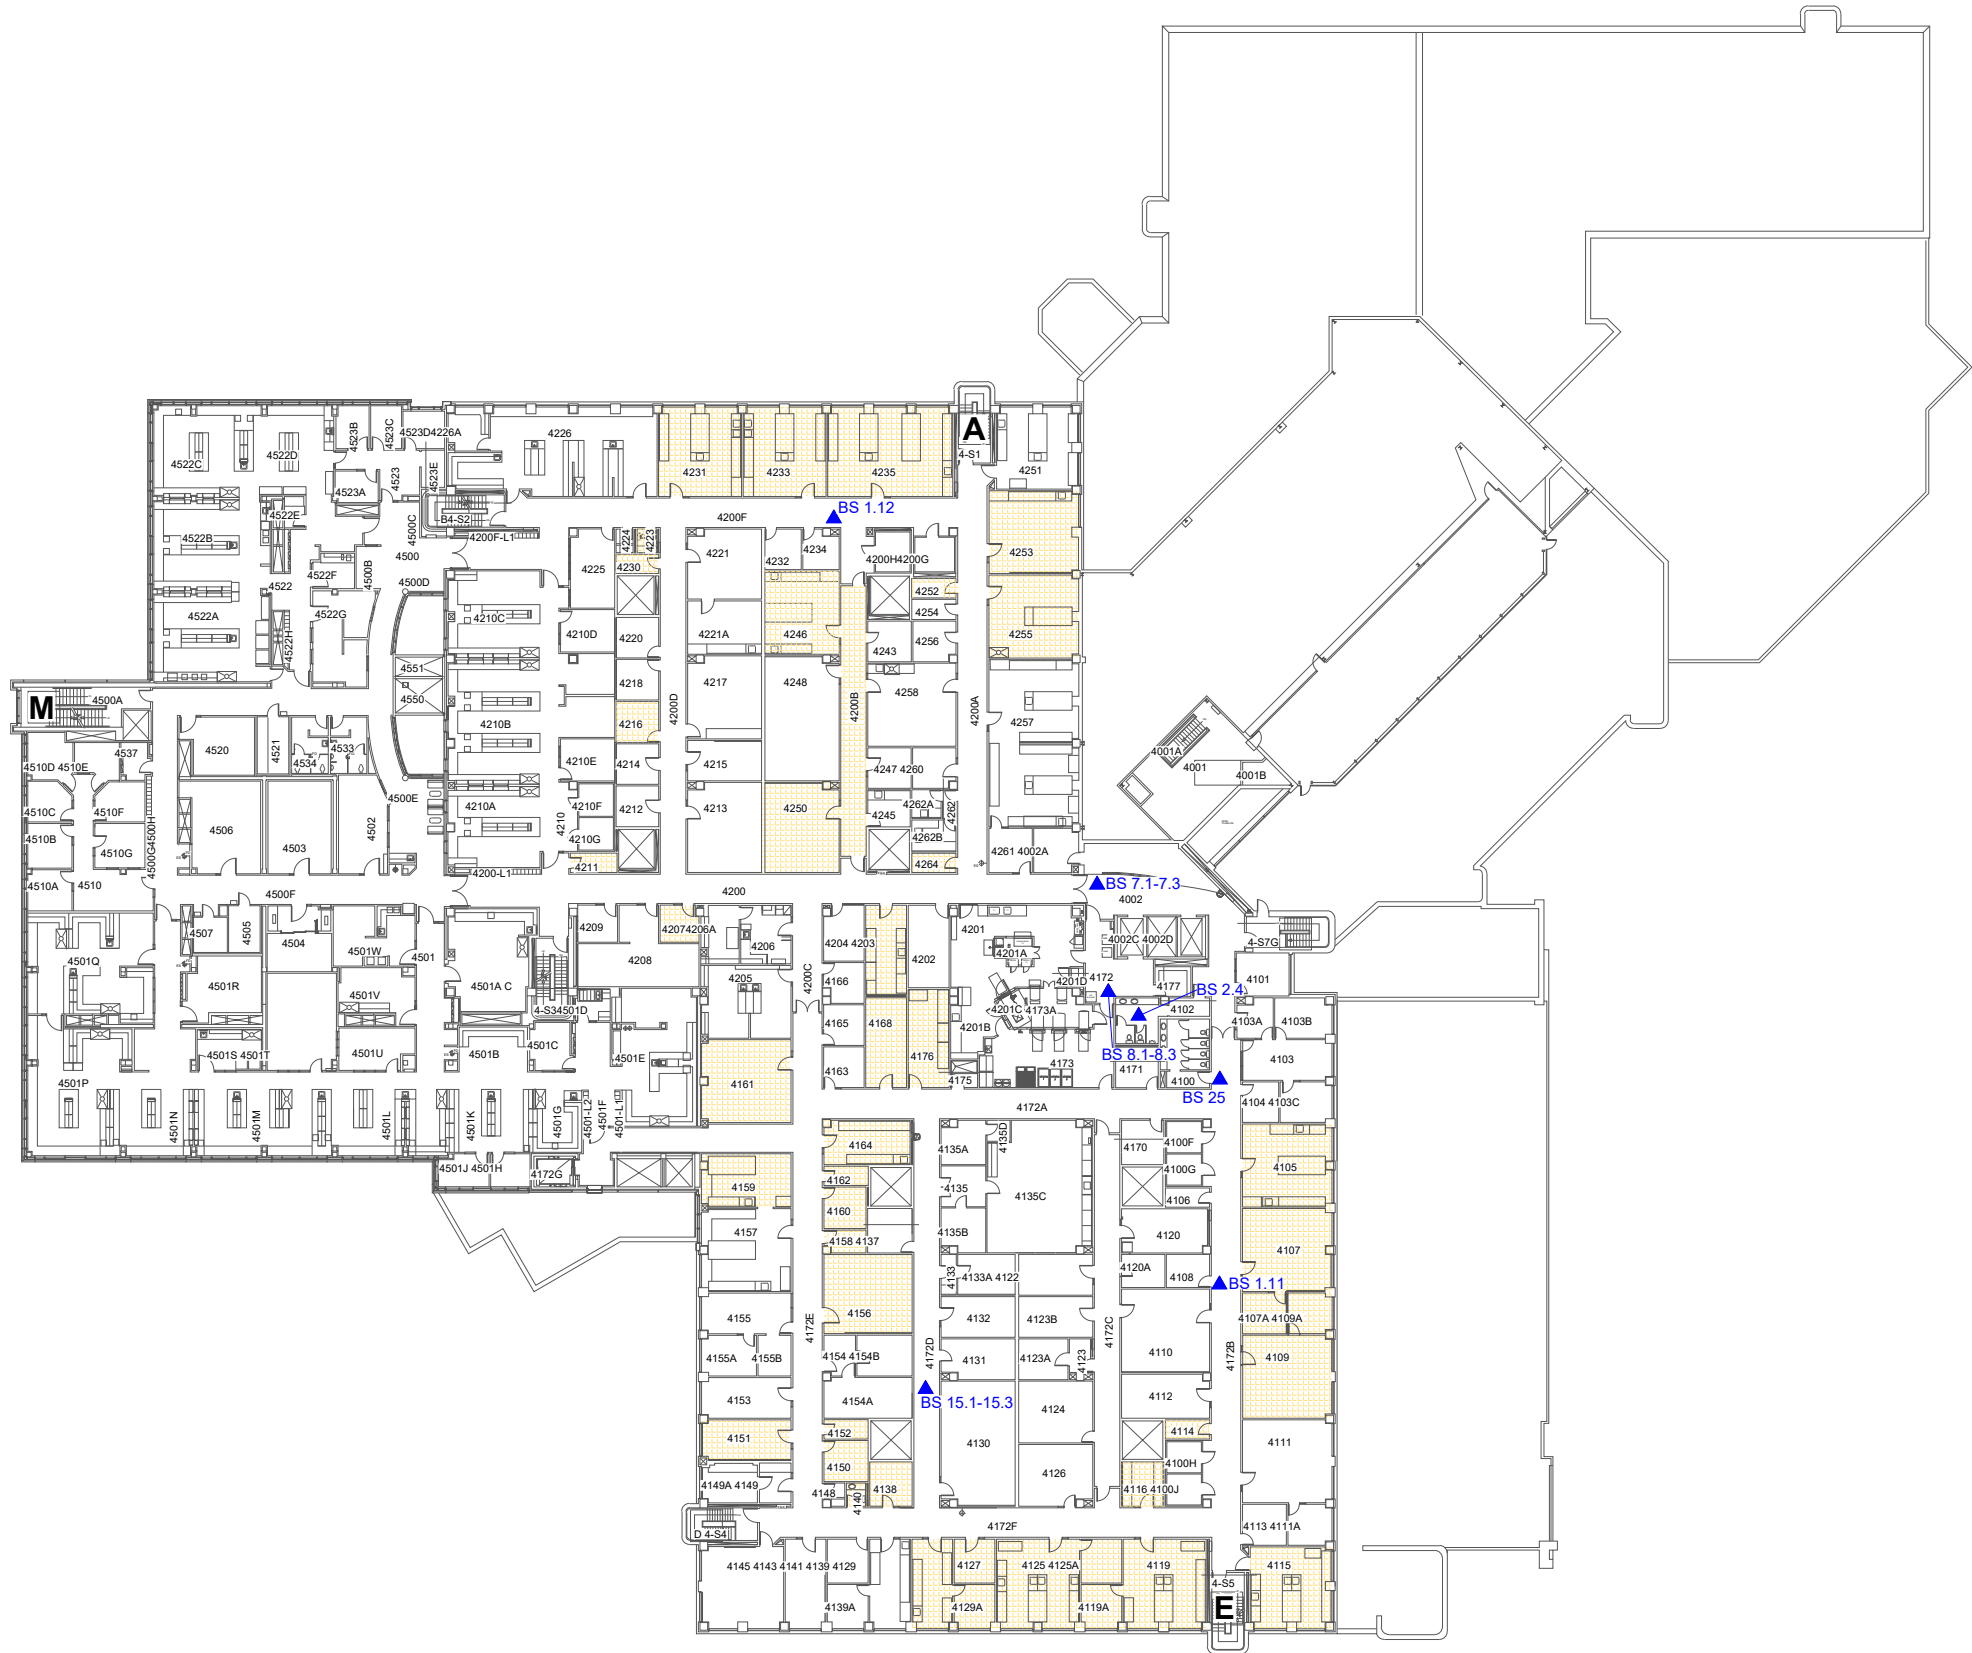
Dessin / Drawing: <b>SITE PLAN &amp; SAMPLE LOCATIONS</b>			
Édifice/Bldg 050	Niveau/Level: 4	Feuille/Sheet: A-4	
Échelle/Scale: 1:600	Revision: 1	08/09/2015	6 of/de 8

**Legend:**  
▲ Asbestos Bulk Sample  
■ Lead Paint Sample  
**Notes:**  
ACM Transite present in Fume Hoods

ACM Vinyl Floor Tiles (VFT)  
ACM Carpet Mastic

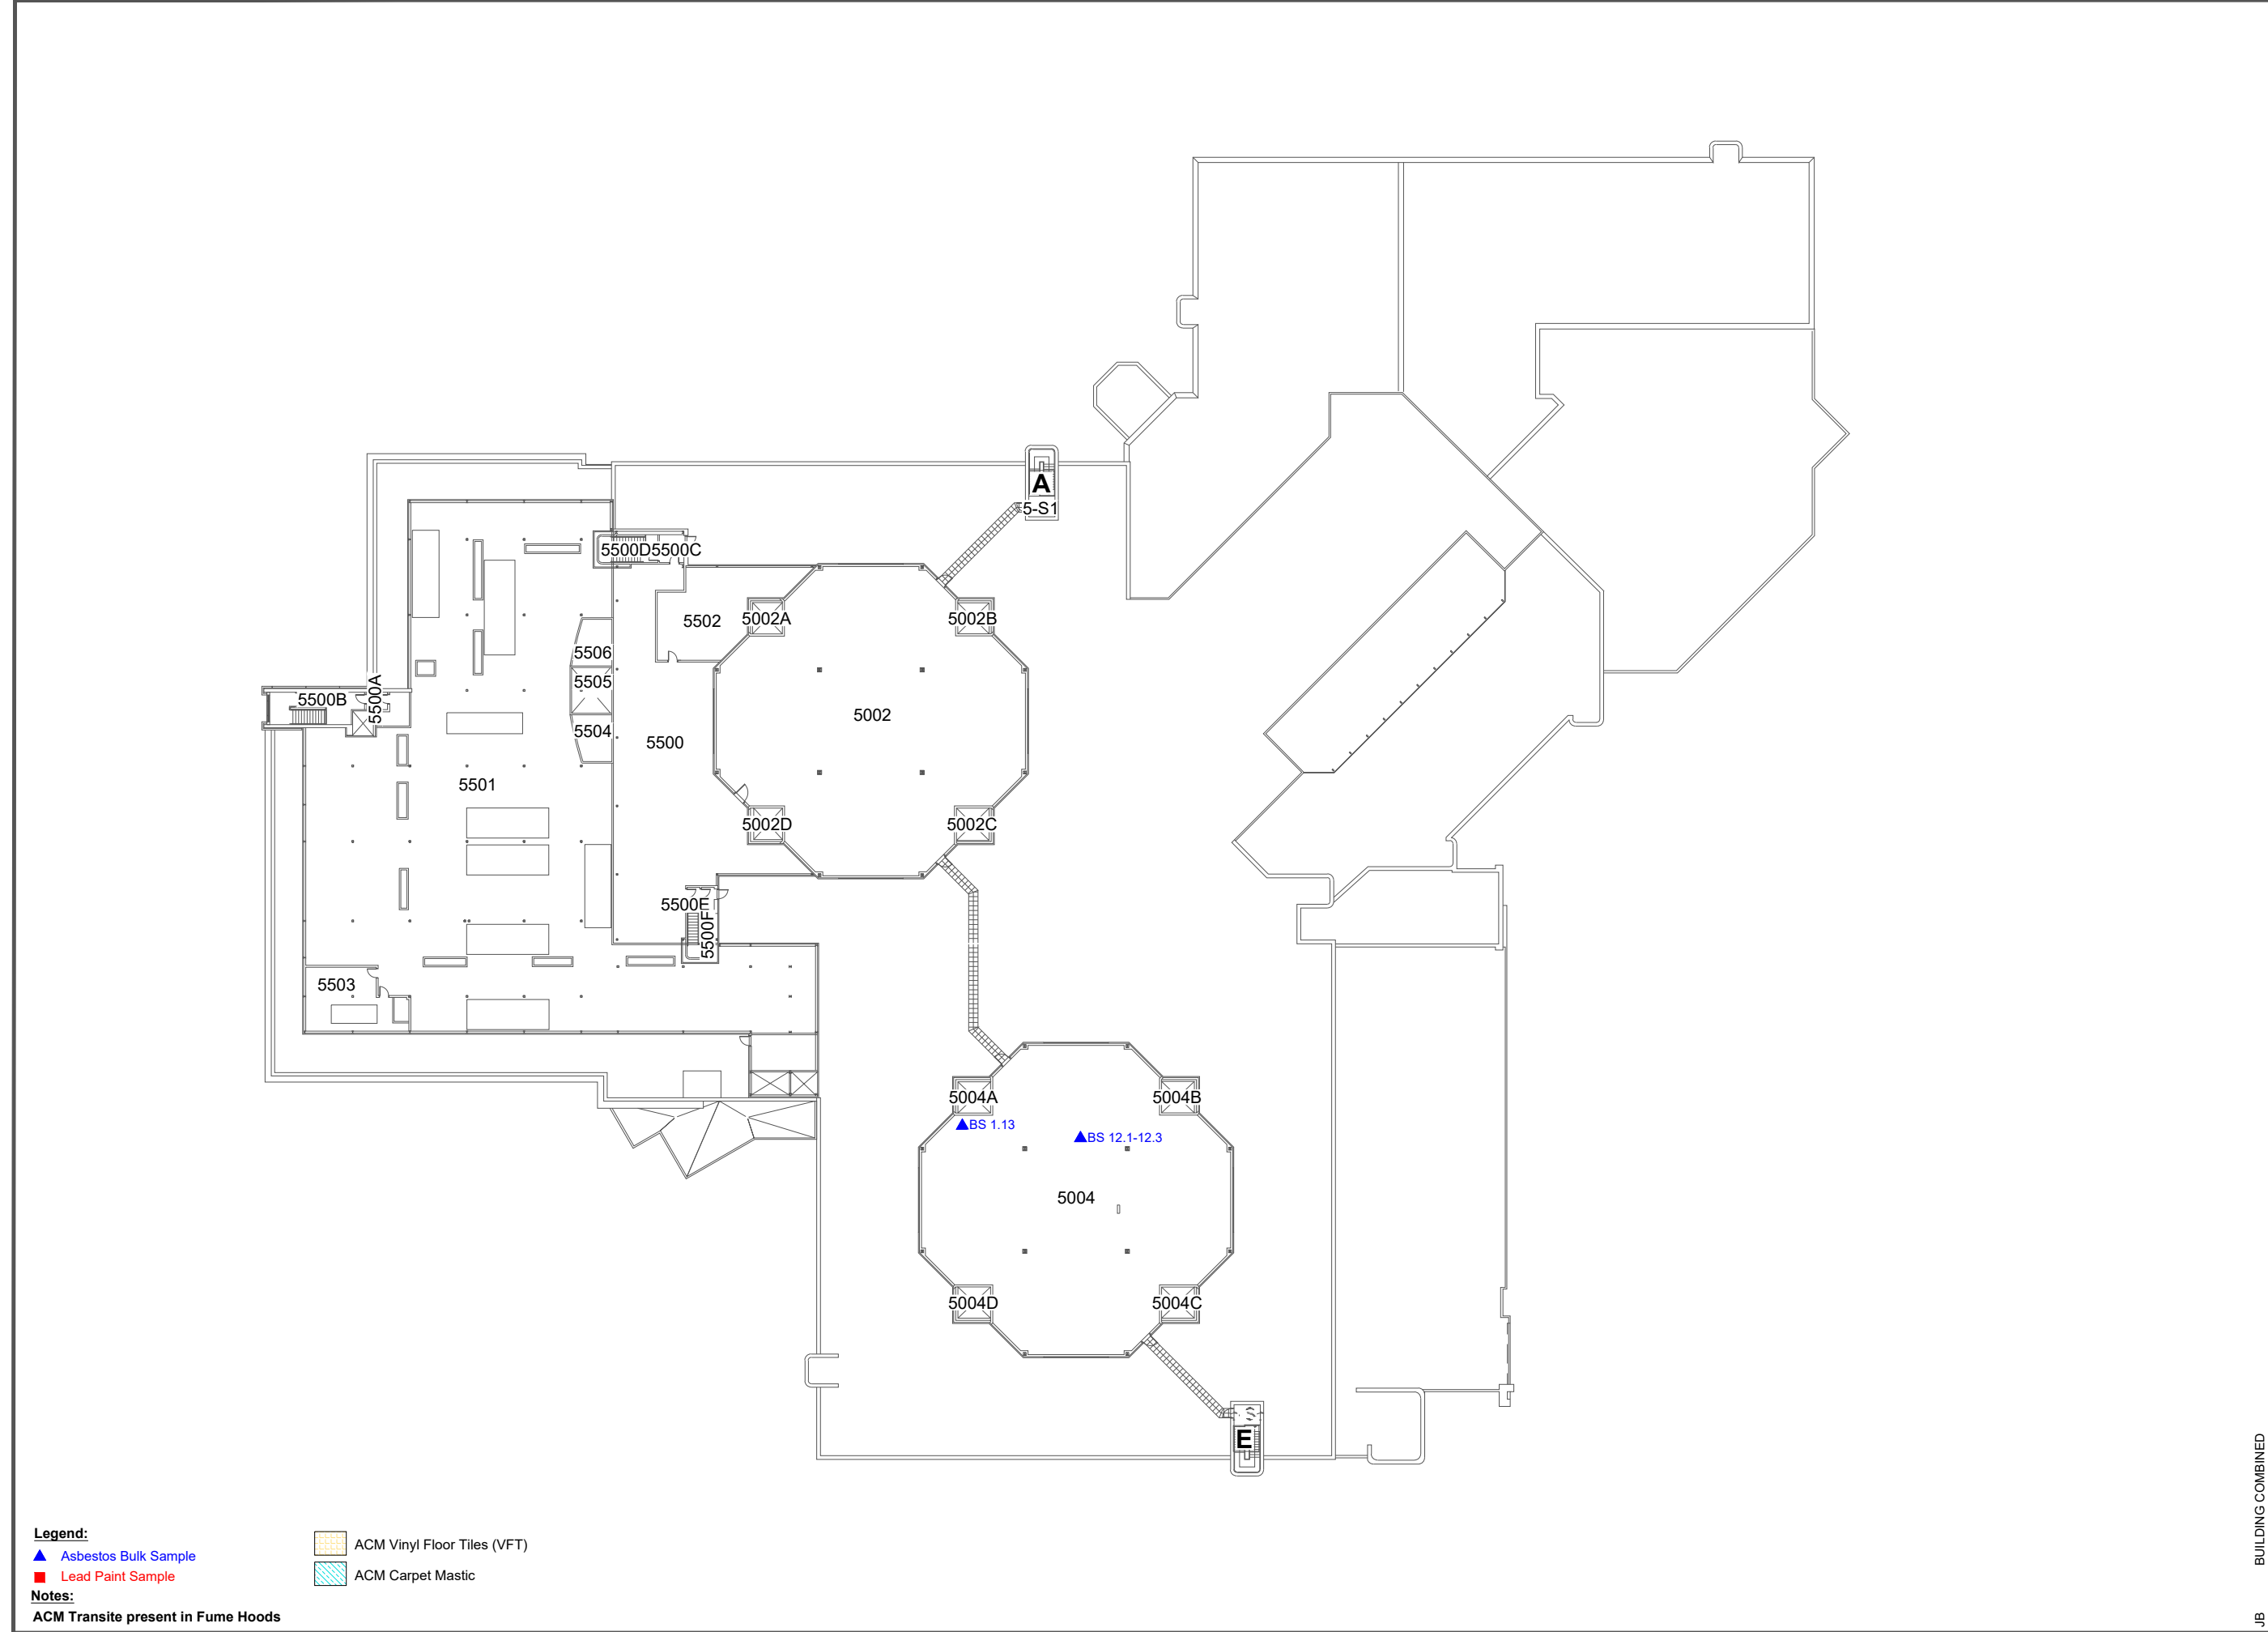
**Notes:**  
ACM Transite present in Fume Hoods
