HAZARDOUS MATERIALS SURVEY AND 2023 REASSESSMENT STANTON RESIDENCE, OTTAWA, ON

Project No.: Z2021102HZ / CCC-230252-00

University of Ottawa

McIntosh Perry Limited (MPL)

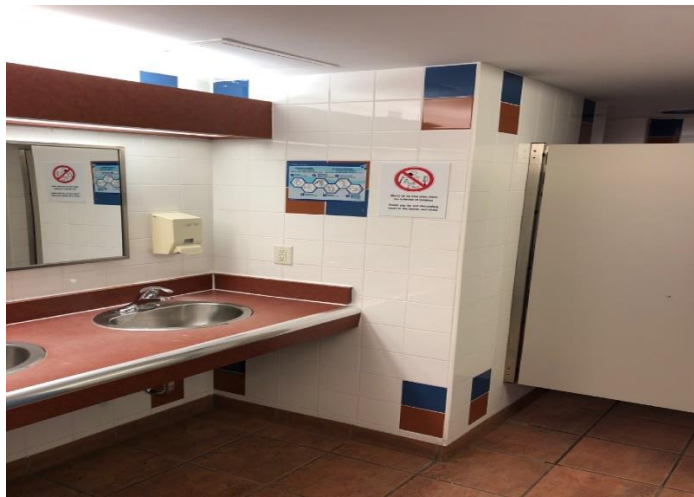
To avoid damage and compromising the integrity of the structure, no bulk samples of the ceramic wall/floor tile grout were collected. Prior to renovation/demolition, concrete brick mortar should be examined and tested for asbestos content. Ceramic wall/floor tile grout should therefore be considered to contain asbestos until bulk samples and analysis proves otherwise.

Photo 4: Typical view of ceramic floor tile grout suspected of containing asbestos.

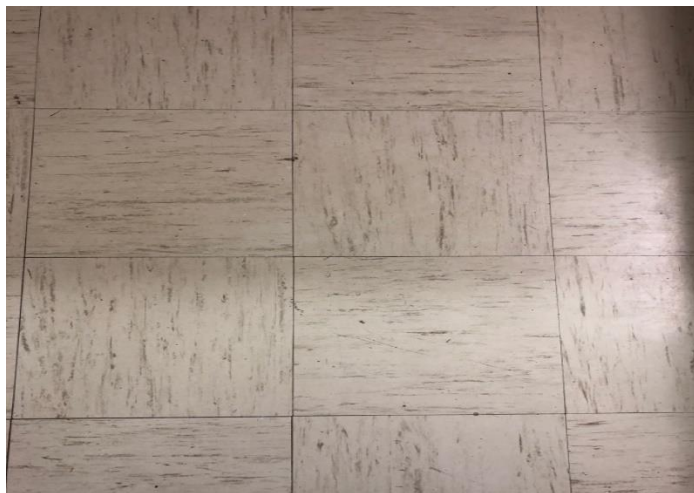
Photo 5: View of asbestos-containing vinyl floor tiles (12"x12" - white with grey streaks) observed in Room 1618A (kitchen).

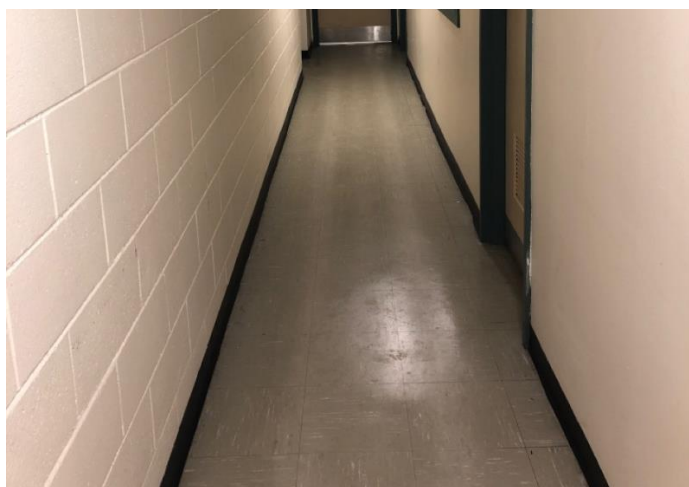
Photo 6: View of asbestos-containing vinyl floor tiles (12"x12" - grey with white streaks) observed in the basement corridor.

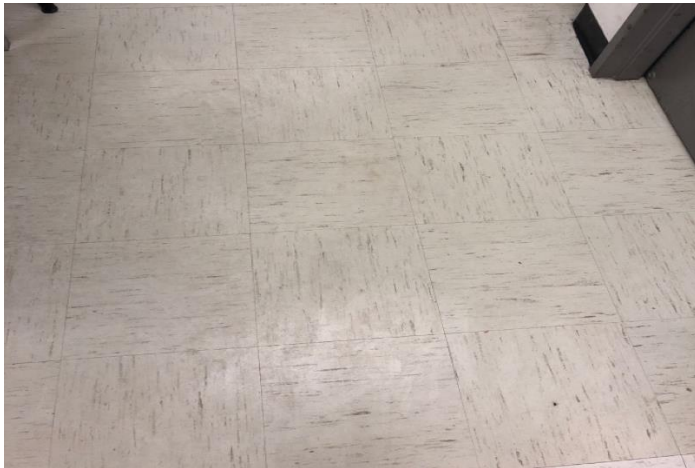
Photo 7: View of asbestos-containing vinyl floor tiles (12"x12" - white with black streaks) observed in Room 017.

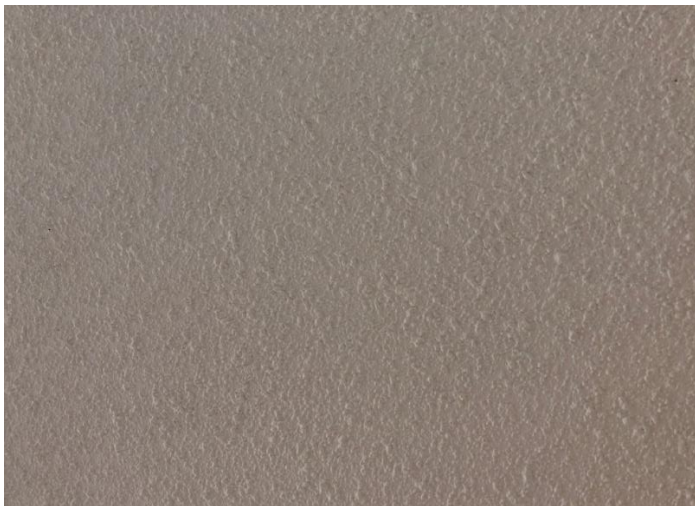
Photo 8: View of asbestos-containing texture coat observed in Room 1608.

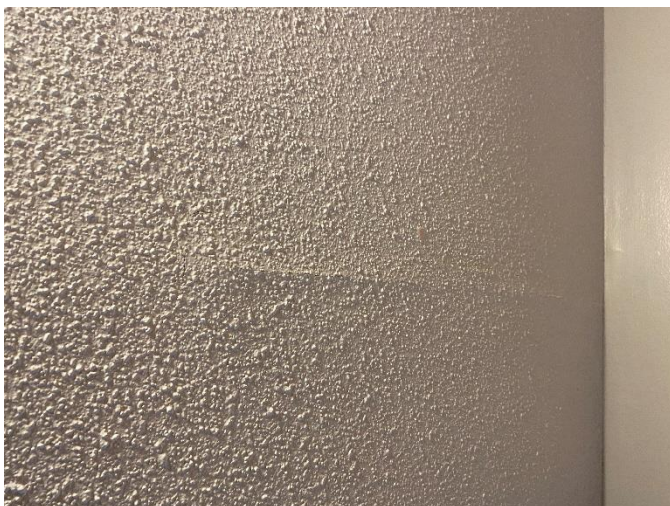
Photo 9: View of asbestos-containing texture coat observed in fair condition in Room 130F.

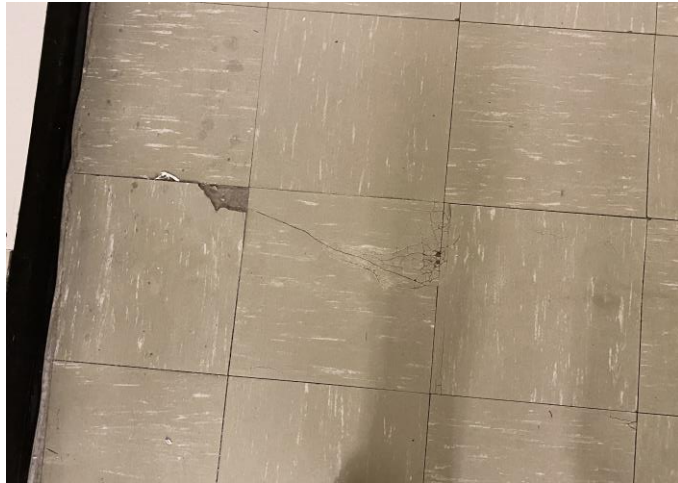
Photo 10: View of asbestos-containing vinyl floor tiles (12"x12"-grey with white streaks) observed in fair condition in Room 130F.

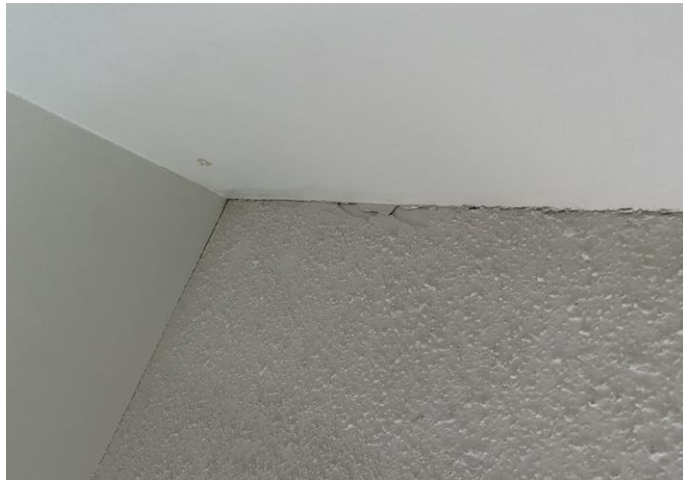
Photo 11: View of asbestos-containing texture coat observed in fair condition in Room 312.

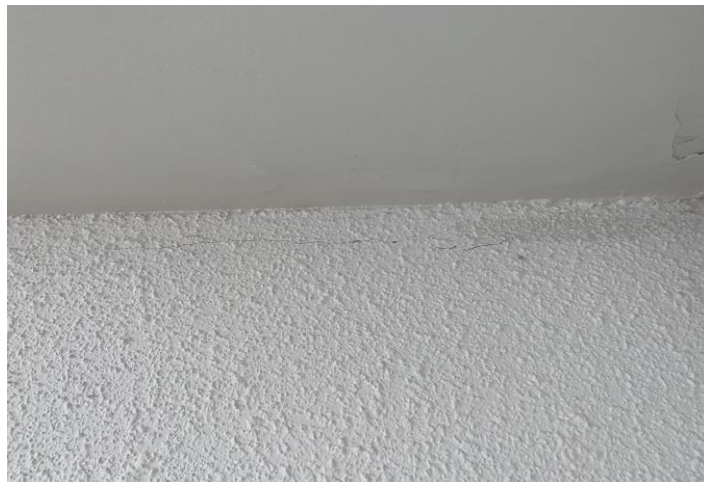
Photo 12: View of asbestos-containing texture coat observed in fair condition in Room 1607.

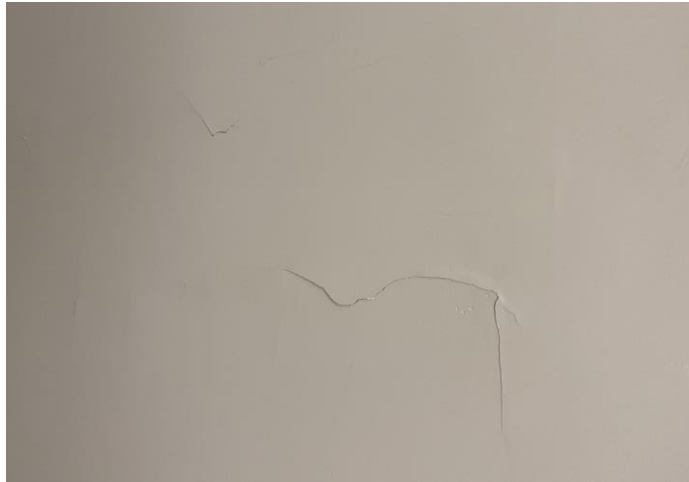
Photo 13: View of asbestos-containing drywall joint compound observed in fair condition in Room 1607.

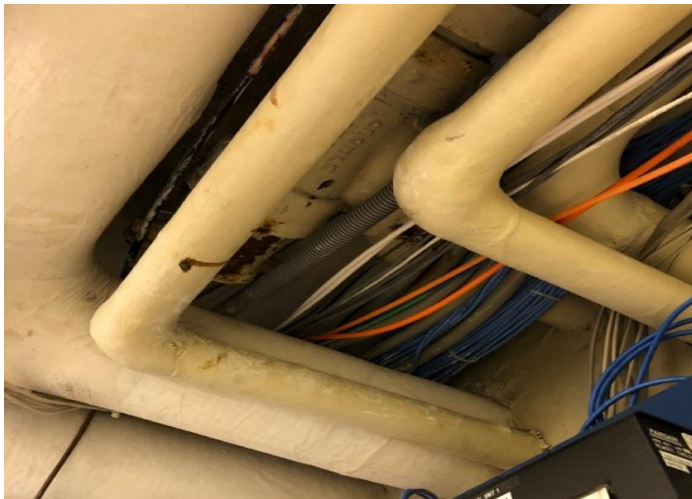
Previously identified mechanical pipe elbows/fittings insulation was observed in Rooms 03, 010B, 016, 025, R140A, penthouse level 1 and penthouse level 2. The laboratory analytical results indicate that this material contains **40-50% Chrysotile asbestos**. This material is considered to be friable and was observed in good condition.

Photo 14: View of asbestos-containing pipe fitting insulation observed in Room 025.

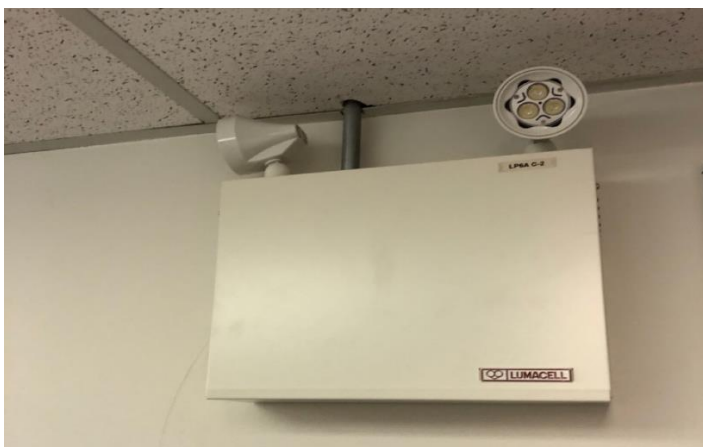
MPL identified lead-containing acid battery packs throughout the subject building. These battery packs were observed on walls and above exits throughout the surveyed building.

Photo 15: View of lead-containing battery packs observed throughout the subject building.

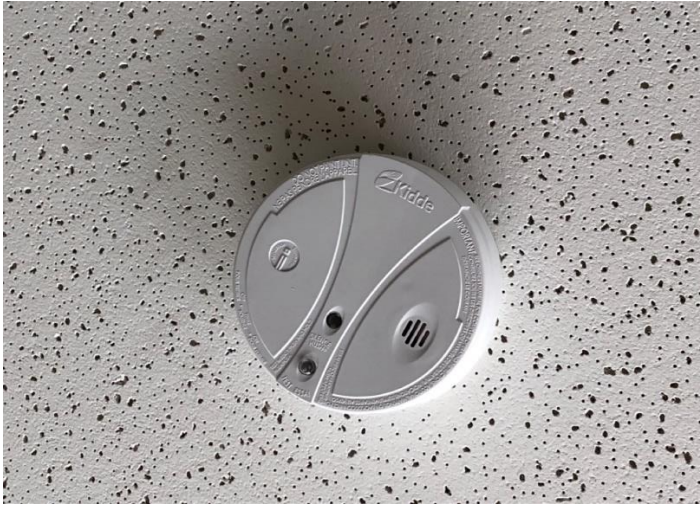
Photo 16: Typical view of smoke detectors containing radioactive materials.

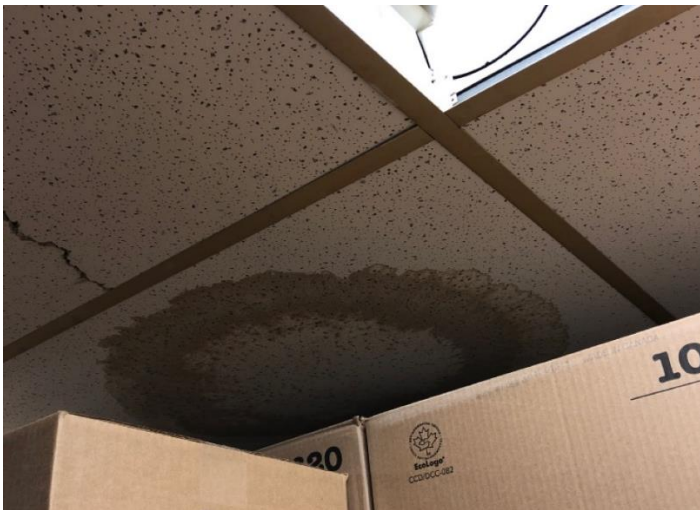
Photo 17: View of water damaged ceiling tiles observed in Room 100G.
