HAZARDOUS MATERIALS SURVEY AND 2023 REASSESSMENT 150 LOUIS-PASTEUR PRIVATE (STEM COMPLEX), OTTAWA, ON

Project No.: Z2021101HZ / CCC-230252-00

University of Ottawa

November 28, 2023

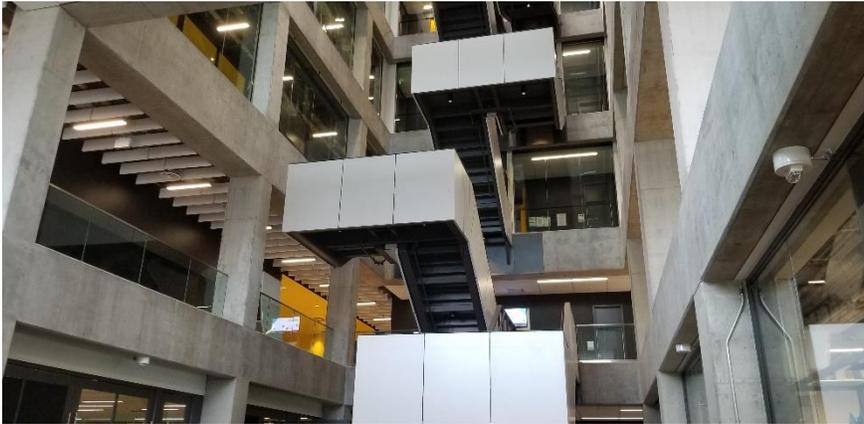
Photo 1: View of typical building finishes.

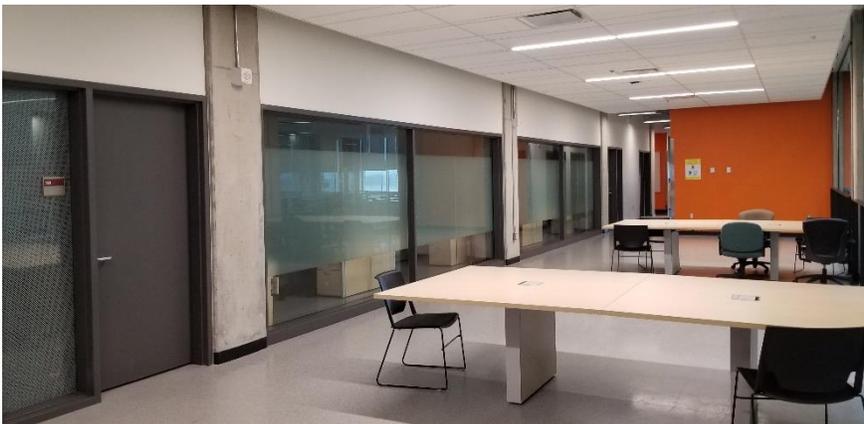
Photo 2: View of typical building finishes.

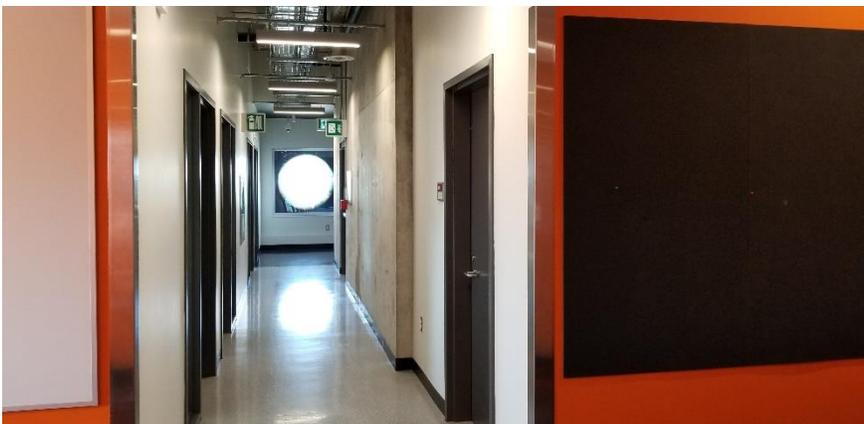
Photo 3: View of typical hallway finishes.

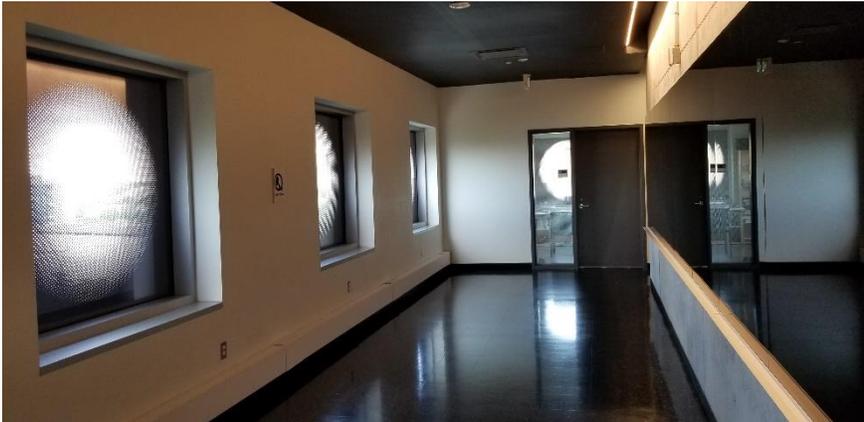
Photo 4: View of typical hallway finishes.

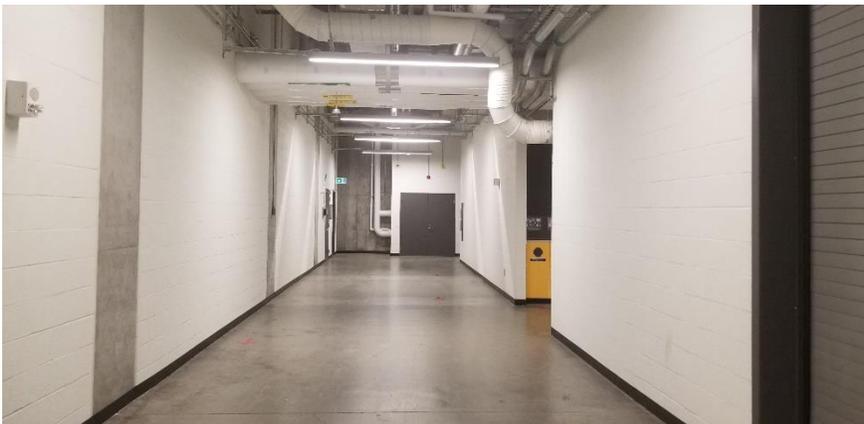
Photo 5: View of typical hallway finishes.

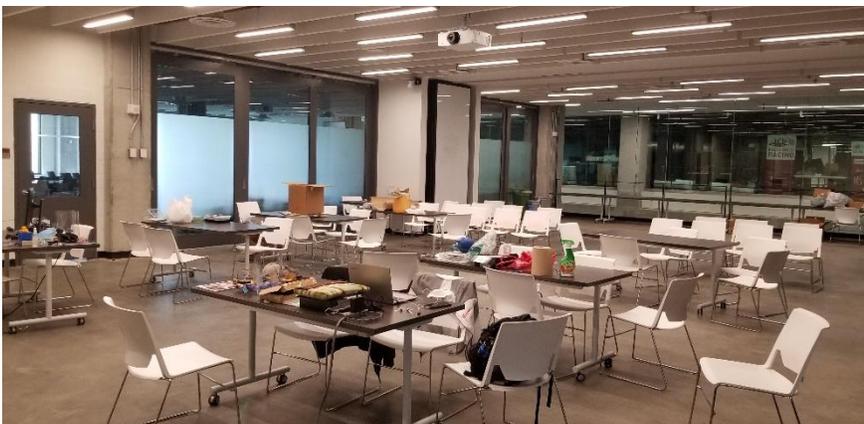
Photo 6: View of typical classroom finishes.

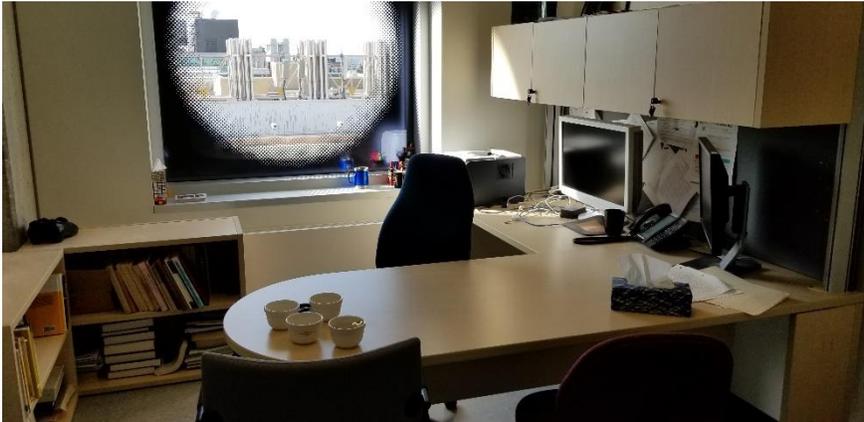
Photo 7: View of typical office finishes.

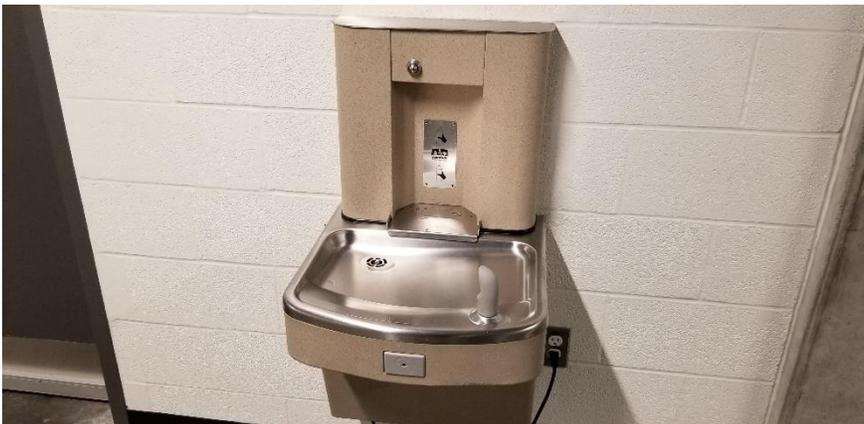
A visual assessment for equipment potentially containing ODSs and other halocarbons was conducted. MPL observed equipment such as refrigerators, water fountains, water coolers, freezers, etc., which contain or are suspected of containing ODSs or other halocarbons.

Photo 8: A typical view of the ODS-containing equipment was observed throughout the subject building.

Please refer to Appendix E – Hazardous Materials Checklist for equipment conditions, quantities (where applicable), and recommended actions.

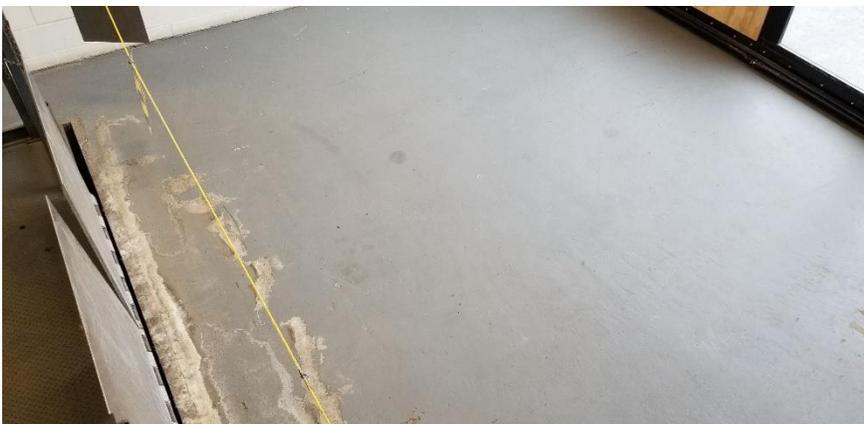
Photo 9: View of the floor with non-lead-containing paint (Grey) in Room 018.

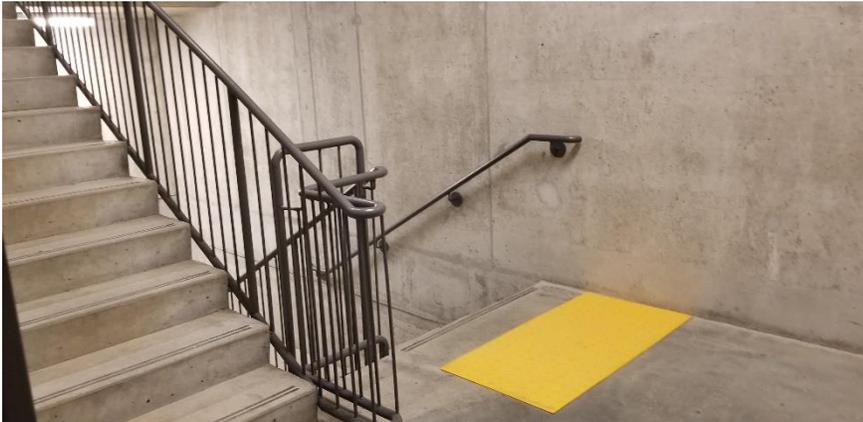
Silica is expected to be present in building materials such as concrete, brick, mortar and ceramic tiles throughout the structures. Free crystalline silica (α -Quartz) may be a component in ceiling tiles and gypsum boards. Silica (including free crystalline silica) may also be a component of concrete and brick surfaces noted in the building.

Photo 10: Typical silica containing concrete finishes.

Please refer to Appendix E – Hazardous Materials Checklist for equipment conditions, quantities (where applicable), and recommended actions.

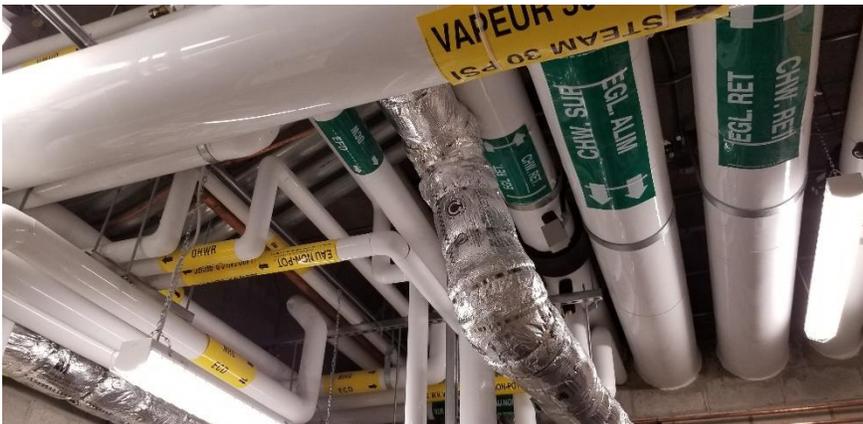
Photo 11: Typical view of fibreglass mechanical insulation throughout the subject building.
