# HAZARDOUS MATERIALS SURVEY AND 2023 REASSESSMENT TUNNEL SYSTEM, OTTAWA, ON

Project No.: Z2021101HZ / CCC-230252-00

University of Ottawa

McIntosh Perry Limited (MPL)

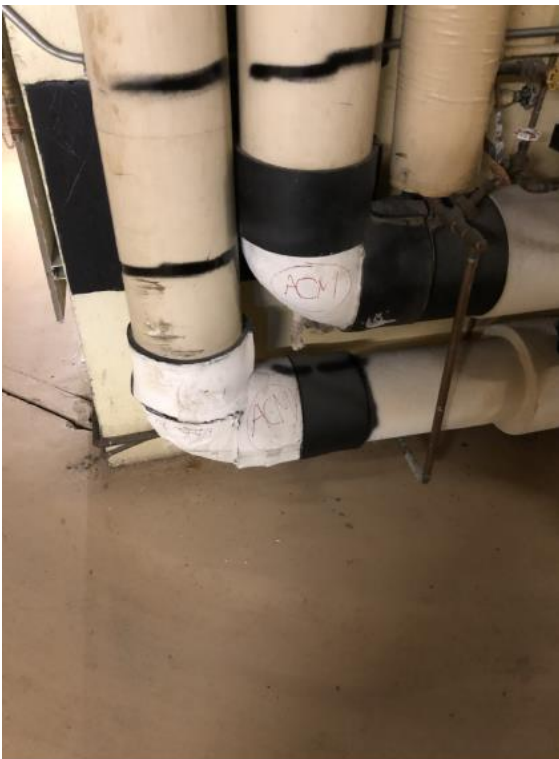
Mechanical pipe elbow/fitting insulation was observed throughout the surveyed area. The laboratory analytical results of mechanical piping insulation samples previously collected indicate that this material contains 60% Chrysotile asbestos. This material is considered to be friable and was observed in good, fair and, in select areas, poor condition.

Photo 2: View of asbestos-containing mechanical pipe elbow insulation observed in Tunnel 6-4.

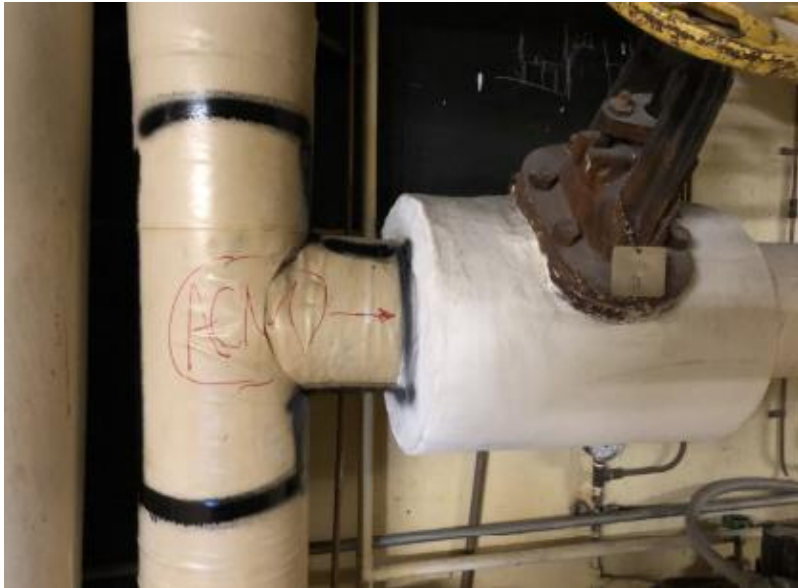
Photo 3: View of asbestos-containing mechanical fitting insulation observed in Tunnel 6-5.

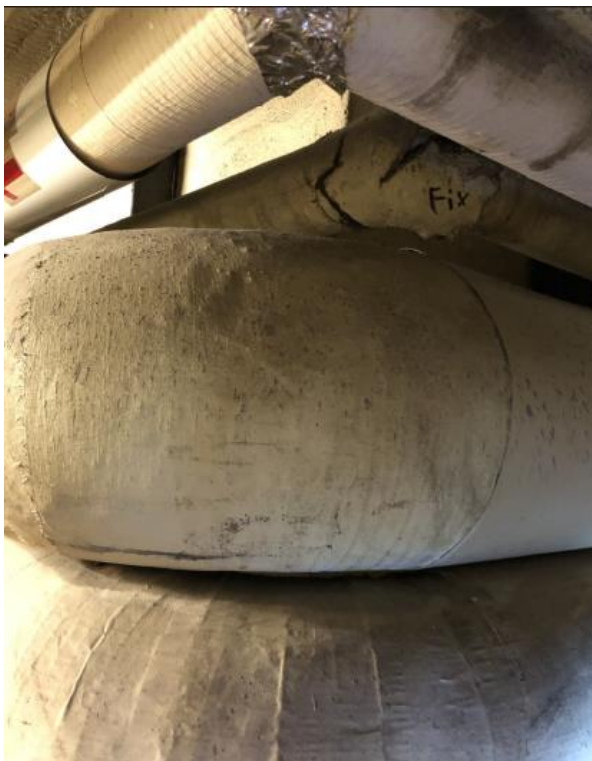
Photo 4: View of asbestos-containing mechanical pipe elbow insulation in Tunnel 3-2, observed to be in poor condition.

- Asbestos-containing materials identified to be in poor condition must be repaired/removed immediately, following Type 2 asbestos abatement work procedures as detailed in O. Reg. 278/05 and disposed of as asbestos waste under O. Reg. 347;

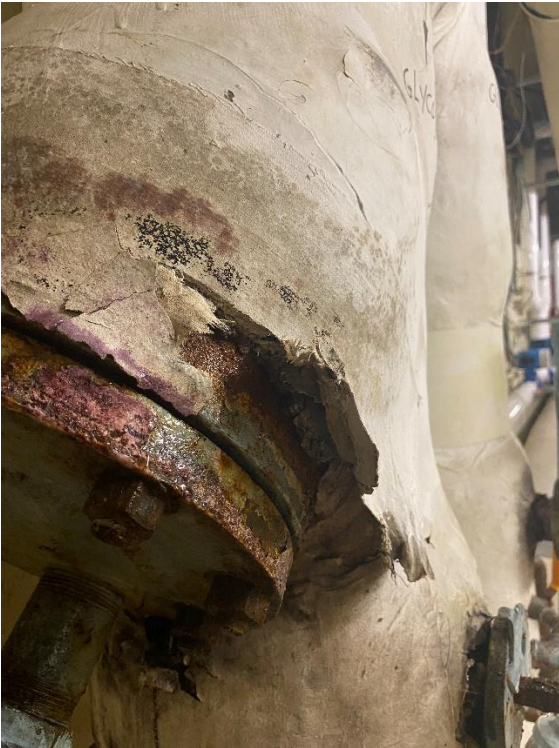
Photo 5: View of asbestos-containing mechanical pipe insulation in Tunnels 2-7, observed to be in poor condition.

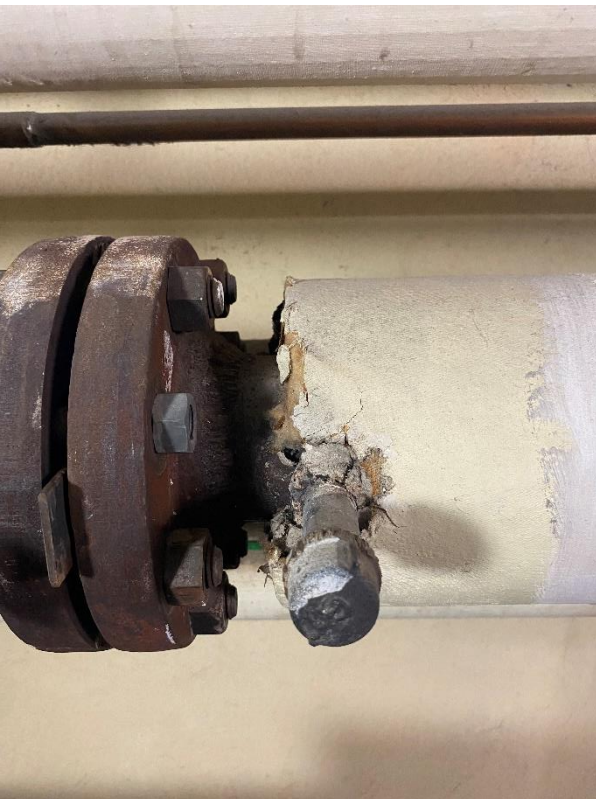
Photo 6: View of asbestos-containing mechanical pipe insulation in Tunnels 9-3, observed to be in poor condition.

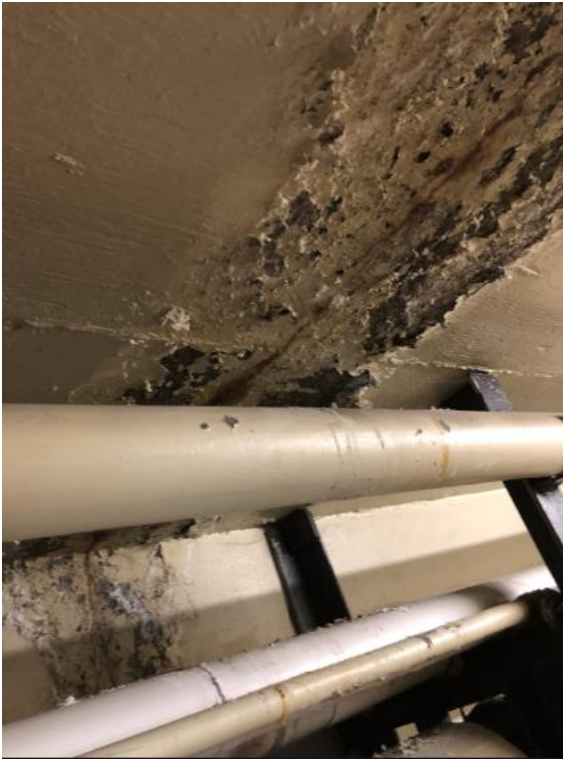
Photo 7: View of water damage observed on the ceiling in Tunnel 3-2.

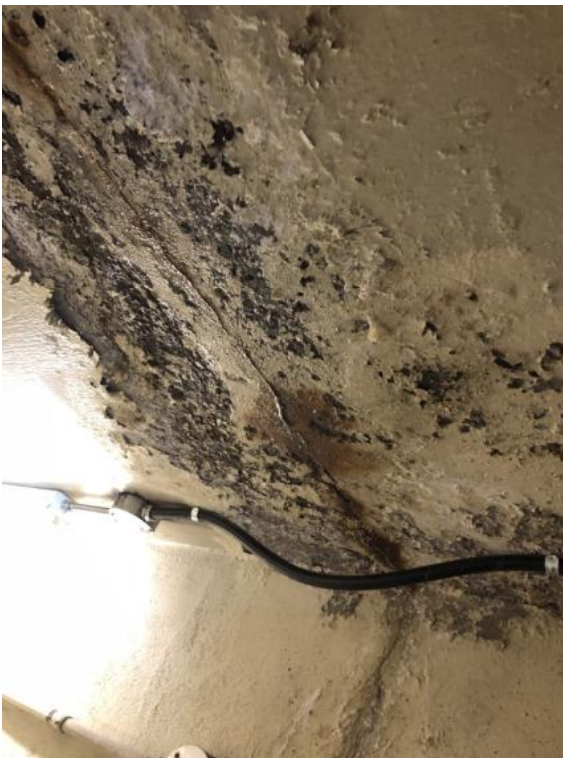
Photo 8: View of water damage observed on the ceiling in Tunnel 3-2.

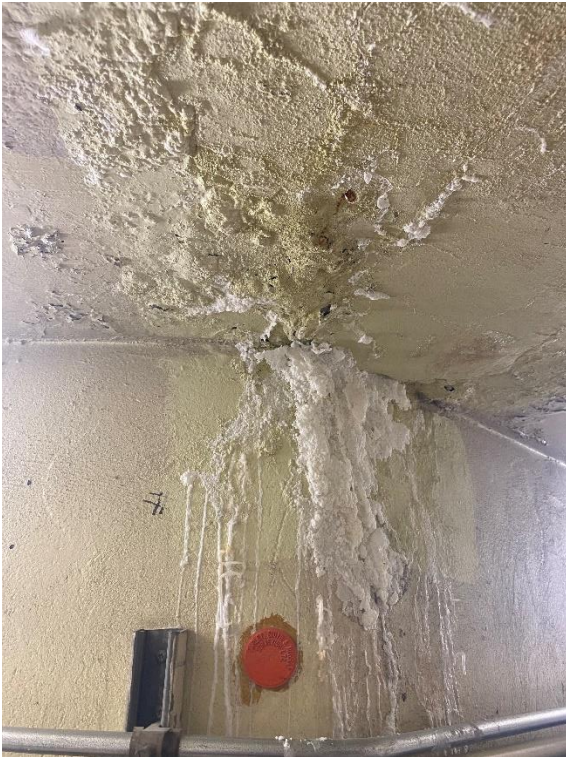
Photo 9: View of water damage observed on the ceiling in the Tunnels during 2023 Reassessment.

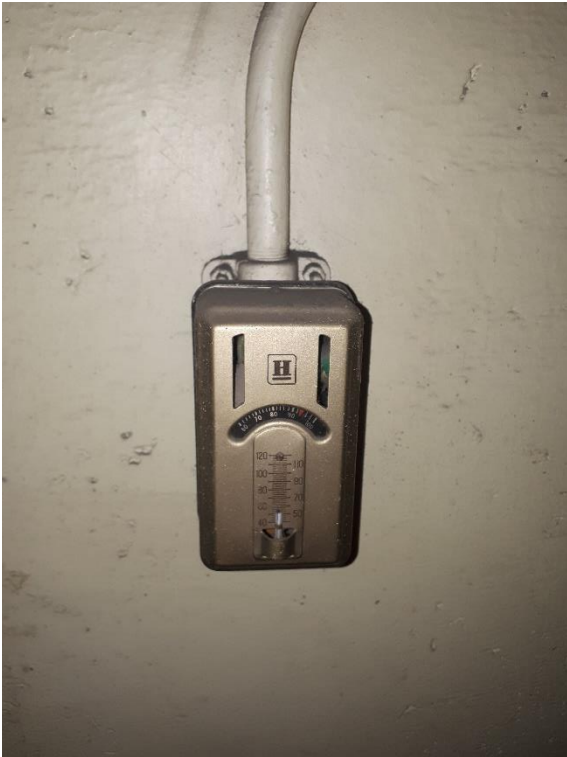
MPL observed thermostats suspected of containing liquid mercury throughout the surveyed area.

Photo 11: View of mercury containing thermostats observed throughout the tunnel system.
