HAZARDOUS MATERIALS SURVEY AND 2023 REASSESSMENT UNIVERSITY CENTRE (UCU), OTTAWA, ONTARIO

Project No.: Z1920014HZ / CCC-230252-00

University of Ottawa

February 20, 2024

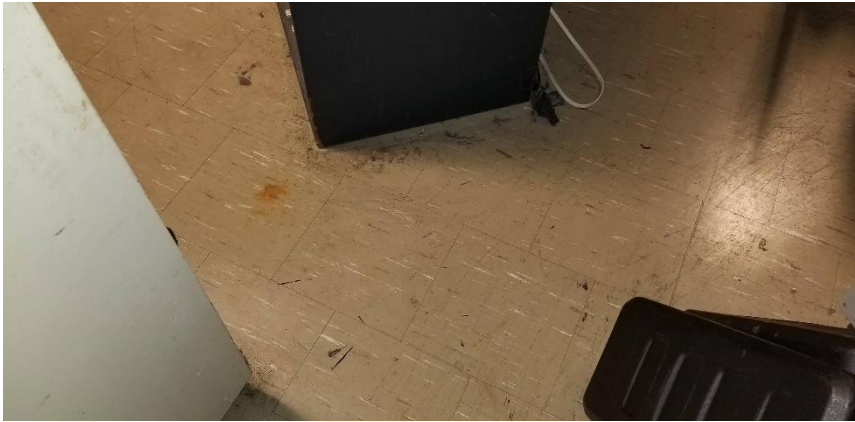
- Vinyl floor tiles (12"x12"-Beige w/ White and Brown Flakes) was observed and previously sampled from Room 100G. The laboratory analytical results for the samples collected indicate that this material **contains 1% Chrysotile asbestos**. Visually similar vinyl floor tiles were observed in Room 0014A and 0014B. This material is considered non-friable and was observed to be in good condition. Its associated mastic (Black) does not contain asbestos.

Photo 1: View of asbestos-containing vinyl floor tiles (12"x12"-Beige with White and Brown Flakes) observed to be in good condition in Room 100G.

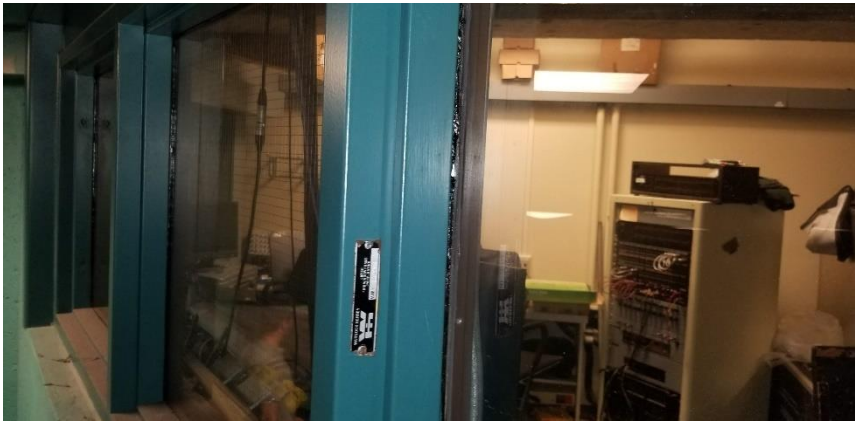
Window caulking (Black) was previously sampled from Room 100G. The laboratory analytical results indicate that this material **contains 8% Chrysotile asbestos**. This material is considered non-friable and was observed to be in good condition.

Photo 2: View of asbestos-containing window caulking (Black) observed to be in good condition outside of Room 100G.

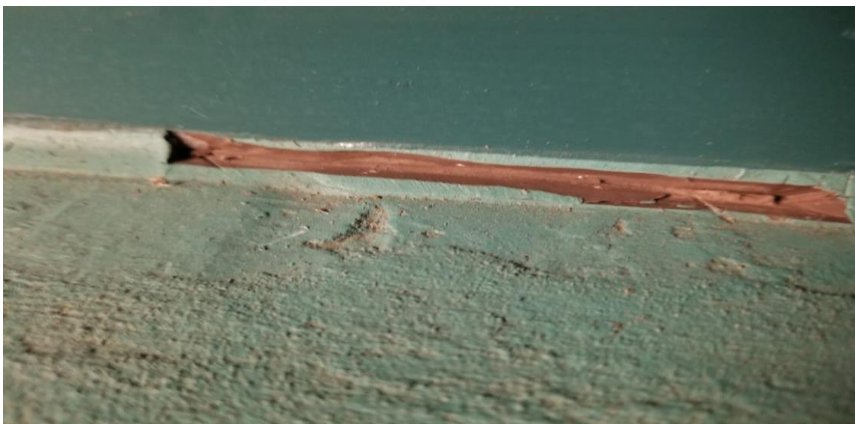
Wall caulking (Brown) was previously sampled from Room 100G. The laboratory analytical results indicate that this material **contains 5% Chrysotile asbestos**. This material is considered non-friable and was observed to be in good condition.

Photo 3: View of asbestos-containing wall caulking (Brown) observed to be in good condition in Room 014.

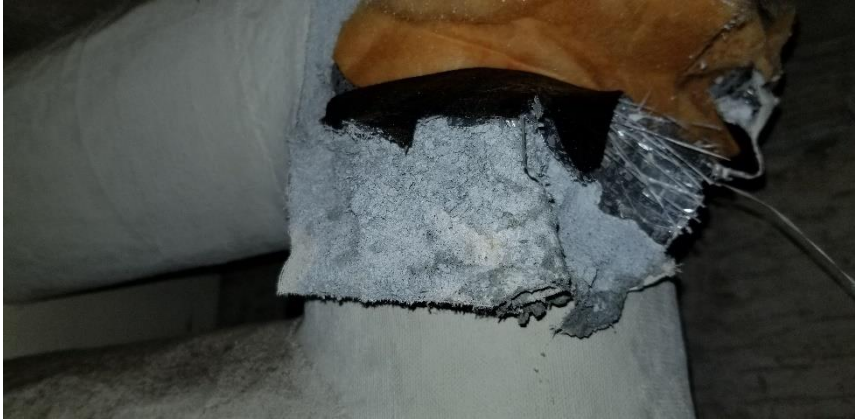
Mechanical pipe elbows/fittings insulation was observed and previously sampled from foam insulation pipe in Room 0029, 014B and 100G. The laboratory analytical results from the samples collected indicate that the

parging cement **contains 20-60% Chrysotile asbestos**. This material is considered friable and was observed to be in good condition.

Photo 4: View of asbestos-containing parging on pipe fitting observed in Room 100G.

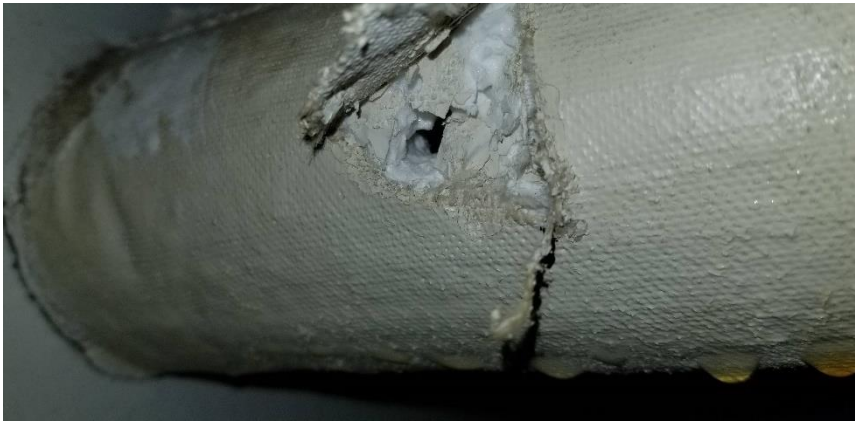
Photo 5: View of asbestos-containing parging observe in pipe straight in Room 0029.

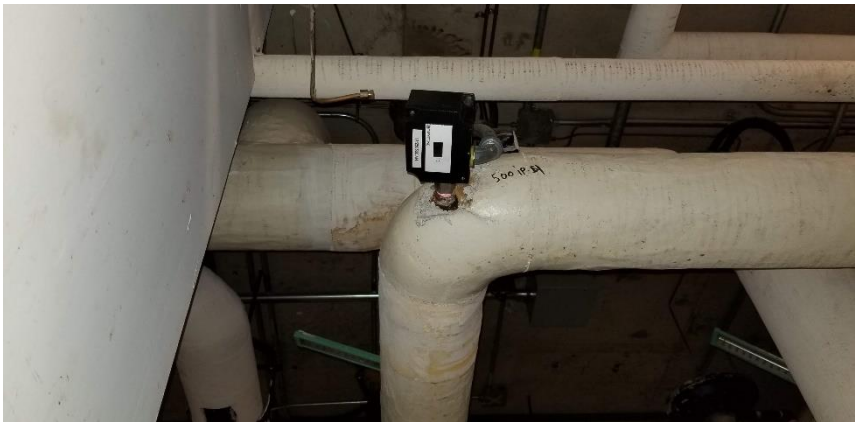
Mechanical pipe elbows/fittings insulation previously identified and was observed 0013, 0014, 0016, 0031, 0033, 0033D, 0033A, 02, 015, 035G, 100D and 202A. The laboratory analytical results indicate that the paring cement **contains 35-60% Chrysotile asbestos**. This material is considered friable and was observed to be in good condition with the exception of select areas that were observed to be in poor condition.

Photo 6: View of asbestos-containing parging cement on pipe fitting observed to be in poor condition in Room 0033H.

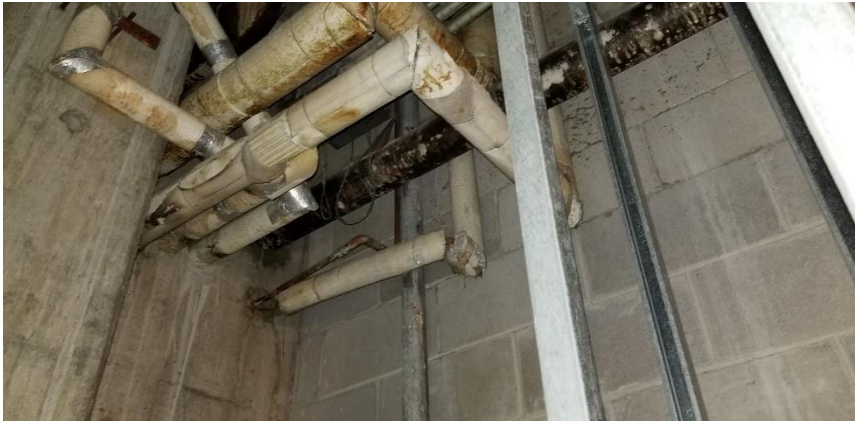
Previously identified asbestos-containing Aircell pipe insulation was observed in Room 003, 0018, 0023, 0030, 0033A, 02, 03, 08A, 018, 034A, 034B, 035G, 100D, 202A and 211. The Aircell pipe insulation **contains 40-45% Chrysotile asbestos**. This material is considered to be friable and was observed to be in good condition with the exception of select areas that were observed to be in poor condition.

Photo 7: View of asbestos-containing mechanical pipe straight insulation (AirCell) observed to be in poor condition in Room 0033B.

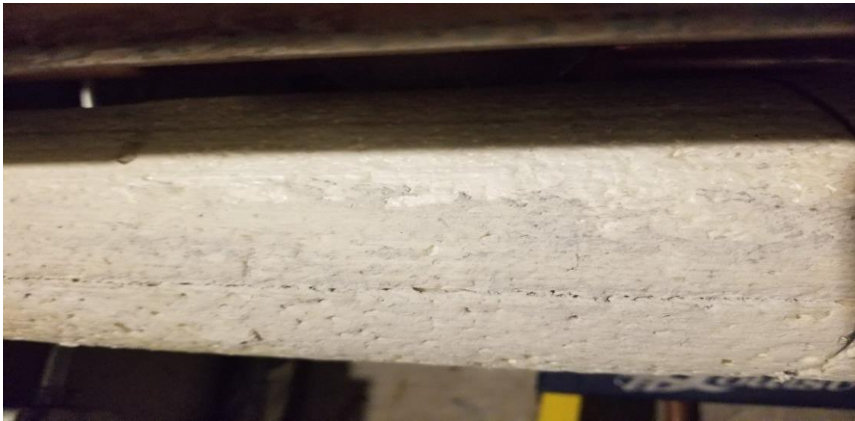
Photo 8: View of asbestos-containing parging on foam pipe insulation observed to be in good condition in Room 0027.

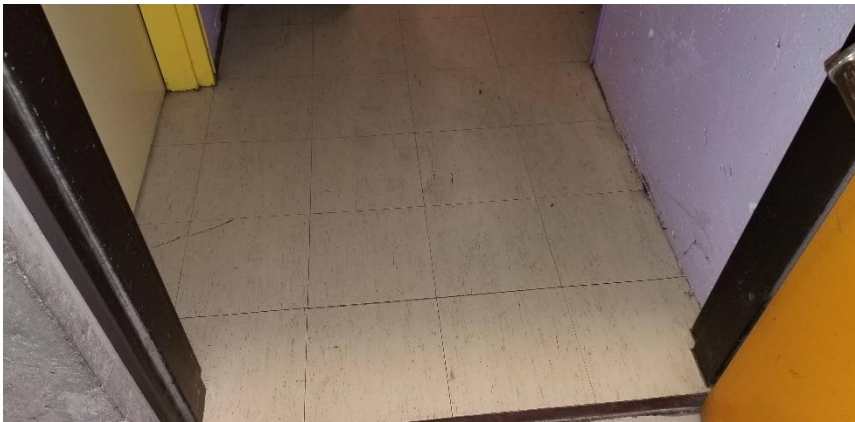
- Vinyl floor tiles (12"x12"-Beige w/ Brown Spots) previously identified to **contain 14.6% Chrysotile asbestos** were observed in Room 002, 003, 004, 005, 006, 0015, 0015A, 03F, 018B, 034B, 034D, 036, 100D, 128, 201A, 202A, 202B, 203, 211, 211D, 212, 215A, 300, 301A, 301C, 306A, 306B, 306C, 306D, 306F, 327, 330 and 332. This material is considered non-friable and was observed to be good condition.

Photo 9: View of previously identified asbestos-containing vinyl floor tiles (12"x12" - Beige with Brown Spots) observed to be in good condition in the hallway of 002 and in adjacent rooms.

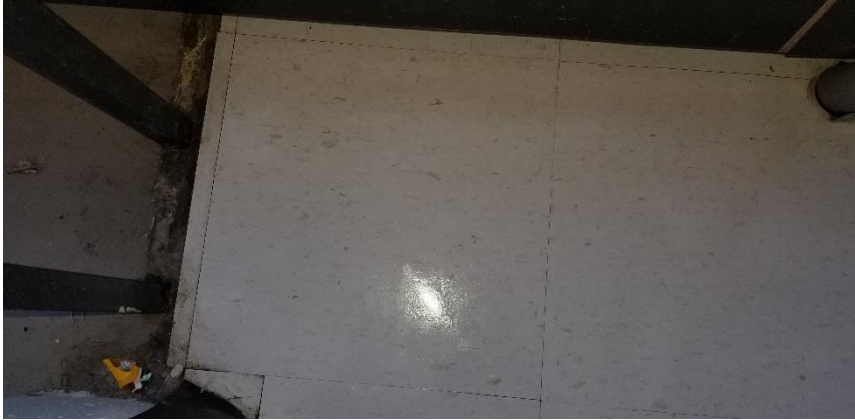
Photo 10: View of asbestos-containing vinyl floor tiles (12"x12"-Beige with Gray Flakes) observed to be in good condition at the A03 stairwell landing.

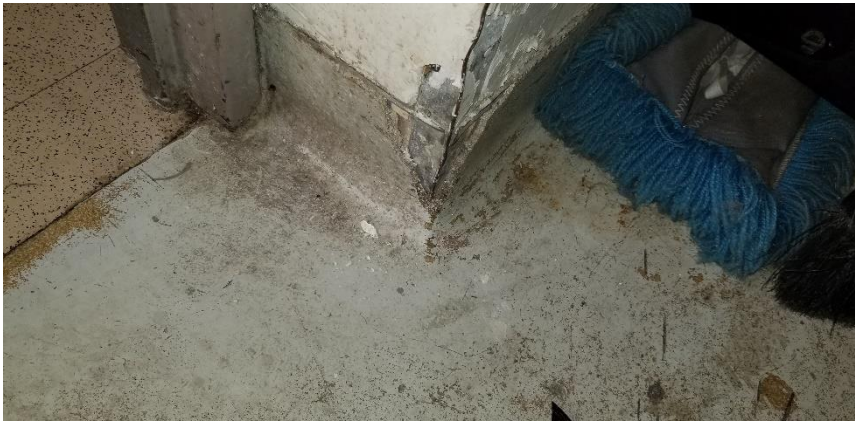
Cementitious floor coating finishes (Grey) were observed and previously sampled in Room 210. The laboratory analytical results of cementitious coating samples previously collected indicate that this material **contains 1% Chrysotile asbestos**. This material is considered friable and was observed in good condition with the exception of select areas that were observed to be in poor condition.

Photo 11: View of asbestos-containing cementitious floor coating observed in Room 210.

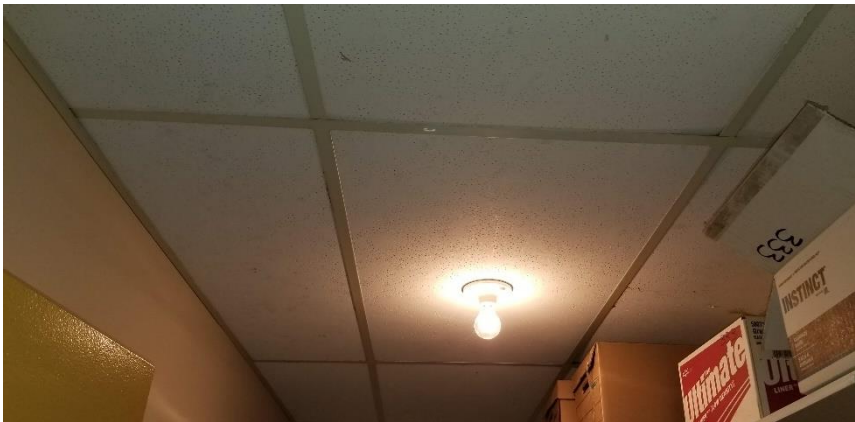
- Suspended ceiling tiles (2'x4'-White w/ Dots) previously identified to **contain 2% Chrysotile asbestos and <1% Amosite asbestos** were observed in the following locations: 002, 003, 004, 005, 0013, 0014A, 0014B, 0018, 0021, 0030, 038B, 101, 102, 102,102C ,102D,102B, 105, 201, 201 A,201B, 202, 202A,

202B, 204, 211J, 212, 215, 215E, 215G, 2015H, 218, 300, 302, 306, 306A, 306B, 306C, 306D, 306F, 309, 318C, 320A, 323, 324, 326, 328, 330, 332, 333B, 337, 336, and 339A. **This material was observed to be in poor condition in Room 002 during the 2023 Reassessment Survey.**

Photo 12: View of asbestos-containing suspended ceiling tiles (2'x4'-White with dots) observed to be in Room 333B.

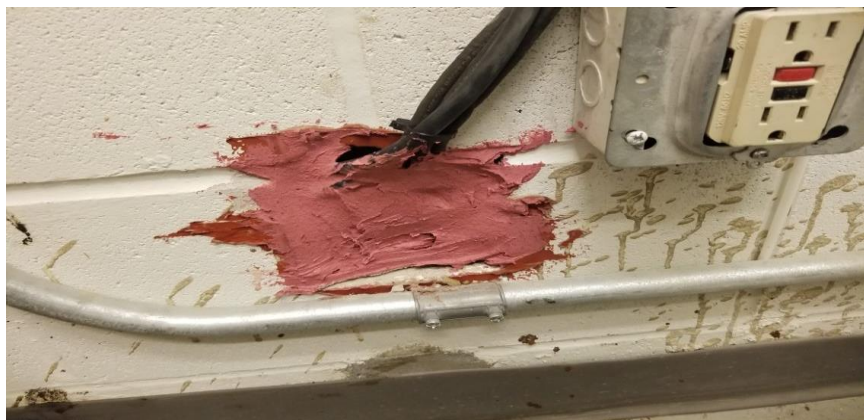
Firestop caulking (Pink) was observed and previously sampled from Room 0027F. The laboratory analytical results from the samples collected indicate that this material does not contain asbestos.

Photo 13: View of non-asbestos containing firestop caulking (Pink) observed in Room 0027F.

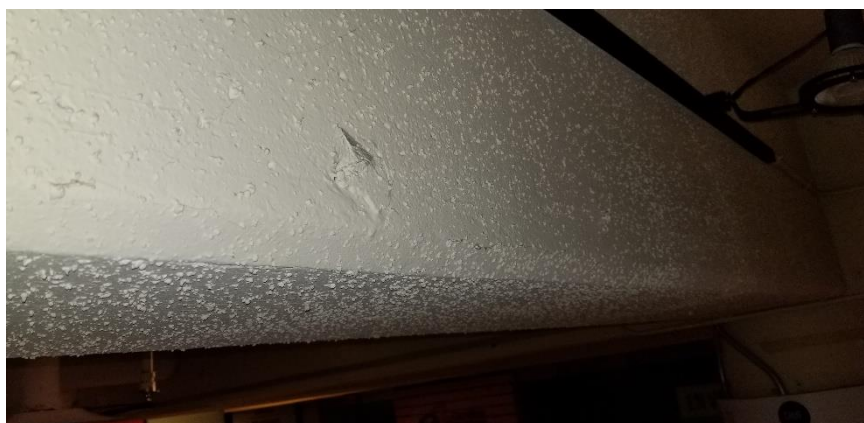
Ceiling texture coat was observed and previously sampled from area 031. The laboratory analytical results for the samples collected indicate that this material does not contain asbestos.

Photo 14: View of non-asbestos containing ceiling texture coat observed on the concrete ceiling deck in the common area 031.

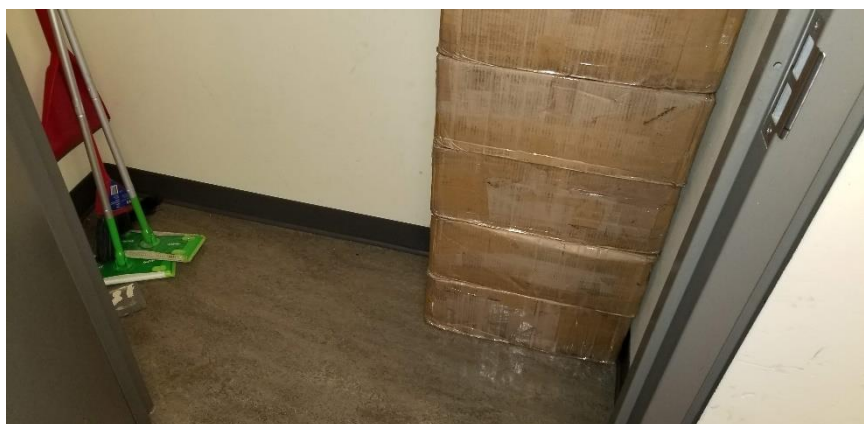
Photo 15: View of non-asbestos containing vinyl sheet flooring (Gray) observed in Room 031C.

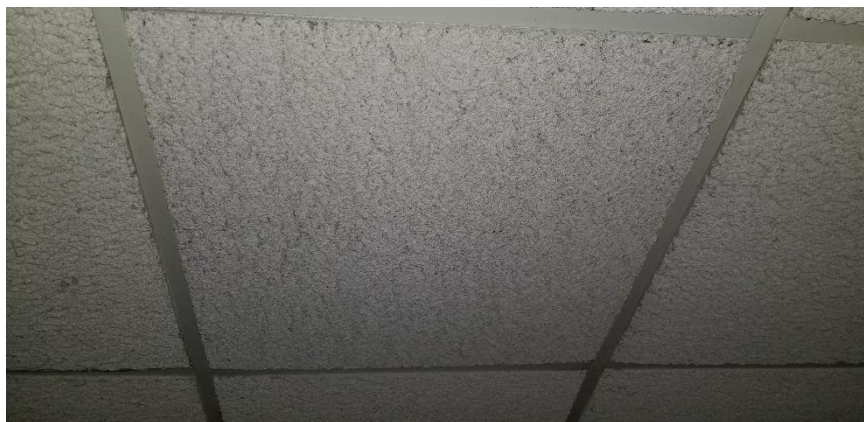
- Suspended ceiling tiles (2'x2'-Deep Texture) were observed and previously sampled in hallway 014. The laboratory analytical results for the samples collected indicate that this material does not contain asbestos.

Photo 16: View of non-asbestos containing suspended ceiling tiles (2'x2'-Deep Texture) observed in 014 Hallway.

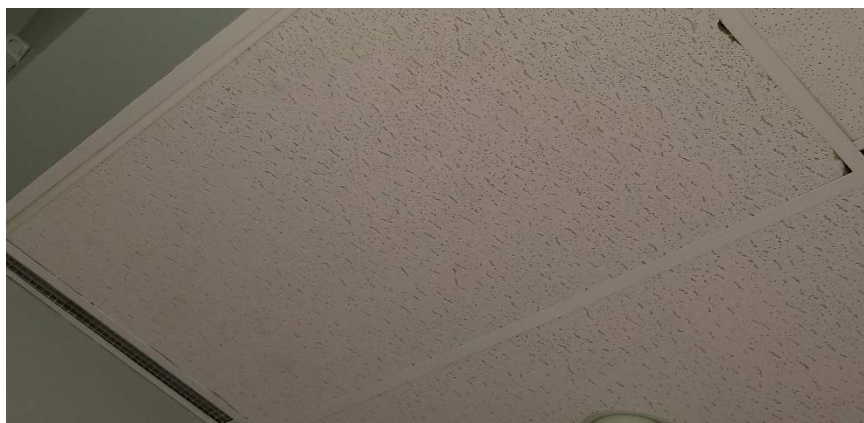
- Suspended ceiling tiles (2'x4'- Pinholes with large fissures) were observed and previously sampled in 211. The laboratory analytical results for the samples collected indicate that this material does not contain asbestos.

Photo 17: View of non-asbestos containing suspended ceiling tiles (2'x4'-Pinholes with Large Fissures) observed in Room 211.

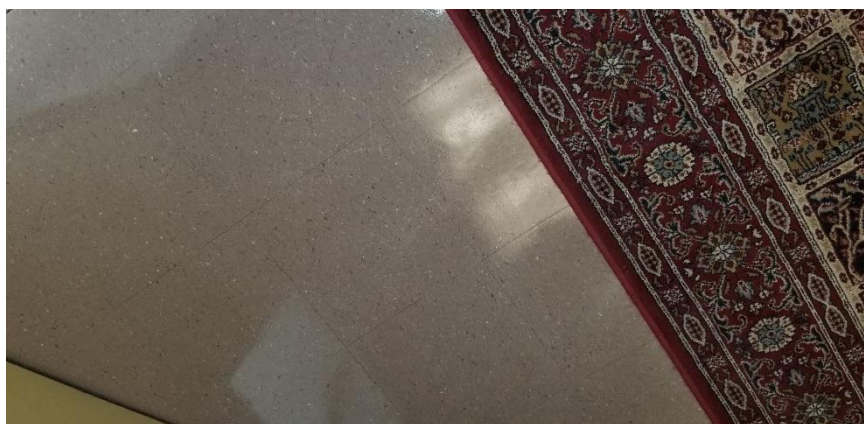
- Vinyl floor tiles (12"x12"-Purple) was observed and previously sampled from Room 324. The laboratory analytical results for the samples collected indicate that this material and its associated mastic (Colourless) do not contain asbestos.

Photo 18: View of non-asbestos containing vinyl floor tiles (12"x12"-Purple) observed in Room 324.

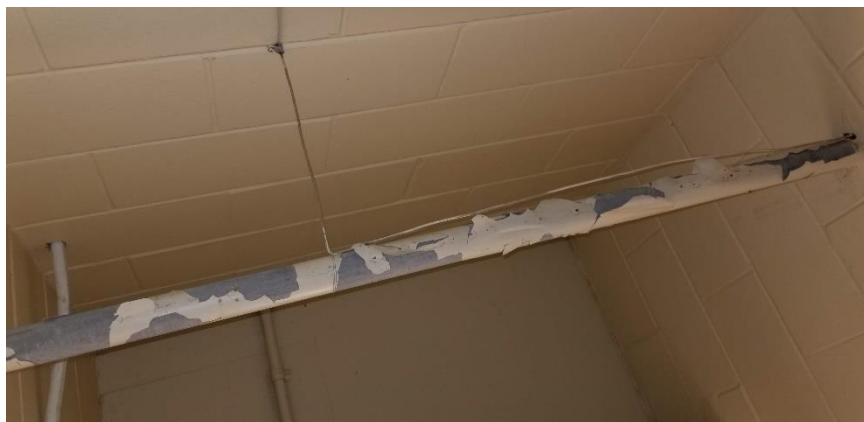
Photo 19: View of lead paint finish (Off-White) observed to be in poor condition on a mechanical pipe in Room 017.

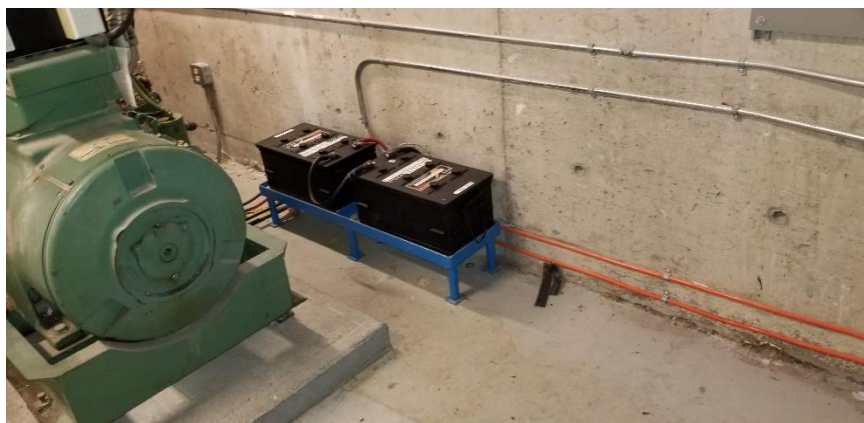
Photo 20: View of lead containing acid batteries observed to be in good condition in Room 0033H.

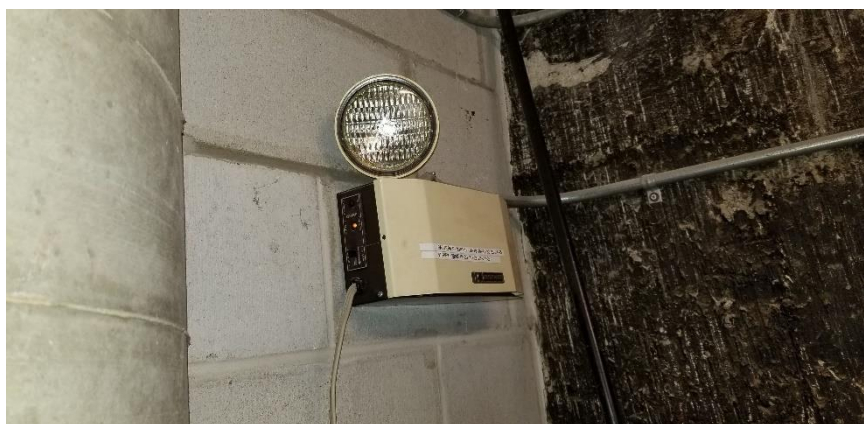
Photo 21: View of lead containing battery packs observed in Room 0033A.

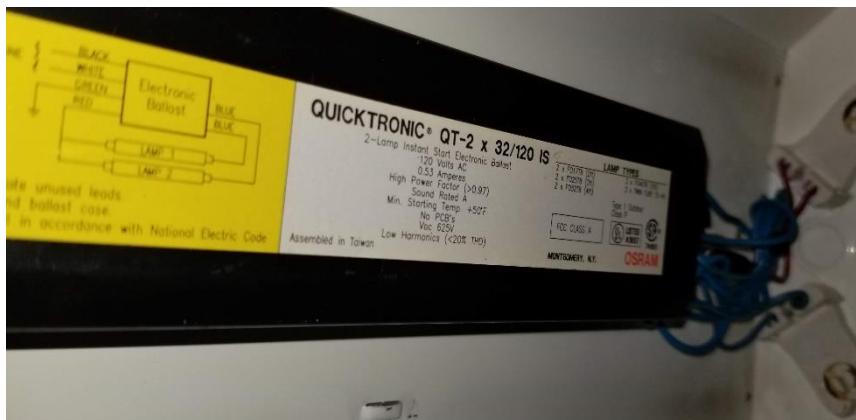
Photo 22: View of non-PCB containing light ballast observed in Room 100G.

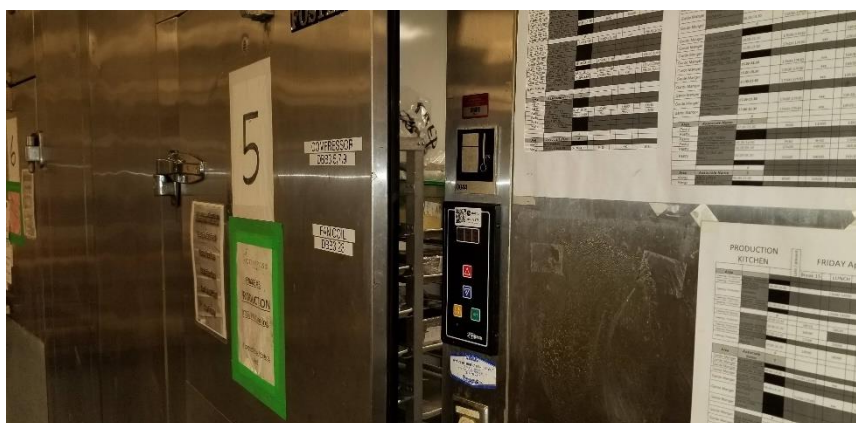
Photo 23: View of Foster walk-in freezer containing R-12 refrigerant in area 0044.

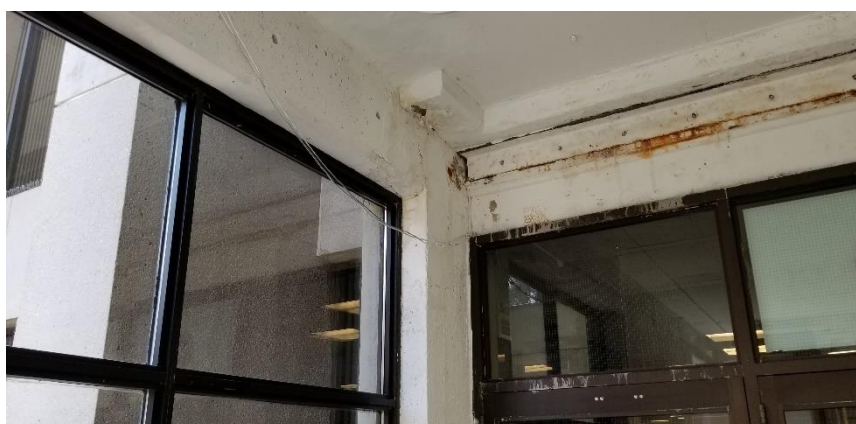
Photo 24: View of water staining observed on concrete ceiling deck and walls in the 022B Hallway.
