# HAZARDOUS MATERIALS SURVEY AND 2023 REASSESSMENT VANIER HALL, OTTAWA, ON

Project No.: Z1920014HZ / CCC-230252-00

Re: Vanier Hall - 136 Jean-Jacques-Lussier Private  
Hazardous Materials Survey and 2023 Reassessment  
McIntosh Perry Limited Reference No. Z1920014HZ / CCC-230252-00

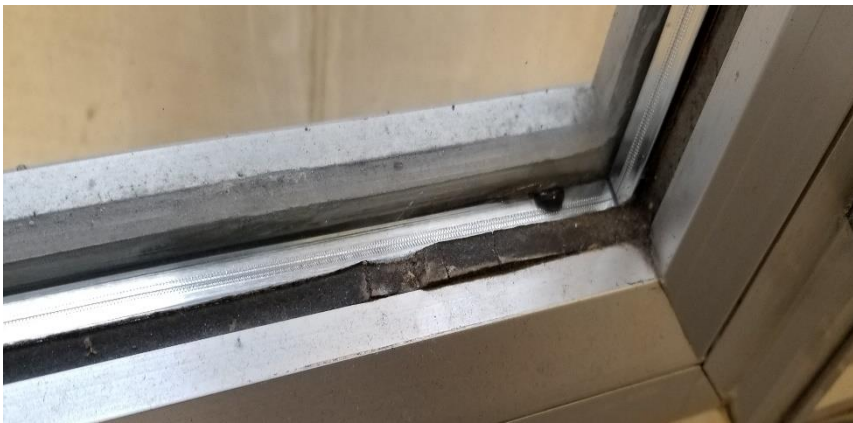
Window caulking (Black) was observed and previously sampled from Room 1070 and all stairwells throughout the subject building. The laboratory analytical results indicate that this material **contains 1% Chrysotile asbestos**. This material is considered to be non-friable and was observed in good condition.

**Photo 2:** View of asbestos-containing window caulking observed to be in good condition in Room 1070 and other stairwells throughout the subject building.

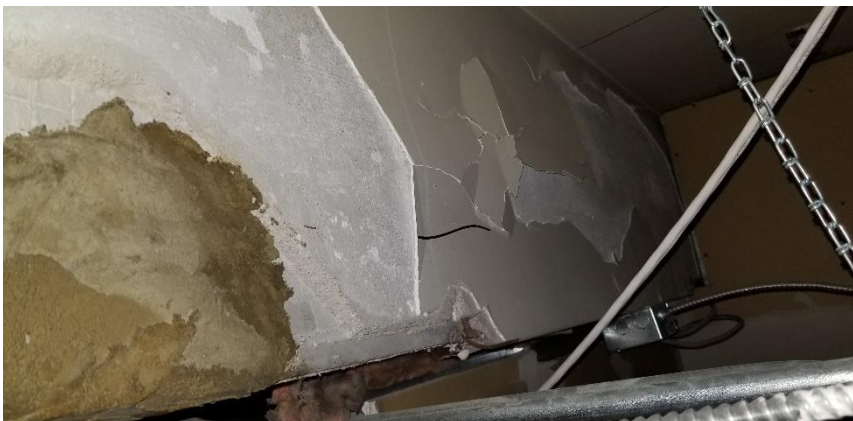
Ceiling and wall plaster were observed and sampled from Room 1026, 5040, 5076, and 5082. The laboratory analytical results for the samples collected indicate that this material **contains 0.5% Chrysotile**. Since plaster is a homogeneous material, all areas must be treated as asbestos-containing unless additional testing confirms otherwise. **This material is considered friable and observed to be in good condition with the exception of select areas that were observed to be in fair and poor condition during the 2023 Reassessment.**

**Photo 3:** View of asbestos-containing wall plaster observed to be in poor condition in Room 5082.

- Asbestos-containing materials identified to be in poor condition must be repaired/removed immediately, following Type 1/2/3 asbestos abatement work procedures as detailed in O. Reg. 278/05 and disposed of as asbestos waste under O. Reg. 347;
- Asbestos-containing materials that have been identified to be in fair condition should be either repaired (where possible) and/or closely monitored for signs of further deterioration. Depending on type of material and location, these materials should be scheduled for removal if there is potential risk of exposure to worker and/or occupants;

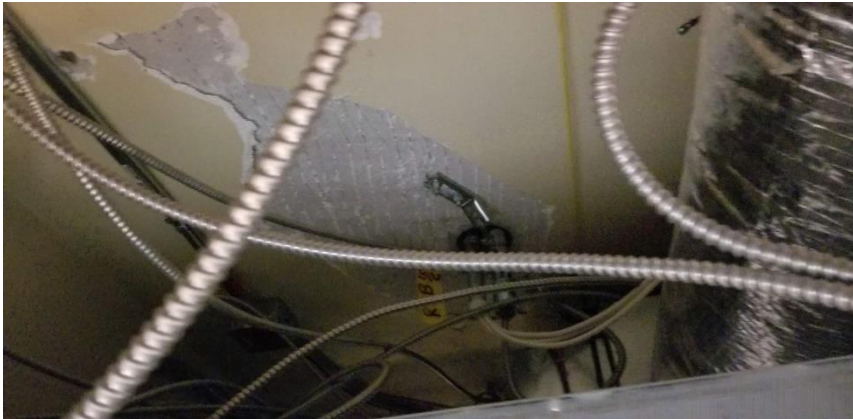
**Photo 4:** View of asbestos-containing ceiling plaster observed to be in poor condition above the suspended ceiling tiles in Room 1026.

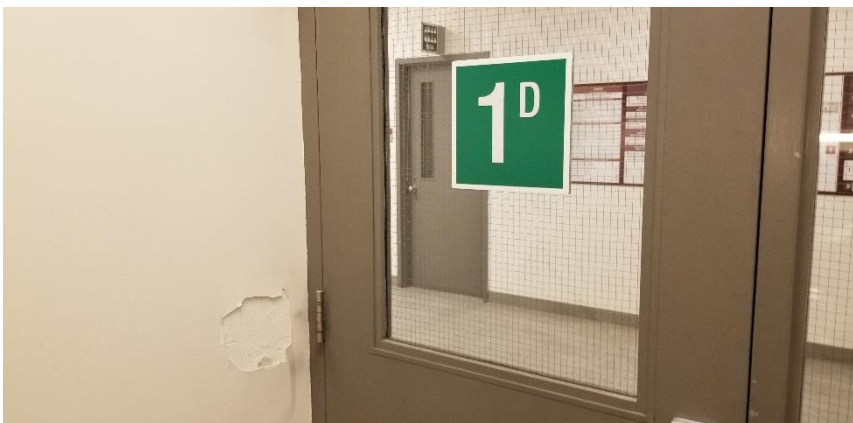
**Photo 5:** View of asbestos-containing wall plaster observed to be in poor condition in Room 1070.

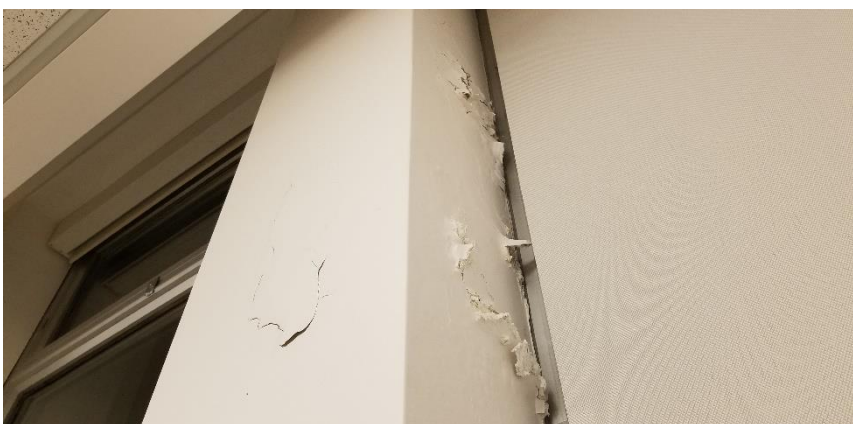
**Photo 6:** View of asbestos-containing wall plaster observed to be in poor condition Room 1076.

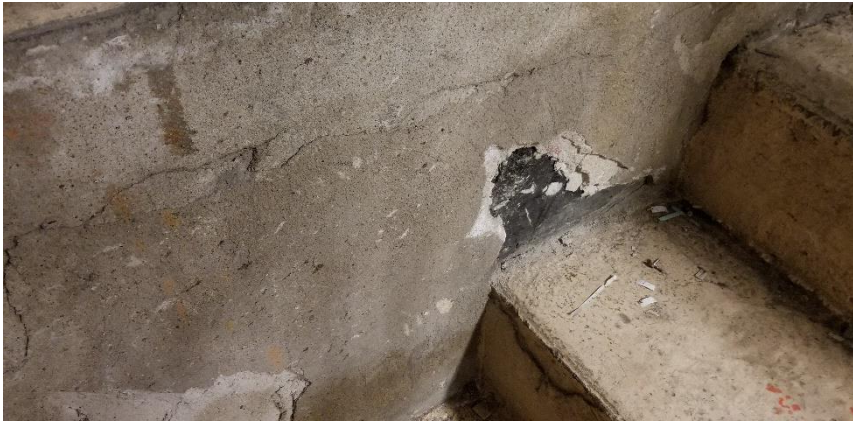
**Photo 7:** View of asbestos-containing wall plaster observed to be in poor condition in Room 0189.

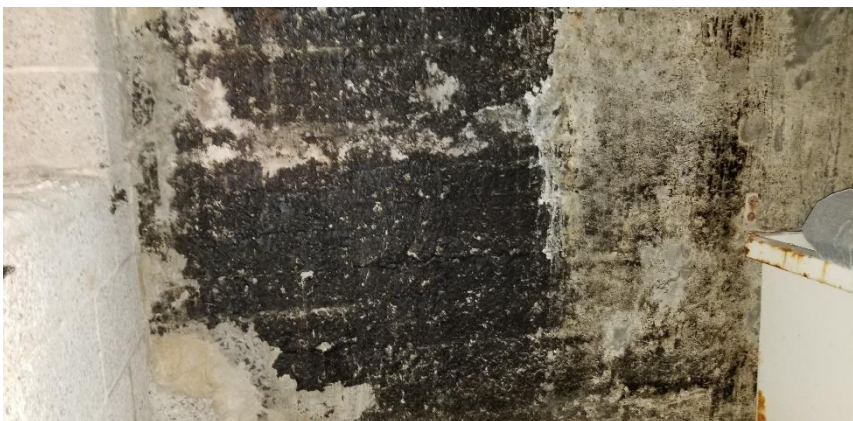
Wall mastic (Black) observed and sampled on the walls of Room 0140. The laboratory analytical results for the samples collected indicate that this material does not contain asbestos.

**Photo 9:** View of non-asbestos containing wall mastic (Black) observed in Room 0140.

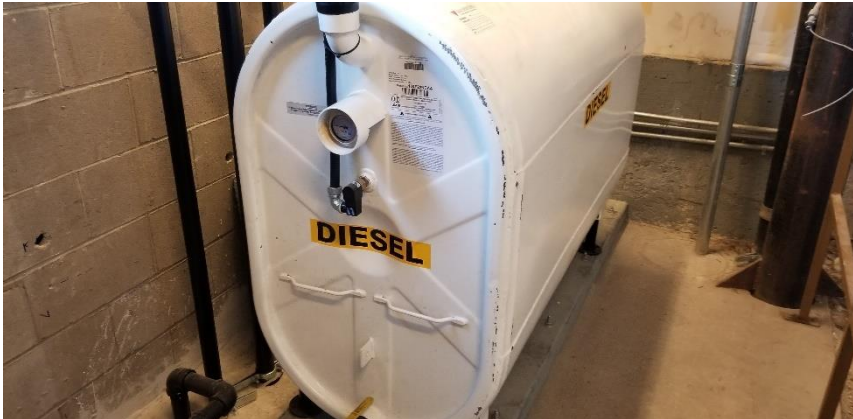
A visual survey of the subject building was conducted to determine if any USTs and ASTs were present. MPL observed one (1) diesel Storage Tanks located in Rooms 0140 and 7028A.

**Photo 10:** View above ground storage tank observed to be in good condition in Room 7028A.

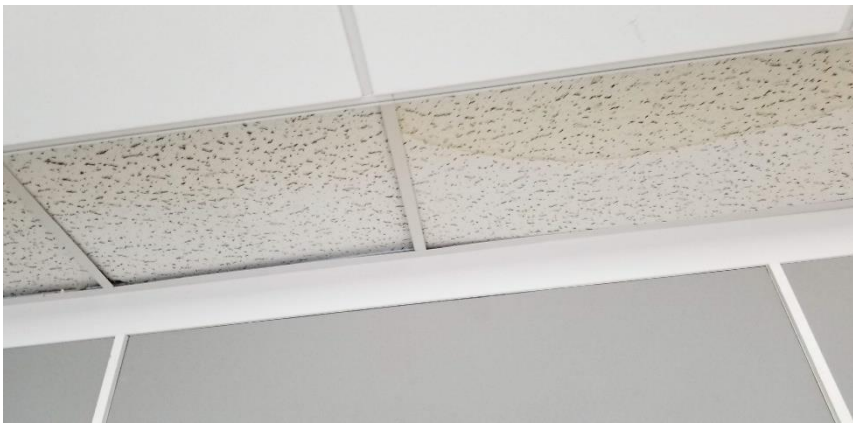
A visual survey of the subject building was conducted to determine if any water damaged was present. **MPL identified select areas throughout the subject building, where materials were affected by water damage during the 2023 Reassessment.**

**Photo 11:** View of water-staining observed on suspended ceiling tiles in Room 5069A.

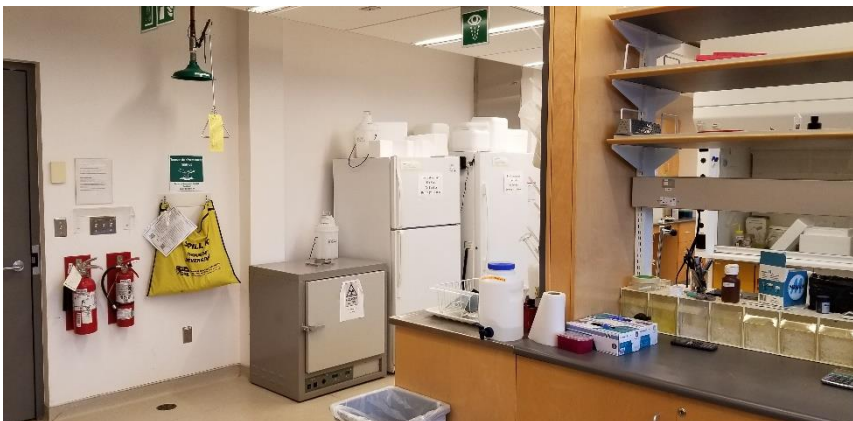
**Photo 12:** View of storage unit containing radioactive materials observed to be in good condition in Room 2041.

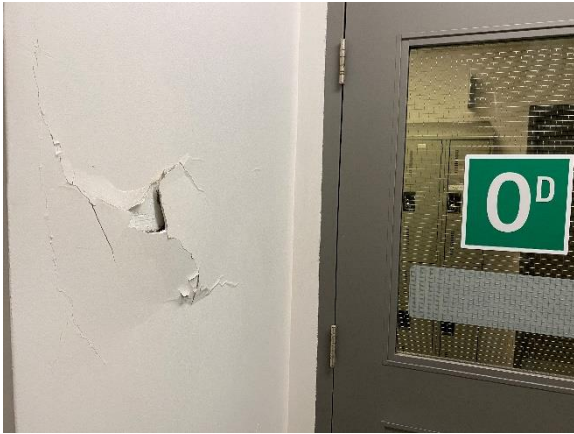
**Photo 13:** View of asbestos-containing plaster wall observed to be in poor condition in Room 0170 during the 2022 Reassessment.

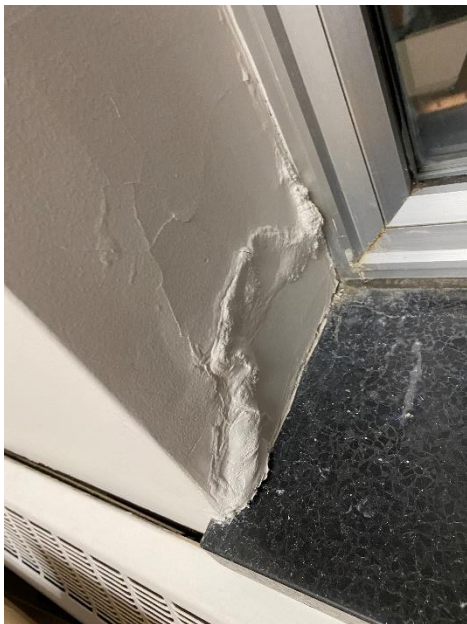
**Photo 15:** View of asbestos-containing plaster wall observed to be in poor condition in Room 3065 during the 2022 Reassessment.

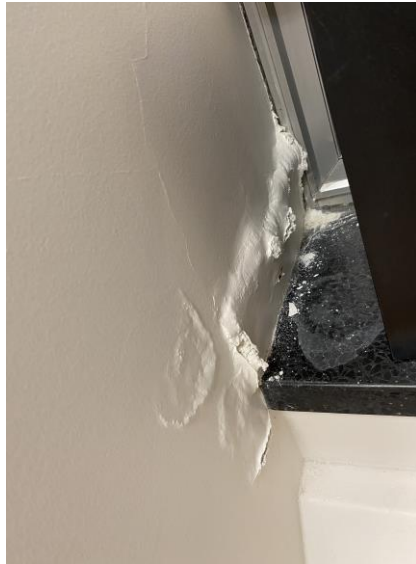
**Photo 16:** View of the water damaged asbestos-containing plaster wall observed to be in poor condition in Room 3079 during the 2022 Reassessment.

Water stained/damaged wall and ceiling plaster that is also determined to contain asbestos must be replaced following appropriate asbestos abatement procedures as outlined in O.Reg. 278/05.
