HAZARDOUS MATERIALS SURVEY AND 2025 REASSESSMENT TABARET HALL, OTTAWA, ON

Project No.: CCO-252985-00

Prepared for:
University of Ottawa

February 25, 2026

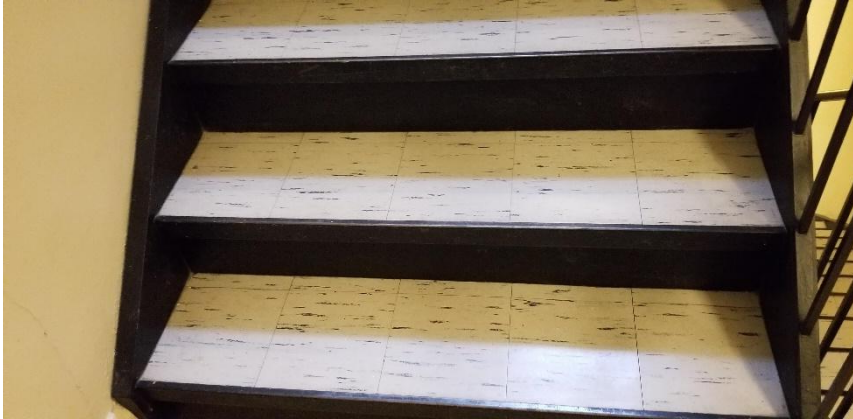
Photo 1: View of asbestos-containing vinyl floor tiles (9"x9"-White and Black) observed to be in good condition in C207C.

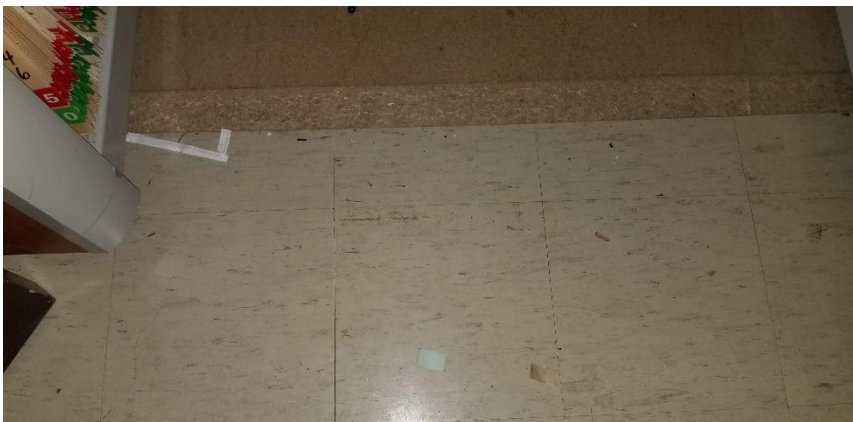
- Previously identified vinyl floor tiles (12"x12"- Cream and Brown Coloured) were observed in Rooms W0011H, W0017, W0023, W0033, W0035, W0037, W0041, W0043, N009, C450C, and C459. This material **contains 8.7% Chrysotile asbestos**. This material is considered to be non-friable and was observed to be in good condition with the exception of select areas that were observed to be in fair condition. Visually similar vinyl floor tile was observed enclosed under a 2nd layer of flooring in Room W0029. Although the condition of the vinyl floor tiles could not be assessed, this material is non-friable and considered to be enclosed within multiple layers and can remain in place until renovation and/or replacement, as long as it is not damaged or disturbed.

Photo 2: View of asbestos-containing vinyl floor tiles (12"x12"-Cream and Brown Coloured) observed to be in good condition in Room W0041.

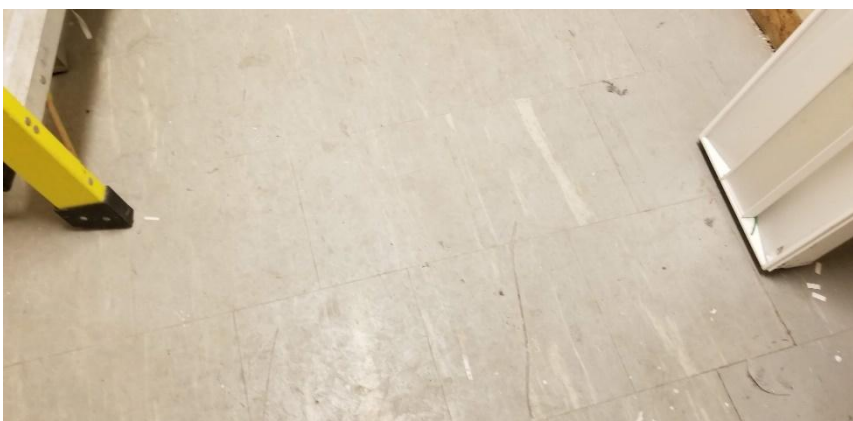
Photo 3: View of asbestos-containing vinyl floor tiles (9"x9"-Grey Coloured) observed to be in good condition in Room C08.

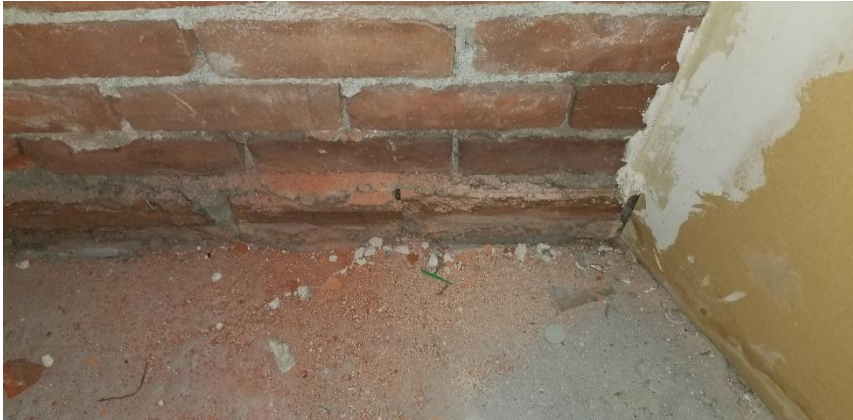
Photo 4: View of the asbestos-containing brick mortar observed to be in poor condition in Room C455.

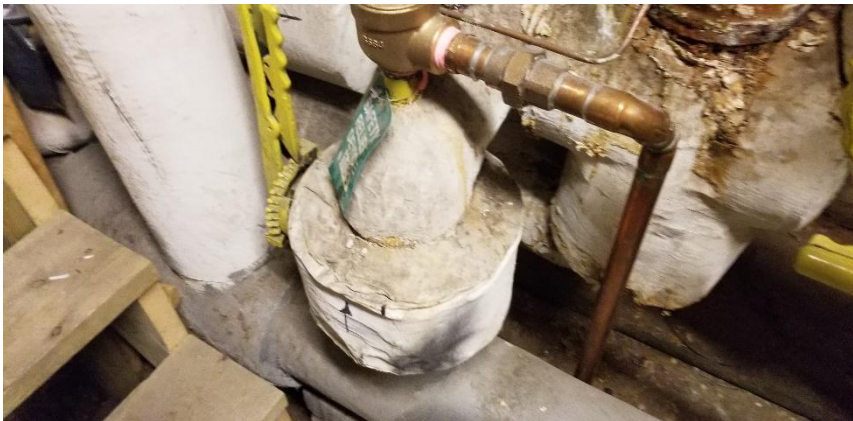
Previously identified asbestos-containing mechanical pipe elbows/fittings insulation was observed in Rooms M0013, M0016, M0018, M0019, N001A, N002, C01, C01B, C01D, L064B, L070D, C111, N103, and N107A. This material is considered to be friable. This material was observed to be in good condition.

Photo 5: View of asbestos-containing mechanical pipe fitting insulation observed to be in good condition in Room C01B.

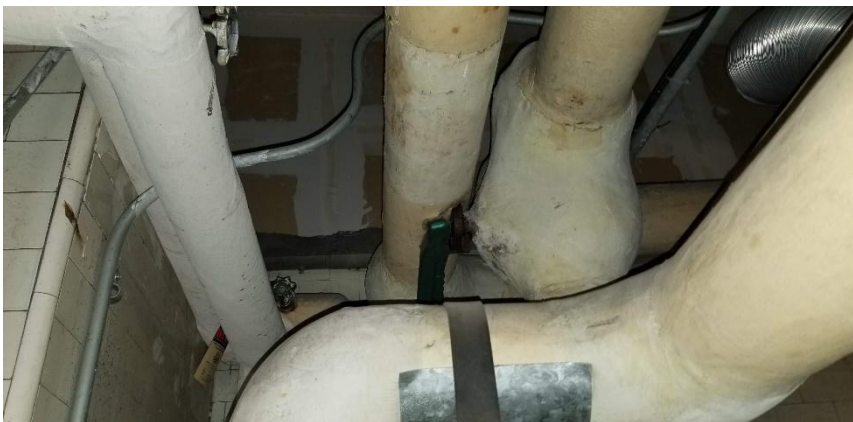
Photo 6: View of asbestos-containing mechanical pipe fitting insulation observed to be in good condition in Room C01D.

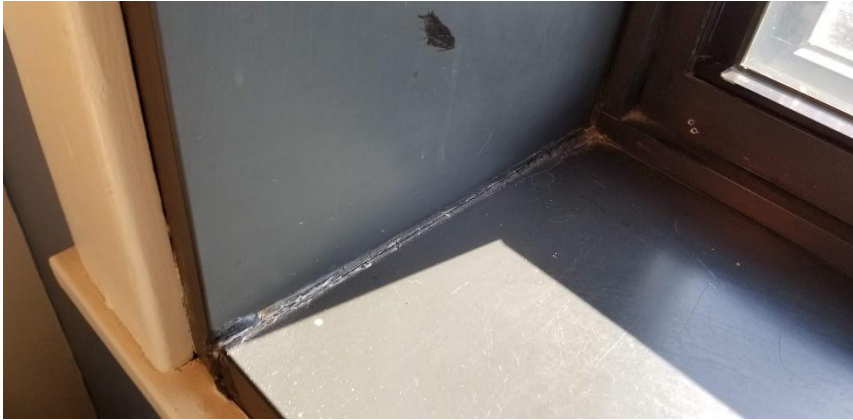
Photo 7: View of asbestos-containing window frame caulking observed to be in fair condition in Room M386F.

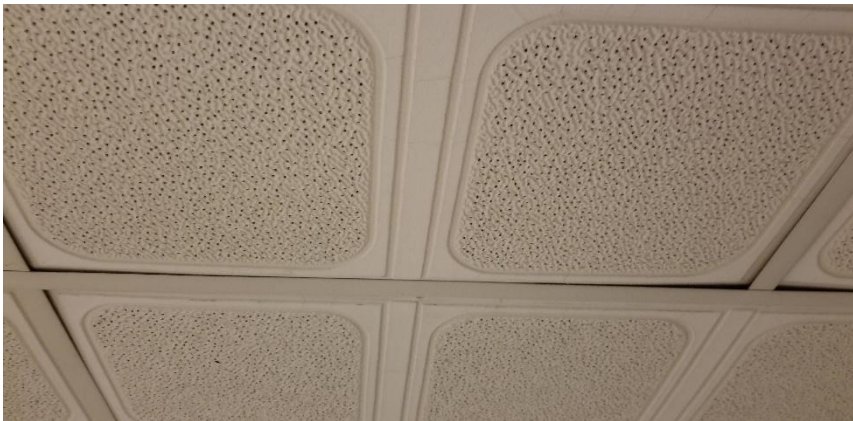
- Previously identified suspended ceiling tiles (2'x4' Suspended Ceiling Tiles, square pattern with pinholes) were observed and sampled from room C219A. The laboratory analytical results of samples collected indicate that this material does not contain asbestos.

Photo 8: View of non-asbestos containing suspended ceiling tiles (2'x4'-Square Pattern with Pinholes) observed in Room C219.

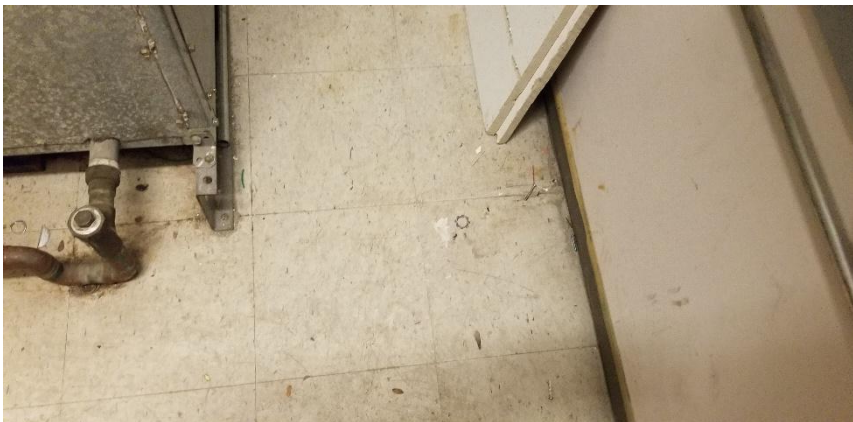
Photo 9: View of non-asbestos containing vinyl floor tiles (12"x12"-Off White with Small Grey Streaks) observed in Room N0122B.

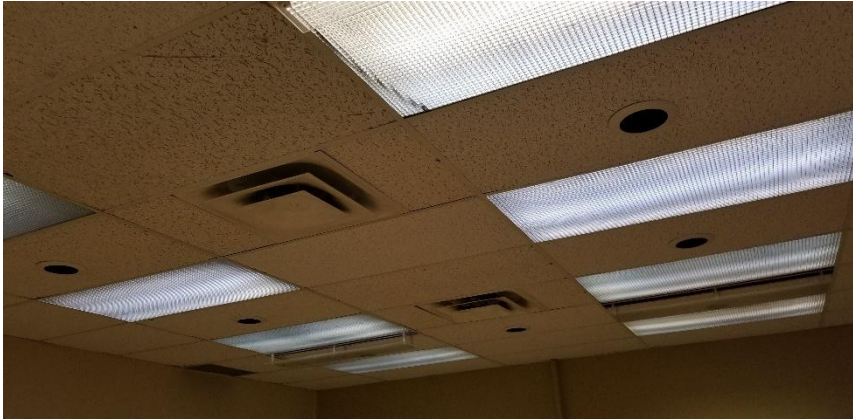
- Previously identified suspended ceiling tiles (2'x4'-White Tone) were observed in Rooms W007, W0011(A, B, C, D, E, F, G, H), W0013, W0015, W0021, W0029, W0031, W0031(A, B, C, D), W0045, C012, C012A, C017B, C017D, M089, M092, N0105, W021, W023, W023(A, B, C, D, E, F, G), W024, W027, W030, W030A and W035. This material **contains 2% Chrysotile asbestos**. This material was observed to be in good condition

Photo 10: View of asbestos-containing suspended ceiling tiles (2'x4"-White Tone) observed to be in good condition in Room C012A.

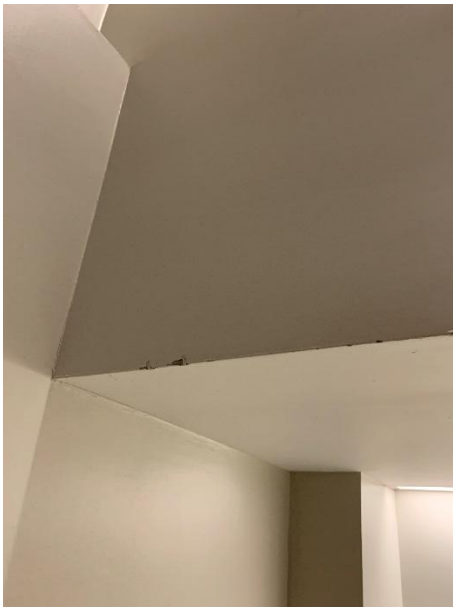
Photo 11: View of asbestos-containing ceiling plaster and drywall joint compound observed throughout the building.

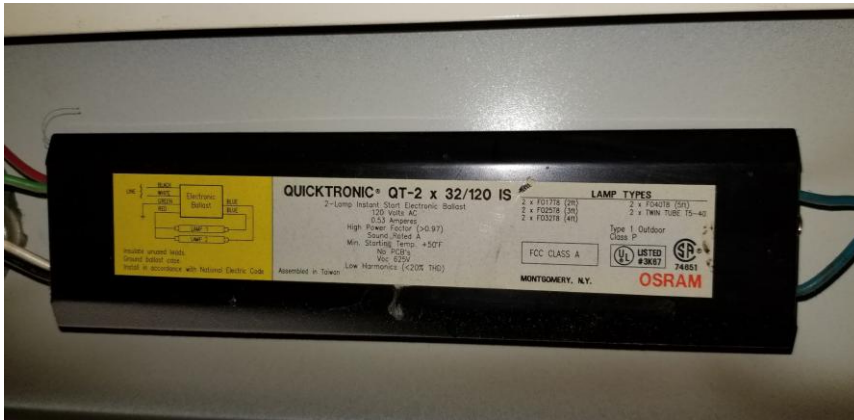
Photo 12: View of non-PCB Containing light ballasts observed in C459.

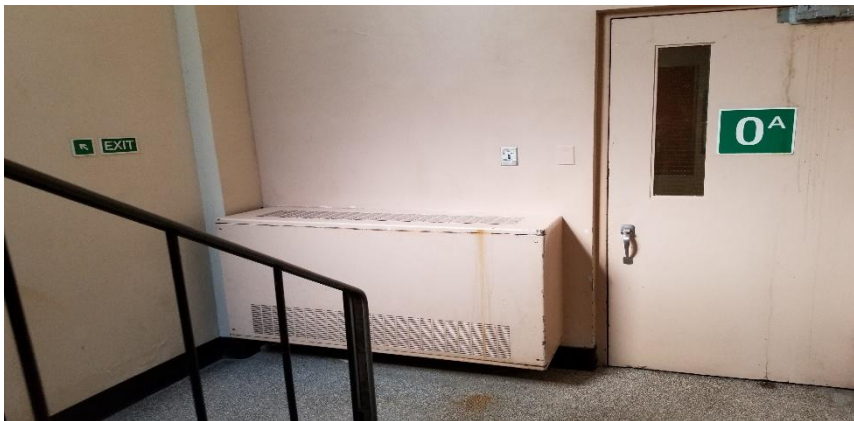
Photo 13: Typical view of low-level lead containing pink paint finish observed to be in good condition on radiators and walls throughout the subject building.
