HAZARDOUS MATERIALS SURVEY AND 2025 REASSESSMENT MONTPETIT HALL – 125 UNIVERSITY PRIVATE, OTTAWA, ON

Project No.: CCO-252985-00

University of Ottawa

March 20, 2026

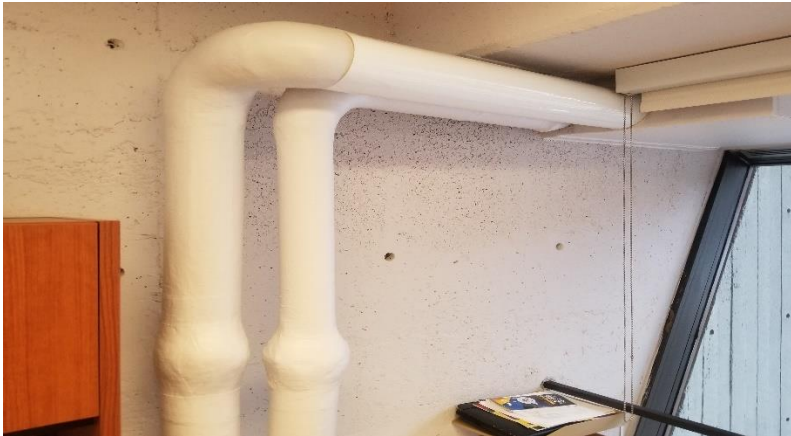
Previously identified asbestos-containing parging cement mechanical insulation on pipe elbows/fittings were observed in Rooms 0012, 002, 003B, 002A, 007B, 007A, 009, 0012, 011, 02C, 022, 023, 024, 050, 051,213, 200, 205A, 216, 306B, 311D, 316A. This material was previously sampled was determined to **contain between 5-60% Chrysotile asbestos** and is considered to be friable. This material was observed to be in good condition during the 2025 Reassessment.

Photo 1: View of asbestos-containing pipe fitting insulation observed in Room 306B.

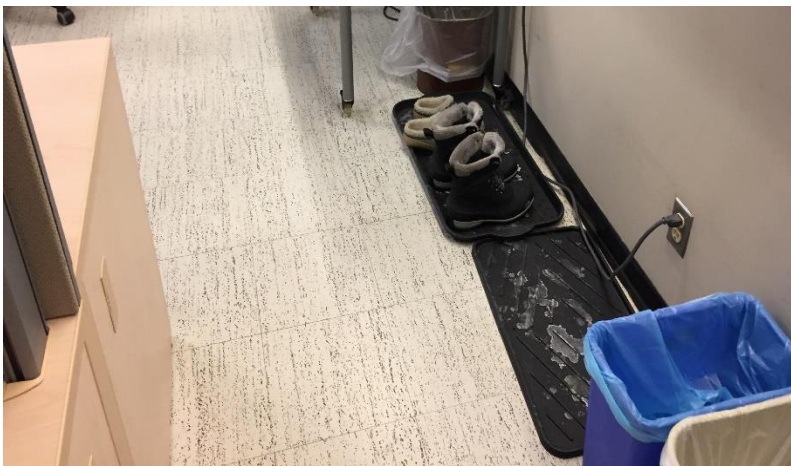
- Previously identified asbestos-containing vinyl floor tiles (12" x 12" – White with Black Dots) were observed in Room 300, 301C, 302, 304A 428 and 400. This material **contains 39% Chrysotile asbestos** and is considered to be non- friable. This material was observed to be in good condition.

Photo 2: View of asbestos-containing vinyl floor tiles observed in Room 428.

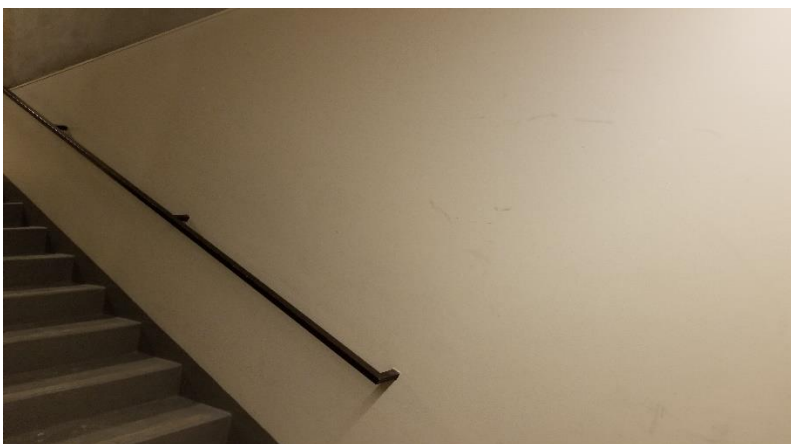
Previously identified asbestos-containing drywall joint compound was observed in Room 404. This material **contains 2% Chrysotile asbestos**. Since drywall joint compound is a homogeneous material, all areas must be treated as asbestos-containing unless additional testing confirms otherwise. This material was observed in good condition.

Photo 3: Typical view of asbestos-containing drywall observed throughout the subject building.

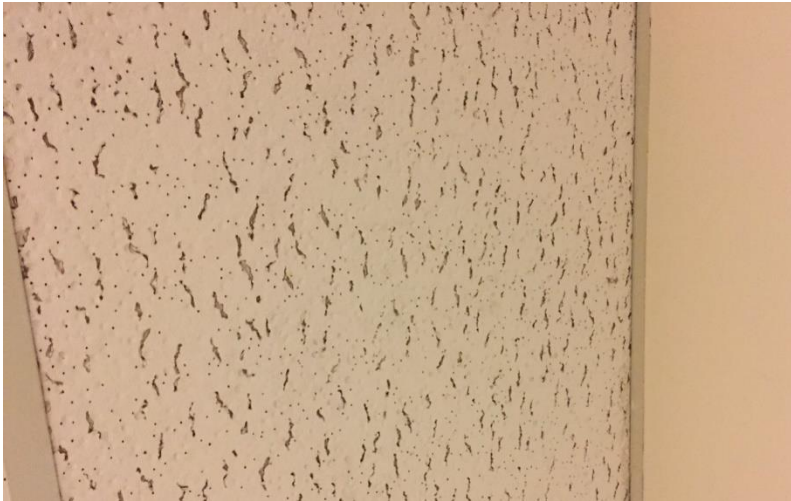
- Suspended ceiling tiles (2'x4' – Pinholes with Wavy Fissures) were observed and previously sampled in Room 415, 405 and 405A. The laboratory analytical results indicate that this material **contains 0.5% Amosite asbestos**. This material was observed to be in good condition.

Photo 4: View of asbestos-containing suspended ceiling tiles observed in Room 415.

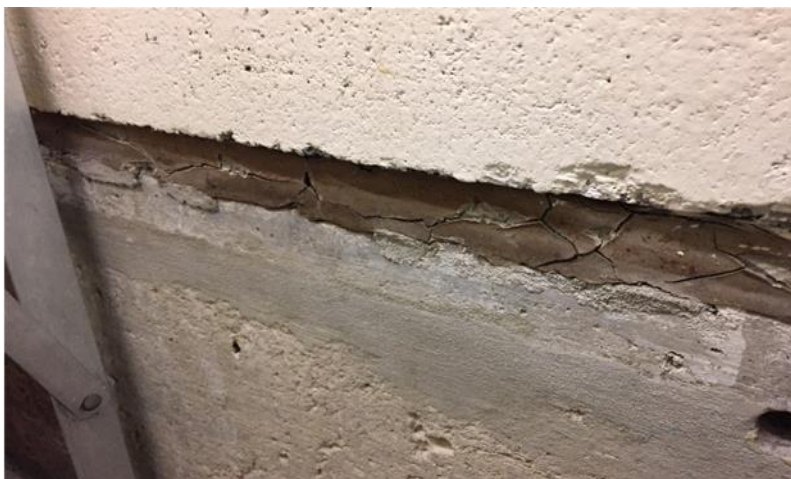
Photo 5: View of asbestos-containing wall caulking (tan) observed in Room 0024 observed to be in fair condition.

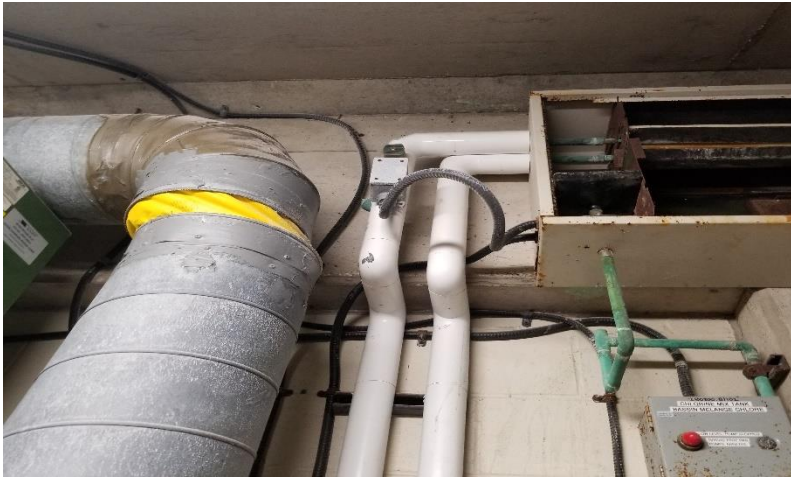
To avoid damage and compromising the integrity of the structure, no bulk samples of the flexible duct connector in Room 020C were collected. Prior to renovation/demolition, flexible duct connector should be examined and tested for asbestos content. Flexible duct connector should therefore be considered to contain asbestos until bulk samples and analysis proves otherwise.

Photo 6: View of flexible duct connector observed in Room 020C suspected to contain asbestos.

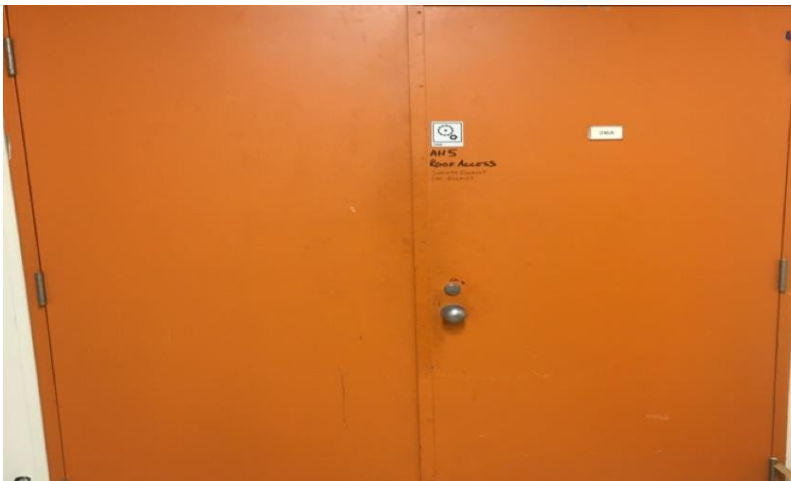
Photo 7: View of orange lead-containing paint observed on the door of Room 316.

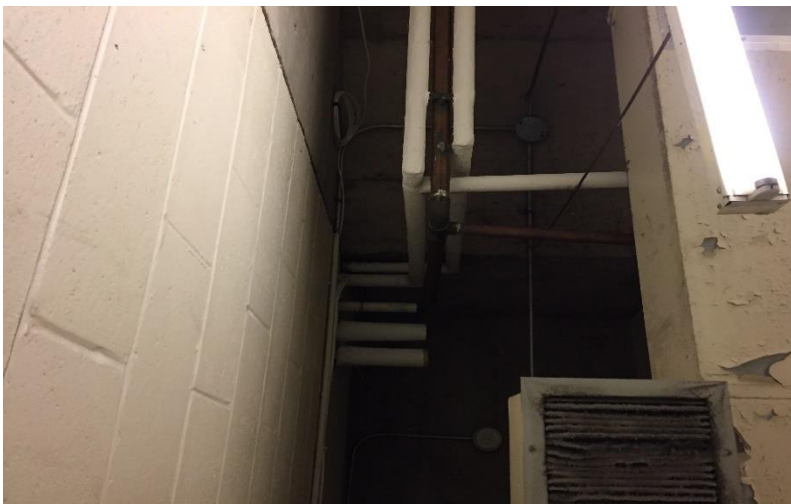
Photo 8: View of lead containing beige paint observed to be in poor condition in Room 023A.

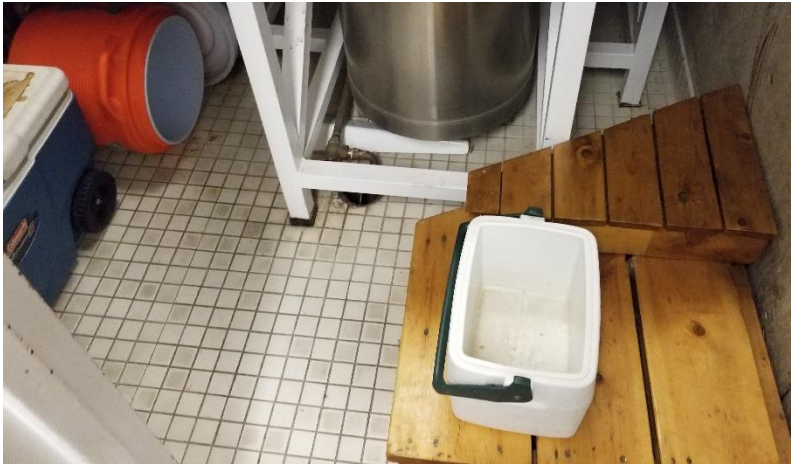
To avoid damage and compromising the integrity of the structure, no bulk samples of the ceramic wall/floor tile grout were collected. Prior to renovation/demolition, ceramic wall/floor tile grout should be examined and tested for asbestos content. Ceramic wall/floor tile grout should therefore be considered to contain asbestos until bulk samples and analysis proves otherwise.

Photo 11: View of ceramic floor tiles grout observed throughout the subject building suspect to contain asbestos.

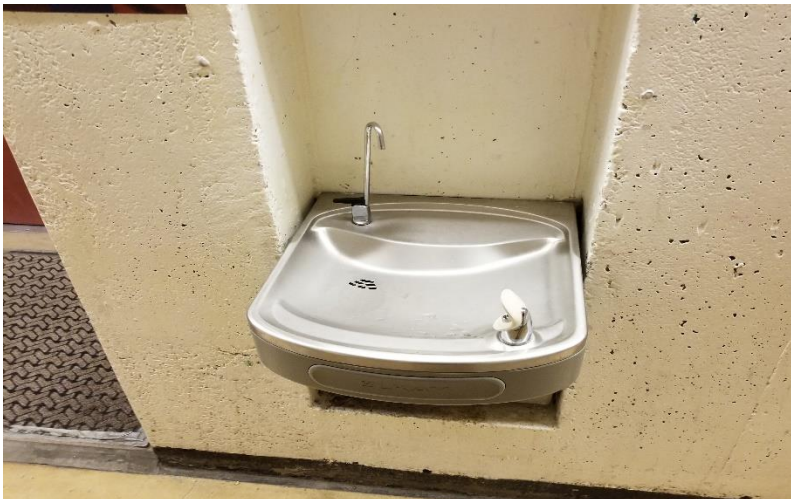
Photo 12: Typical view ODS containing water fountains observed throughout the subject building.
