HAZARDOUS MATERIALS SURVEY AND 2025 REASSESSMENT 112 HENDERSON AVENUE, OTTAWA, ON

Project No.: CCO-252985-00

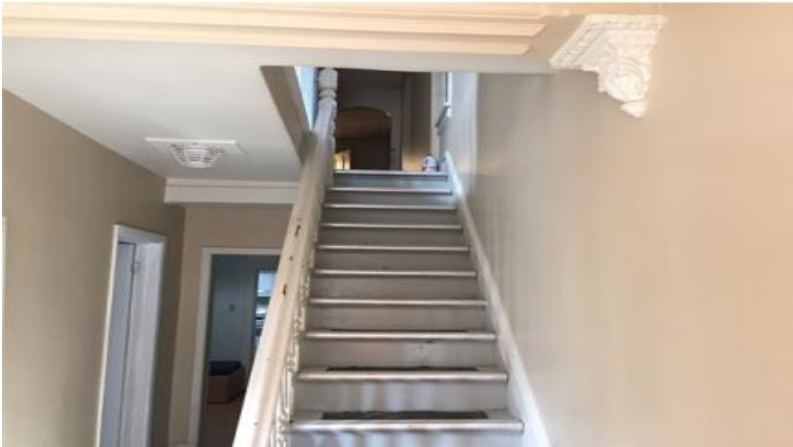
Photo 1: View of typical finishes observed at the building located at 112 Henderson Avenue.

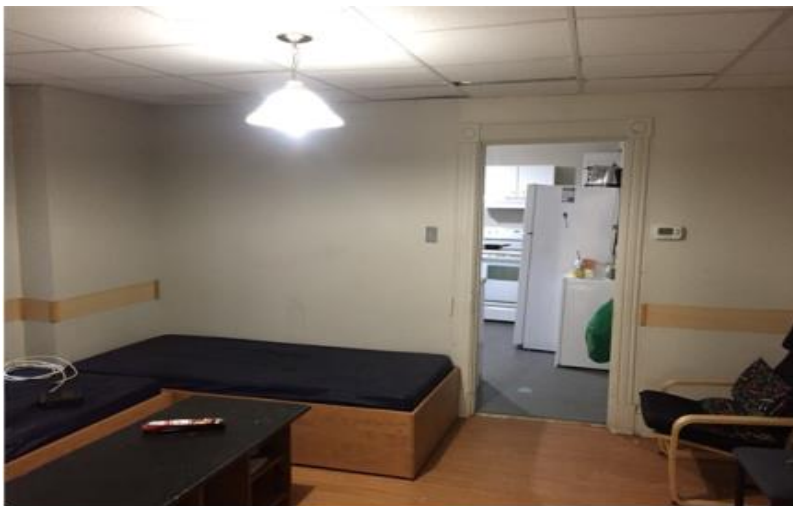
Photo 2: View of typical finishes observed at the building located at 112 Henderson Avenue.

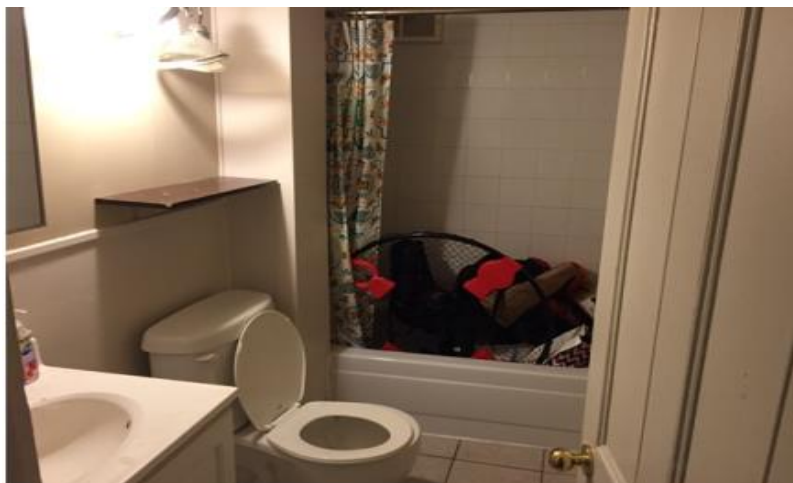
Photo 3: View of typical finishes observed at the building located at 112 Henderson Avenue.

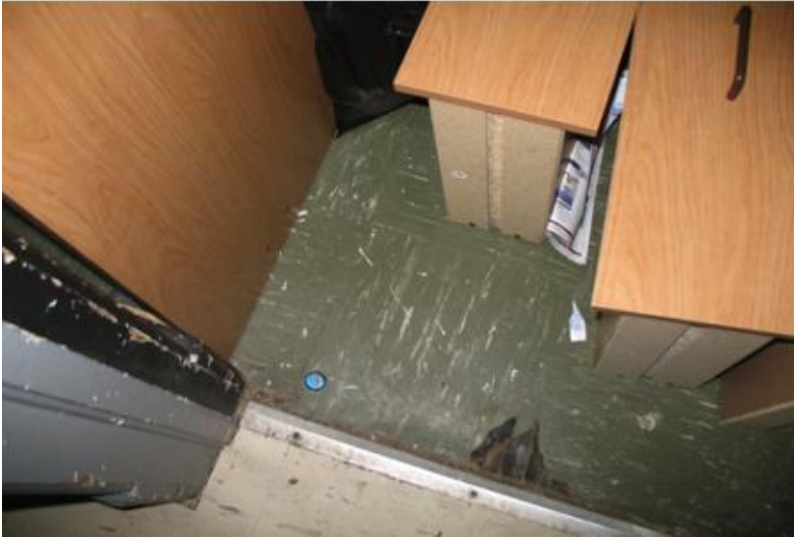
Photo 4: View of previously sampled asbestos-containing vinyl floor tile in the southside bedroom, now presumed to be under new flooring. (Ref. 0459870 (27))

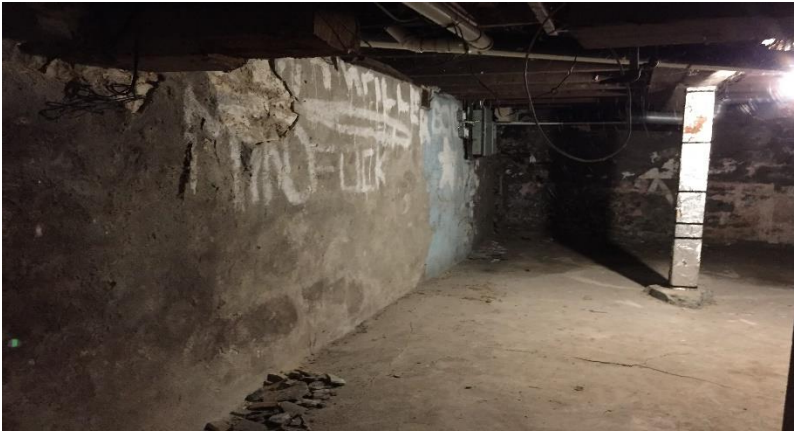
Photo 5: View of asbestos-containing texture coat observed to be in poor condition in the basement.

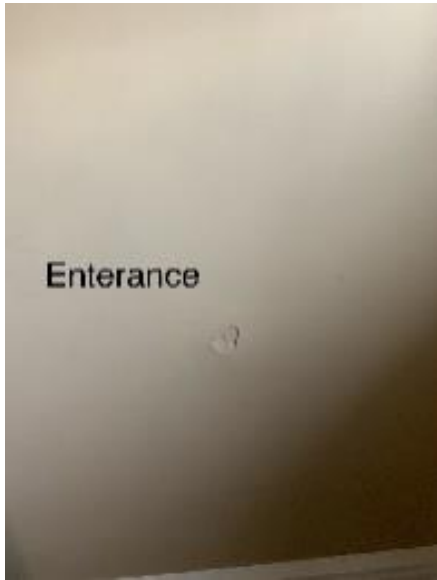
Photo 6: View of white lead paint observed in fair condition in the entrance wall of the subject building.

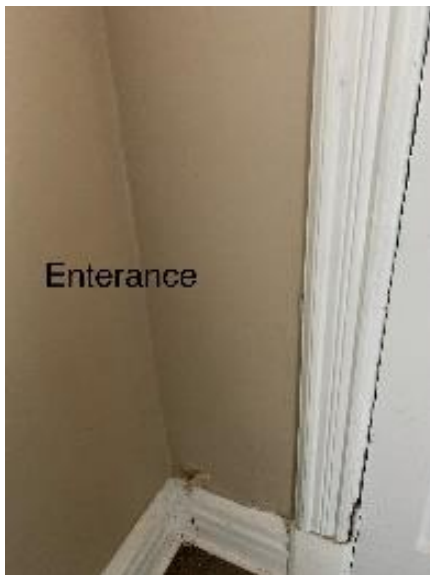
Photo 7: View of beige lead paint observed in fair condition in the entrance wall of the subject building.

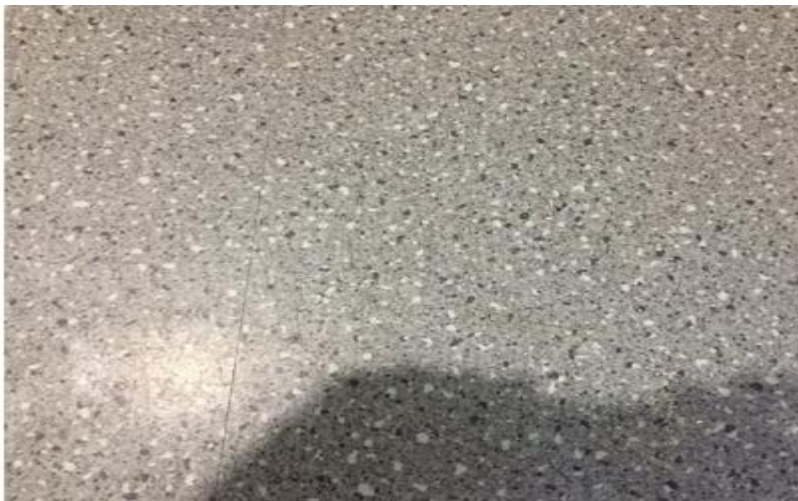
Photo 8: View of non-asbestos-containing vinyl sheet flooring observed in the kitchen on the 1st floor of the subject building.

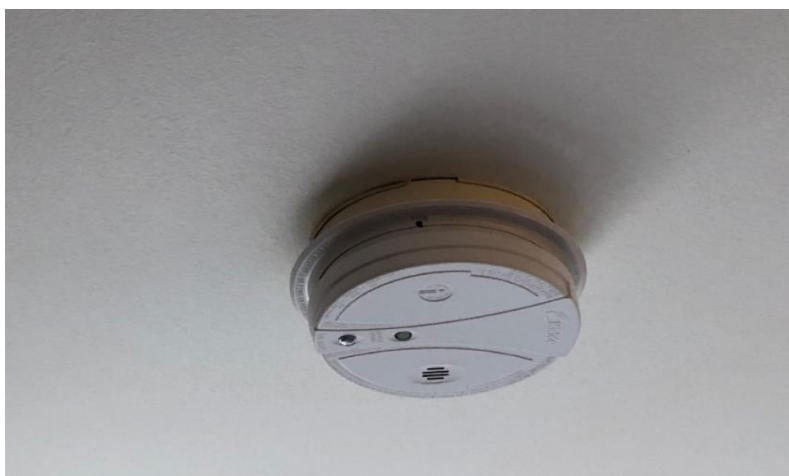
Photo 9: Typical view of smoke detectors containing radioactive materials.

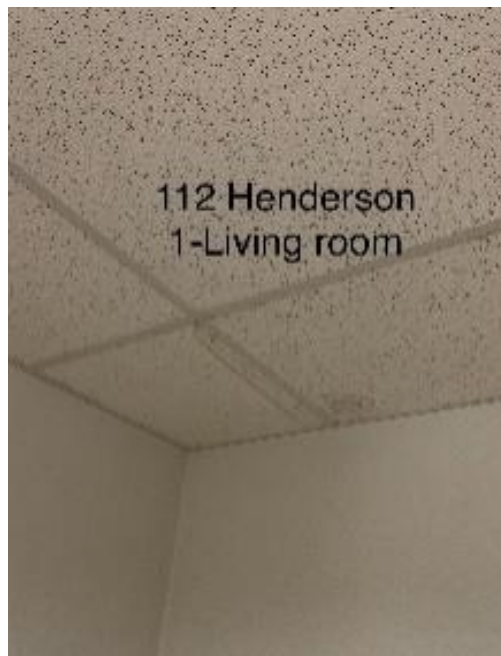
Photo 10: View of water damaged ceiling tiles observed in Room C on the 1st floor of the subject building.
