HAZARDOUS MATERIALS SURVEY AND 2025 REASSESSMENT 120 HENDERSON AVENUE, OTTAWA, ON

Project No.: CCO-252985-00

Prepared for:
University of Ottawa

Prepared by:
Egis Canada Limited (Egis)

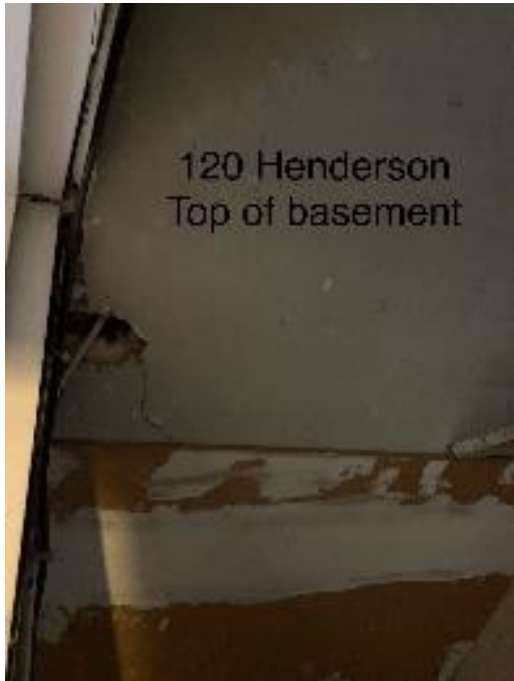
Previously identified ceiling/Wall plaster was observed throughout the subject building. The laboratory analytical results of plaster samples collected indicate that this material **contains 0.5% Chrysotile asbestos**. Since plaster is a homogeneous material, all areas must be treated as asbestos-containing unless additional bulk sampling and analysis until proven otherwise. This material is considered to be friable and was observed to be in good condition.

Photo 4: View of asbestos-containing wall plaster observed to be in poor condition at the top of the basement stairs.

- Asbestos-containing materials identified to be in poor condition must be repaired/removed immediately, following Type 1/2/3 asbestos abatement work procedures as detailed in O. Reg. 278/05 and disposed of as asbestos waste under O. Reg. 347;

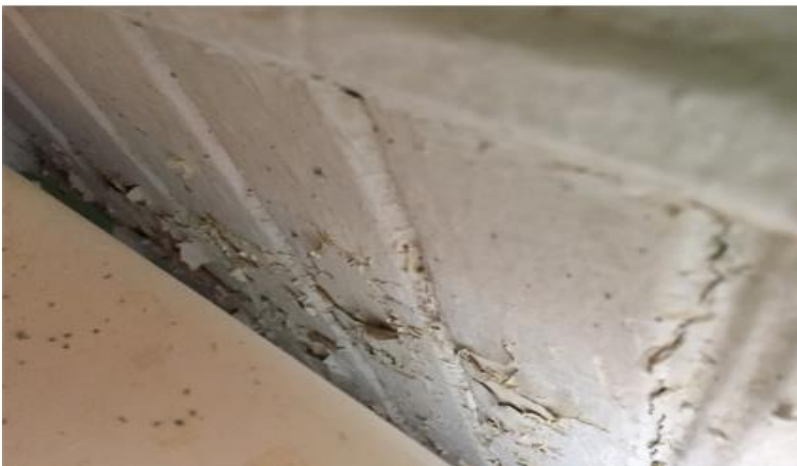
The paint finishes highlighted in pink in the above table are considered lead-containing paints or surface coatings with concentrations greater than 0.1% lead by weight. These paint finishes were observed to be in good condition with the exception of select areas that were observed in poor condition.

Photo 5: View of lead-containing white paint observed to be in poor condition in the bathroom on the 2nd floor.

Paints identified to contain lead that are in poor condition must be immediately repaired and/or stabilized following a minimum Type 1/2 lead abatement procedures as per OMOL "Lead on Construction Project" dated April 2011.

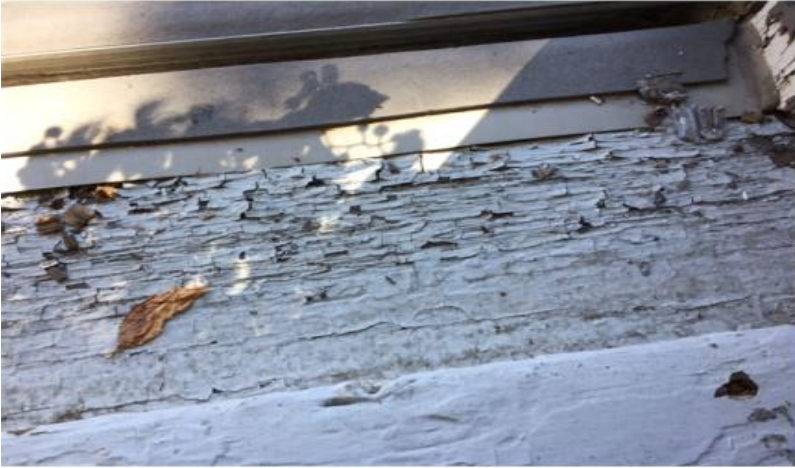
Photo 6: View of lead-containing white paint observed to be in poor condition in Room E on the 2nd floor.

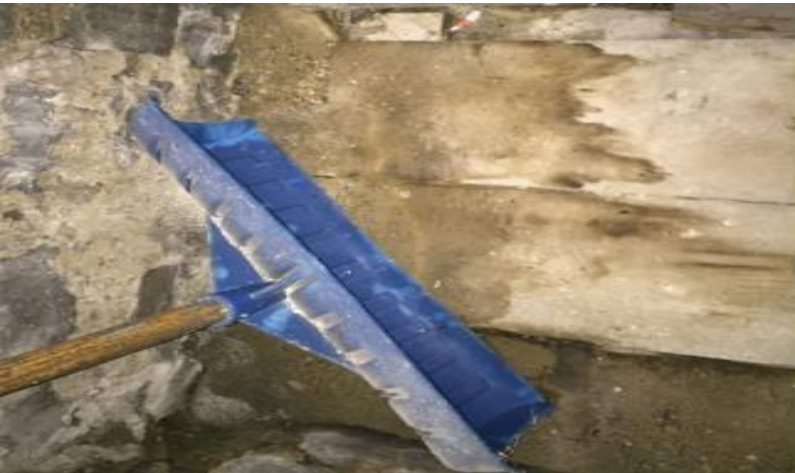
Photo 7: View of water-damaged wood stairs in the basement.

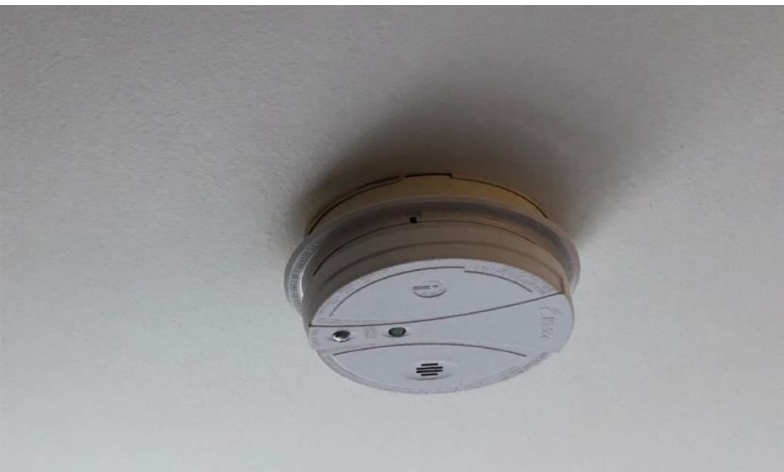
A visual assessment of the subject building was conducted to determine if any electrical components containing radioactive materials were present. Smoke detectors were observed throughout the subject building, which contained small quantities of radioactive material.

Photo 8: Typical view of smoke detectors containing radioactive materials.

The radioactive sources in smoke alarms are sealed and contained within a metal case inside the smoke detector and must not be damaged or tampered with. These materials do not pose a hazard as long as they remain contained and properly disposed at the time of removal or replacement.
