# HAZARDOUS MATERIALS SURVEY AND 2025 REASSESSMENT 134 HENDERSON AVENUE, OTTAWA, ON

Project No.: CCO-252985-00

Prepared for:  
University of Ottawa

Prepared by:  
Egis Canada Limited (Egis)

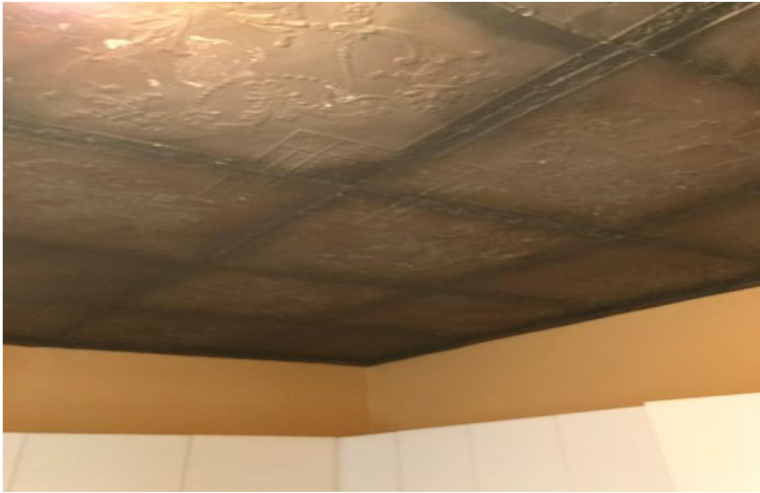
**Photo 1:** View of finishes observed in the kitchen at 134 Henderson Avenue.

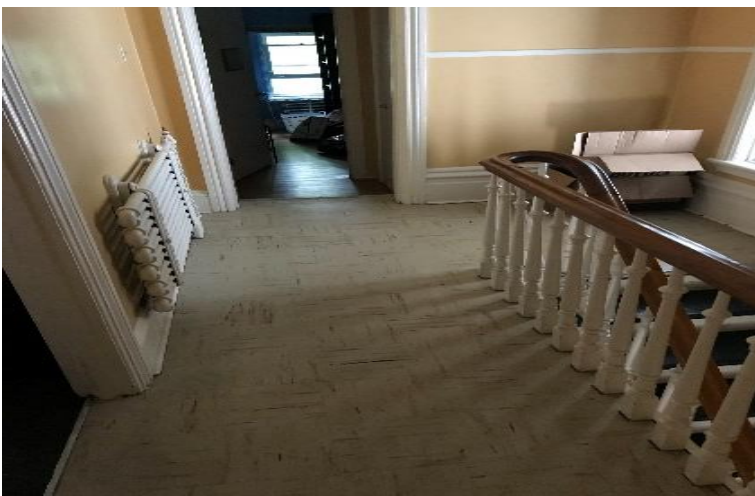
- Vinyl floor tiles (9"x9" – Beige/Brown) were observed throughout the 1st-floor hallway/landing (Room 100A). The laboratory analytical results of vinyl floor tile samples collected indicate that this material **contains 2.0% Chrysotile asbestos**. The associated mastic (Brown) does not contain asbestos. This material is considered to be non-friable and was observed to be in good condition.

**Photo 2:** View of asbestos-containing vinyl floor tile observed in the 1<sup>st</sup> floor landing.

- Materials identified to contain asbestos that are in good condition and do not pose a risk to workers or occupants can be managed in place. Prior to renovation/demolition activities that may disturb the ACMs, these materials must be removed following appropriate Type 1/2/3 asbestos abatement work procedures as detailed in O. Reg. 278/05 and disposed of as asbestos waste under O. Reg. 347;

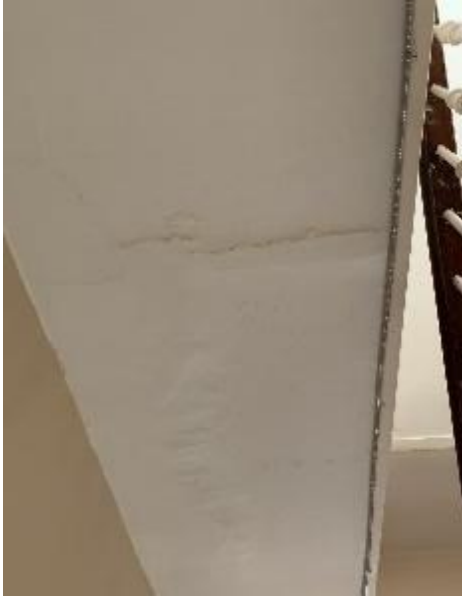
**Photo 3:** View of water damage observed on the ceiling of 1<sup>st</sup> floor entrance.

Water stained/damaged ceiling tiles observed throughout the subject building should be replaced as part of regular maintenance and the underlying cause of the water leakage should be identified and repaired following the university of Ottawa **Mould Control and Water Damage Restoration Program**, March 2023.

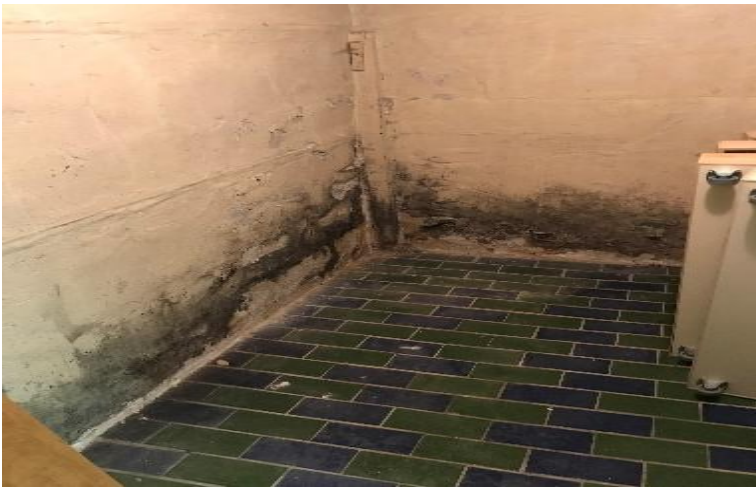
**Photo 4:** View of suspect mold growth observed on concrete walls in the basement of the subject building.
