HAZARDOUS MATERIALS SURVEY AND 2025 ASSESSMENT 200 LEES, FACULTY OF HEALTH SCIENCES, OTTAWA, ON

Project No.: CCO-252985-00

Prepared for:
University of Ottawa

Prepared by:
Egis Canada Limited (Egis)

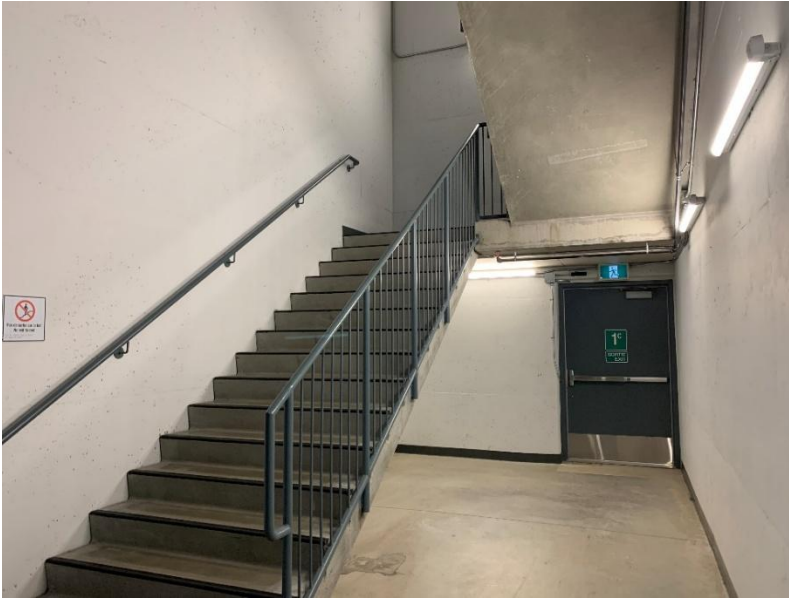
Photo 3: Typical view of staircase finishes containing silica brick, mortar, and concrete.

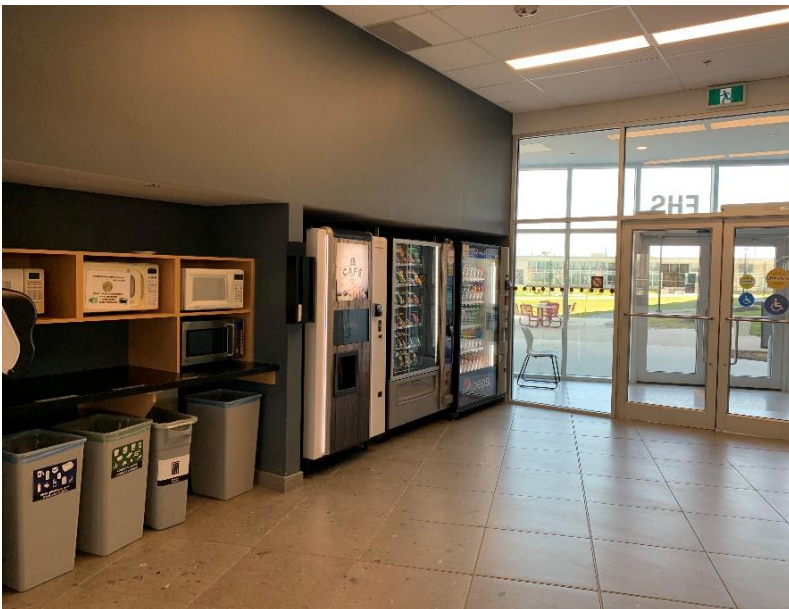
Photo 4: View of refrigerators containing ozone depleting substances.

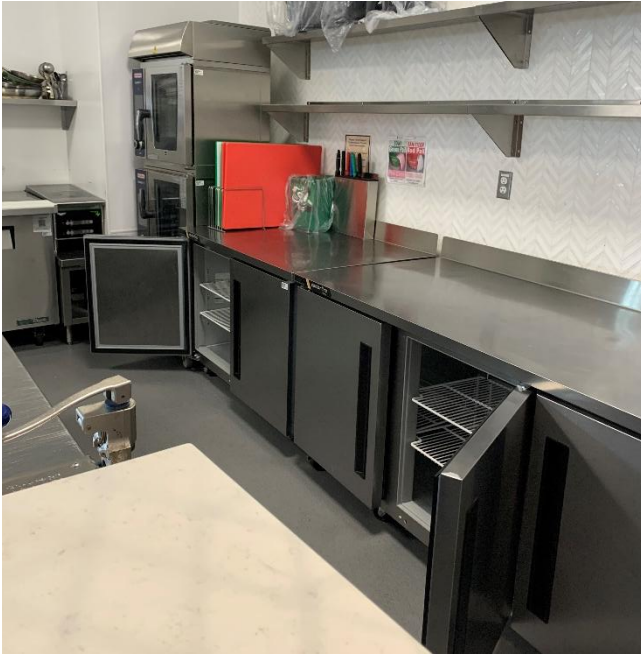
Photo 5: View of refrigerators containing ozone depleting substances.

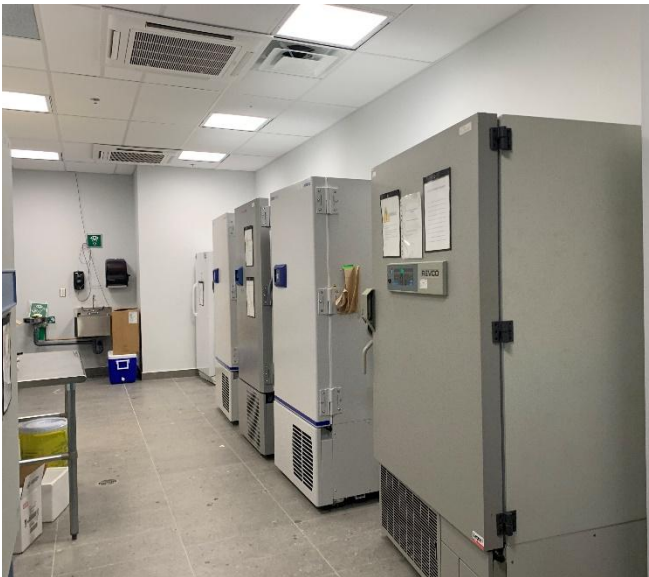
Photo 6: View of refrigerators containing ozone depleting substances.

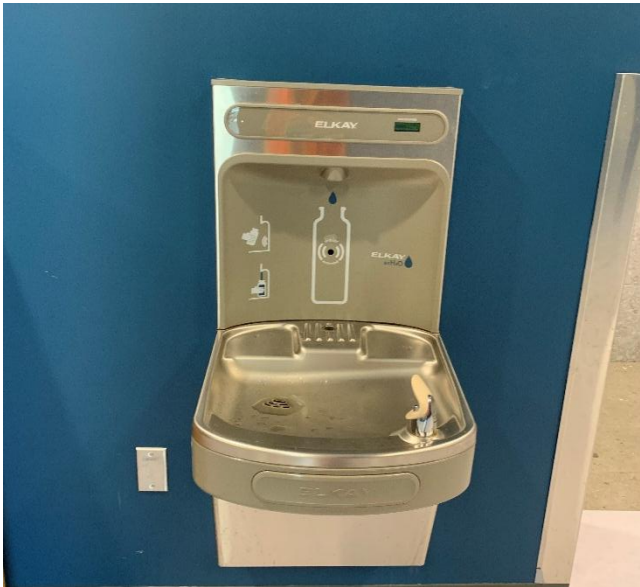
Photo 7: View of water coolers containing ozone depleting substances.

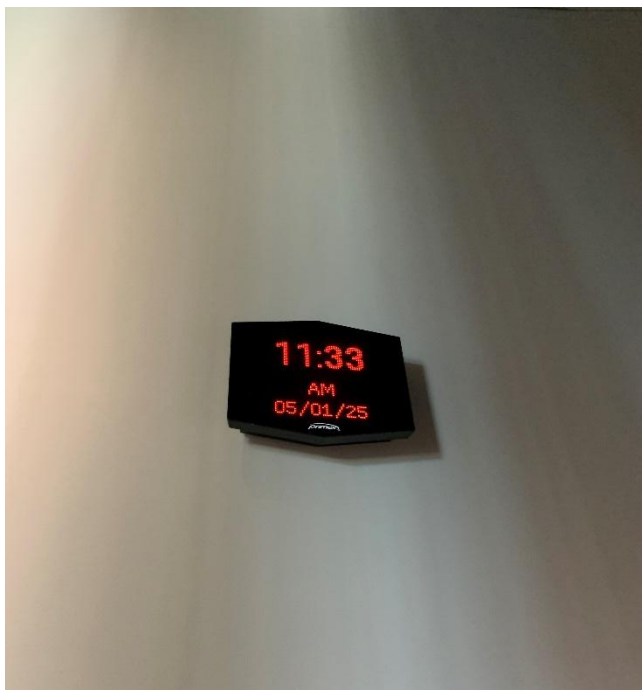
Photo 8: Lead-acid batteries present in clocks.

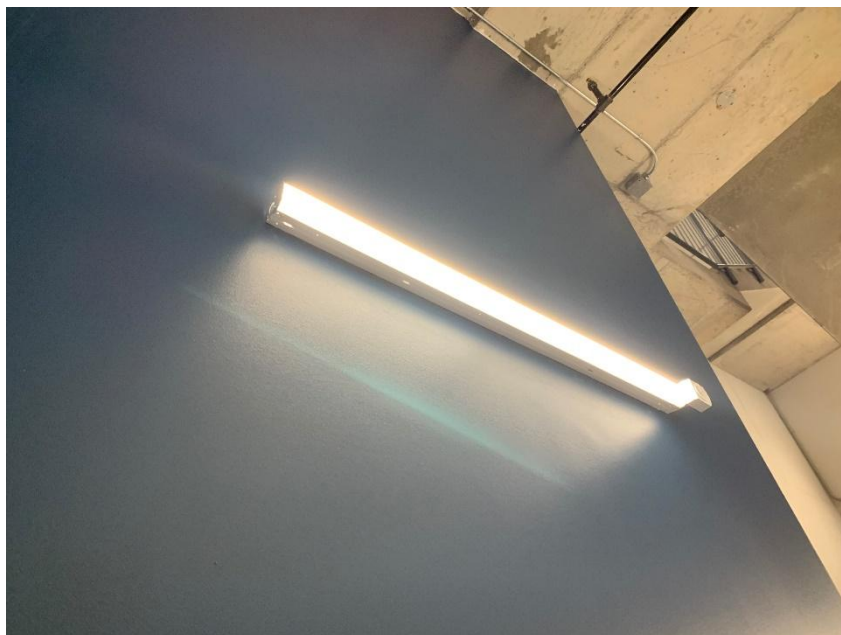
Egis identified lead-containing acid battery packs throughout the subject building. These battery packs were observed on walls and above exits throughout the surveyed building.

Photo 9: Lead-acid batteries present in emergency lights

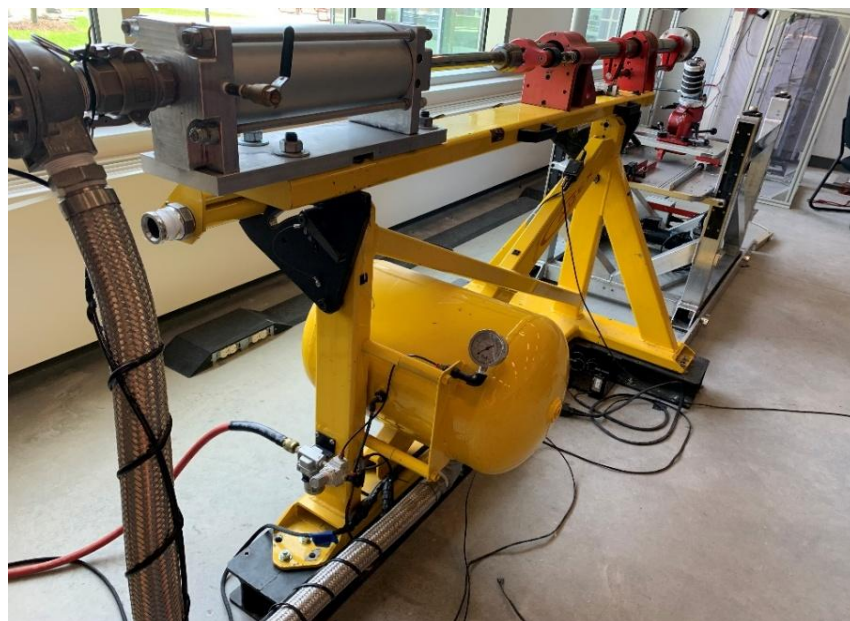
Egis identified pressure gauges containing liquid mercury at the mechanical room on the fifth floor of the subject building. They were observed in good condition. Egis did not identify suspected float switches that may contain liquid mercury within the subject building.

Photo 10: View of pressure gauges containing liquid mercury in room 146.

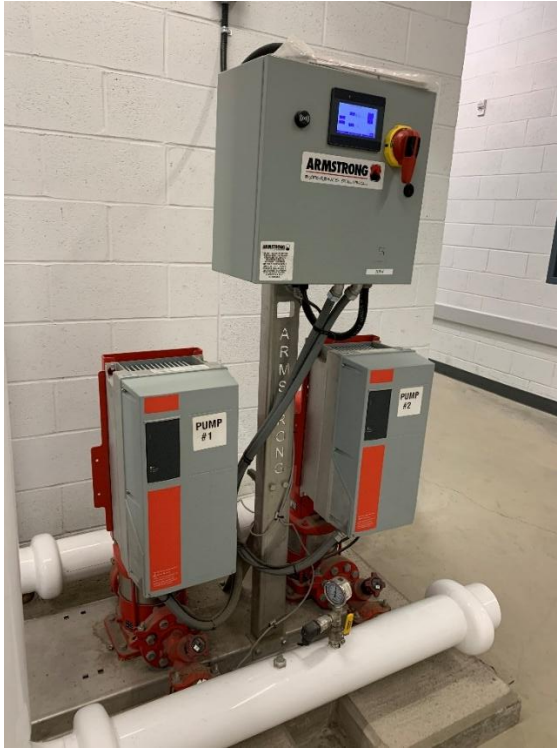
Photo 11: View of pressure gauges containing liquid mercury in room 154.

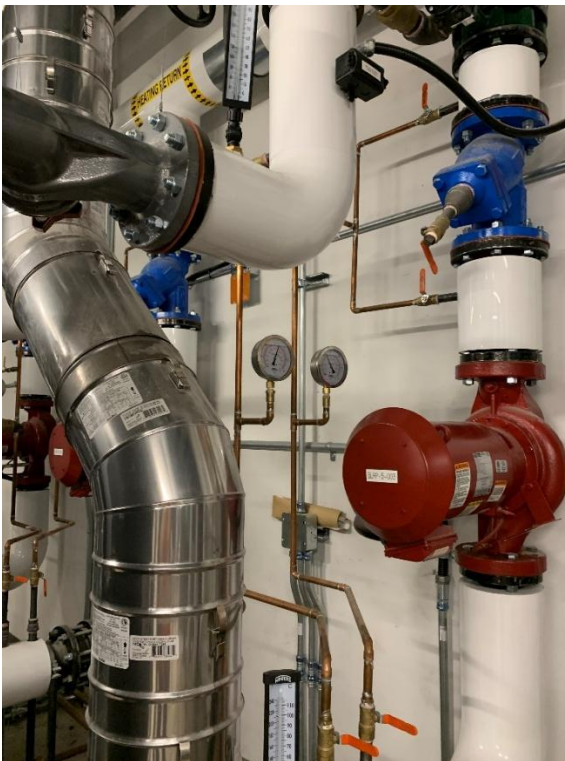
Photo 12: View of pressure gauges containing liquid mercury in room 529.
