HAZARDOUS MATERIALS SURVEY AND 2025 REASSESSMENT 116 HENDERSON AVENUE, OTTAWA, ON

Project No.: CCO-252985-00

Prepared for:
University of Ottawa

Prepared by:
Egis Canada Limited (Egis)

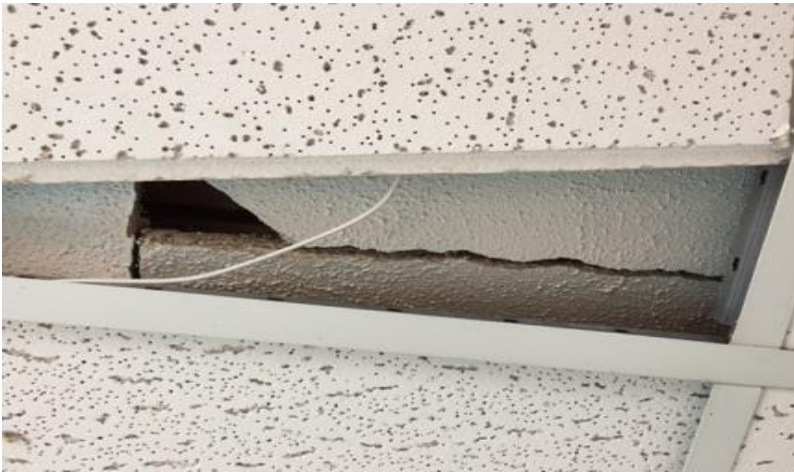
A ceiling texture coat was observed and sampled in Room 201 (above the suspended ceiling tiles). The laboratory analytical results of texture coat samples collected indicate that this material does not contain asbestos.

- Suspended ceiling tiles (2'x4' - Pinholes with Large Fissures) were observed and sampled in Room 201. The laboratory analytical results of ceiling tile samples collected indicate that this material does not contain asbestos.
- Suspended ceiling tiles (2'x4' - Pinholes with Small Fissures) were observed and sampled in Room 201. The laboratory analytical results of ceiling tile samples collected indicate that this material does not contain asbestos.

Photo 4: View of suspended ceiling tiles with a ceiling texture coat above, as observed in Room A on the second floor.

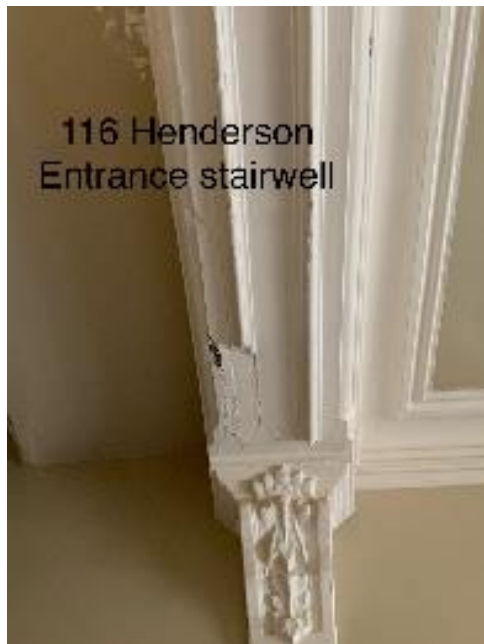
Previously identified drywall joint compound was observed throughout the subject building. The laboratory analytical results of drywall joint compound samples collected indicate that this material **contains 0.50% Chrysotile asbestos**. Since drywall joint compound is a homogeneous material, all areas must be treated as asbestos-containing unless additional bulk sampling and analysis until proven otherwise. **This material was observed to be in good and fair condition throughout the subject building.**

Photo 5: View of ACM drywall joint compound in fair condition was observed on the first-floor entrance stairwell of the subject building.

- Asbestos-containing materials that have been identified to be in fair condition should be either repaired (where possible) and/or closely monitored for signs of further deterioration. Depending on type of material and location, these materials should be scheduled for removal if there is potential risk of exposure to worker and/or occupants;

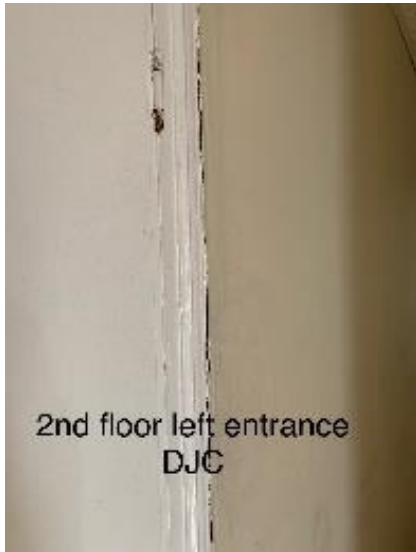
Photo 6: View of ACM drywall joint compound in fair condition was observed on the second floor entrance stairwell of the subject building.

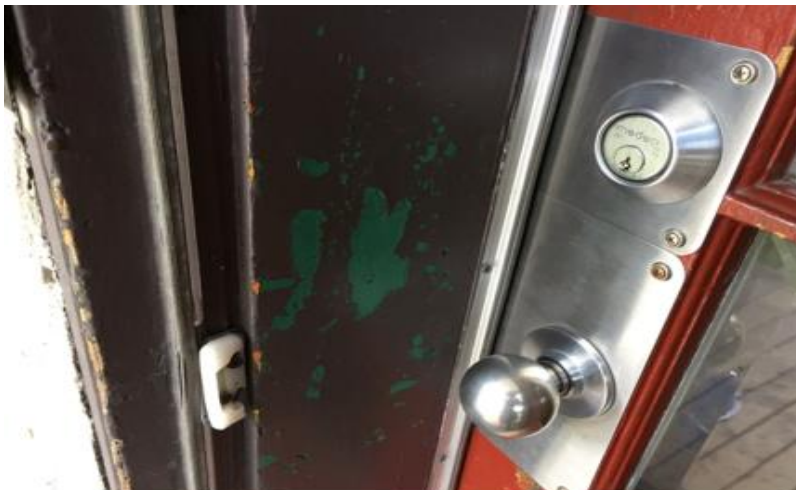
The paint finishes highlighted in pink in the above table are considered lead-containing paints or surface coatings with concentrations greater than 0.1% lead by weight. These paint finishes were observed to be in good condition with the exception of select areas that were observed in poor condition.

View of lead-containing dark grey paint observed to be in poor condition on the front door.

Paints identified to contain lead that are in poor condition must be immediately repaired and/or stabilized following a minimum Type 1/2 lead abatement procedures as per OMOL "Lead on Construction Project" dated April 2011.

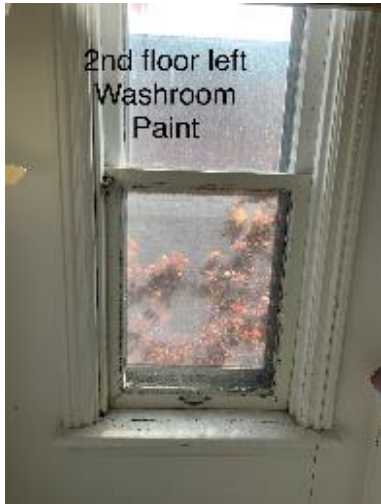
Photo 8: View of lead-containing white paint observed to be in poor condition on the washroom window frame.

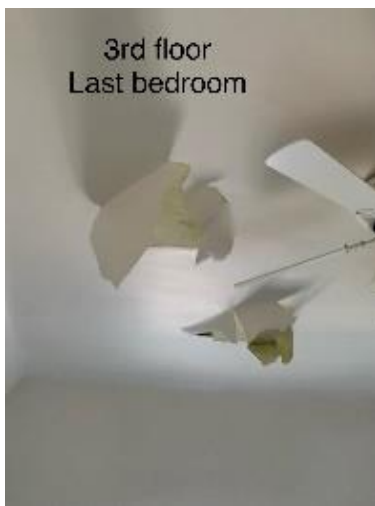
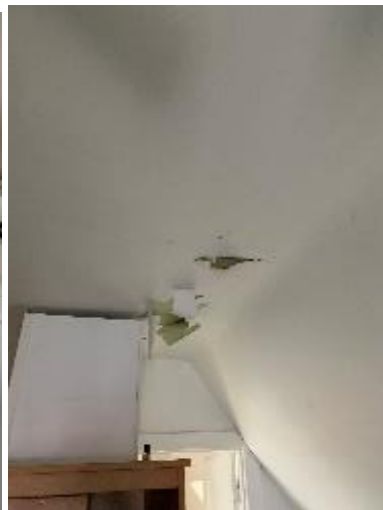
Photo 9: View of lead-containing white paint observed to be in poor condition on the ceiling of 3rd floor bedroom.

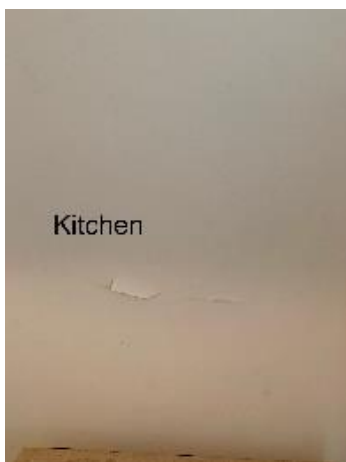
Photo 10: View of lead-containing white paint observed to be in fair condition on the wall of 1st floor kitchen.

Paints identified to contain lead that are in fair condition should be either repaired (where possible) and/or closely monitored for signs of further deterioration.

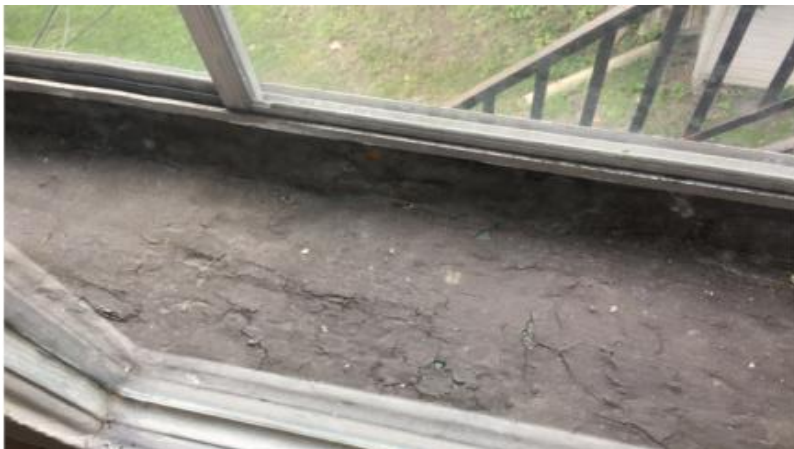
Photo 11: View of lead-containing brown paint observed to be in poor condition in the kitchen.

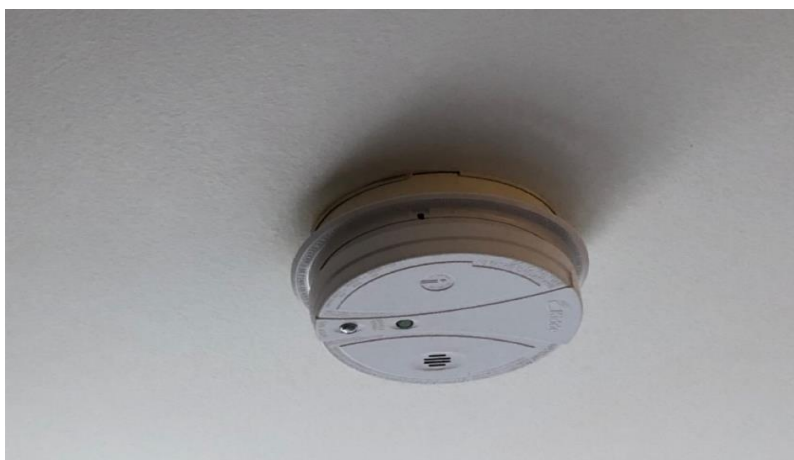
A visual assessment of the subject building was conducted to determine if any electrical components containing radioactive materials were present. Smoke detectors were observed throughout the subject building, which contained small quantities of radioactive material.

Photo 12: Typical view of smoke detectors containing radioactive materials.

The radioactive sources in smoke alarms are sealed and contained within a metal case inside the smoke detector and must not be damaged or tampered with. These materials do not pose a hazard as long as they remain contained and properly disposed at the time of removal or replacement.
