HAZARDOUS MATERIALS SURVEY AND 2025 REASSESSMENT 613 KING EDWARD AVENUE, OTTAWA, ON

Project No.: CCO-252985-00

University of Ottawa

March 20, 2025

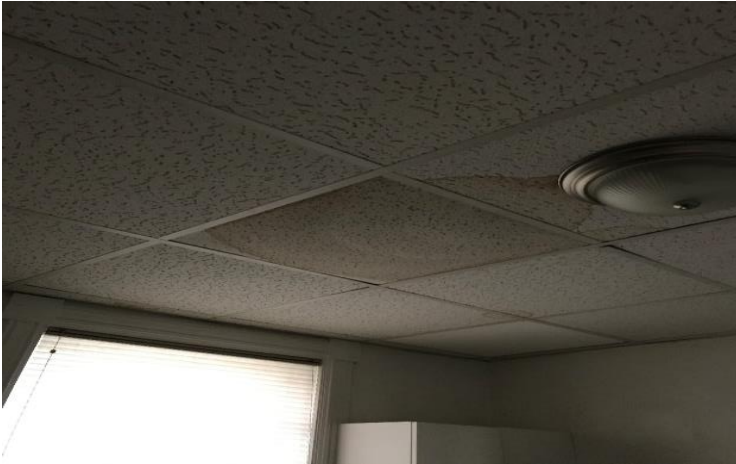
Photo 1: View of water damaged ceiling tiles (2'x2') observed in the kitchen within the subject building.

Water-stained/damaged ceiling tiles observed throughout the subject building should be replaced as part of regular maintenance, and the underlying cause of the water leakage should be identified and repaired.

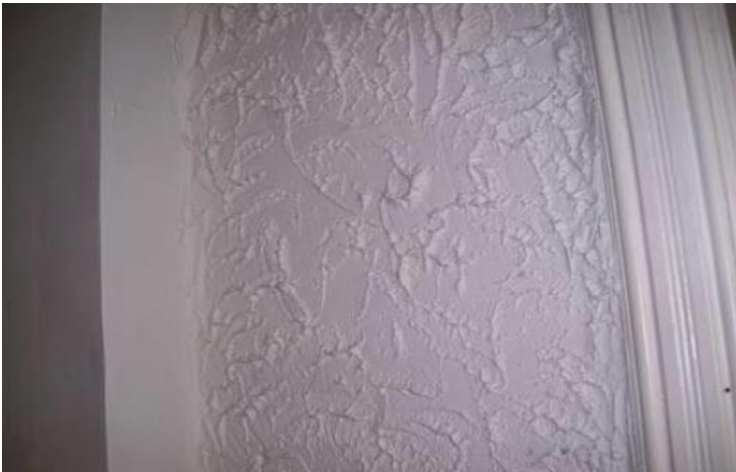
Wall texture coat (Stucco) was observed and sampled in the front room on the 1st floor of the subject building. The laboratory analytical results indicate that this material does not contain asbestos.

Photo 2: View of the non-asbestos-containing texture coat observed in the front room on the 1st floor of the subject building.

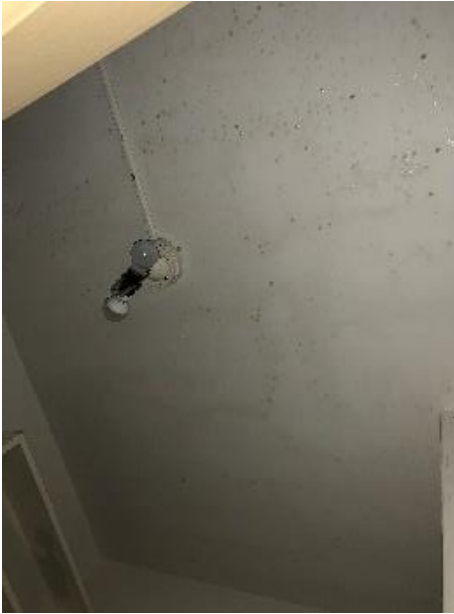
Photo 3: View of mould-affected drywall ceiling observed to be in poor condition located in the Washroom of Unit 202.

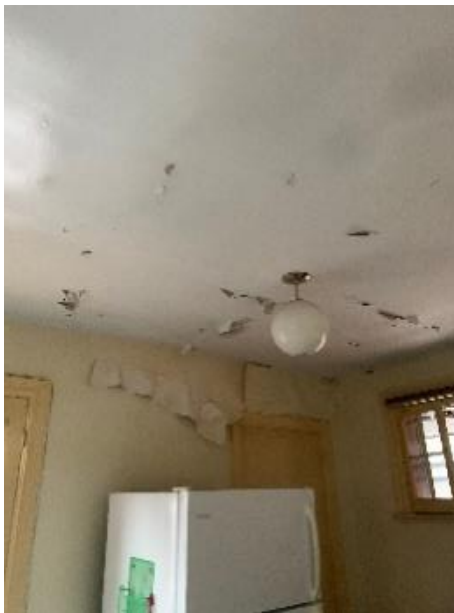
The paint finishes highlighted in pink in the above table are considered lead-containing paints or surface coatings with concentrations greater than 0.1% lead by weight. These paint finishes were observed to be in good condition, except for select areas that were observed in poor condition.

Photo 4: View of lead-containing ceiling and wall paint observed to be in poor condition located within the Kitchen of Unit 202.

Paints identified to contain lead that is in poor condition must be immediately repaired and/or stabilized following a minimum Type 1/2 lead abatement procedures as per OMOL "Lead on Construction Project" dated April 2011.

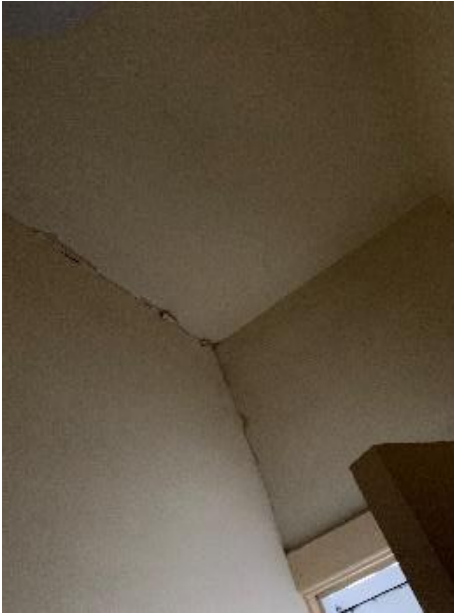
Photo 5: View of lead-containing ceiling and wall paint observed to be in poor condition located within Unit 202.

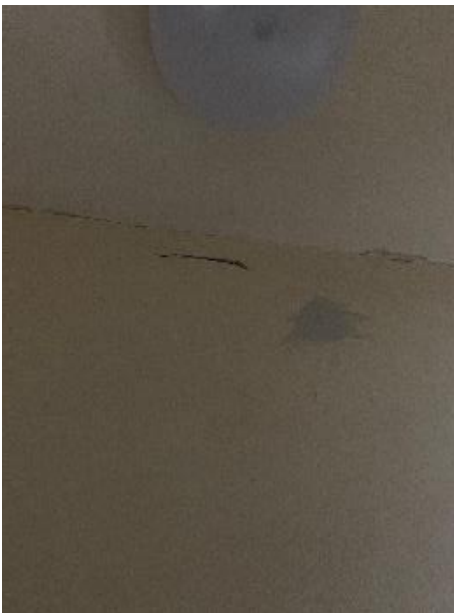
Photo 6: View of lead-containing ceiling and wall paint observed to be in poor condition located within Unit 202.

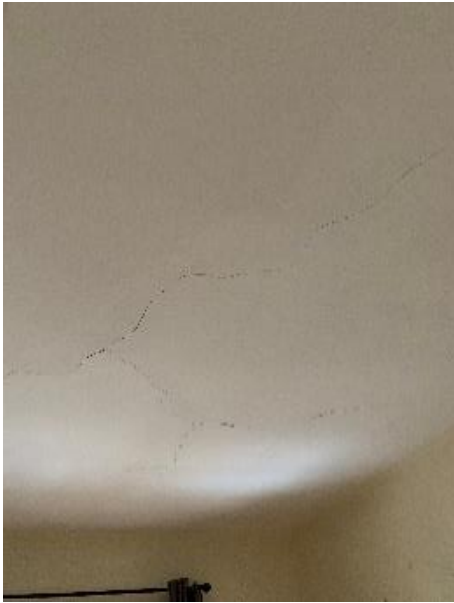
Photo 7: View of lead-containing ceiling and wall paint observed to be in poor condition located within Room A of Unit 202.

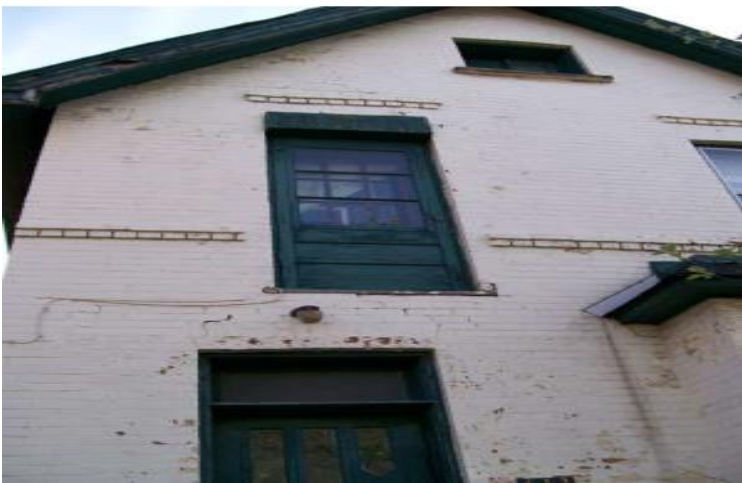
Photo 8: View of green and white lead-containing paint observed to be in poor condition on the exterior of the subject building.
