HAZARDOUS MATERIALS SURVEY AND 2022 REASSESSMENT UNIVERSITY CENTRE (UCU), OTTAWA, ONTARIO

Project No.: Z1920014HZ / CCC-230252-00

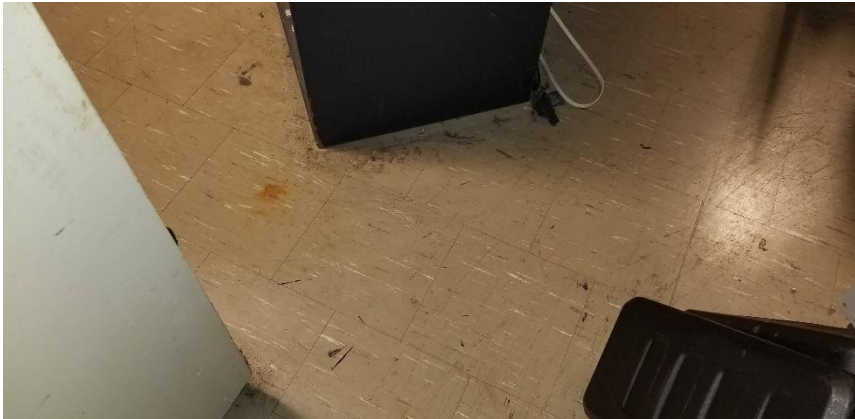
Photo 1: View of asbestos-containing vinyl floor tiles (12"x12"-Beige with White and Brown Flakes) observed to be in good condition in Room 100G.

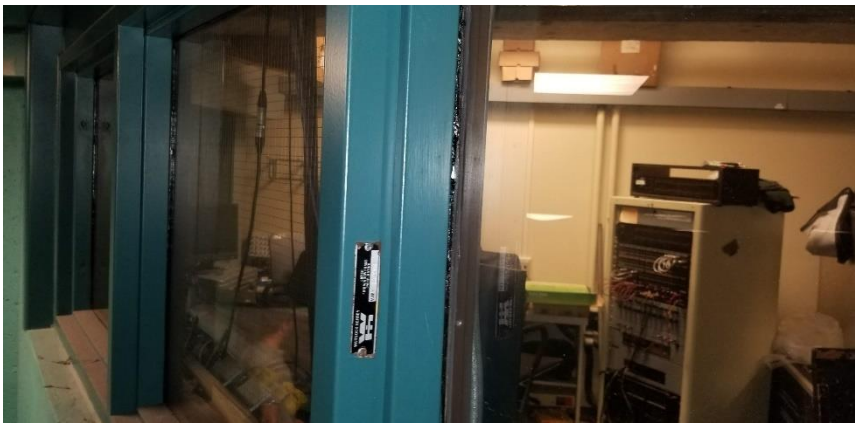
Photo 2: View of asbestos-containing window caulking (Black) observed to be in good condition outside of Room 100G.

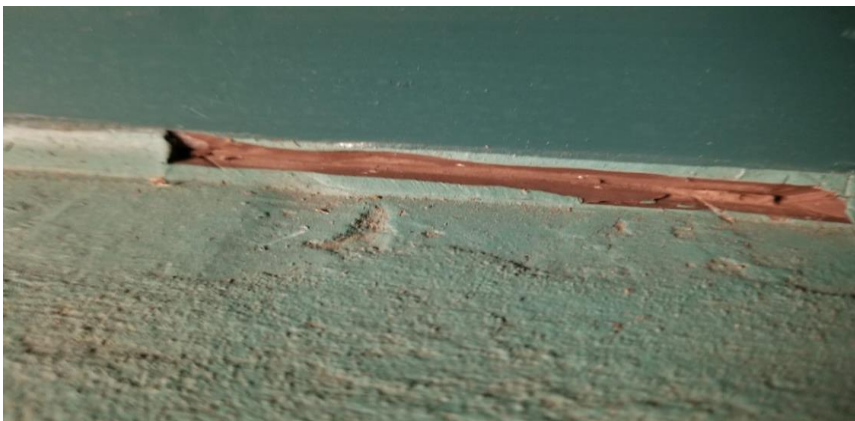
Photo 3: View of asbestos-containing wall caulking (Brown) observed to be in good condition in Room 014.

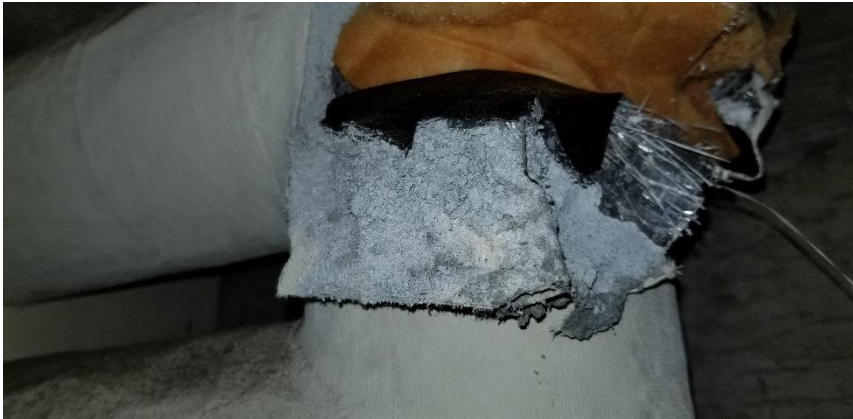
Photo 4: View of asbestos-containing parging on pipe fitting observed in Room 100G.

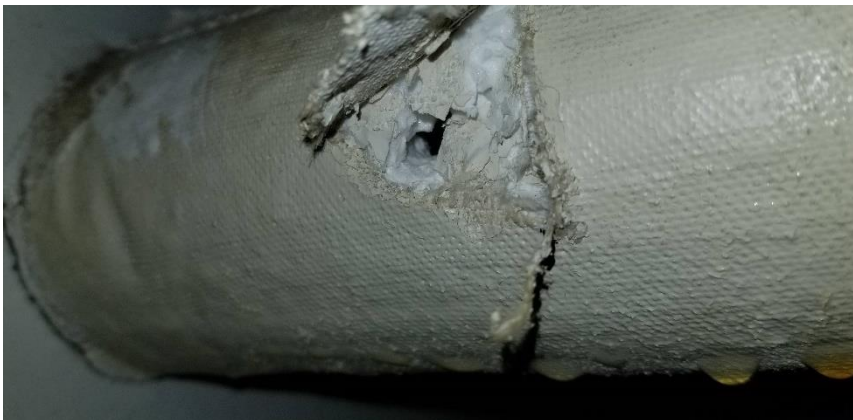
Photo 5: View of asbestos-containing parging observe in pipe straight in Room 0029.

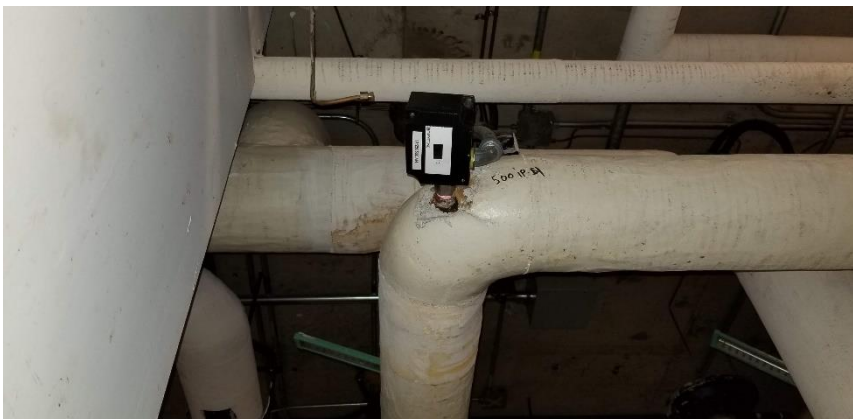
Photo 6: View of asbestos-containing parging cement on pipe fitting observed to be in poor condition in Room 0033H.

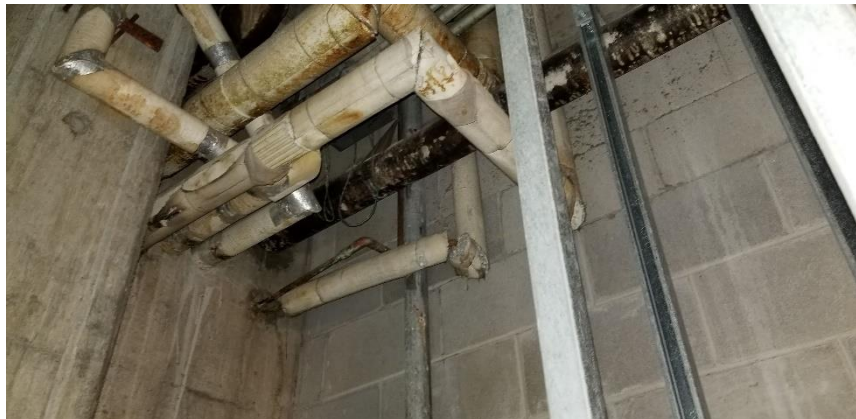
Photo 7: View of asbestos-containing mechanical pipe straight insulation (AirCell) observed to be in poor condition in Room 0033B.

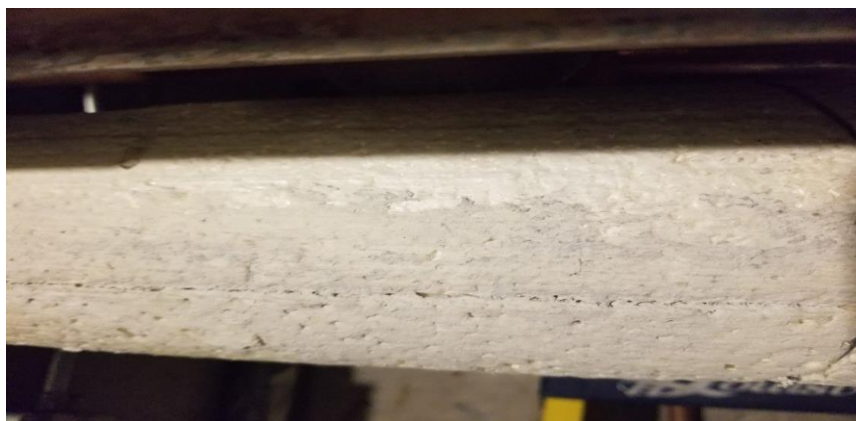
Photo 8: View of asbestos-containing parging on foam pipe insulation observed to be in good condition in Room 0027.

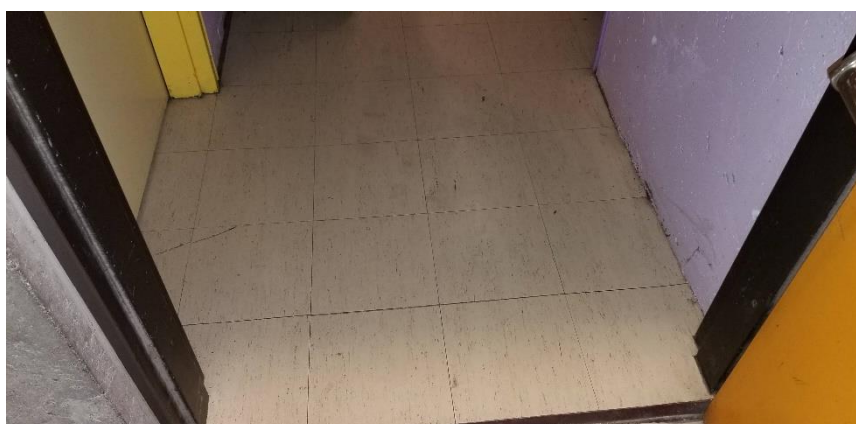
Photo 9: View of previously identified asbestos-containing vinyl floor tiles (12"x12"- Beige with Brown Spots) observed to be in good condition in the hallway of 002 and in adjacent rooms.

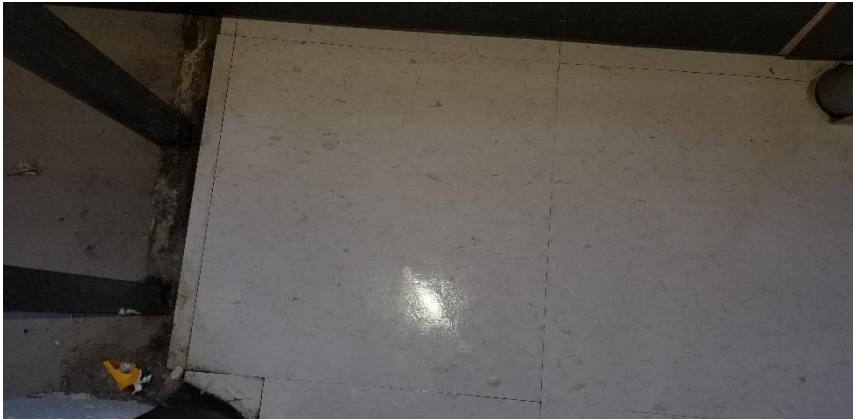
Photo 10: View of asbestos-containing vinyl floor tiles (12"x12"-Beige with Gray Flakes) observed to be in good condition at the A03 stairwell landing.

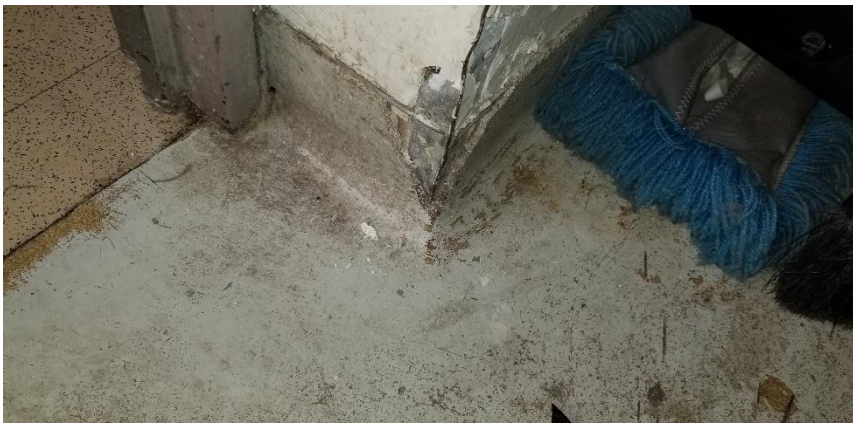
Photo 11: View of asbestos-containing cementitious floor coating observed in Room 210.

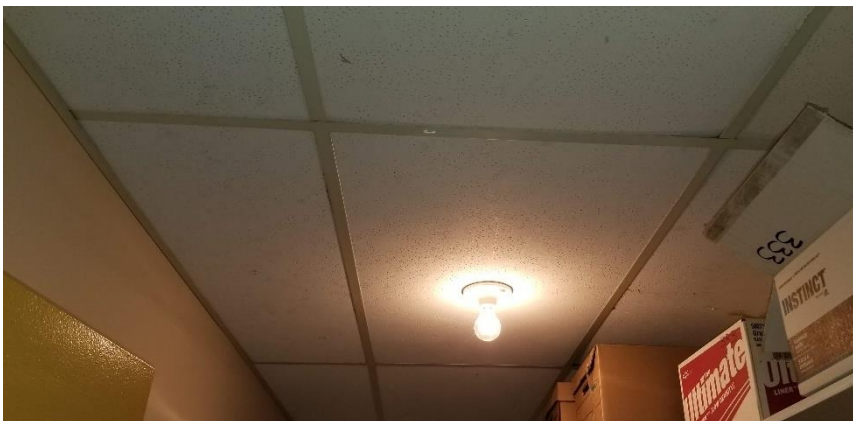
Photo 12: View of asbestos-containing suspended ceiling tiles (2'x4'-White with dots) observed to be in Room 333B.

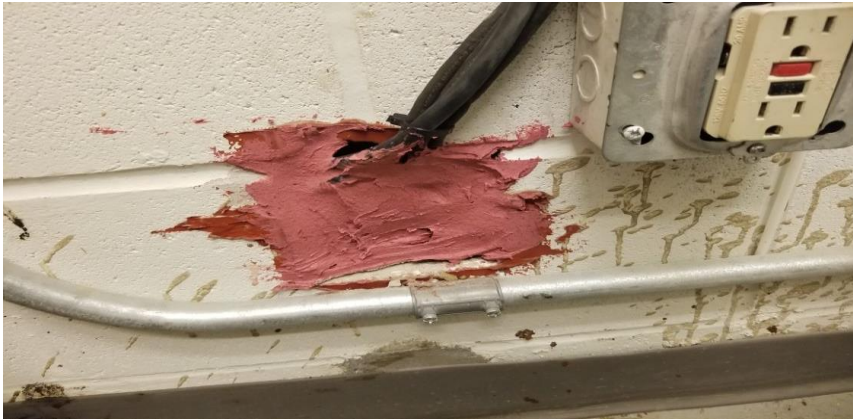
Photo 13: View of non-asbestos containing firestop caulking (Pink) observed in Room 0027F.

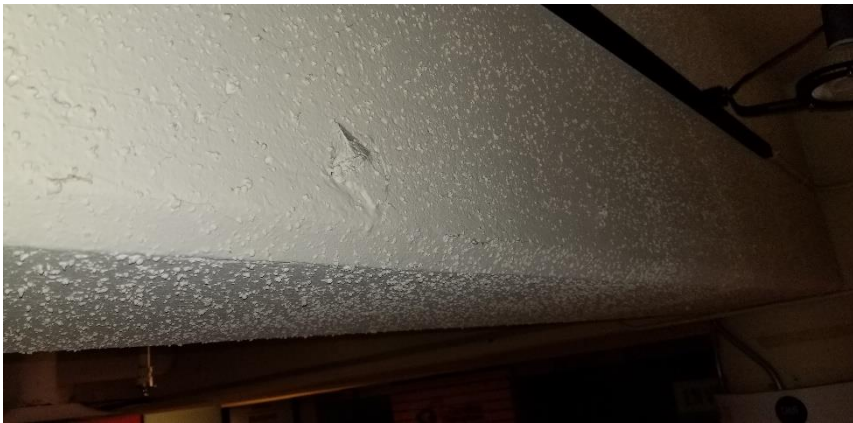
Photo 14: View of non-asbestos containing ceiling texture coat observed on the concrete ceiling deck in the common area 031.

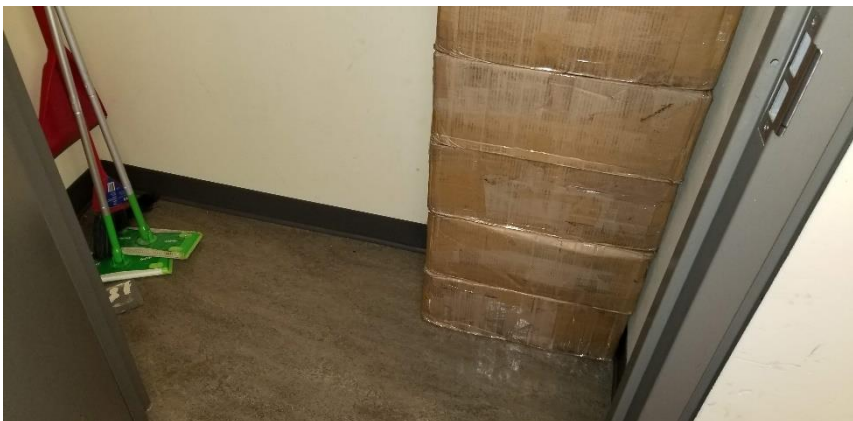
Photo 15: View of non-asbestos containing vinyl sheet flooring (Gray) observed in Room 031C.

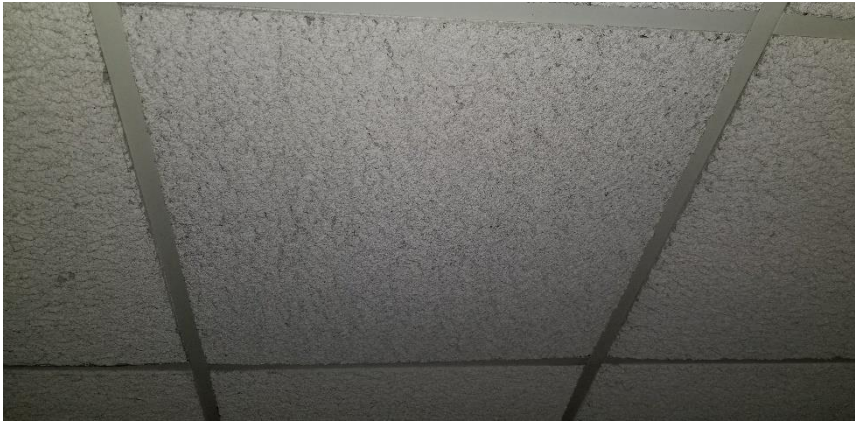
Photo 16: View of non-asbestos containing suspended ceiling tiles (2'x2'-Deep Texture) observed in 014 Hallway.

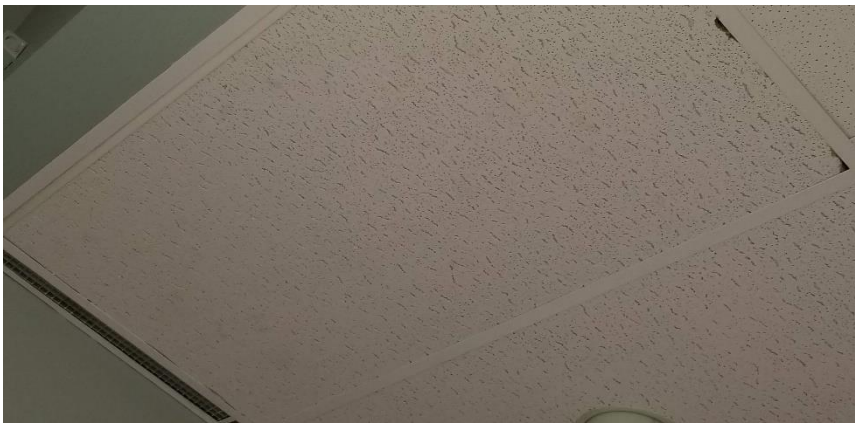
Photo 17: View of non-asbestos containing suspended ceiling tiles (2'x4'-Pinholes with Large Fissures) observed in Room 211.

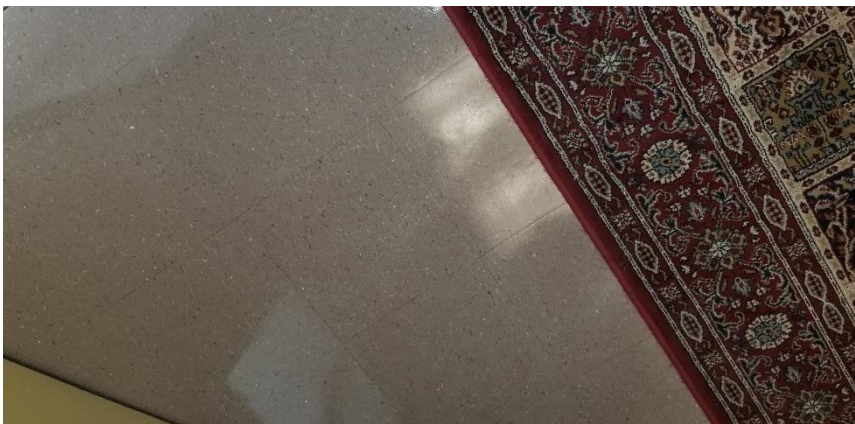
Photo 18: View of non-asbestos containing vinyl floor tiles (12"x12"-Purple) observed in Room 324.

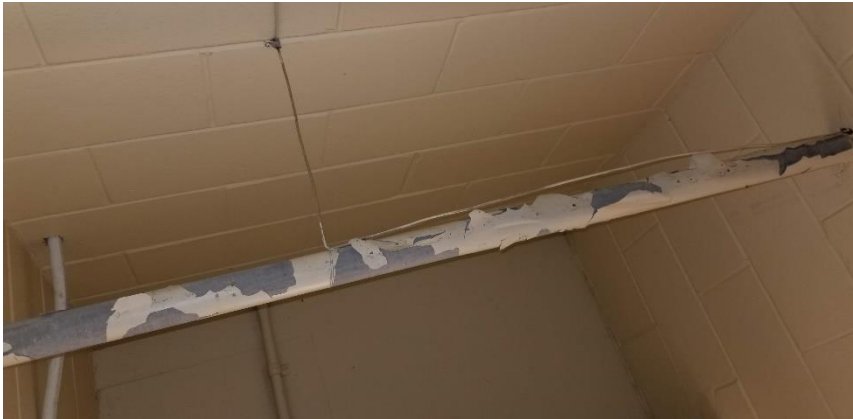
Photo 19: View of lead paint finish (Off-White) observed to be in poor condition on a mechanical pipe in Room 017.

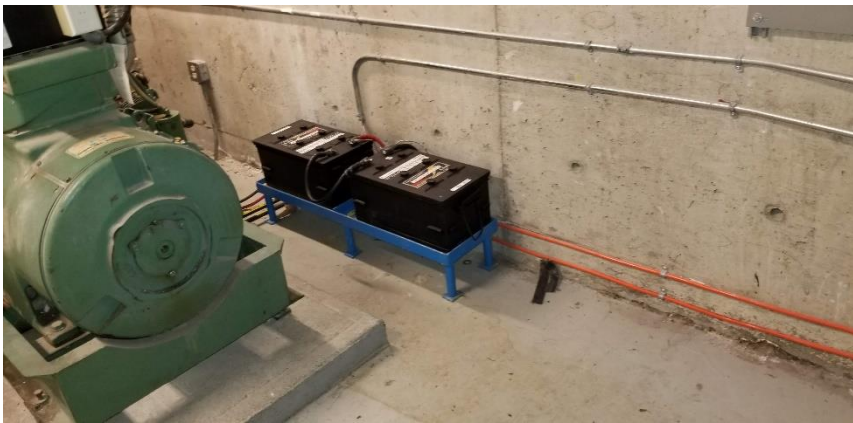
Photo 20: View of lead containing acid batteries observed to be in good condition in Room 0033H.

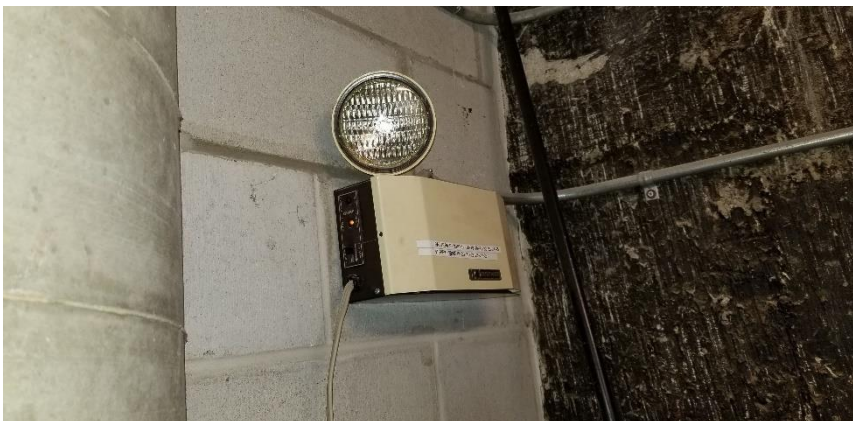
Photo 21: View of lead containing battery packs observed in Room 0033A.

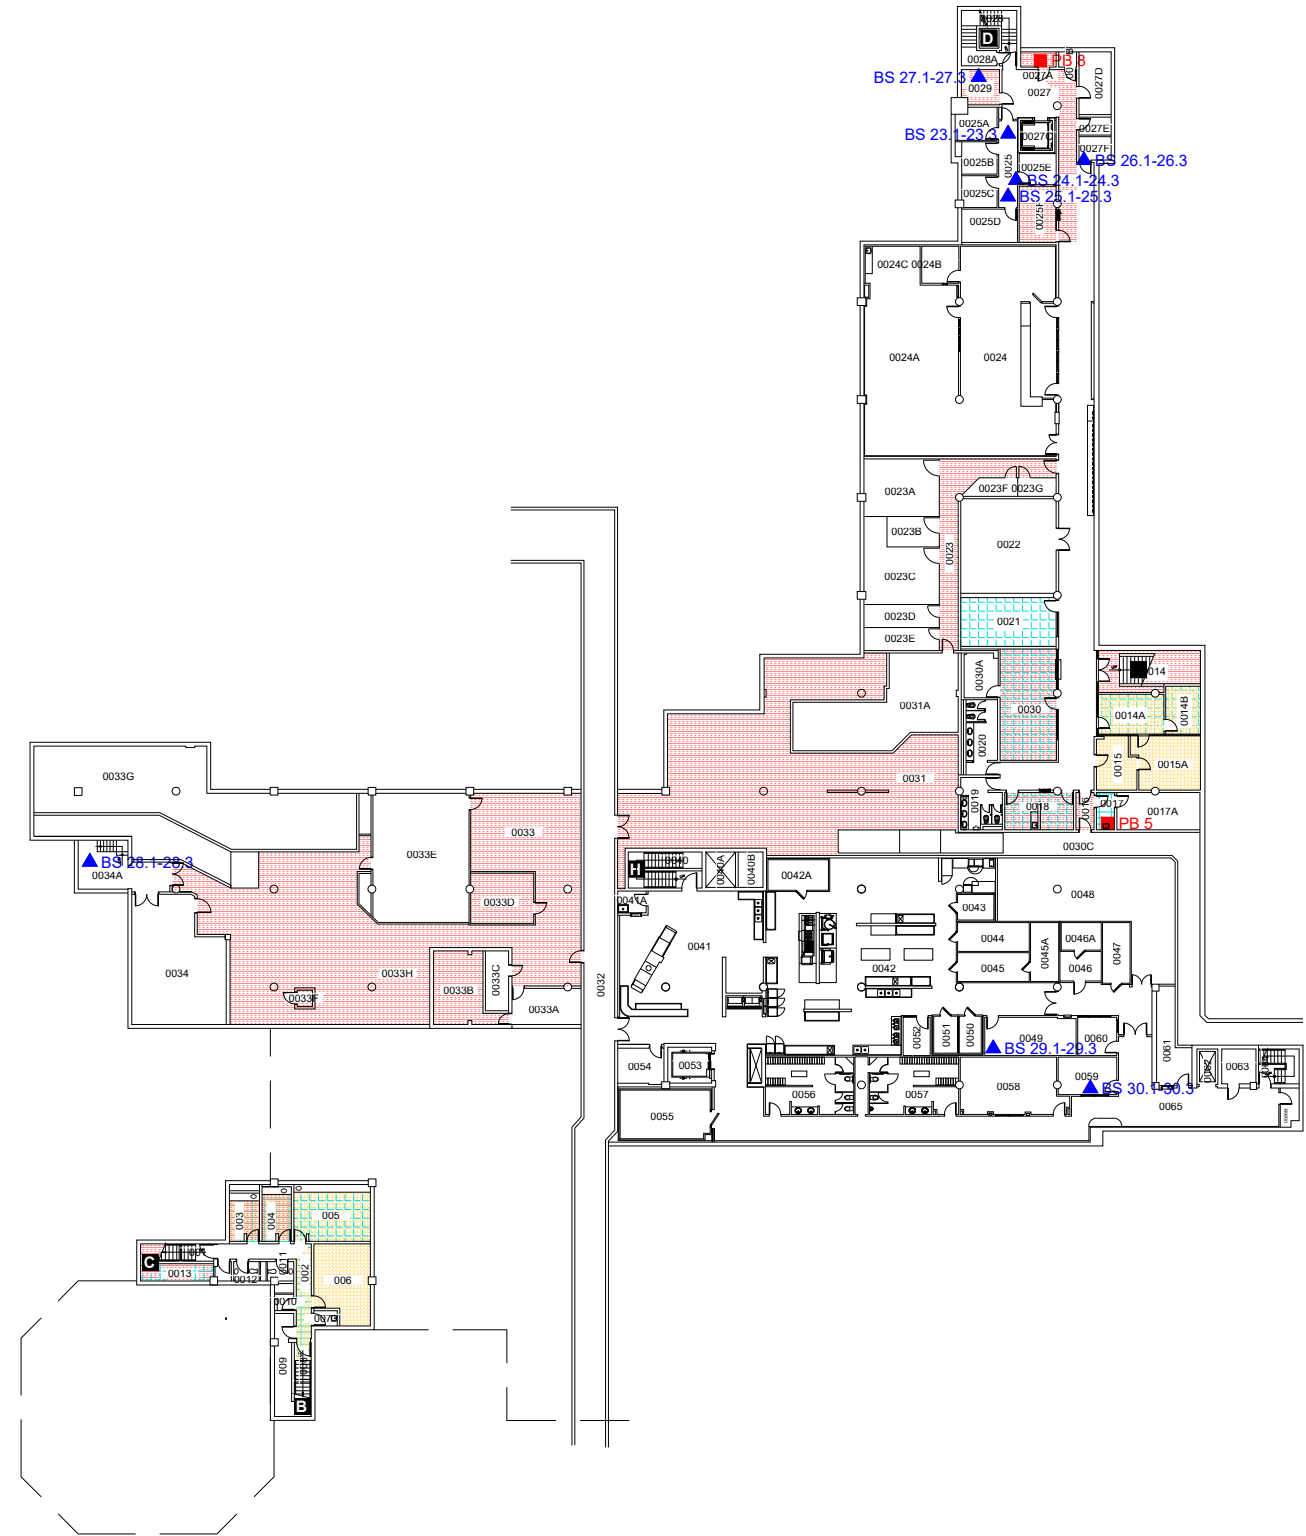
McINTOSH PERRY
 6240 HIGHWAY 7 SUITE 200 WOODBRIDGE ON L4H 4G3
 Tel: 905.856.5200 Fax: 905.695.0221
 Toll Free: 1.888.348.8991 www.mcintoshperry.com

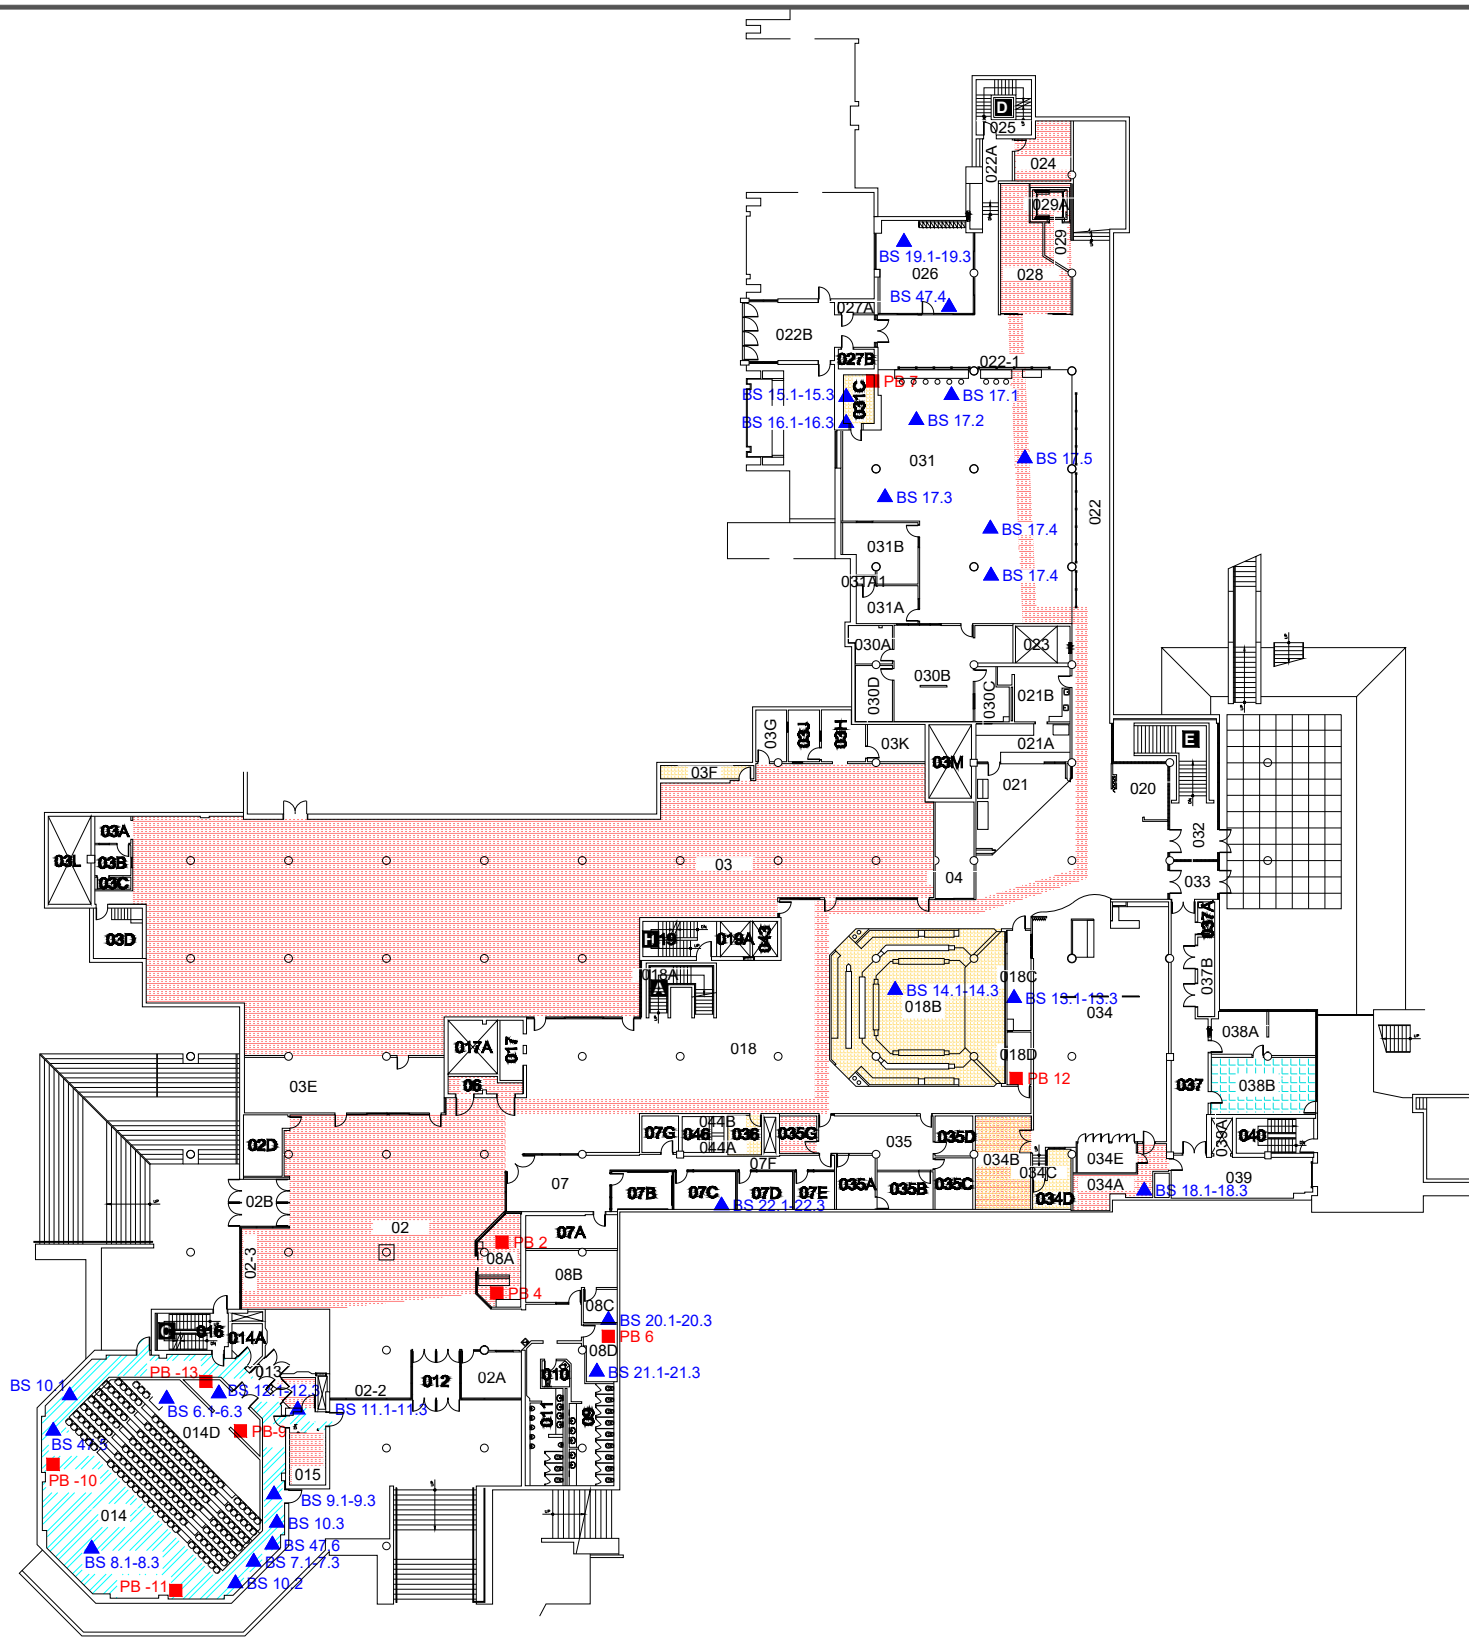
McINTOSH PERRY
 6240 HIGHWAY 7 SUITE 200 WOODBRIDGE ON L4H 4G3
 Tel: 905.856.5200 Fax: 905.695.0221
 Toll Free: 1.888.348.8991 www.mcintoshperry.com

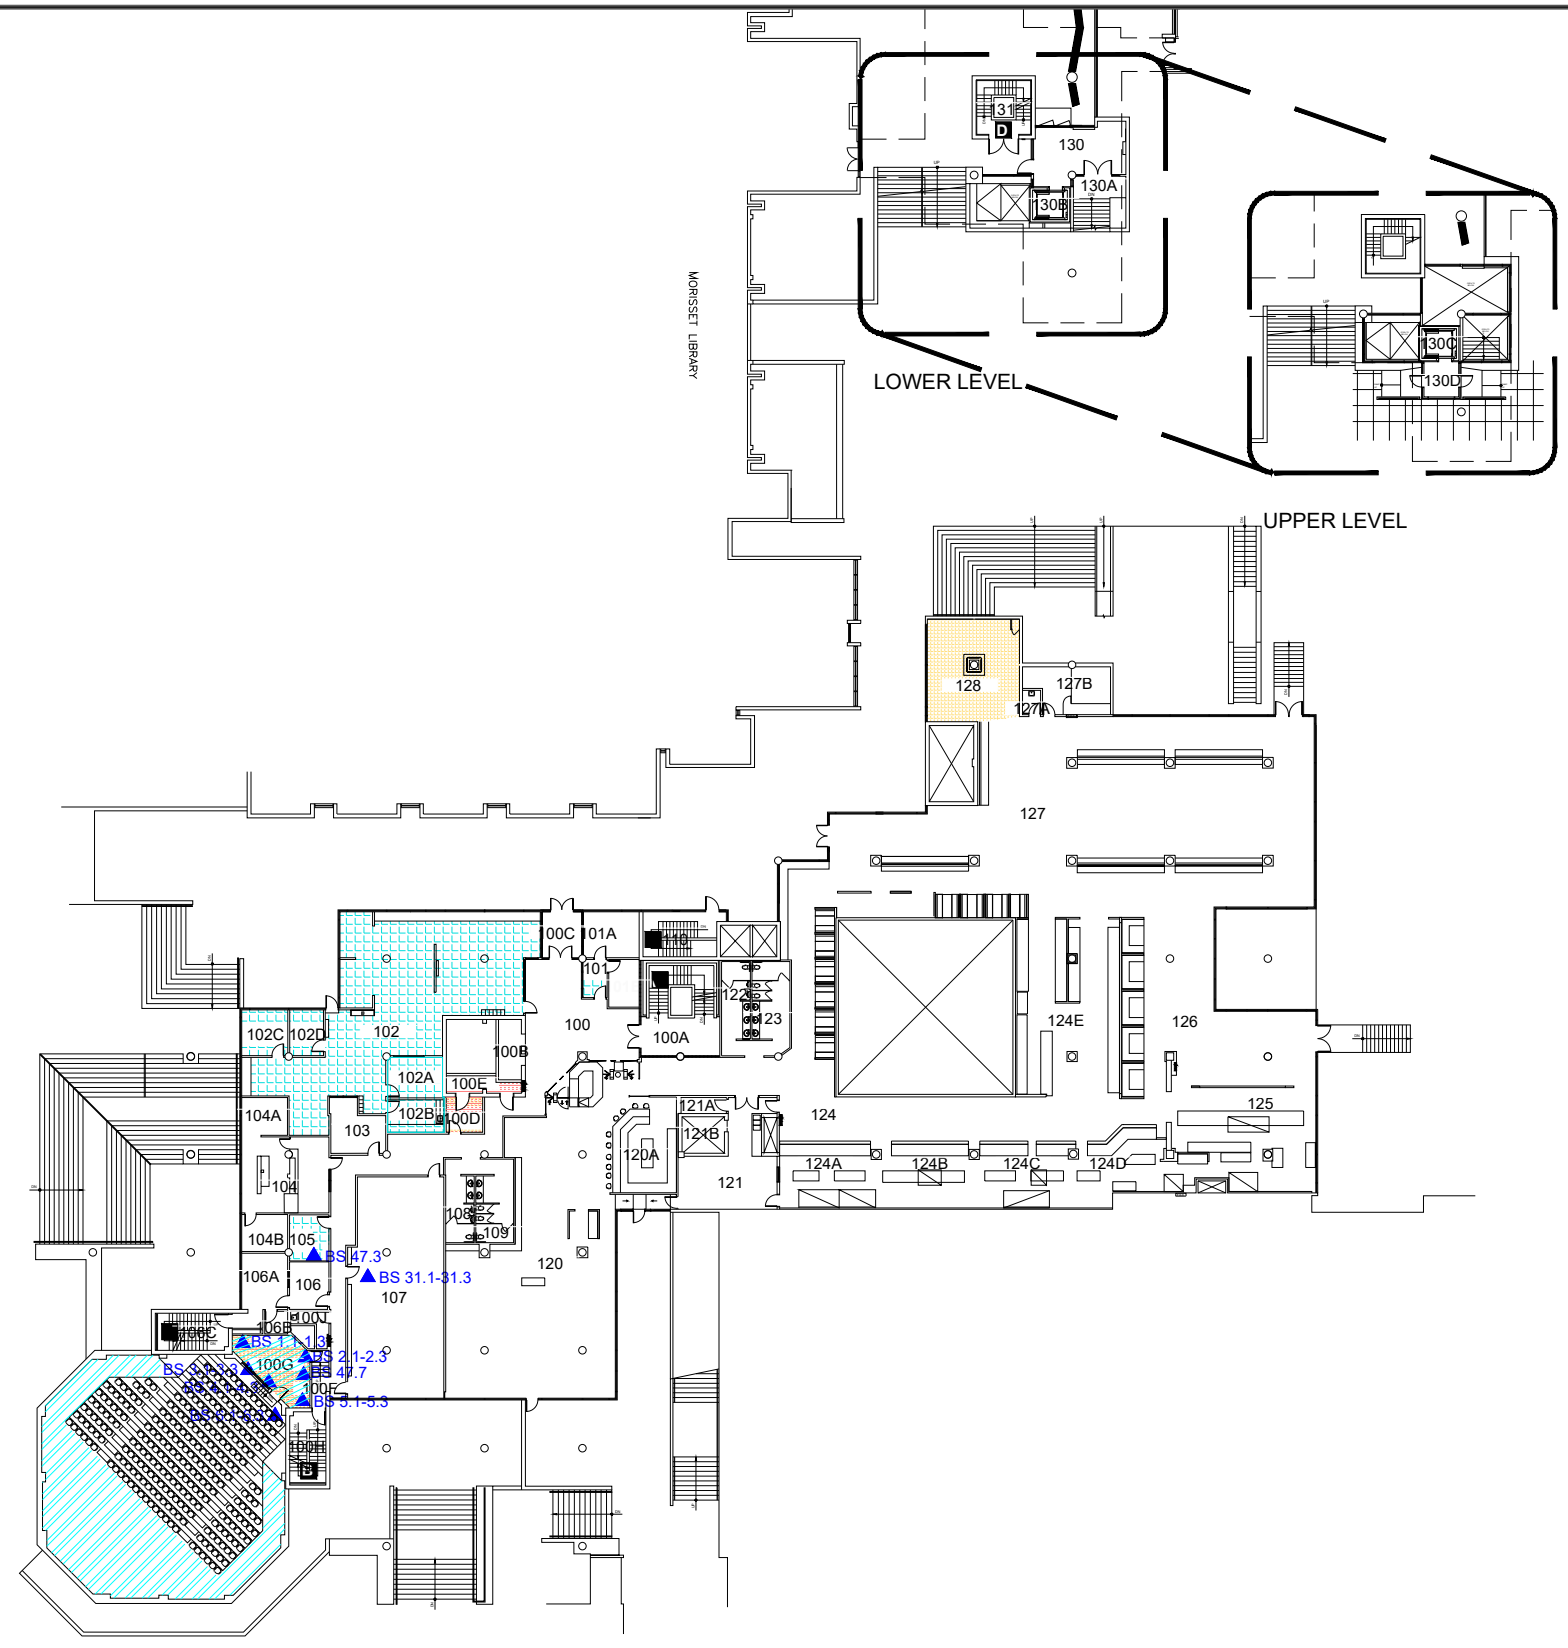
McINTOSH PERRY
 6240 HIGHWAY 7 SUITE 200 WOODBRIDGE ON L4H 4G3
 Tel: 905.856.5200 Fax: 905.695.0221
 Toll Free: 1.888.348.8991 www.mcintoshperry.com

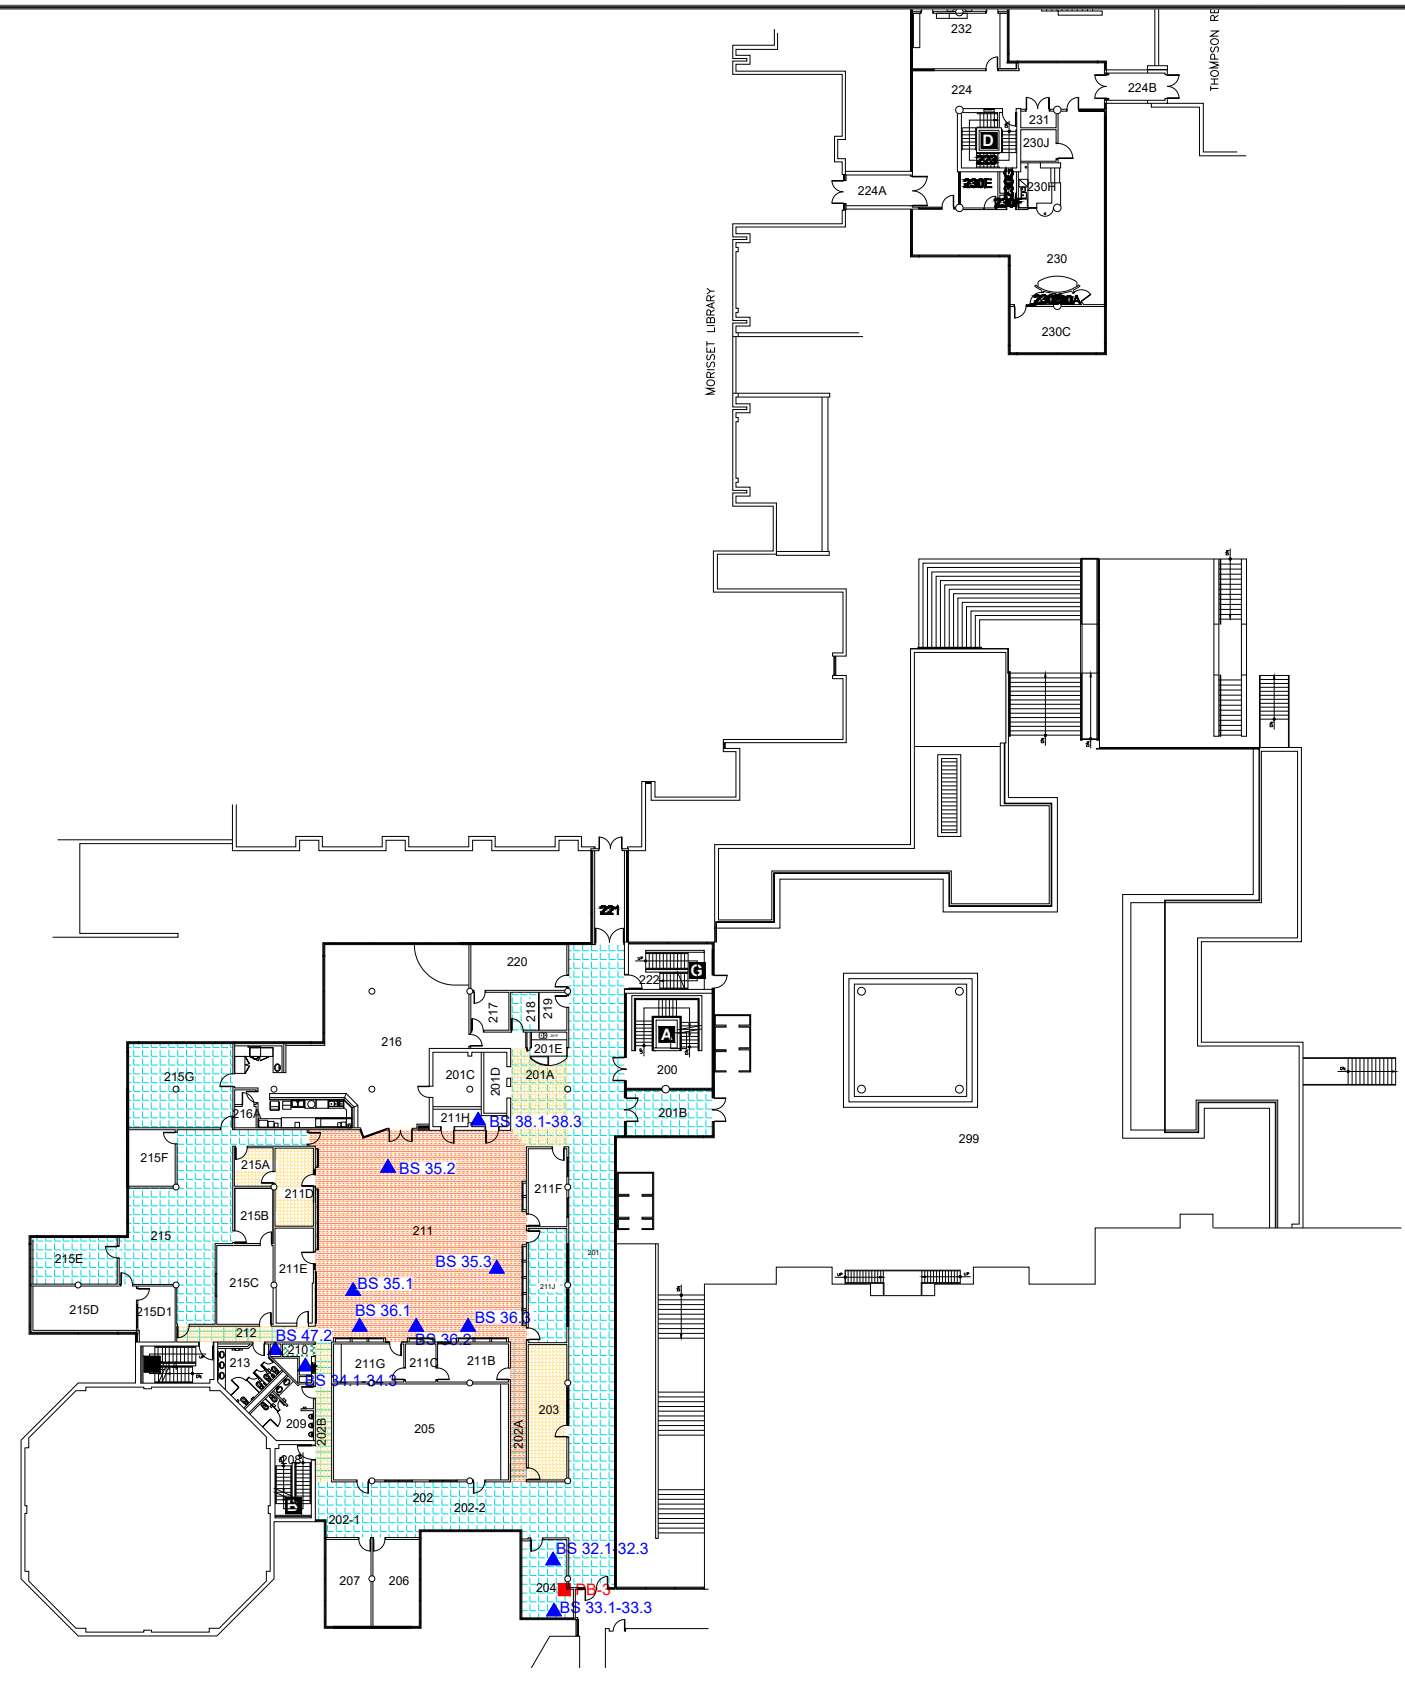
McINTOSH PERRY
 6240 HIGHWAY 7 SUITE 200 WOODBRIDGE ON L4H 4G3
 Tel: 905.856.5200 Fax: 905.695.0221
 Toll Free: 1.888.348.8991 www.mcintoshperry.com
