Type-2 Ceiling Space Investigation for Asbestos-Containing Materials

Simard Hall Building, University of Ottawa Campus, Ottawa, Ontario

BCE Project: **22-1102**

Report Issued: February 3, 2023

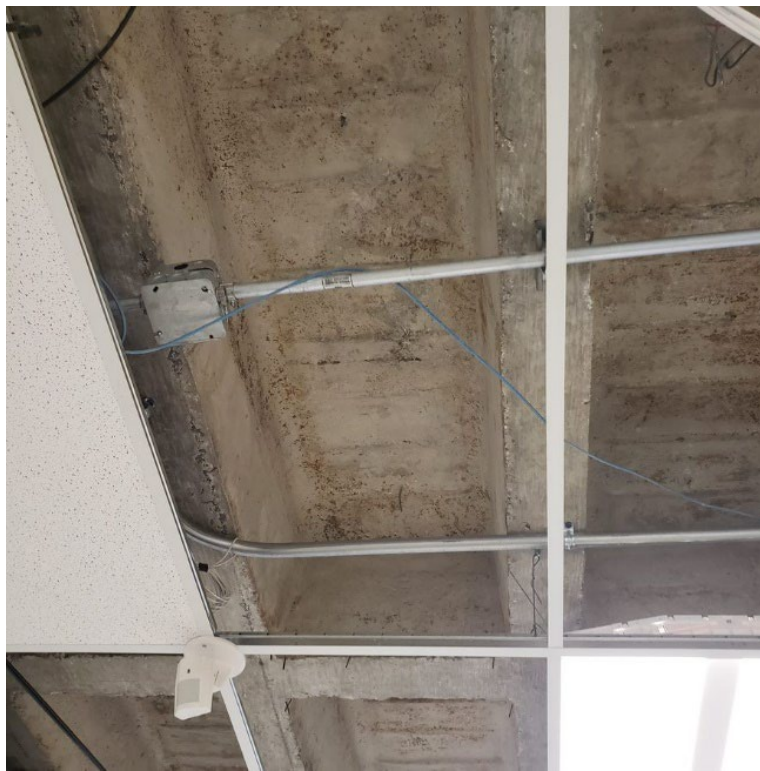
The following photo is an example of bare concrete observed during the ceiling investigation. Corrugated metal ceilings were also observed in various locations. These areas were marked with a **green** sticker.

Photo 1. Example of bare concrete ceiling.

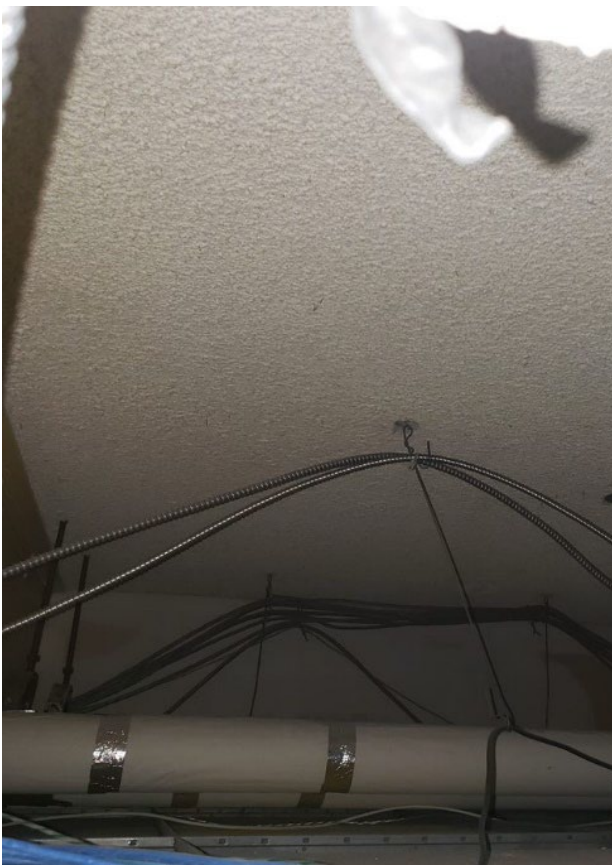
The following photos are examples of cementitious overspray on metal lathe observed during the ceiling investigation. These areas were marked with an **orange** sticker.

Photo 2. Example of cementitious overspray observed in good condition.

- Entry into ceiling spaces throughout the building where cementitious overspray was identified or smooth plaster in poor condition was identified above dropped acoustic ceiling tile grid will require Type-2 asbestos abatement precautions due to the presumed presence of asbestos-containing debris.

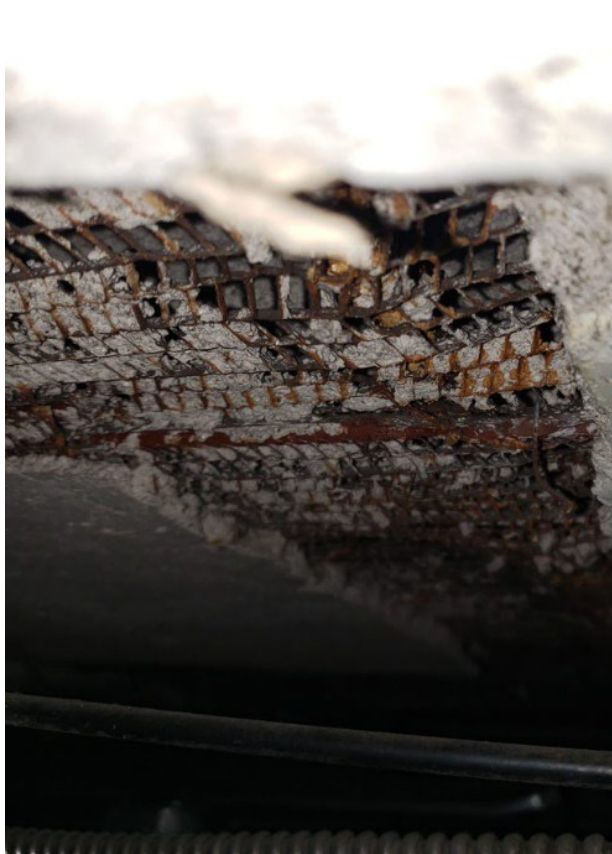
Photo 3. Example of cementitious overspray observed in poor condition.

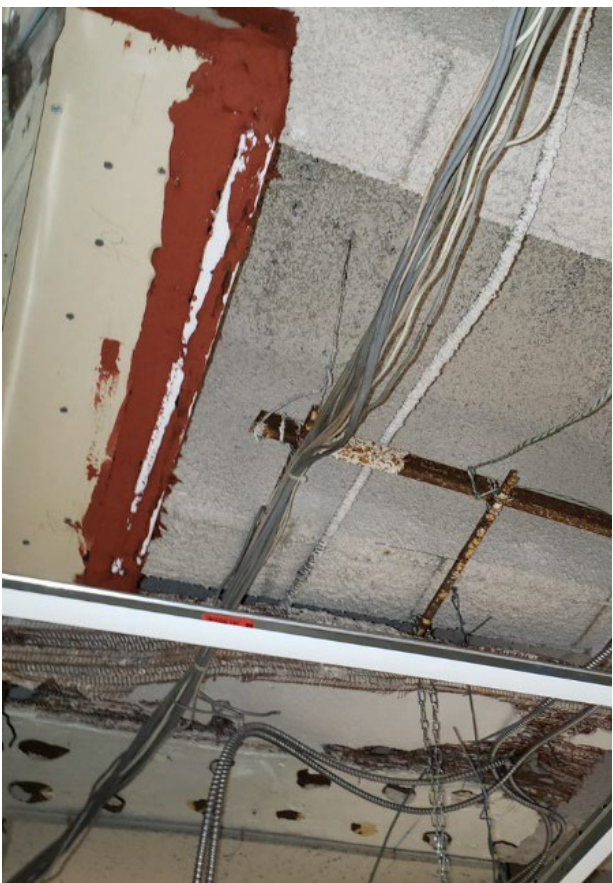
The following photos are examples of cementitious overspray on the concrete deck observed during the ceiling investigation. These areas were marked with an **orange** sticker.

Photo 4. Example of cementitious overspray on concrete deck.

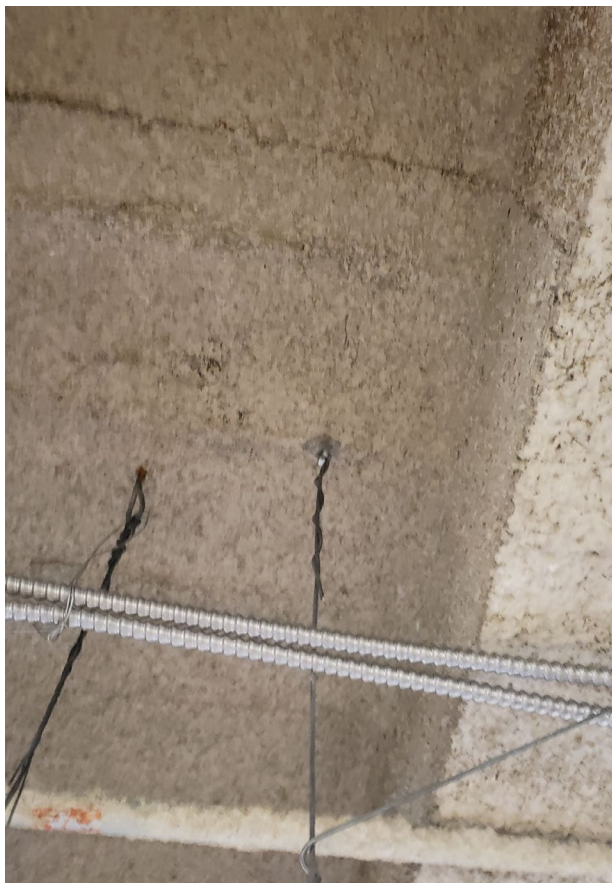
Photo 5. Example of cementitious overspray on concrete deck.

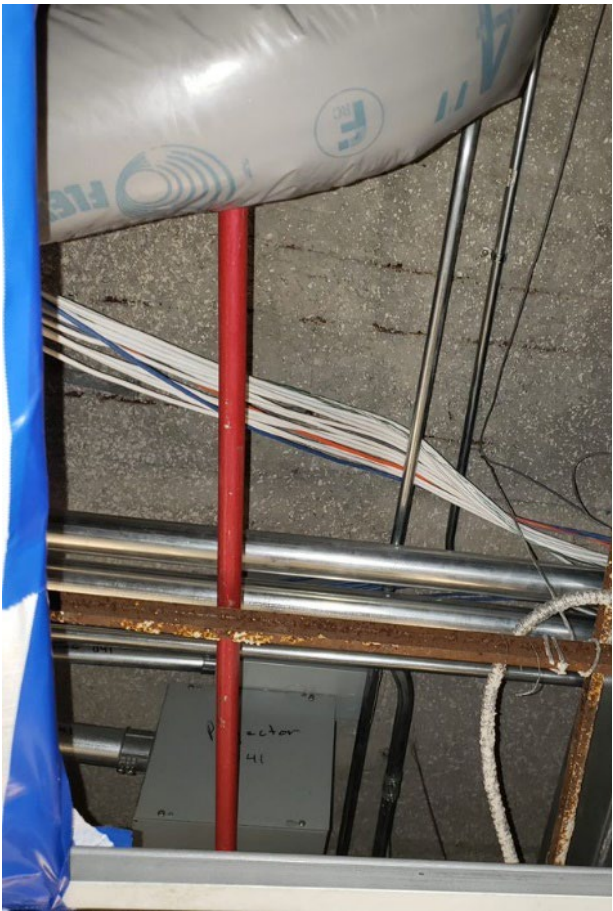
The following photos are examples of minimal cementitious overspray on the concrete deck observed during the ceiling investigation. These areas were marked with a **green** sticker.

Photo 6. View of minimal overspray on concrete deck.

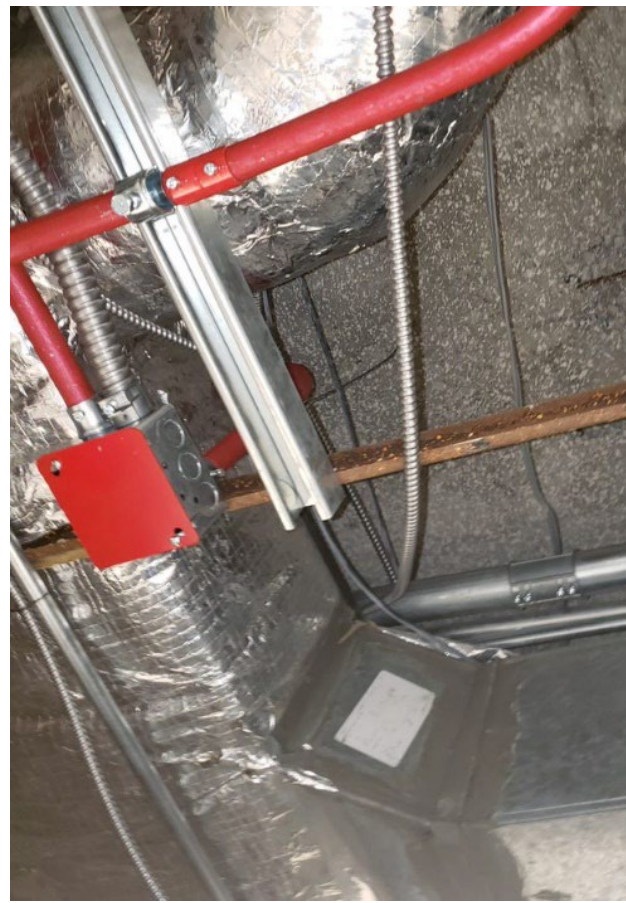
Photo 7. View of minimal overspray on concrete deck.

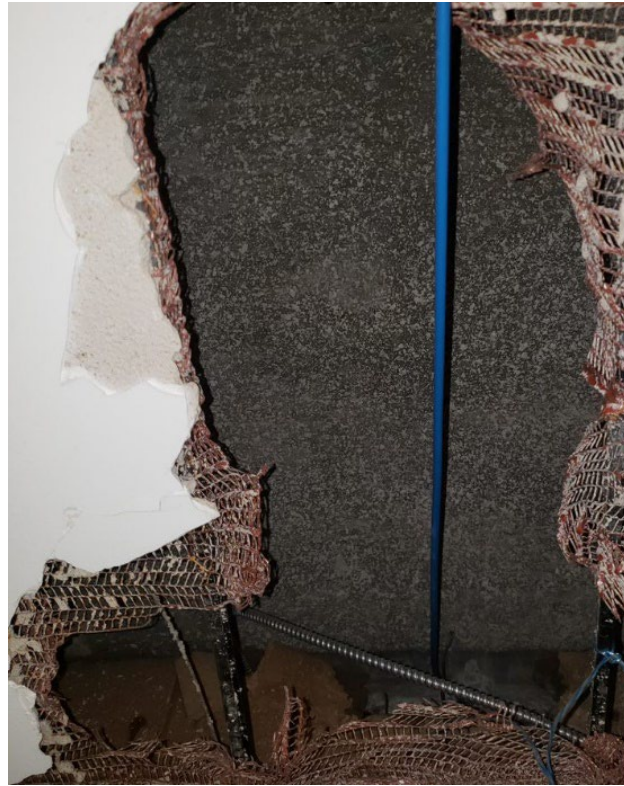
The following photos are examples of smooth plaster observed during the ceiling investigation. These areas were marked with a **green** sticker if observed in good condition, and marked with an **orange** sticker if observed in poor condition.

Photo 9. Example of smooth plaster in poor condition.

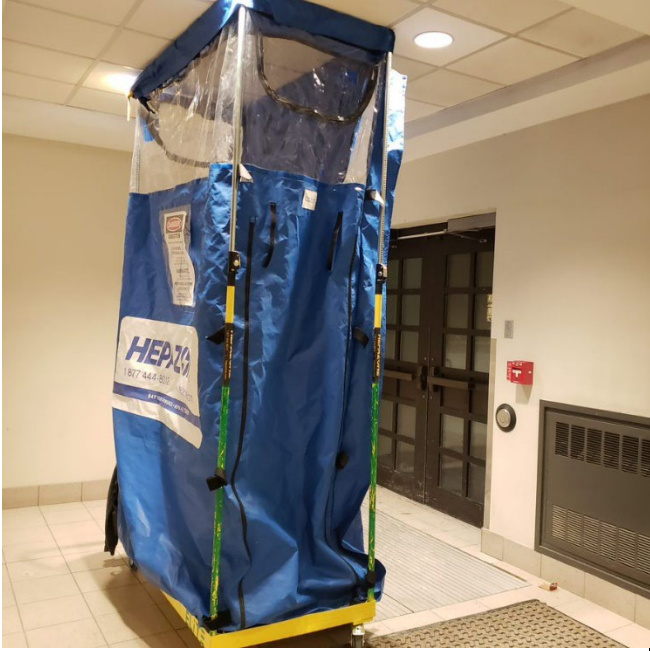
<p>View of Type 2 (intermediate/Moderate Risk) mobile containment used during the ceiling space investigation.</p>
2

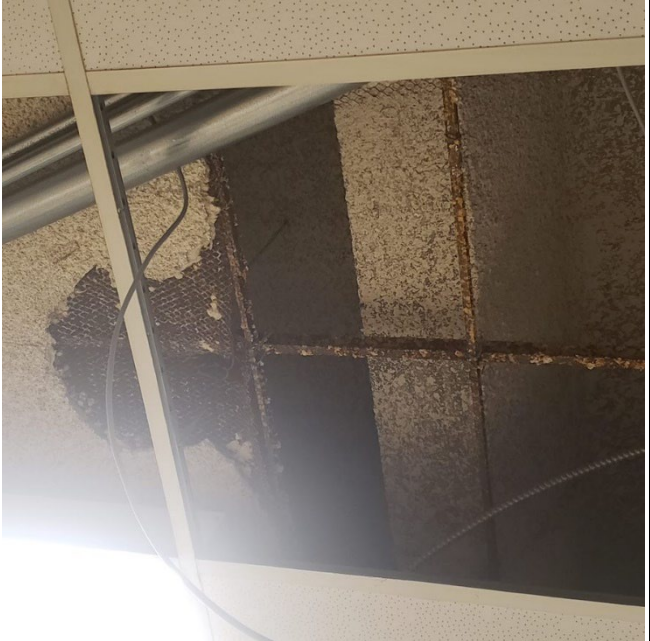
<p>Example of asbestos-containing cementitious overspray on metal lathe, with overspray observed on the concrete deck.</p>

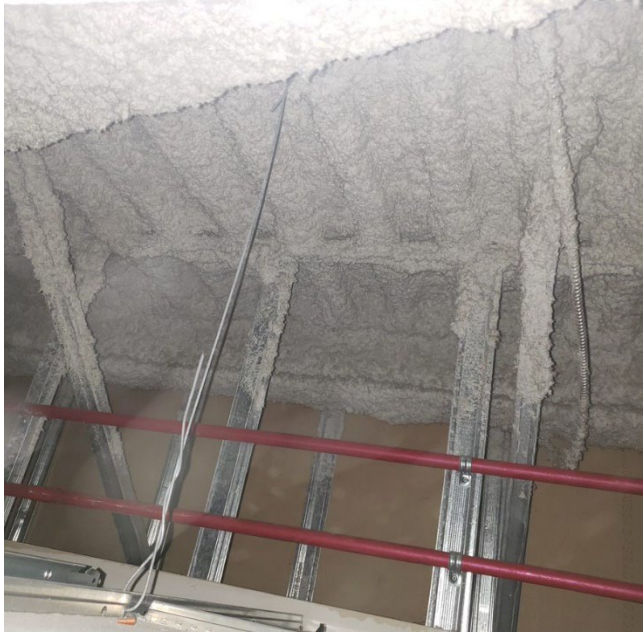
View of non asbestos-contain sprayed fireproofing within 035 corridor above 2' x 2' acoustic ceiling tiles.

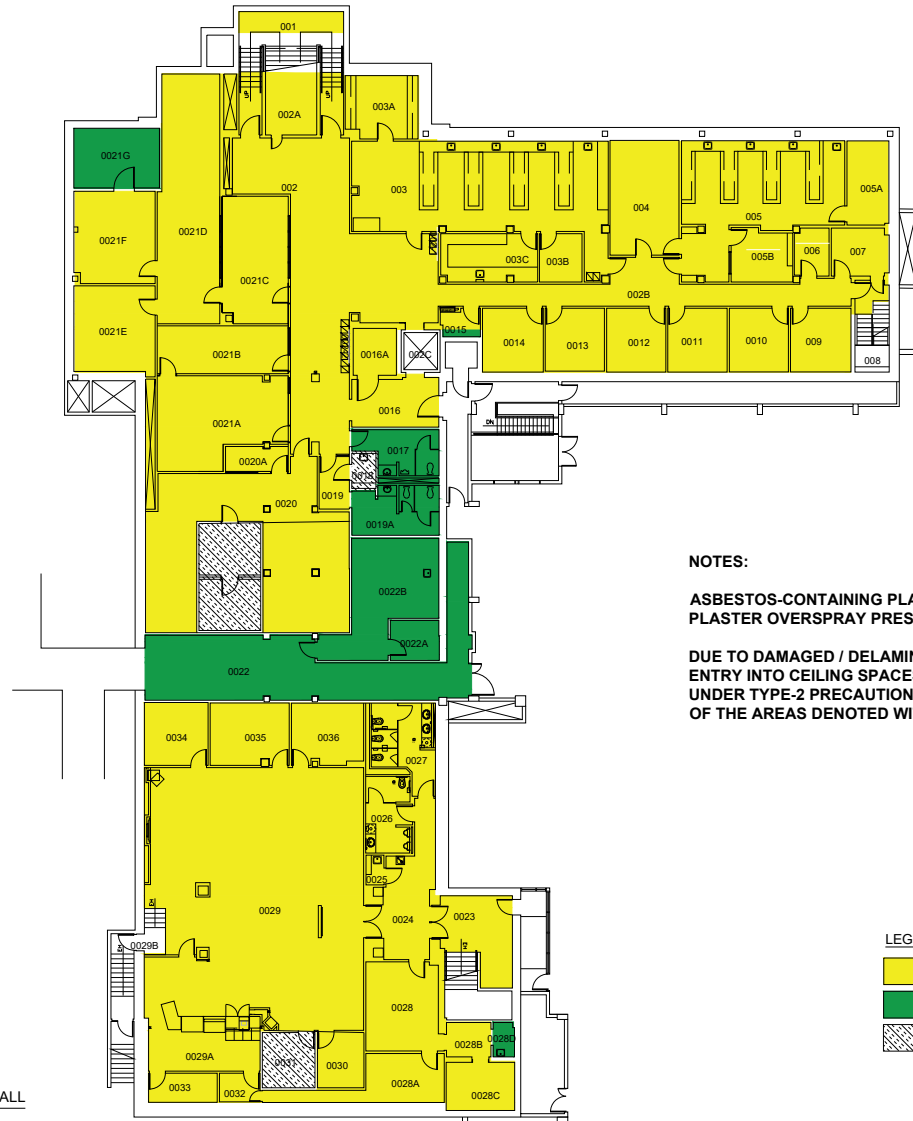
1 LEVEL 00 FLOOR PLAN, SIMARD HALL
NTS

ASBESTOS-CONTAINING PLASTER AND CEMENTITIOUS PLASTER OVERSPRAY PRESENT THROUGHOUT

DUE TO DAMAGED / DELAMINATING PLASTER, ALL ENTRY INTO CEILING SPACES MUST BE COMPLETED UNDER TYPE-2 PRECAUTIONS, WITH THE EXCEPTION OF THE AREAS DENOTED WITH GREEN.

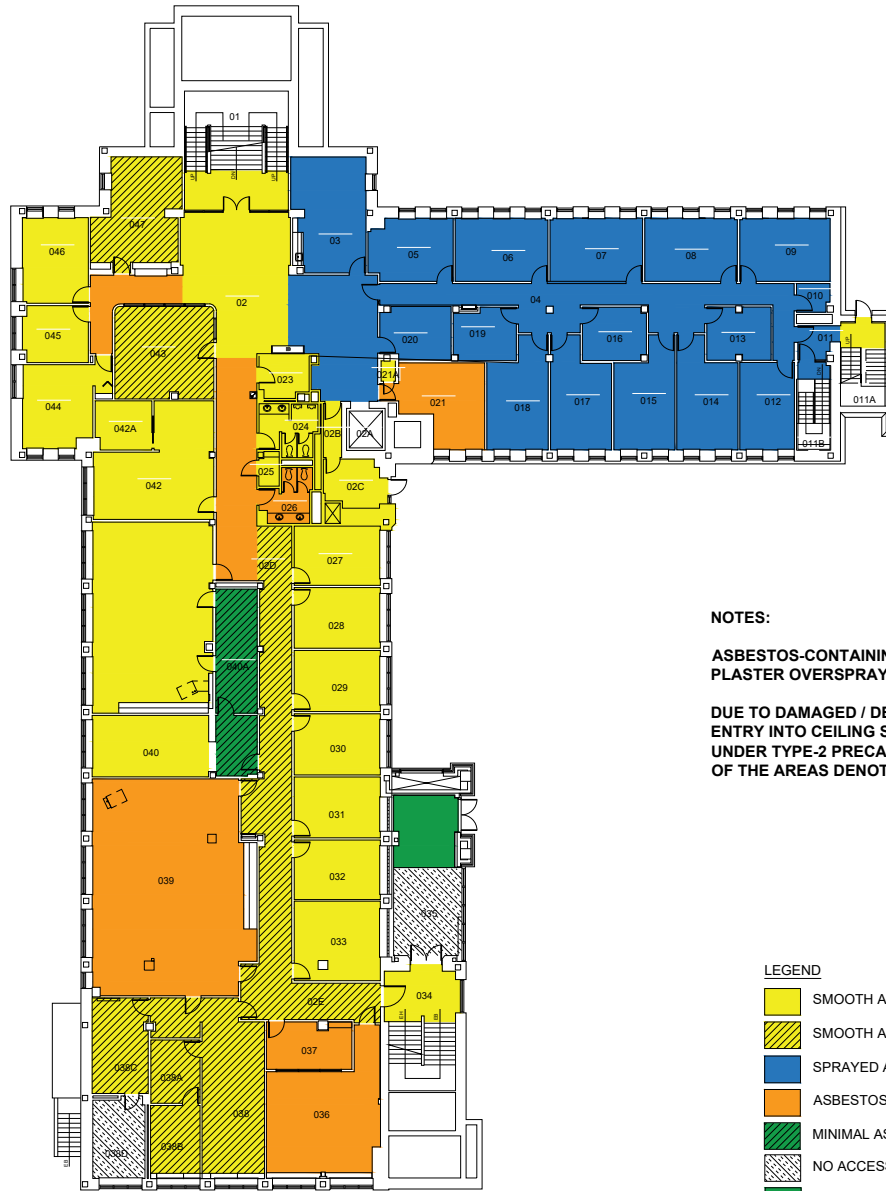
1 LEVEL 0 FLOOR PLAN, SIMARD HALL
NTS

ASBESTOS-CONTAINING PLASTER AND CEMENTITIOUS PLASTER OVERSPRAY PRESENT THROUGHOUT

DUE TO DAMAGED / DELAMINATING PLASTER, ALL ENTRY INTO CEILING SPACES MUST BE COMPLETED UNDER TYPE-2 PRECAUTIONS, WITH THE EXCEPTION OF THE AREAS DENOTED WITH GREEN.

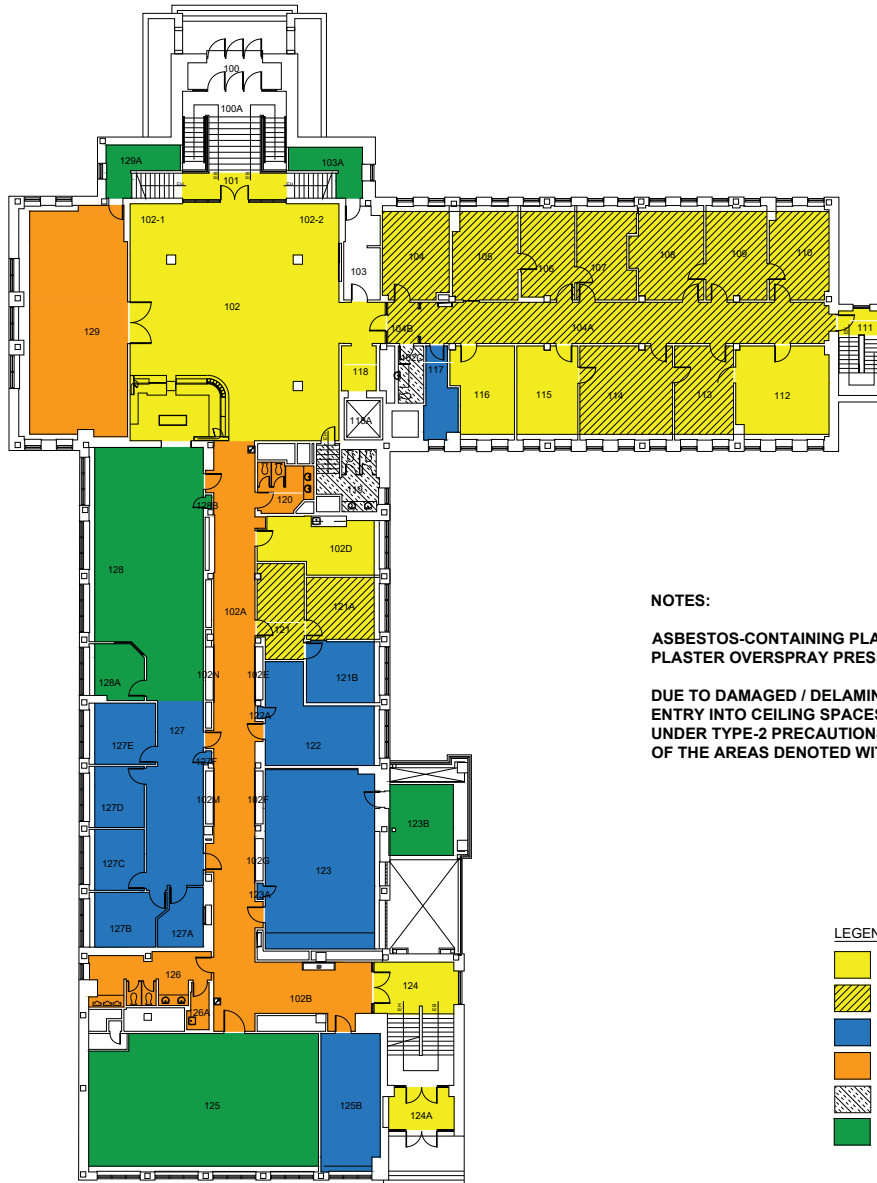
1 LEVEL 1 FLOOR PLAN, SIMARD HALL
NTS

ASBESTOS-CONTAINING PLASTER AND CEMENTITIOUS PLASTER OVERSPRAY PRESENT THROUGHOUT

DUE TO DAMAGED / DELAMINATING PLASTER, ALL ENTRY INTO CEILING SPACES MUST BE COMPLETED UNDER TYPE-2 PRECAUTIONS, WITH THE EXCEPTION OF THE AREAS DENOTED WITH GREEN.
